National Rivers Authority

IMPACT ASSESSMENT OF MELDON QUARRY ON WATER QUALITY IN THE WEST OKEMENT RIVER

FWI/91/002

Author: Dr R.P. Smlth

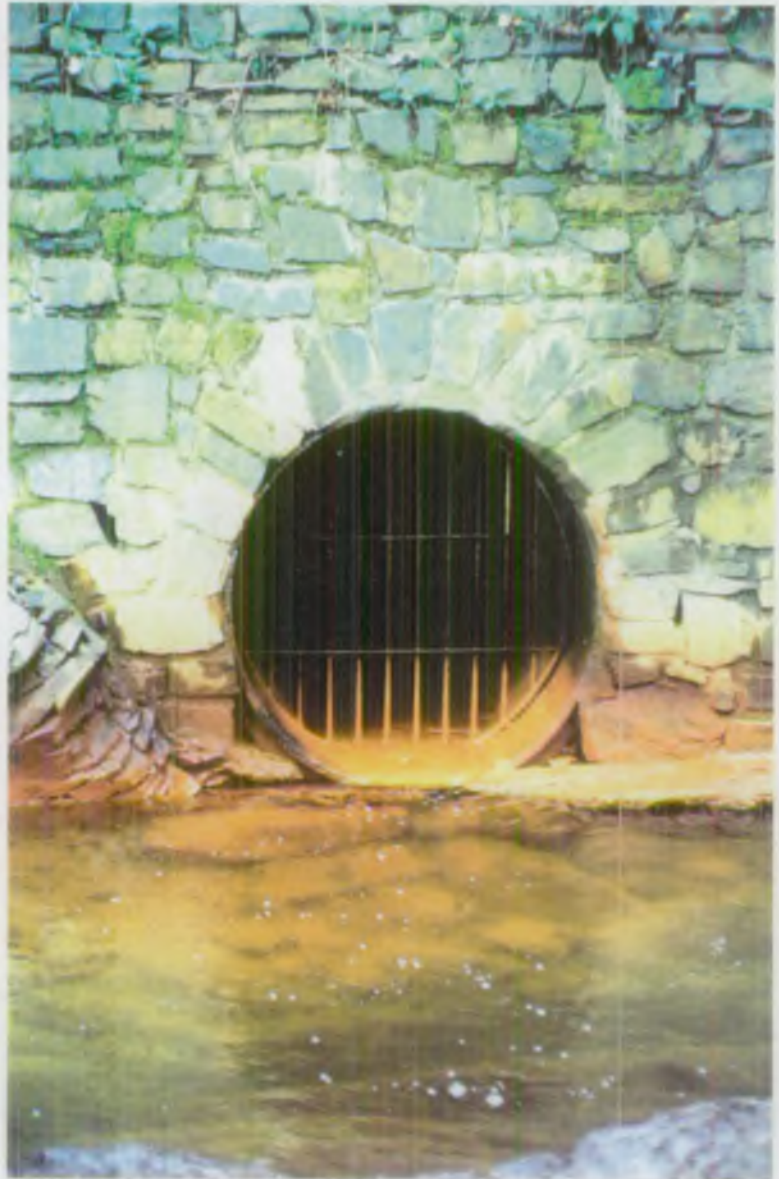
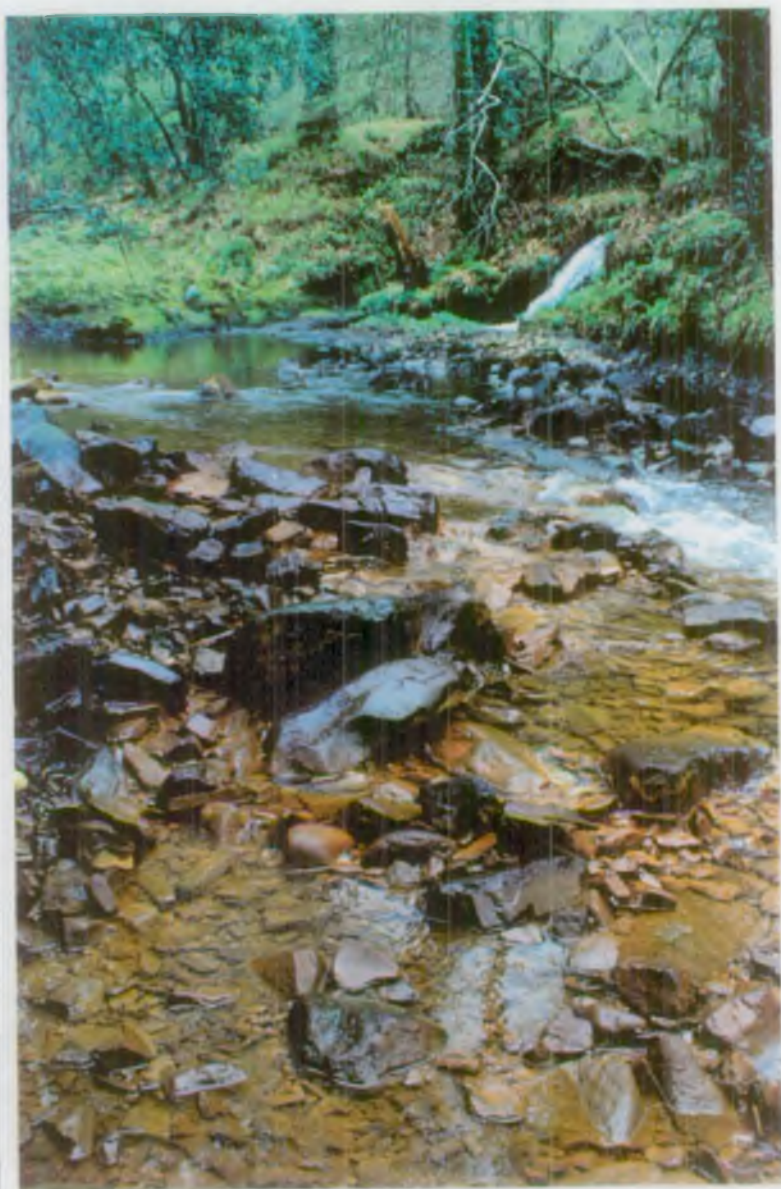
Iron biofouling commonly occurs when air comes in contact with non-acidic groundwater that is rich in soluble iron. Iron precipitating bacteria thrive in these conditions and promote the oxidation of iron-organic complexes and the precipitation of iron hydroxide.

**Iron hydroxide deposits in the drainage adit from Meldon Quarry
and in the West Okement River downstream of the drainage adit**

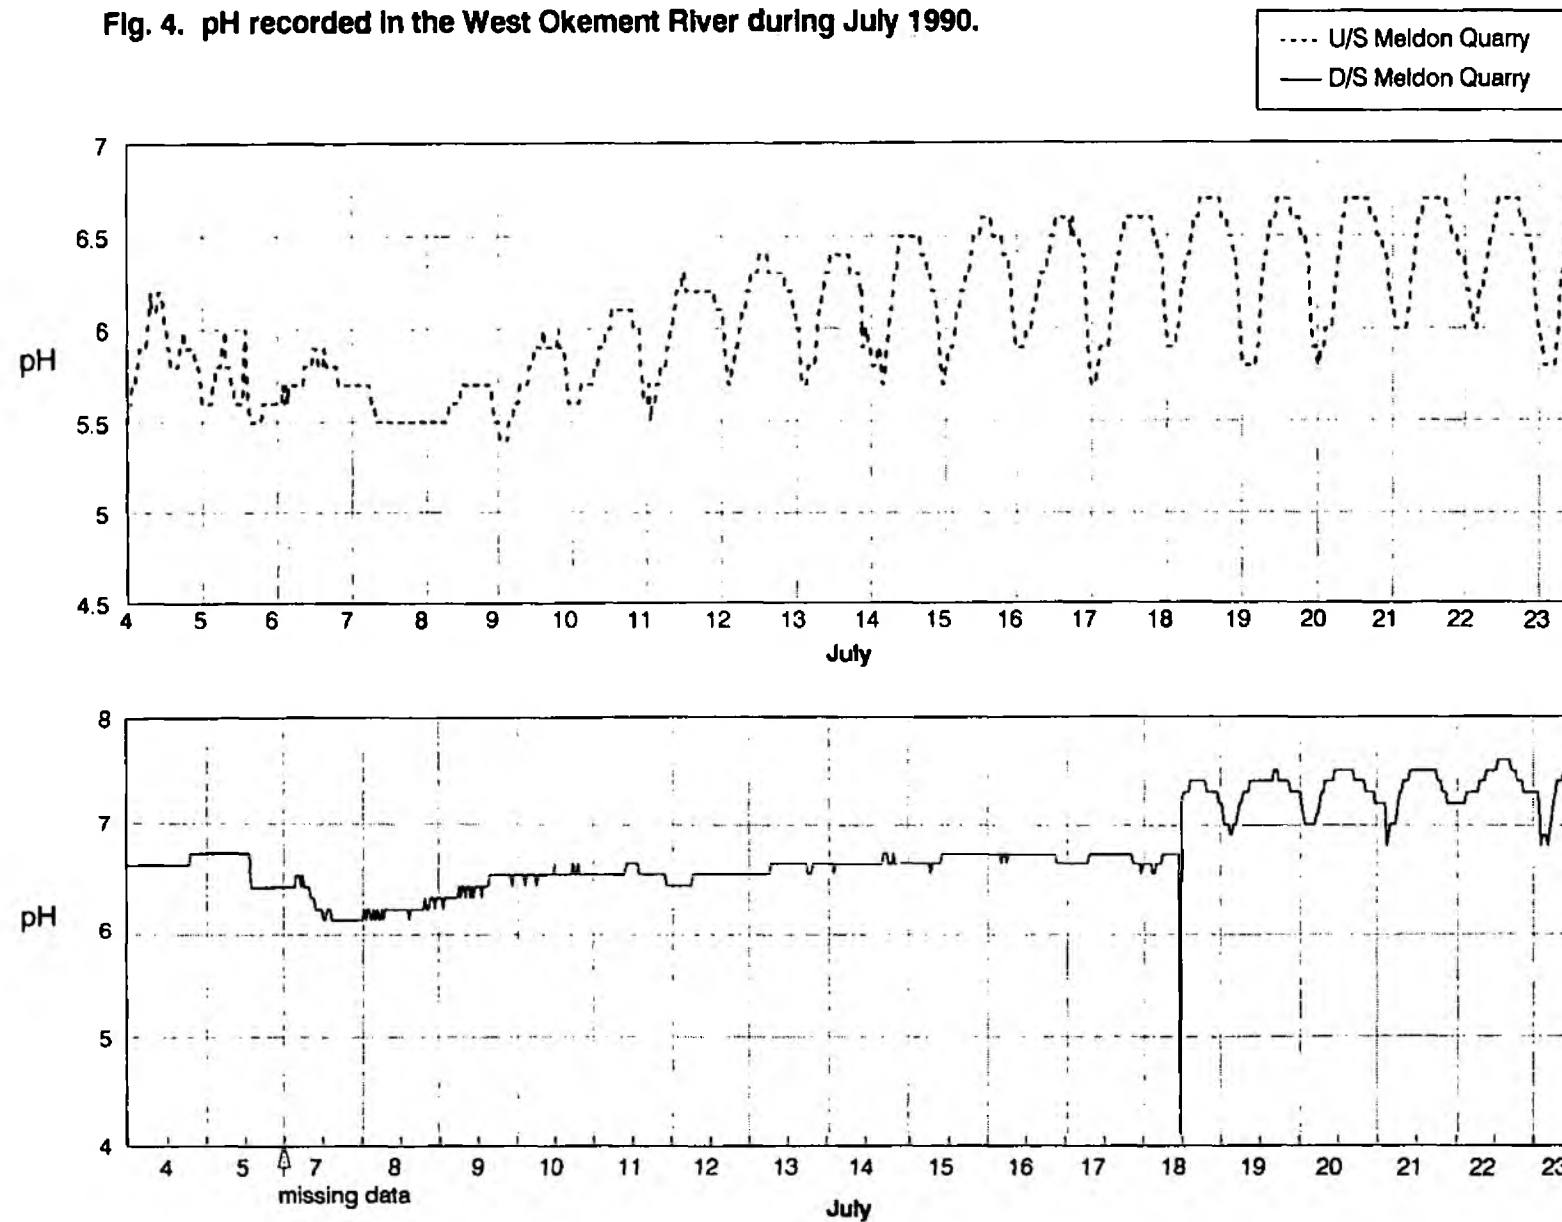
Fig. 4. pH recorded in the West Okement River during July 1990.

Following rainfall on 4 July, pH in the West Okement River upstream of Meldon Quarry became more acidic, changing from pH 6.2 to pH 5.5 and exceeded the lower limit of the EQS (see Fig. 4). The river's acidity decreased as flows receded and a maximum of pH 6.7 was recorded. There was a marked diurnal pH variation during low flows with pH exceeding the lower limit of the EQS during the evening.

pH monitored downstream of Meldon Quarry appeared to be incorrect (see Fig. 4). The data was too consistent and did not conform to expected diurnal variations (except 18-23 July 1990). Consequently the pH data was not used.

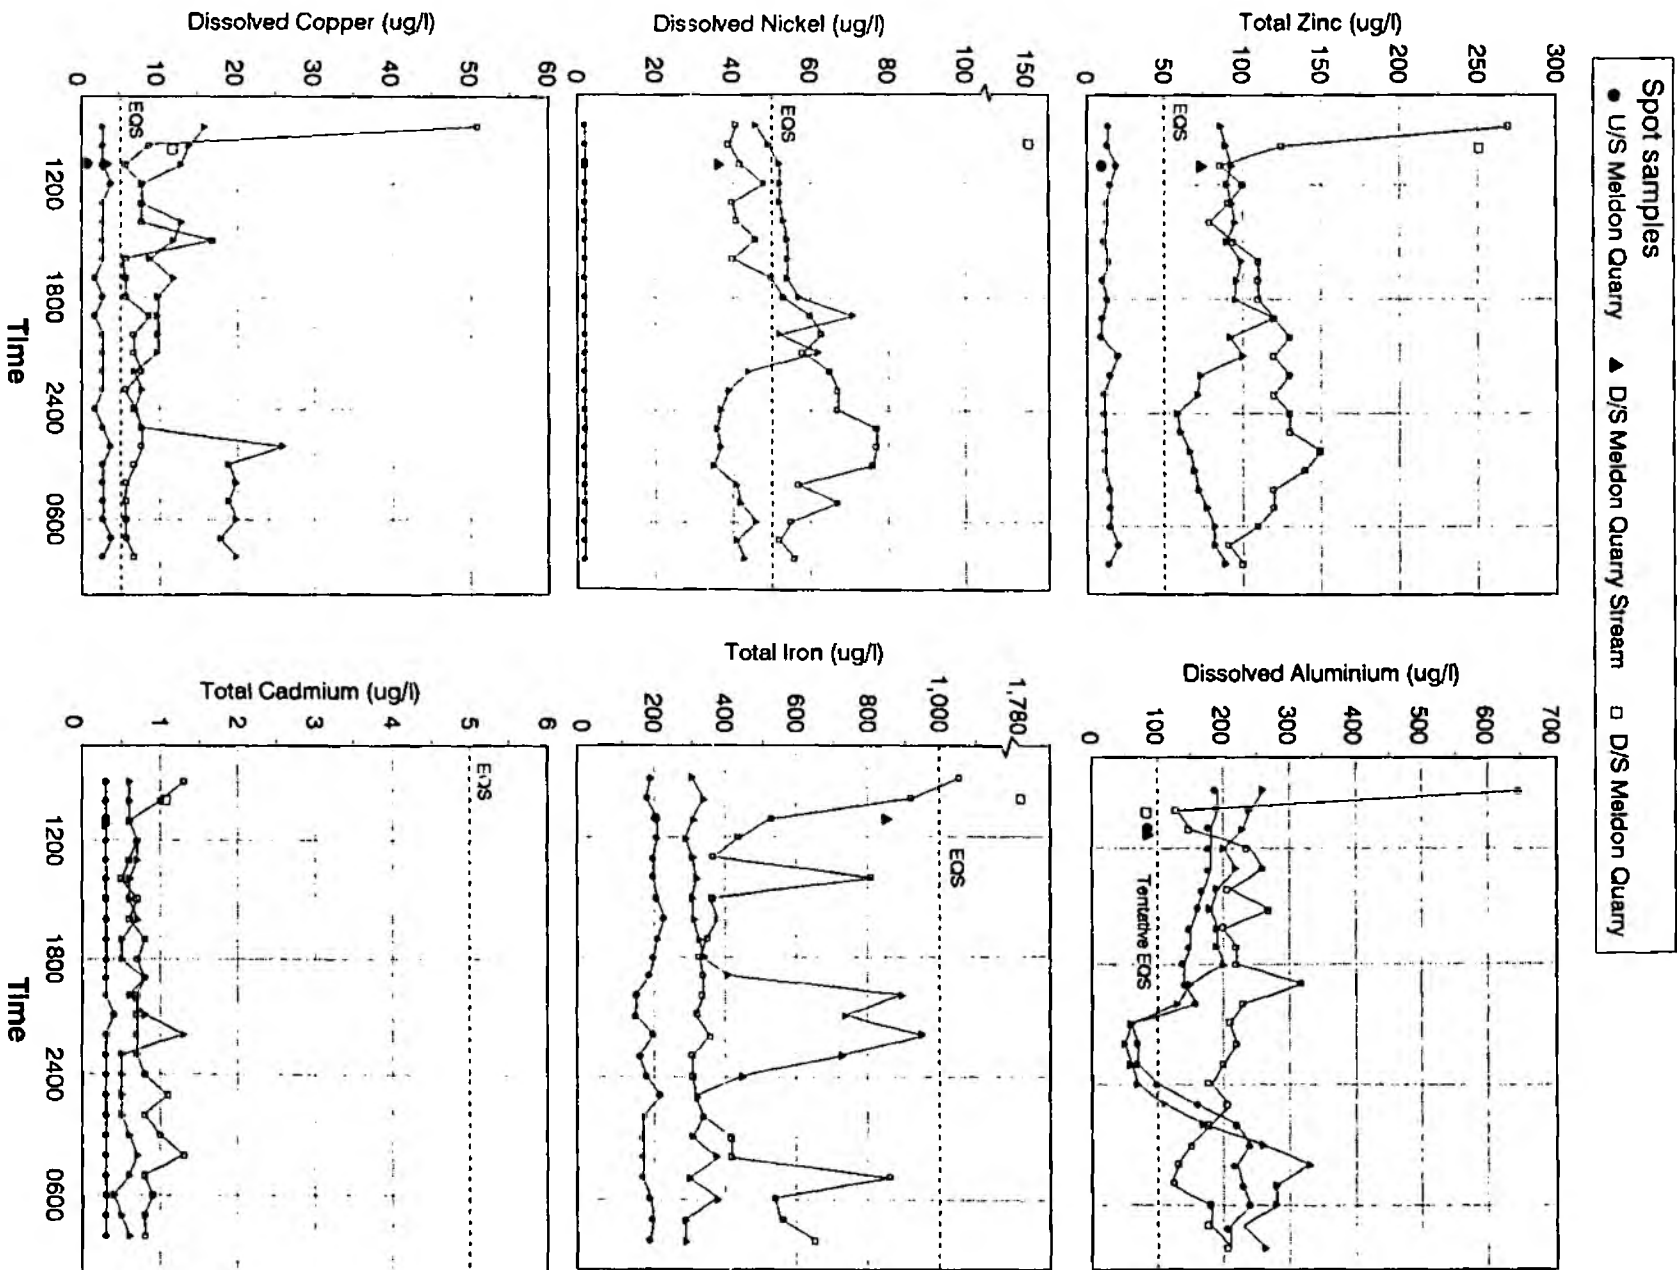
Fig. 5. Water quality in the West Okement River on 4-5 July 1990.

All metal concentrations (except aluminium) were higher downstream of Meldon Quarry and the Meldon Quarry Stream compared to those found upstream (see Fig. 5).

Concentrations of zinc, nickel and copper downstream of Meldon Quarry exceeded the relevant EQS's. Metal concentrations upstream of Meldon Quarry were within the relevant EQS's.

There were marked differences between samples collected by autosamplers and those collected as spot samples at the same site and at approximately the same time (see Fig. 5). It had been noticed that a layer of metals could adsorb onto the sides of the autosample bottles. This layer accumulates during the autosampling period and may explain why spot samples have higher concentrations than those found in samples from the autosampler.

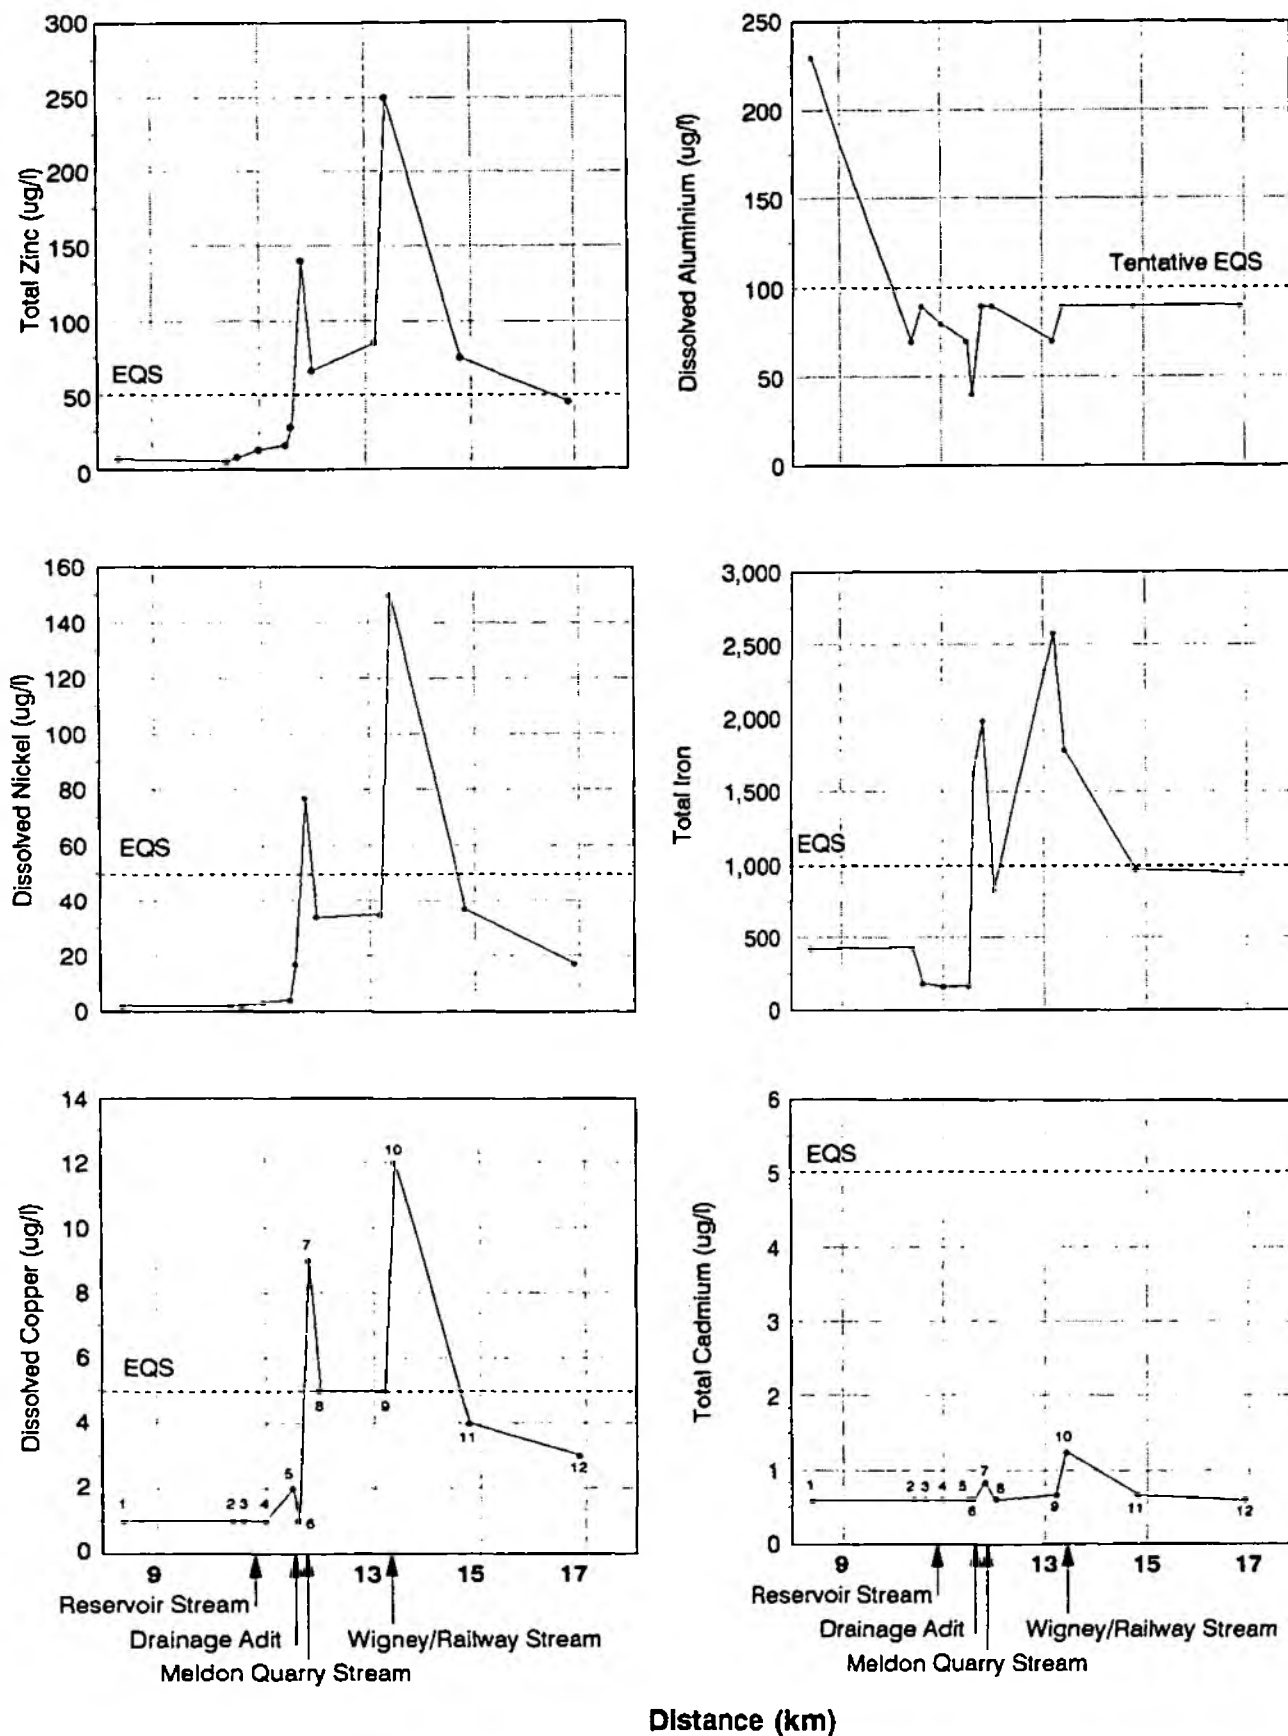
Fig. 6. Water quality at sites along the West Okement River during 4 July 1990

Metal concentrations (except aluminium and cadmium) in the West Okement River exceeded the relevant EQS's downstream of the Meldon Quarry Stream and downstream of the confluence of the Wigney/Railway Streams (see Fig. 6).

Aluminium concentrations exceeded the tentative EQS adopted by NRA SW in the West Okement River above Meldon Reservoir. Downstream of Meldon Reservoir aluminium concentrations remained below the EQS.

The discharge from the drainage adit only increased iron concentrations in the West Okement River to levels above the EQS.

Iron concentrations in the West Okement River exceeded the EQS downstream of the Fowley Stream. The cause of this increase was almost certainly due to the poor water quality found in the Fowley Stream (see above). Poor water quality in the Fowley Stream did not increase nickel, copper, aluminium or cadmium concentrations in the West Okement River above their relevant EQS's. The effect of the Fowley Stream on zinc concentrations in the West Okement River is unknown because the water quality in the West Okement River was already impacted upstream. Further investigation is needed to assess the cause of poor water quality in the Fowley Stream and its impact on water quality in the West Okement River.

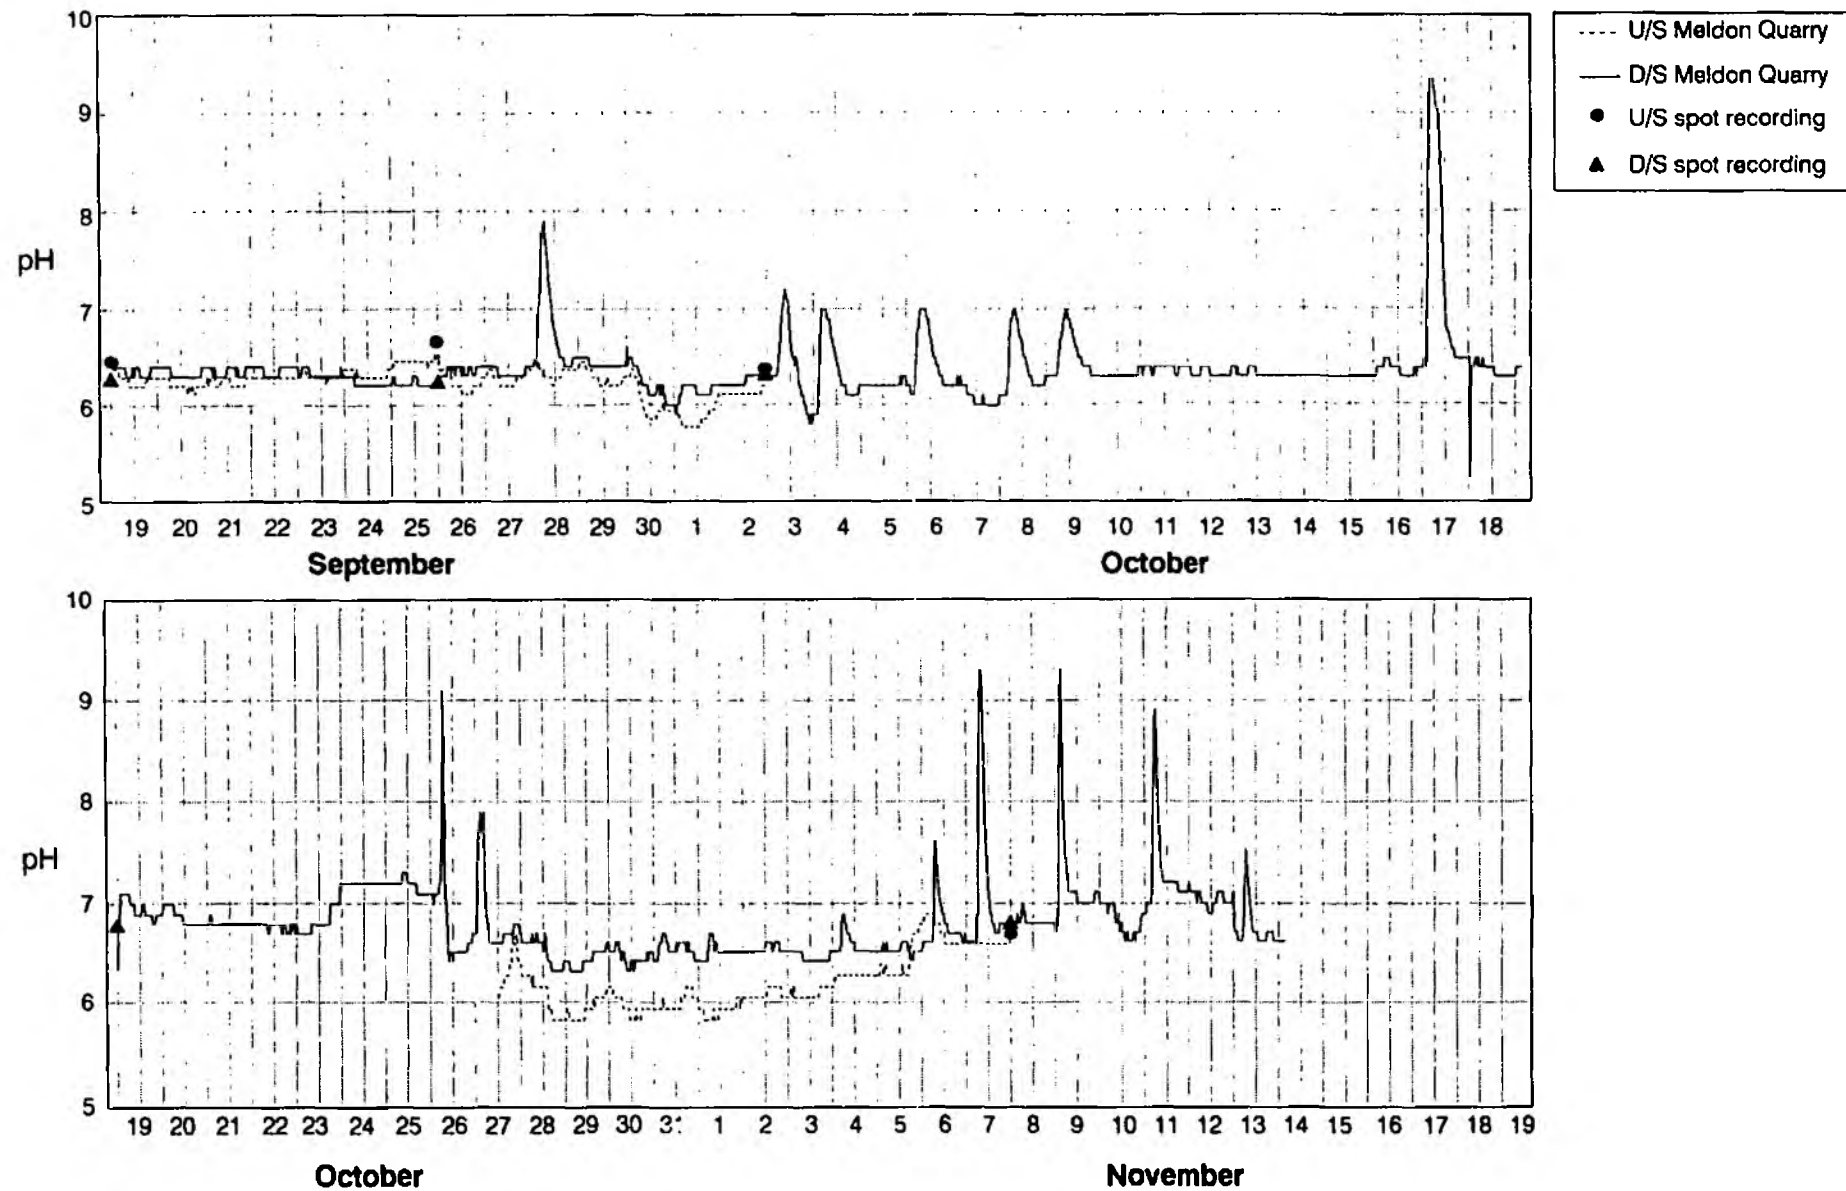
Fig. 7. pH recorded in the West Okement River during September to November 1990.

During rainfall at the end of October 1990, the automatic water quality monitor recorded a pH change from pH 6.7 to pH 5.9 upstream of Meldon Quarry (see Fig. 7). pH values downstream of Meldon Quarry did not change but remained around pH 6.5.

High pH peaks (up to pH 9.3) occurred in the West Okement River downstream of the discharges from Meldon Quarry. These exceeded the upper EQS (=pH 9.0) during October and November. Similar peaks did not occur upstream of the discharges from Meldon Quarry.

Ad hoc lime treatment of discharges by Meldon Quarry was the cause of high pH peaks that occurred in the West Okement River downstream of Meldon Quarry (see Fig. 7). This was brought to the attention of the quarry

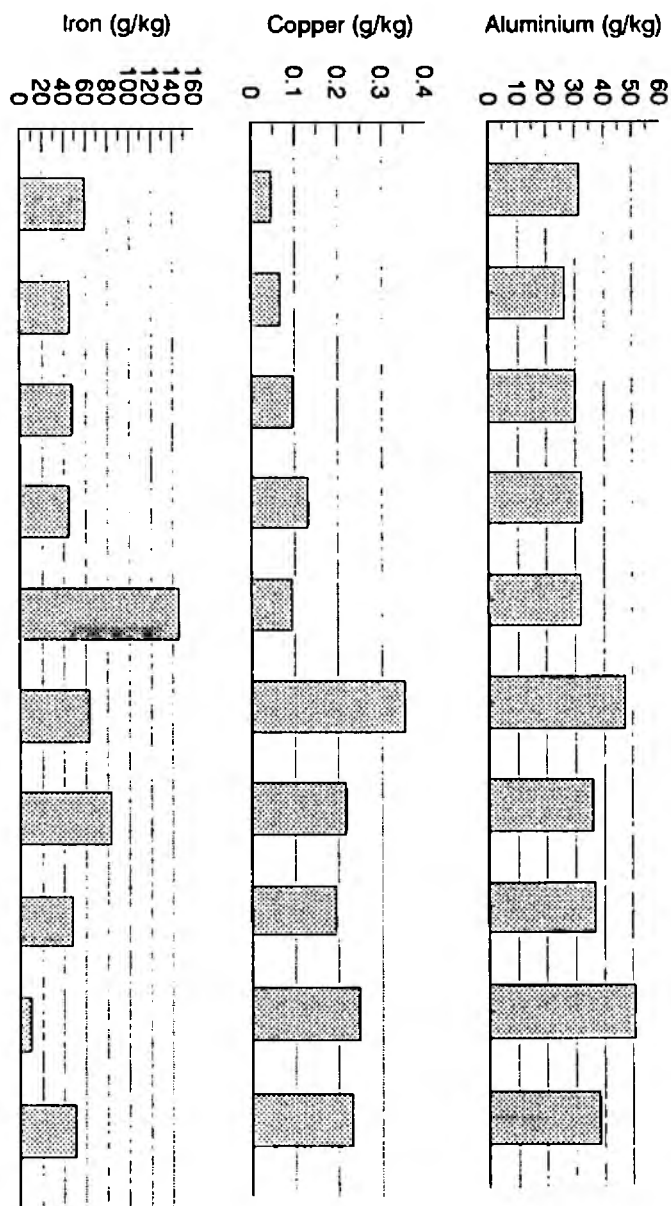
Fig. 9. Metal concentrations in river sediments collected from the West Okement River on 9 August 1990.

A significant increase in iron concentration was found in river sediments collected from the West Okement River downstream of the drainage adit from Meldon Quarry compared with the upstream control site (see Fig. 9). Copper concentrations were higher in river sediments in the West Okement River downstream of the Meldon Quarry Stream compared with the upstream control site.
