**An Investigation into the Frequency of
Discharge of three Combined Sewer Overflows
in the Afan/Kenfig Catchment**

NATIONAL RIVERS AUTHORITY

Tech. Memo Ref: TM/EAW/96/06
Author - Jenkins M.J.

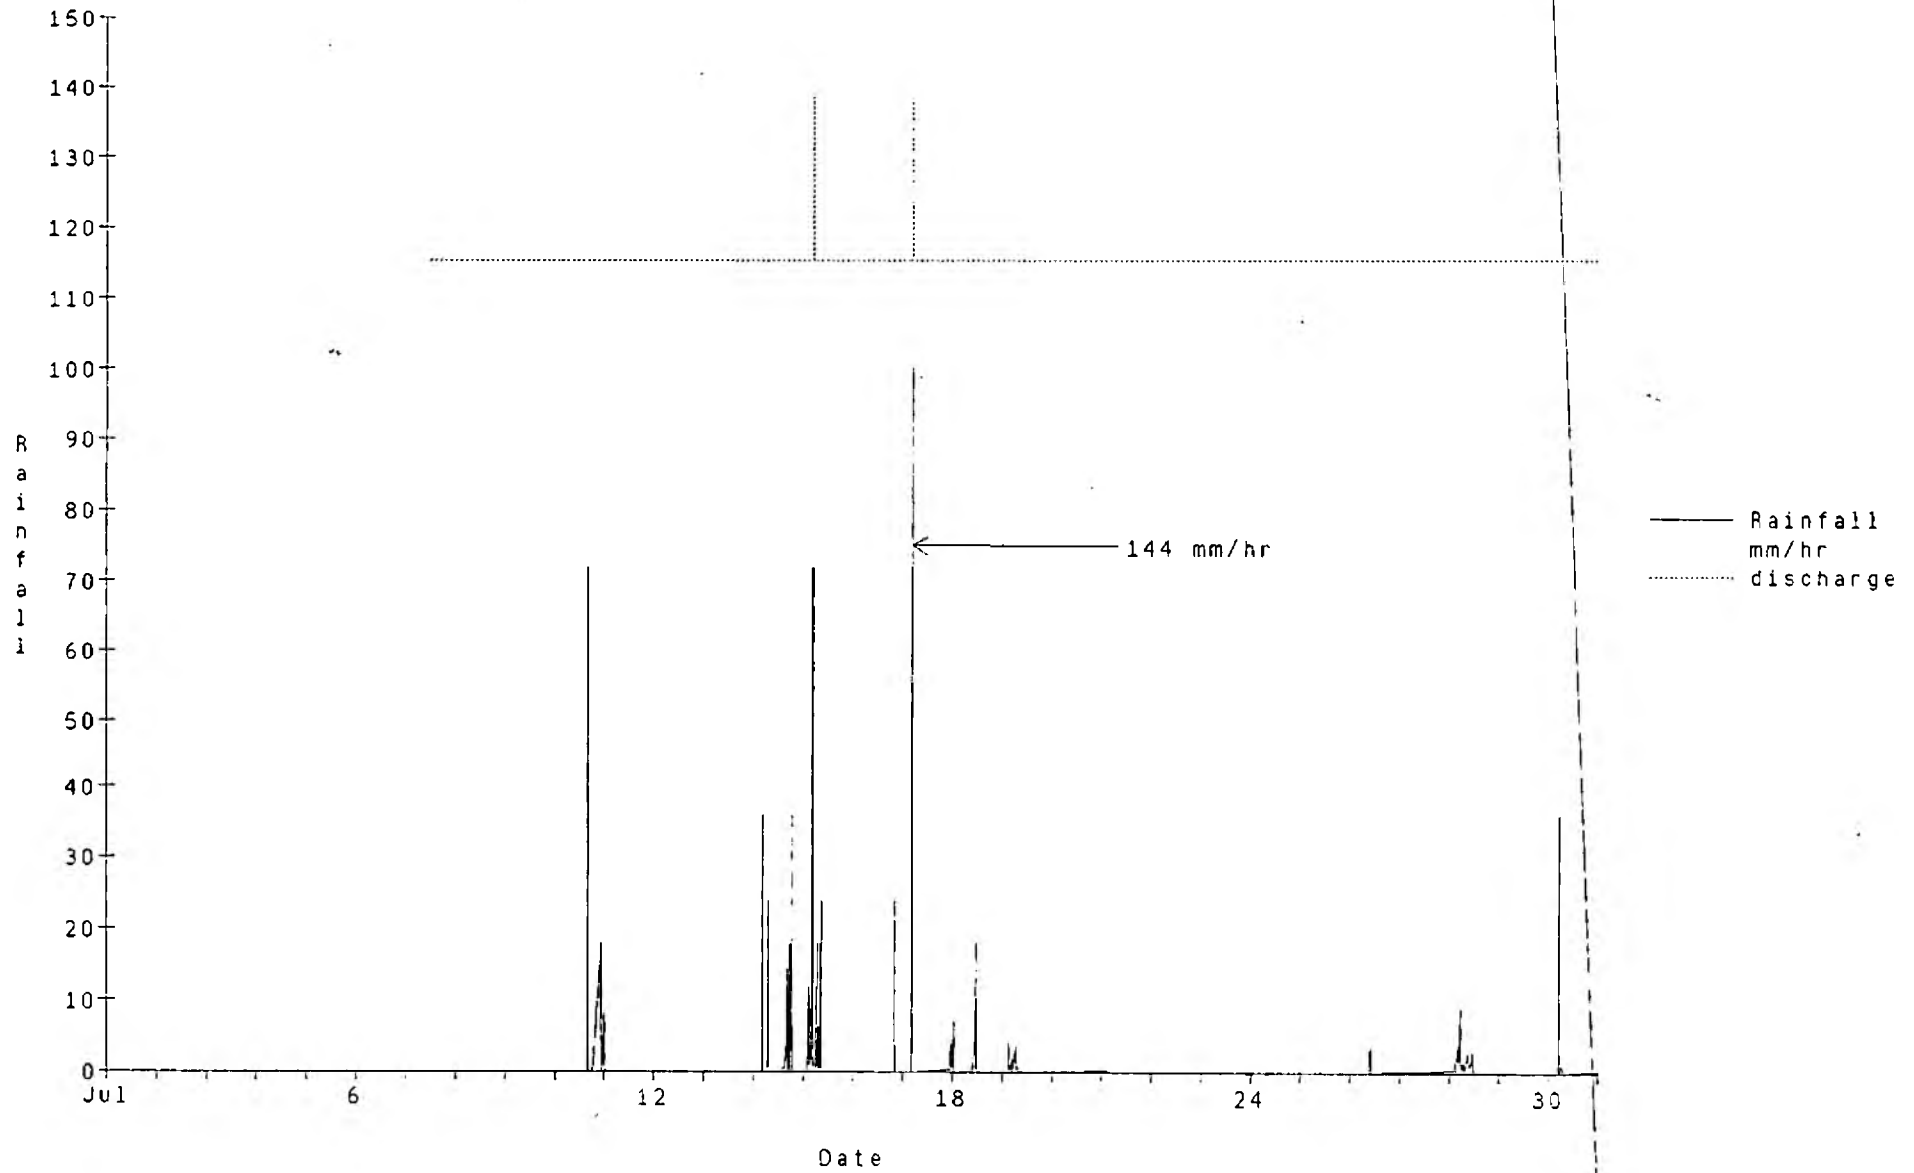
Fig. 1 Relationship between CSD discharge and Rainfall intensity at Bedford Rd. CSO during July

July - Three discharges were detected, each preceded by heavy rainfall (Fig. 1).

On the 15th, a discharge of 1.5 minutes was preceded by steady rain for 2 hours, reaching a peak intensity of 72 mm/hr, 11 minutes prior to the discharge. This heavy rainfall continued through to a second discharge of 19 minutes duration, 19 minutes later.

On the 17th a discharge for 3 minutes followed heavy rainfall, with a peak intensity of 144 mm/hr, 7 minutes prior to the discharge.

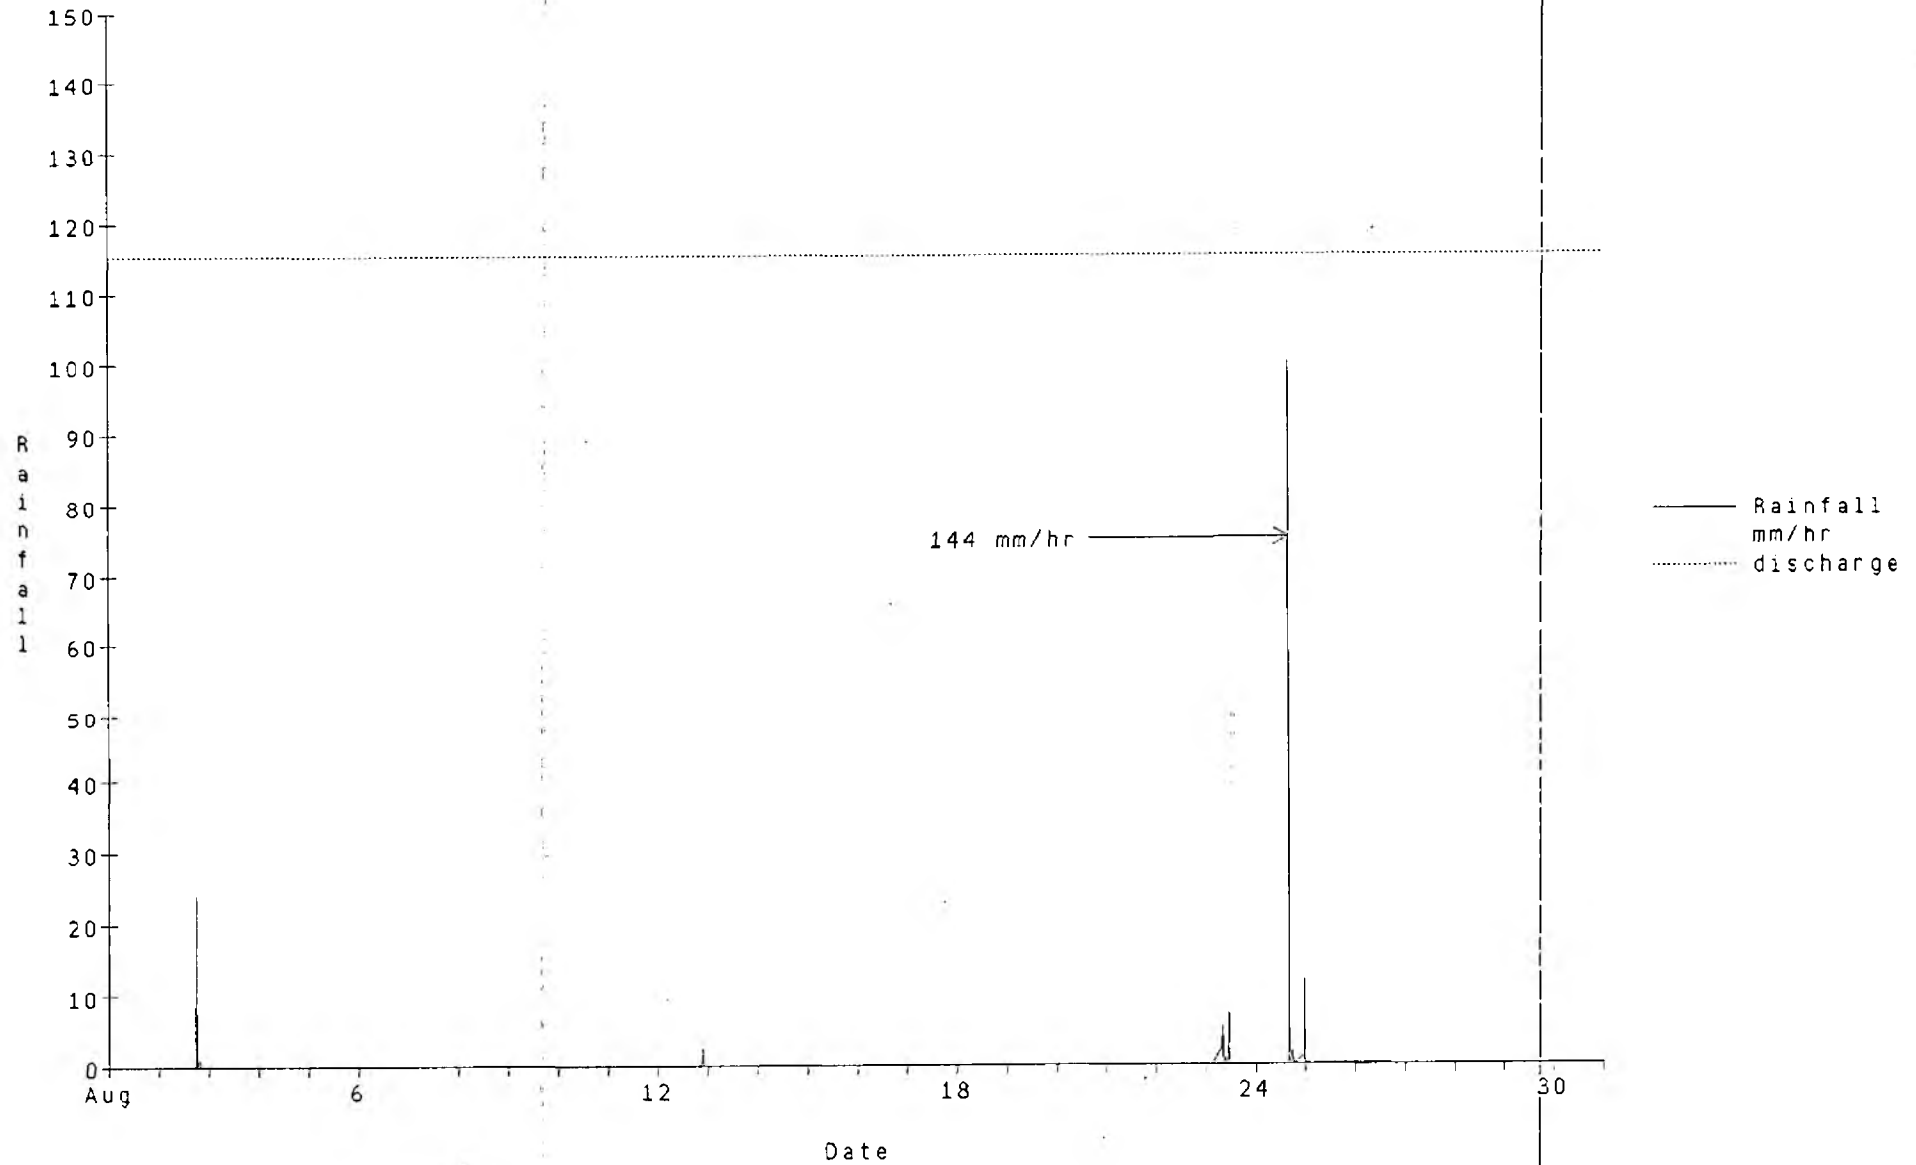
Fig. 2 Relationship between CSO discharge and Rainfall intensity at Bedford Rd. CSO during August

August - Negligible rainfall occurred during the month, and no discharges were detected (Fig. 2).

An intense downpour of short duration occurred on 24th (144 mm/hr), but did not result in an overflow.

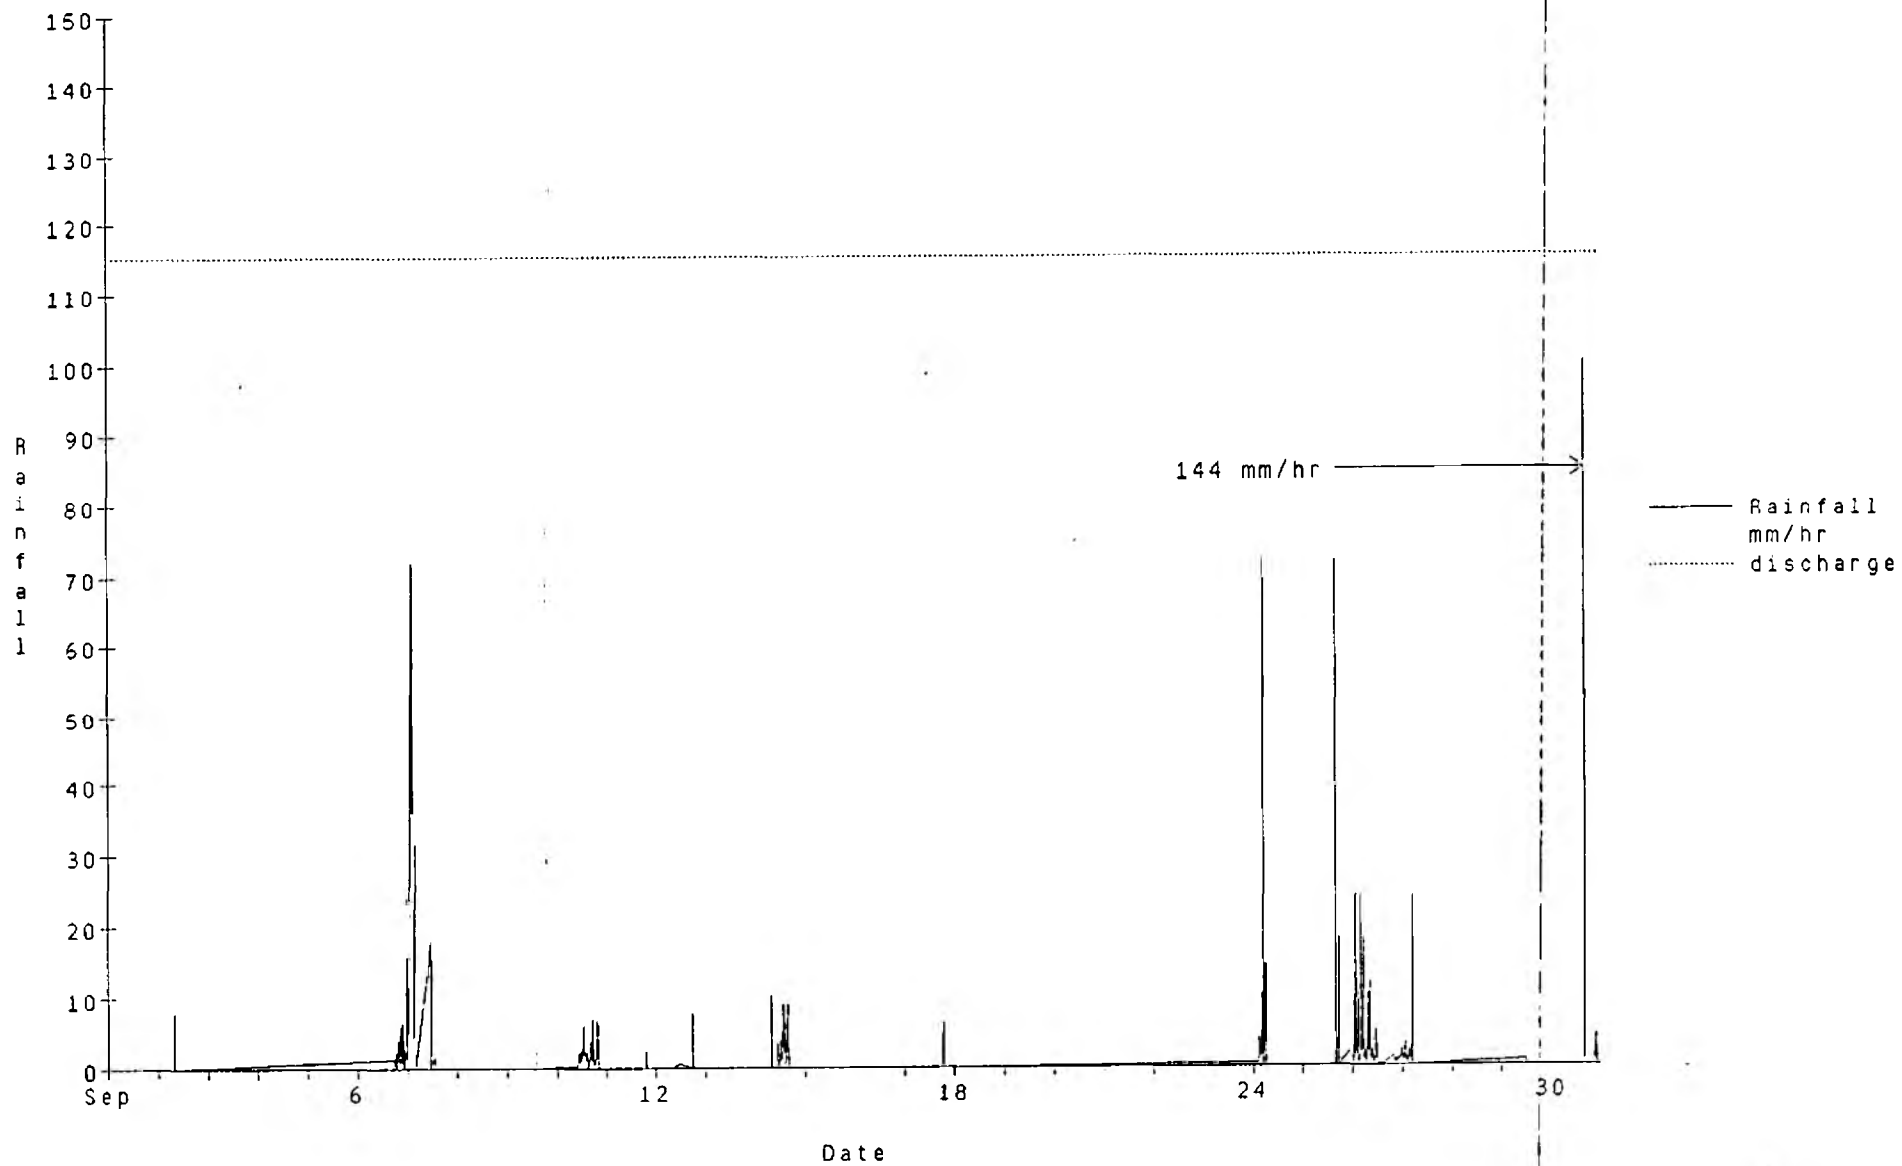
Fig. 3 Relationship between CSO discharge and Rainfall intensity at Bedford Rd. CSO during September

September - This was generally a dry month and no discharges were detected (Fig. 3). Rainfall intensities of up to 72 mm/hr were recorded though these were of short duration (< 5 min).

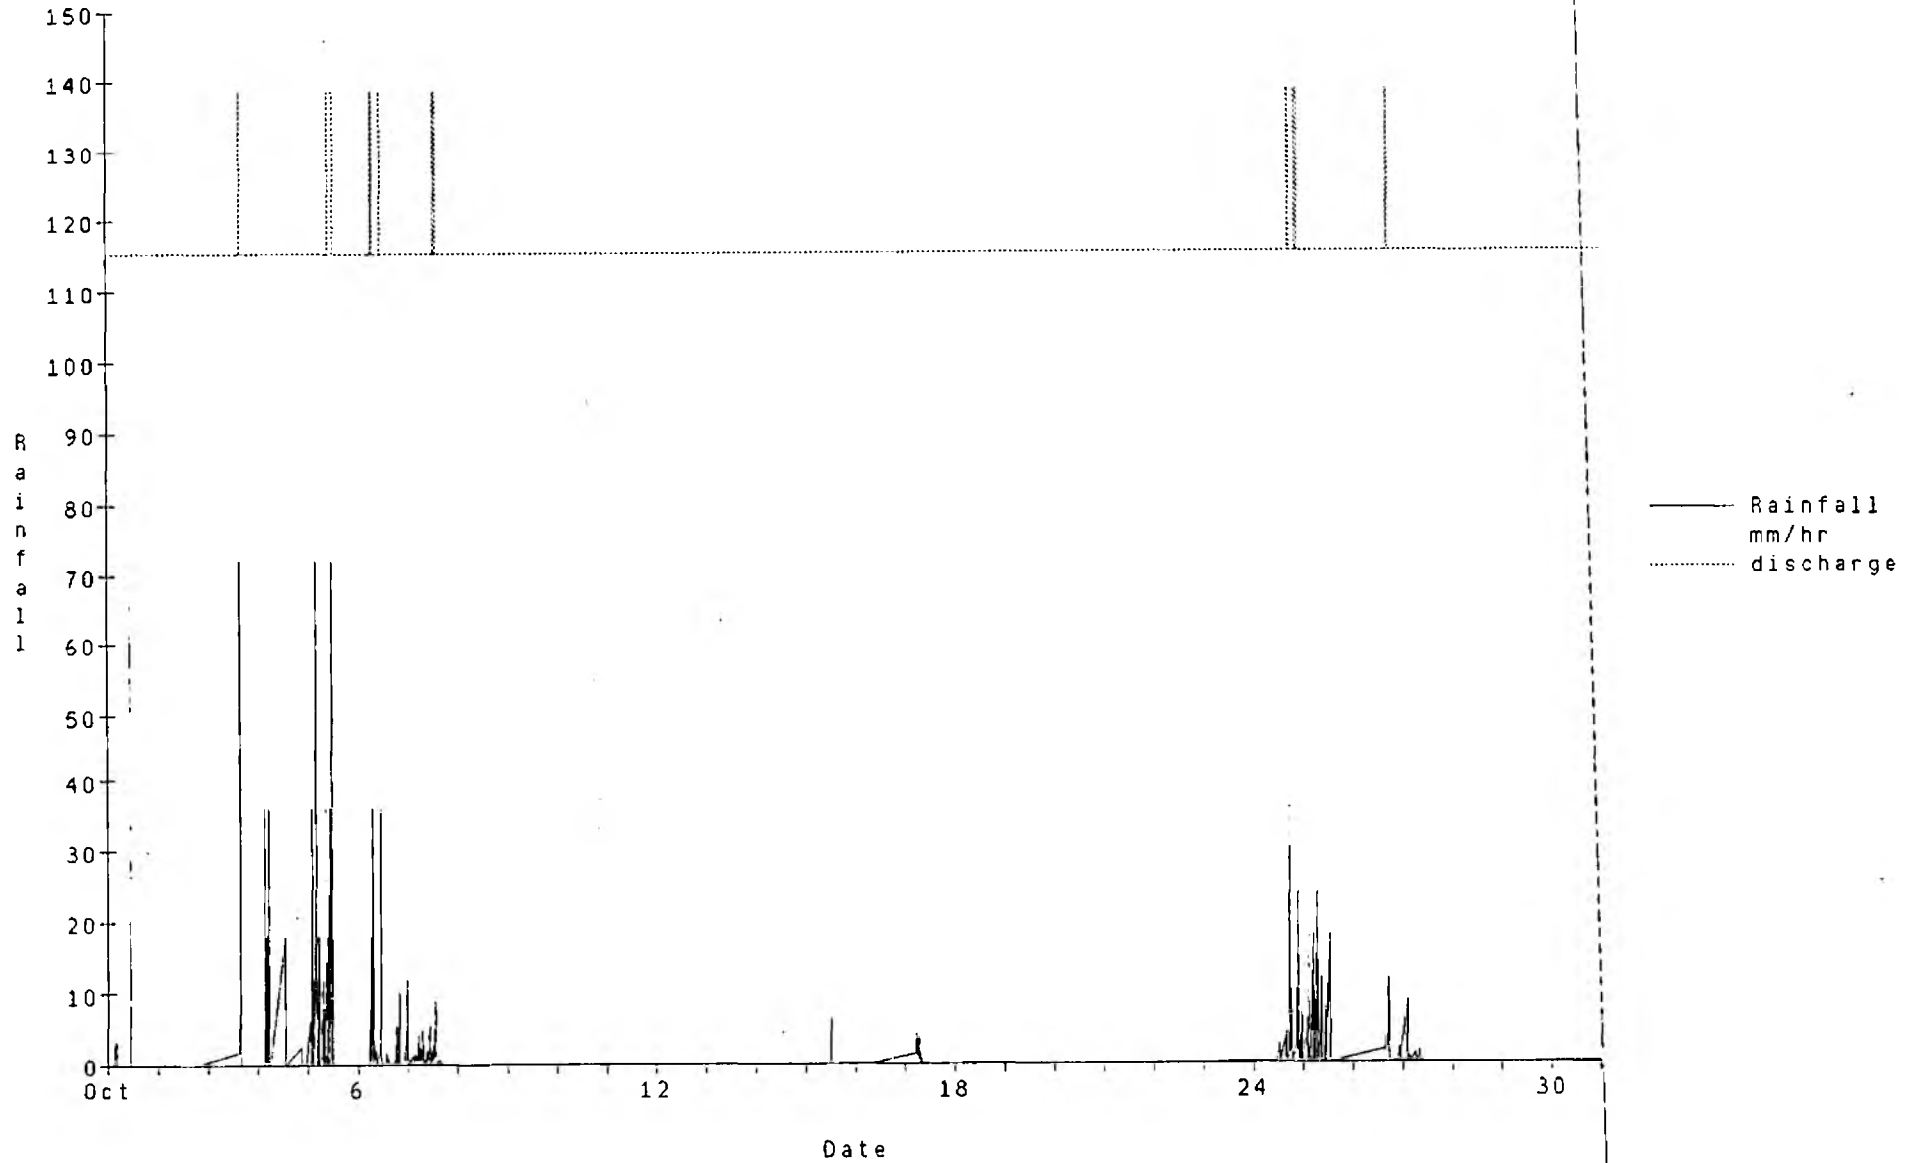
Fig. 4 Relationship between CSO discharge and Rainfall intensity at Bedford Rd. CSO during October

October - Nine discharges were detected during the month (Fig. 4).

On the 3rd, 7 minutes of intense rainfall, up to 72 mm/hr, resulted in a discharge of 8 minutes duration.

A discharge on the 5th, of 2 hours 16 minutes, was preceded by 9.5 hours of rainfall, with intensities up to 72 mm/hr. A discharge was observed during servicing work on 5th when the float switch failed to trip.

Two discharges on the 6th (16 min & 26 min) occurred following rainfall intensities up to 36 mm/hr, six and eight minutes prior to the discharge. A further discharge on the 6th, of 16 minutes duration, was preceded by low to moderate rainfall, up to 18 mm/hr. On the 7th, a discharge of 57 minutes occurred during a period of negligible rainfall (< 7.2 mm/hr).

A discharge on the 24th, of 39 minutes, followed 50 minutes of moderate rainfall up to 36 mm/hr. Rainfall continued at lowered intensities (max 10.3 mm/hr), through to a discharge of 53 minutes, 1 hr 50 minutes after the first.

A discharge on 26th, for 33 minutes, followed low rainfall of up to 10.3 mm/hr. Rainfall increased through the discharge period to 24mm/hr.

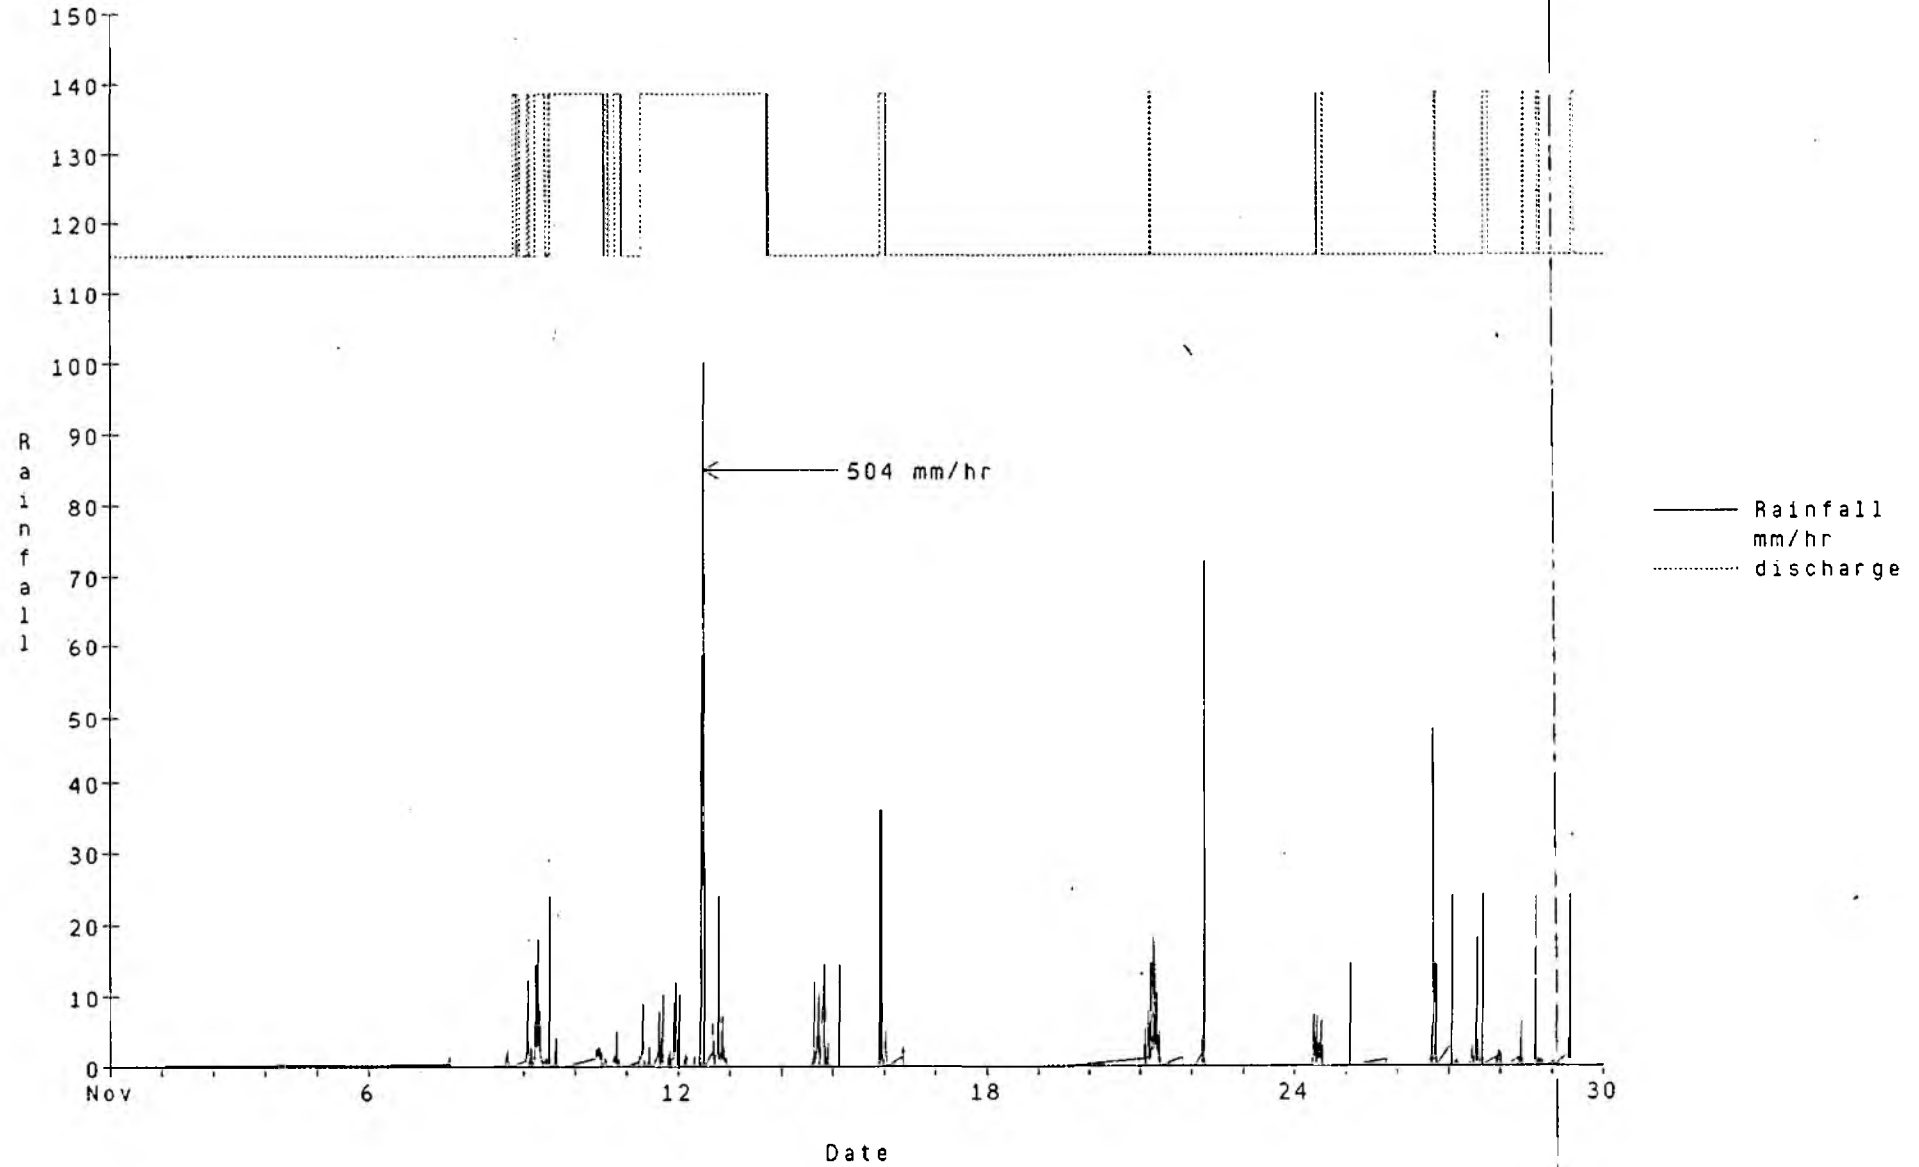
Fig. 5 Relationship between CSO discharge and Rainfall intensity at Bedford Rd. CSO during November

November - A conductivity switch was installed in the chamber to increase the sensitivity of detection. A total of 25 discharges were recorded during the month (Fig. 5). Of these, only four were triggered by moderate to high rainfall/intensities.

On the 15th, moderate rainfall of up to 36 mm/hr triggered a discharge of 2 hrs 30 min. The rain continued at these intensities for 30 minutes into the discharge.

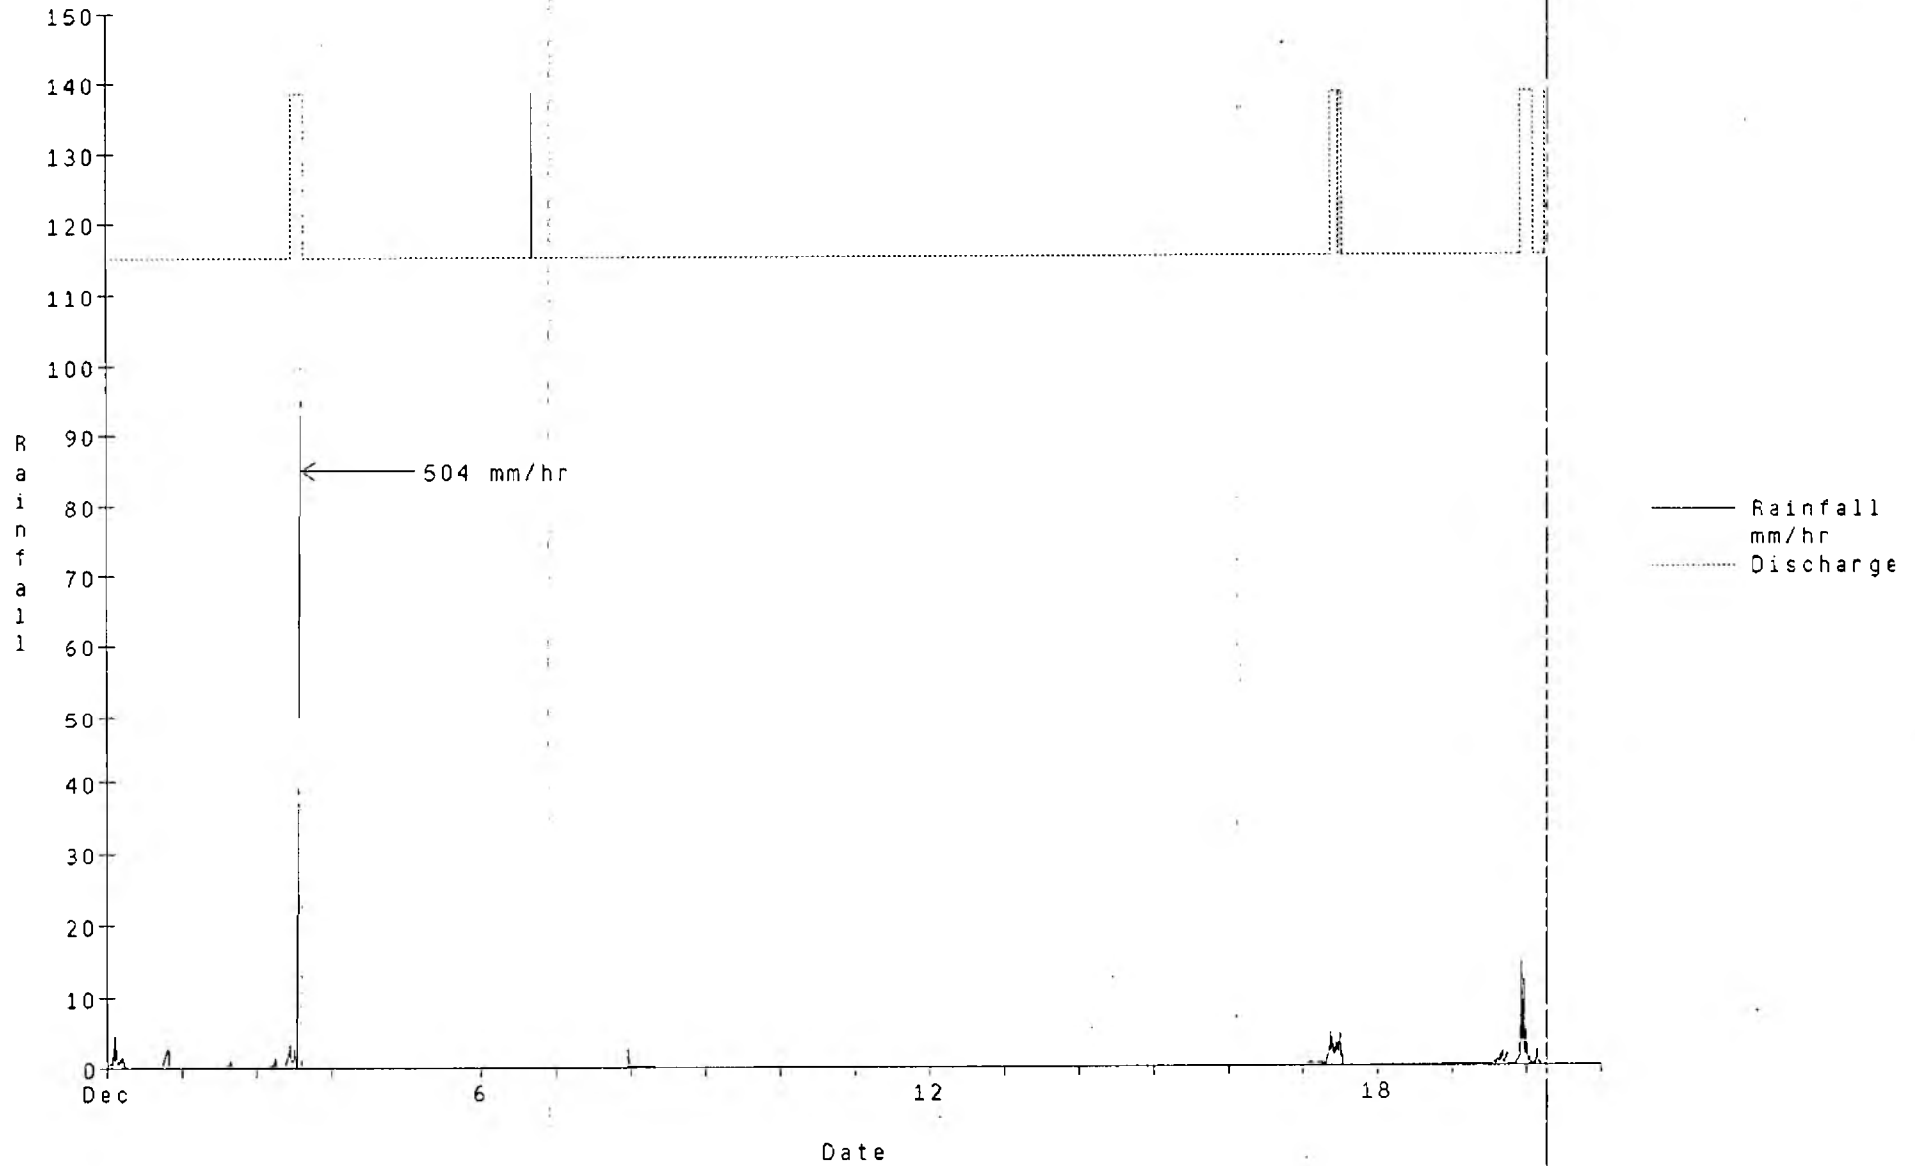
Fig. 6 Relationship between CSO discharge and Rainfall intensity at Bedford Rd. CSO during December

December - Six discharges occurred during the period (Fig. 6), none were triggered by significant rainfall (< 15 mm/hr), though high rainfall intensities were recorded in the latter period of a discharge on the 3rd. Durations ranged from 1 min to 4 hrs 04 min.

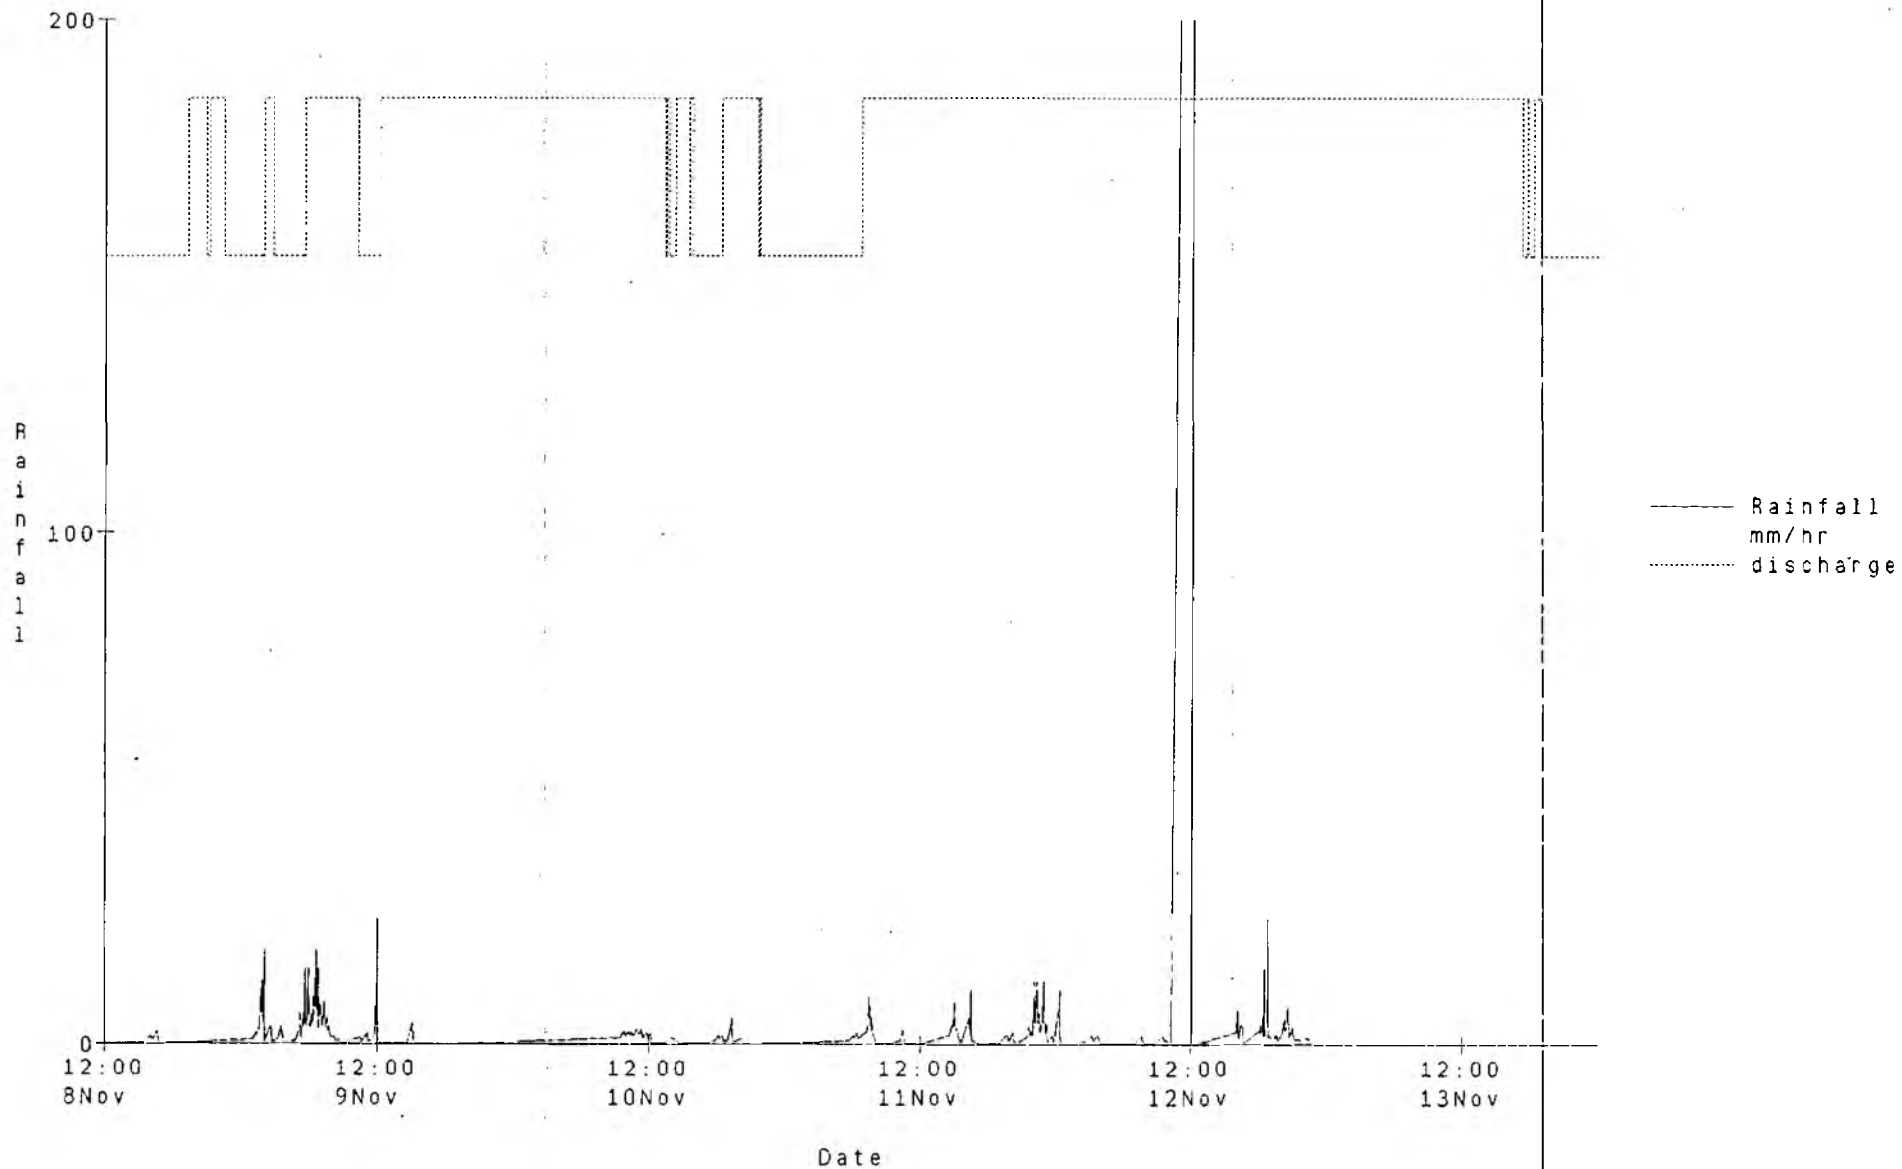
Fig. 7 Relationship between CSO discharge and Rainfall intensity at Bedford Rd. CSO, 8th - 13th November 1995

On the 9th a discharge of 25 hrs 08 min followed 50 minutes of moderate rainfall, up to 24 mm/hr. Rainfall intensities during the discharge period were low (Fig. 7).

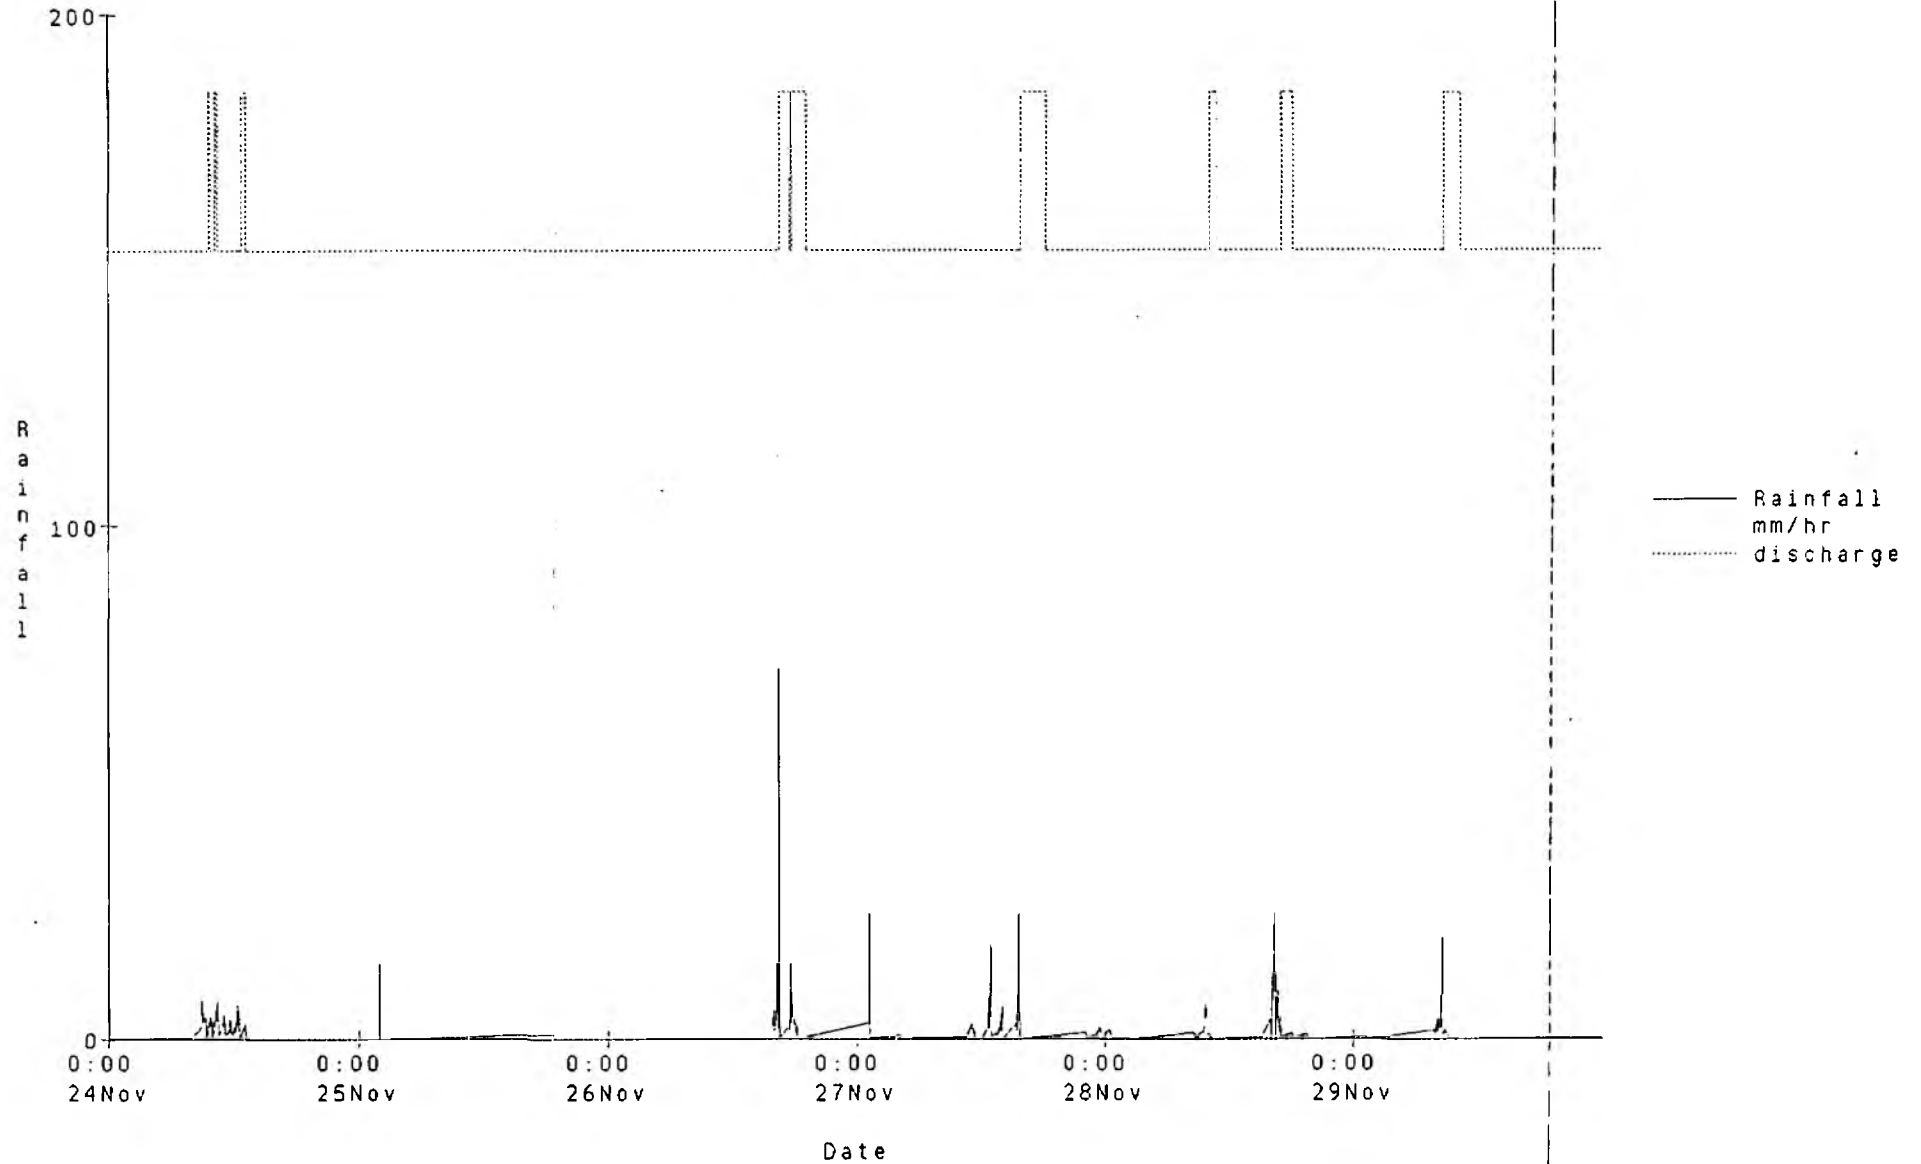
Fig. 8 Relationship between CSO discharge and Rainfall intensity
at Bedford Rd. CSO, 24th - 29th November 1995

High rainfall intensities (max 72 mm/hr) triggered a discharge for 58 minutes on the 26th. Rainfall moderated during the discharge. Intensities up to 14.4 mm/hr followed, resulting in a second discharge, 11 minutes after the first, of 1 hr 25 min duration (Fig. 8).

During the month 21 discharges occurred in the absence of any significant rainfall. These varied from 5 minutes in duration, to a discharge of 58 hrs 28 min commencing on the 11th (Fig. 8).

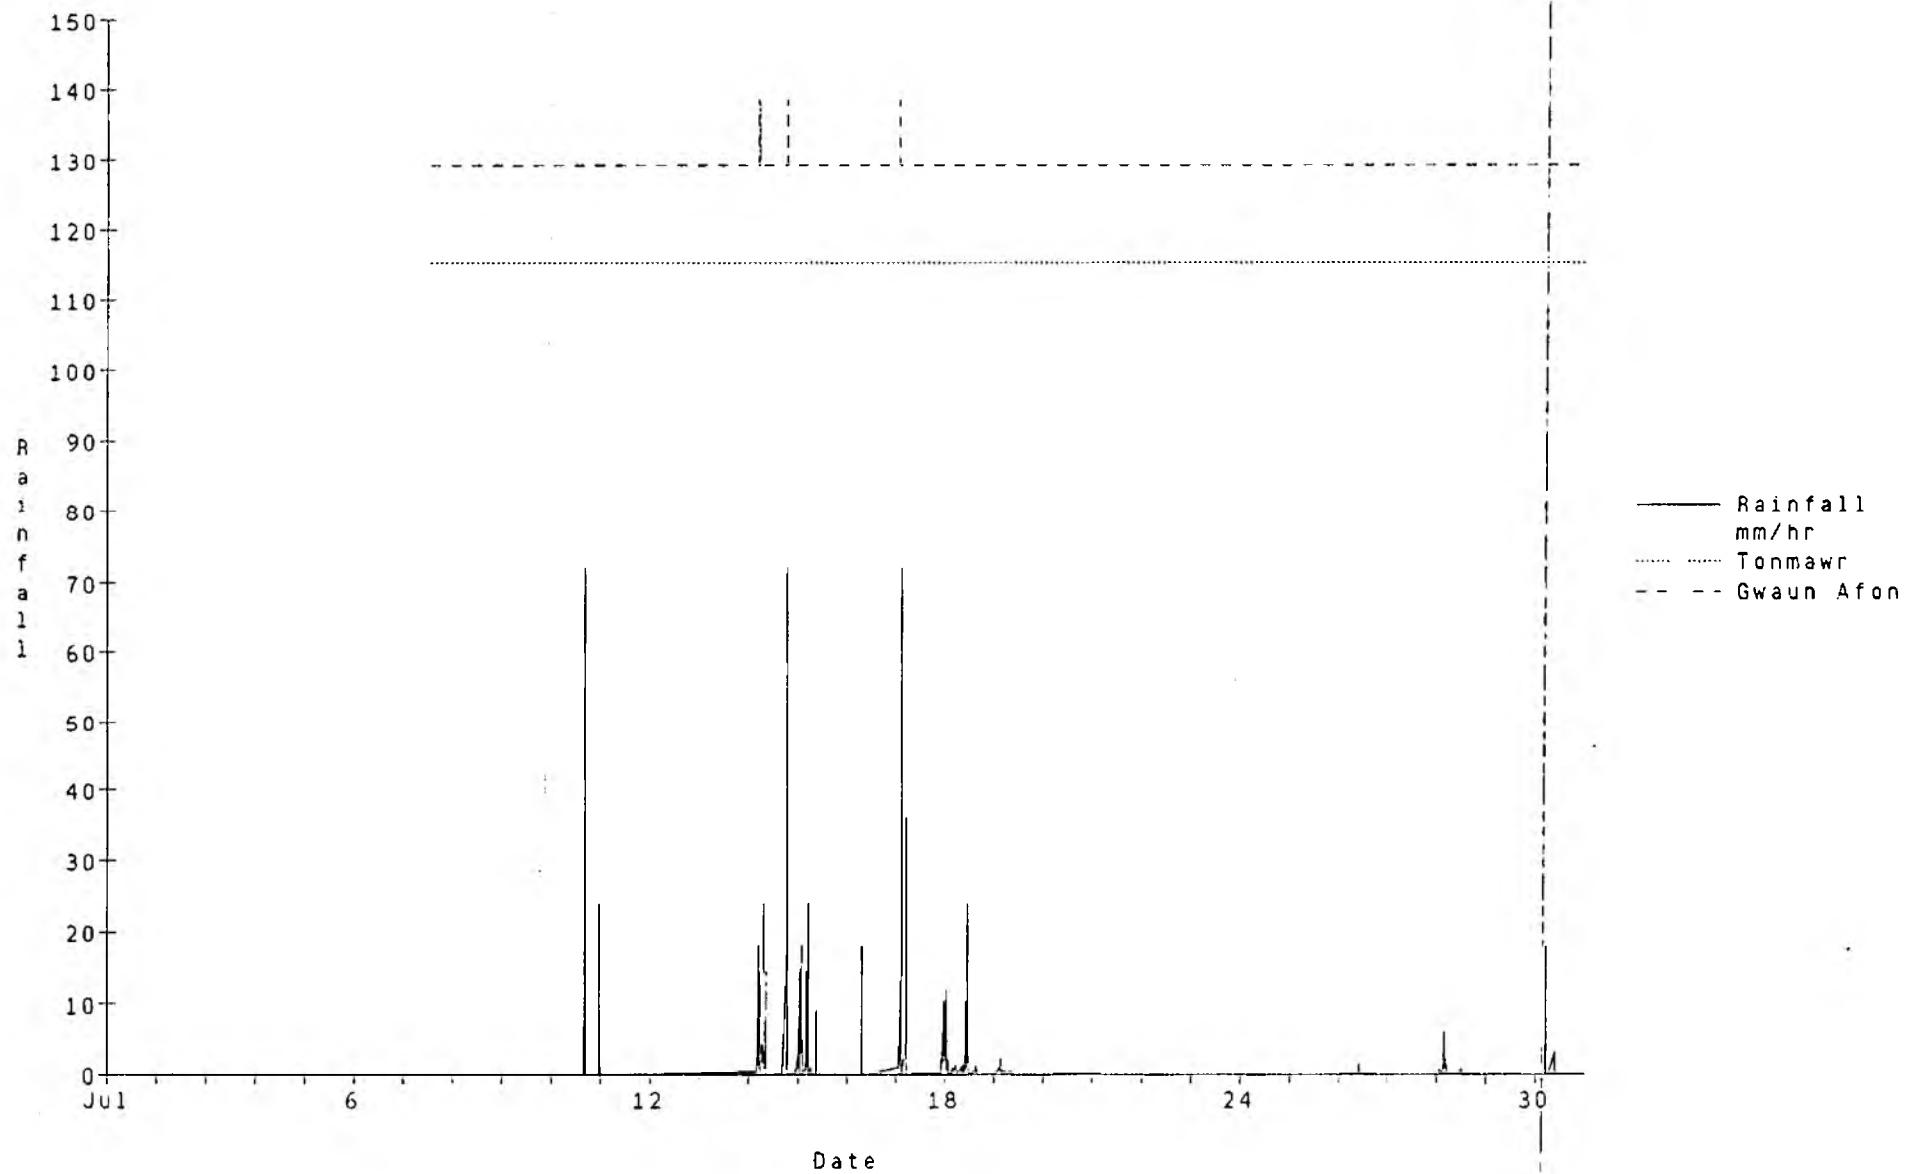
Fig. 9 Relationship between CSO discharge and Rainfall intensity for the Afan Catchment during July

July - Four discharges were detected at Gwaun Afon and no discharges at Tonmawr (Fig. 9).

A discharge of 15 minutes on the 14th was preceded by moderate rainfall up to 18 mm/hr. Intensities continued through the discharge period, triggering a second discharge of 8 minutes duration, 16 minutes later. A further discharge on the 14th, of 40 seconds duration, was preceded by heavy and prolonged rainfall of up to 72 mm/hr. A discharge of 11 minutes on the 17th followed low rainfall, up to 10.3mm/hr. Heavy and prolonged rainfall was recorded at the rain gauge just over an hour after the event. Due to the 4km distance between the CSO and the rain-gauge it is possible that the rain front arrived at Cwmafan before Tonmawr, accounting for the time-lag. Short duration high intensity rainfall, up to 72 mm/hr, was detected in the absence of discharges.
