**An Investigation into the Frequency of
Discharge of three Combined Sewer Overflows
in the Afan/Kenfig Catchment**

NATIONAL RIVERS AUTHORITY

Tech. Memo Ref: TM/EAW/96/06
Author - Jenkins M.J.

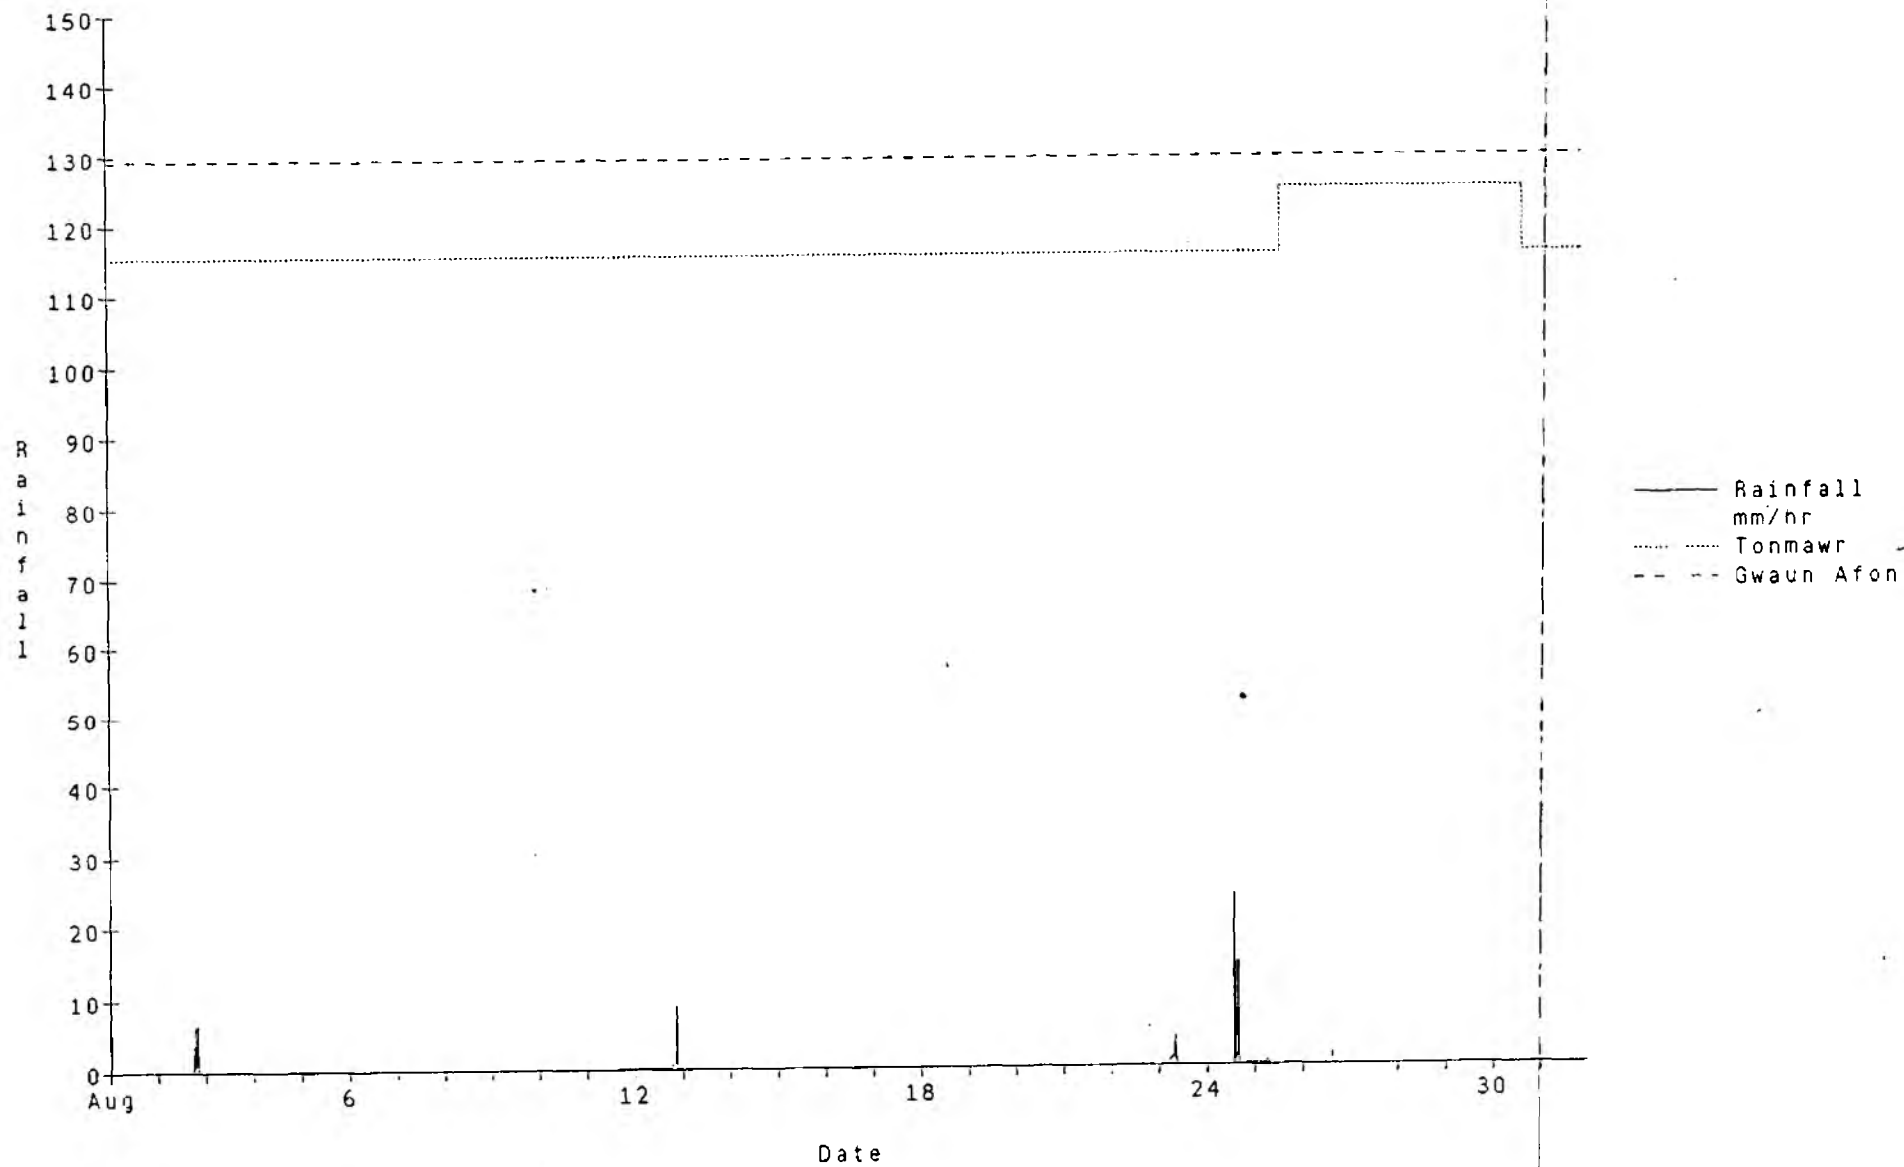
Fig. 10 Relationship between CSO discharge and Rainfall intensity for the Afan Catchment during August

August - Negligible rainfall occurred throughout the month. No discharges were detected from Gwaun Afon CSO, while one discharge occurred under dry weather conditions at Tonmawr CSO for a period of 5 days 2 hours 22 minutes (Fig. 10). Inspections undertaken by Neath Borough Council showed the discharge to be due to a blockage.

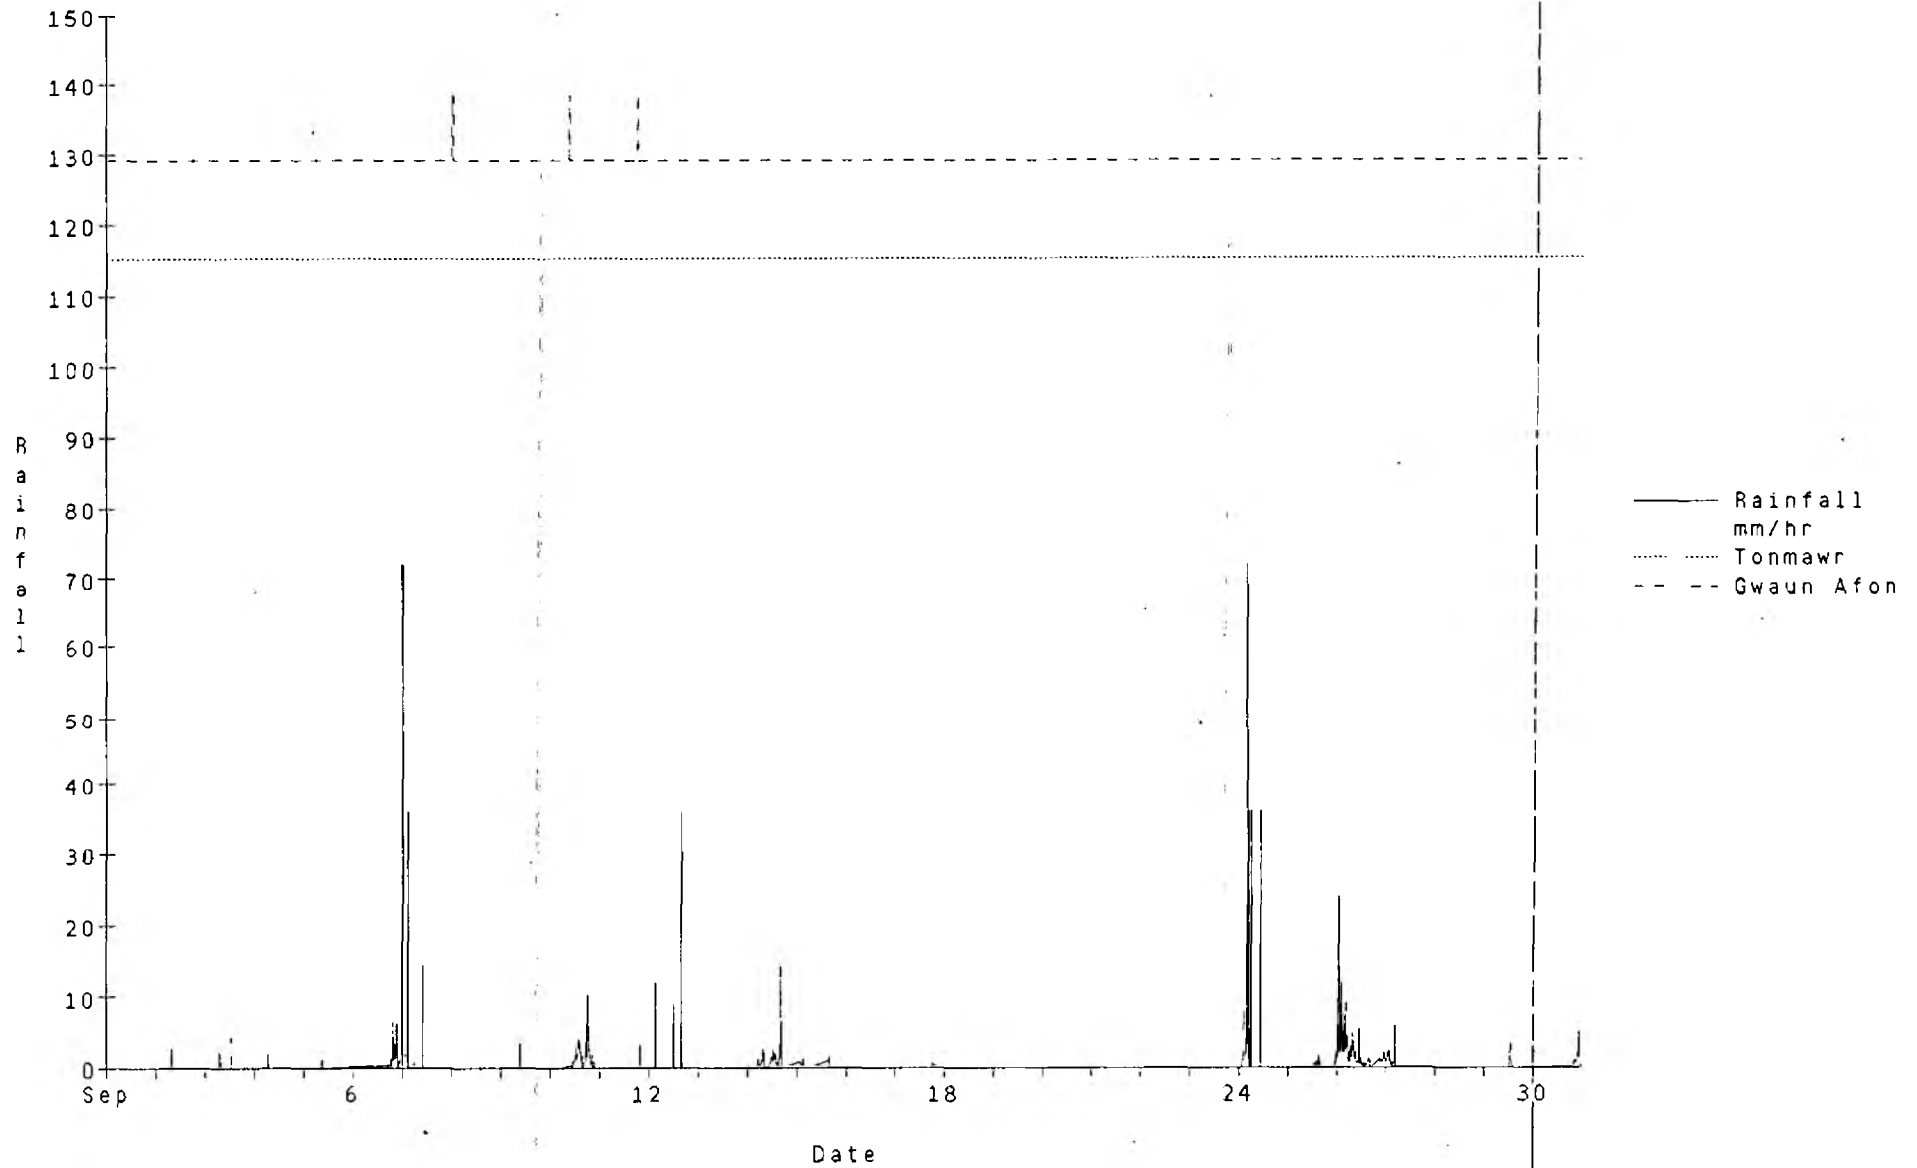
Fig. 11 Relationship between CSO discharge and Rainfall intensity for the Afan Catchment during September

September - A total of 3 discharges were detected from Gwaun Afon, and none from Tonmawr (Fig. 11).

Discharges ranged from 14 minutes to 45 minutes, and all occurred under conditions of low rainfall (< 3.6 mm/hr).

Heavy rainfall on the 24th, up to 74 mm/hr, did not result in a discharge.

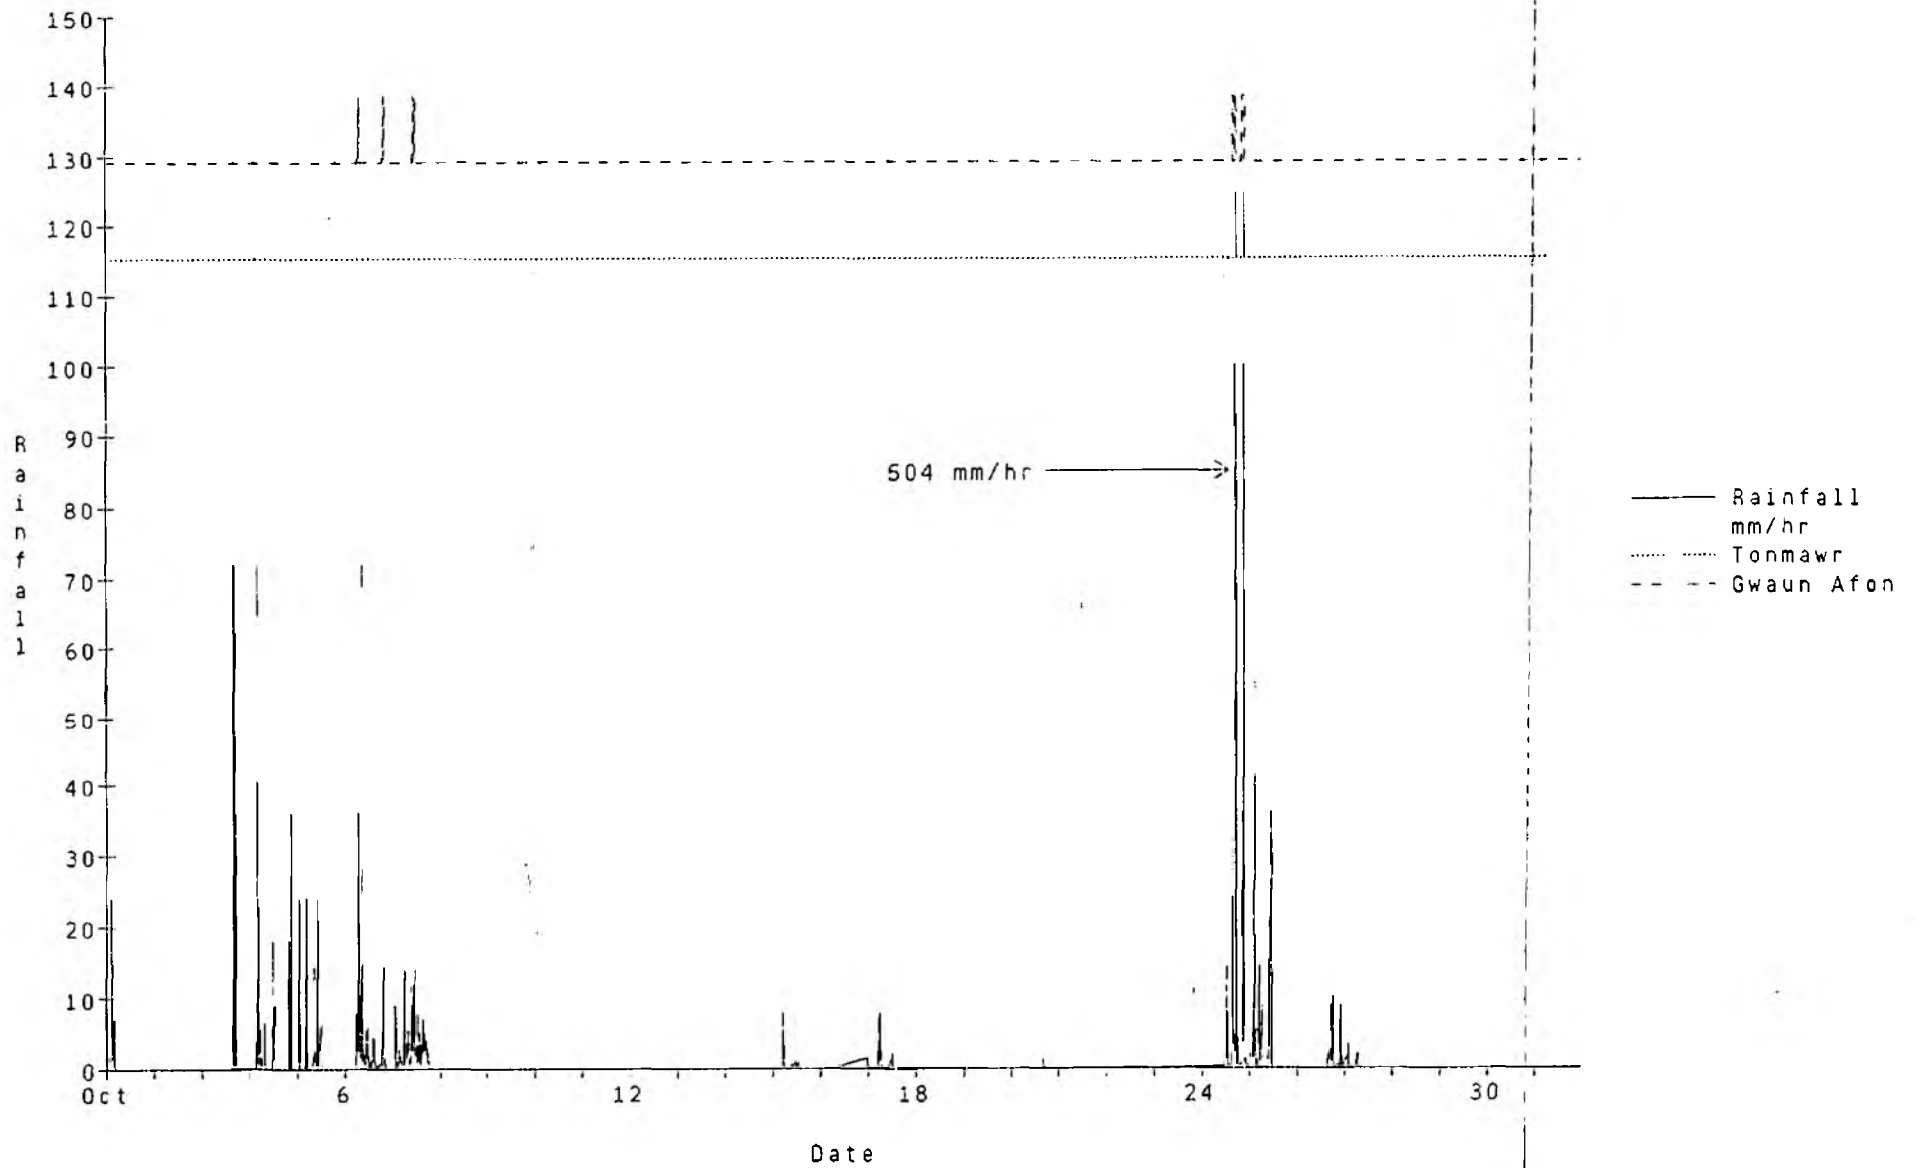
Fig. 12 Relationship between CSO discharge and Rainfall intensity for the Afan Catchment during October

October - Eight discharges were recorded from Gwaun Afon, and 2 from Tonmawr, all associated with moderate to heavy rainfall (Fig. 12).

Heavy rain occurred on the 3rd and 4th (72mm/hr), with no associated discharges.

Three discharges on the 6th (25, 7, and 28 minutes), from Gwaun Afon CSO, followed moderate rainfall, with intensities up to 36 mm/hr.

A discharge of 49 minutes on the 7th, at Gwaun Afon CSO, followed prolonged low

intensity rainfall (9 hours, max 10.3mm/hr). This was followed by a further discharge of 27 minutes, 9 mins after the first discharge (max 14.4 mm/hr).

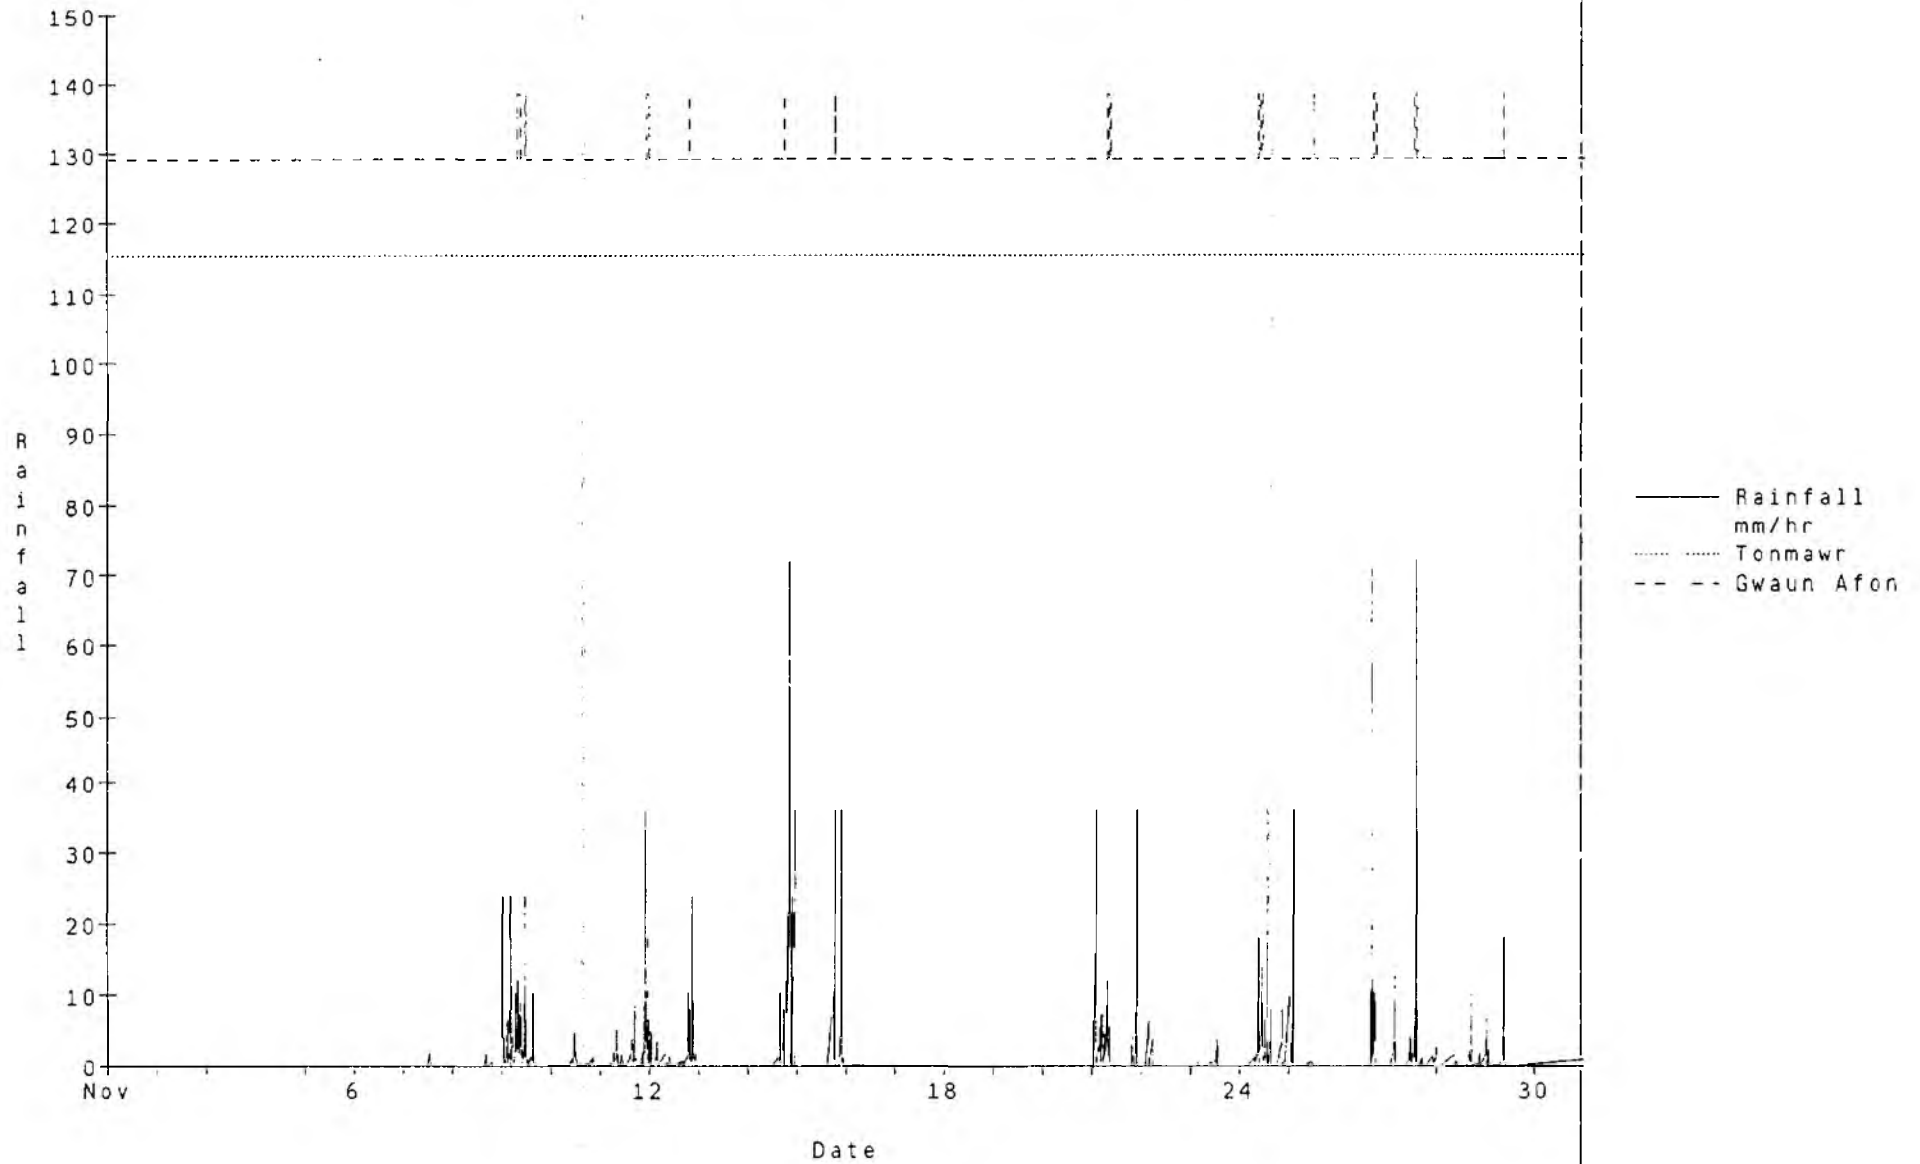
Fig. 13 Relationship between CSO discharge and Rainfall intensity for the Afan Catchment during November

November - 17 discharges were recorded from Gwaun Afon CSO during the month, but no discharges were recorded at Tonmawr (Fig. 13).

A number of discharges followed prolonged low to moderate intensity rainfall:-

Two discharges on the 9th (1hr 37 min and 39 min, max 24 mm/hr), one on the 11th (1hr 12 min, max 36 mm/hr), 12th (18 min, max. 10.3 mm/hr), 14th (20 min, low intensity) and two on the 21st (53 min & 2 min, low intensity).

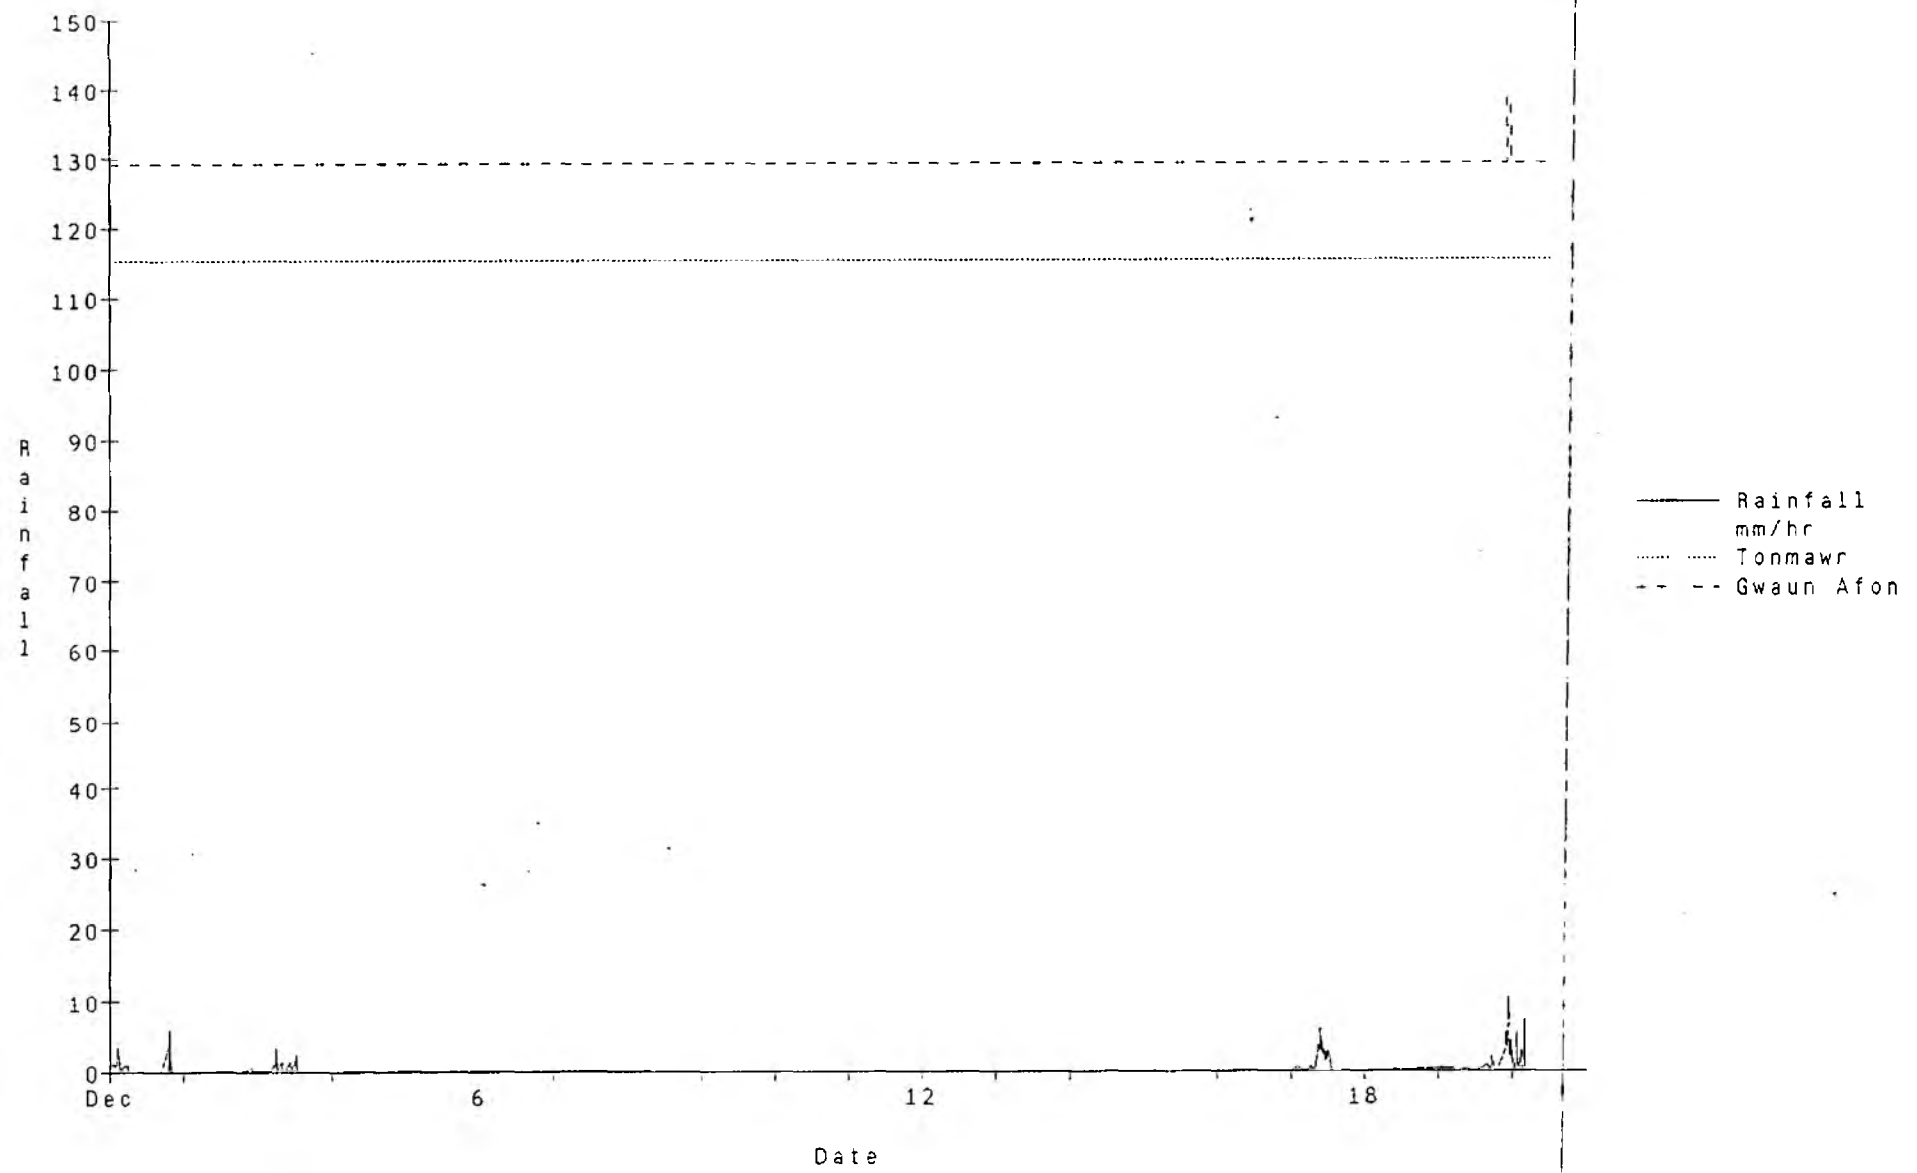
Fig. 14 Relationship between CSO discharge and Rainfall intensity for the Afan Catchment during December

December - One discharge was detected from Gwaun Afon during the month, but none from Tonmawr.

A discharge of 1 hour 10 min followed 30 minutes of low intensity rainfall up to 5.5 mm/hr (Fig. 14).

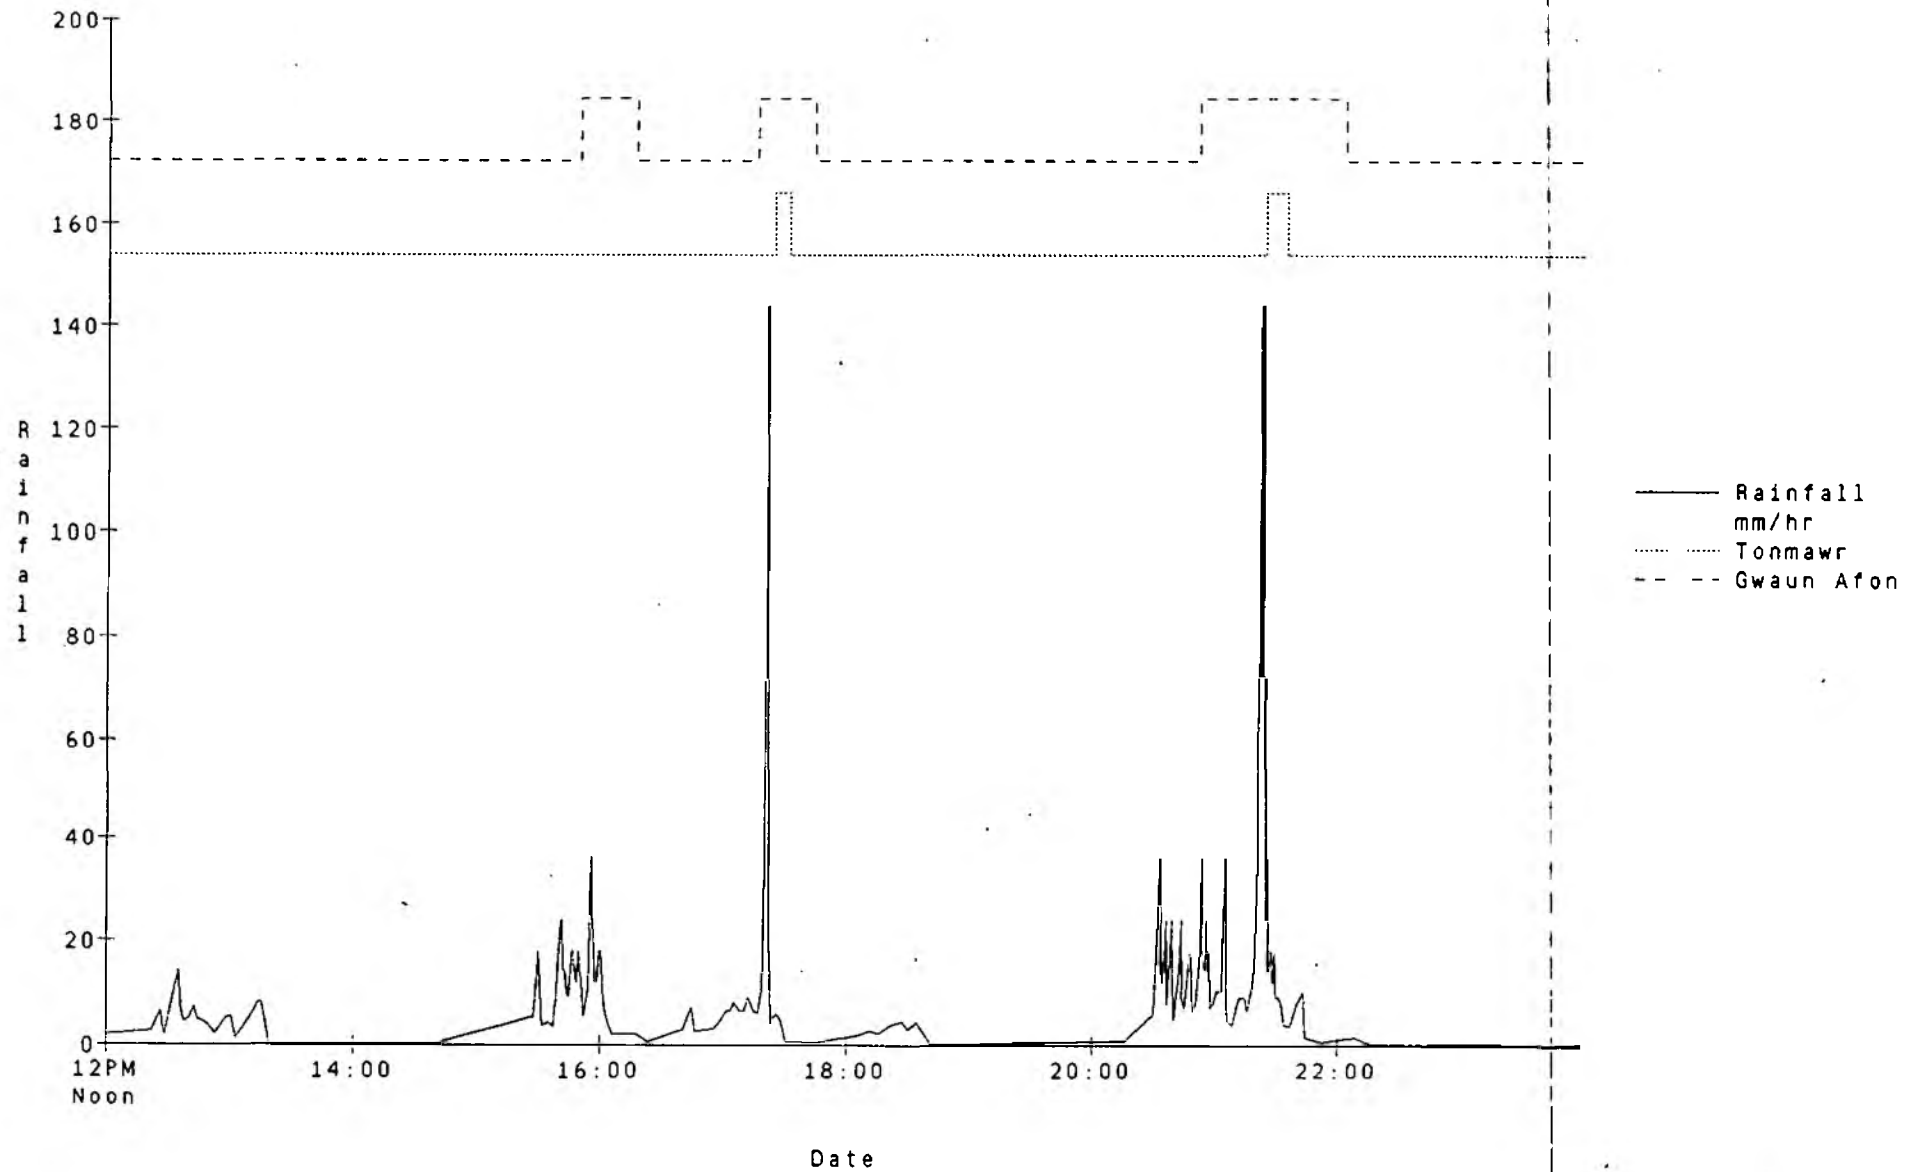
Fig. 15 Relationship between CSO discharge and Rainfall intensity for the Afan Catchment on 24/10/95

Moderate rainfall on the 24th (max 24 mm/hr), from 1222 hrs, resulted in a discharge of 27 mins duration at Gwaun Afon. Continuing rainfall, increasing in intensity (max. 144 mm/hr), triggered both Gwaun Afon and Tonmawr CSO's for 28 min and 7 min respectively. Further heavy rain (144 mm/hr) triggered both CSO's for 1 hour 11 min and 10 min respectively (Fig. 15).

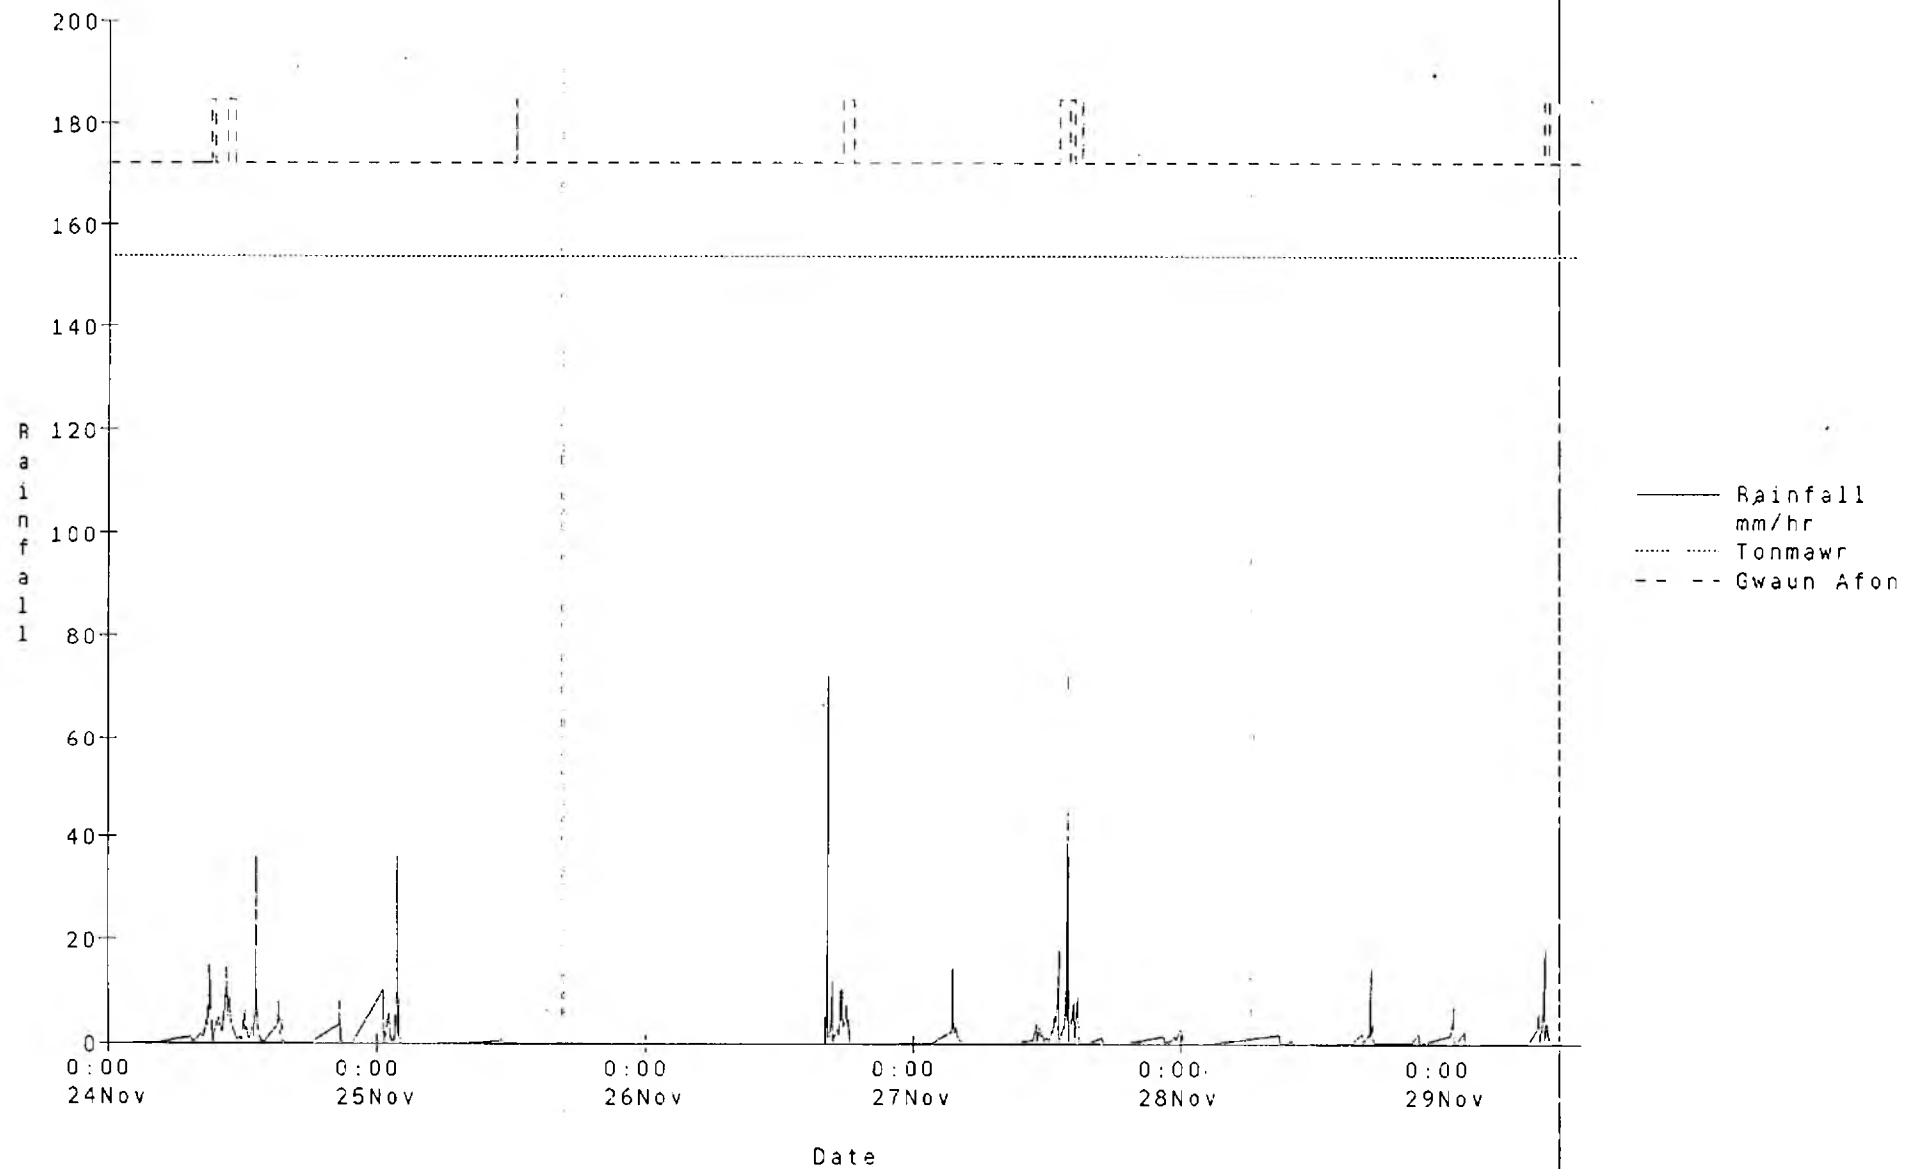
Fig. 16 Relationship between CSO discharge and Rainfall intensity for the Afan Catchment on 24th - 29th November 1995

On the 24th a discharge of 19 minutes followed 1.5 hours of low to moderate rainfall (max 18 mm/hr). Rainfall continued through to a second discharge of 44 minutes, approximately 1 hour later. A discharge on the 25th for 7 minutes occurred in the absence of rain. A discharge of 1 hour on the 26th followed 1.5 hours of moderate to high rainfall intensities (max. 72mm/hr) (Fig. 16).

Three discharges occurred on the 27th. The first (21 mins) followed low rainfall, intensities. These increased to a maximum of 72 mm/hr, triggering two further discharges of 28 mins and 2 mins. A discharge of 14 mins on the 29th followed low to moderate rainfall (Fig. 16).
