**DEVON AREA
INTERNAL REPORT**

**ENVIRONMENT
AGENCY**

**Investigation into Failures of the
River Dalch from Canns Mill Bridge
to Below Lapford Sewage
Treatment Works**

**July 2000¹
DEV/EP/07/00
(CATCHMENT 30D)**

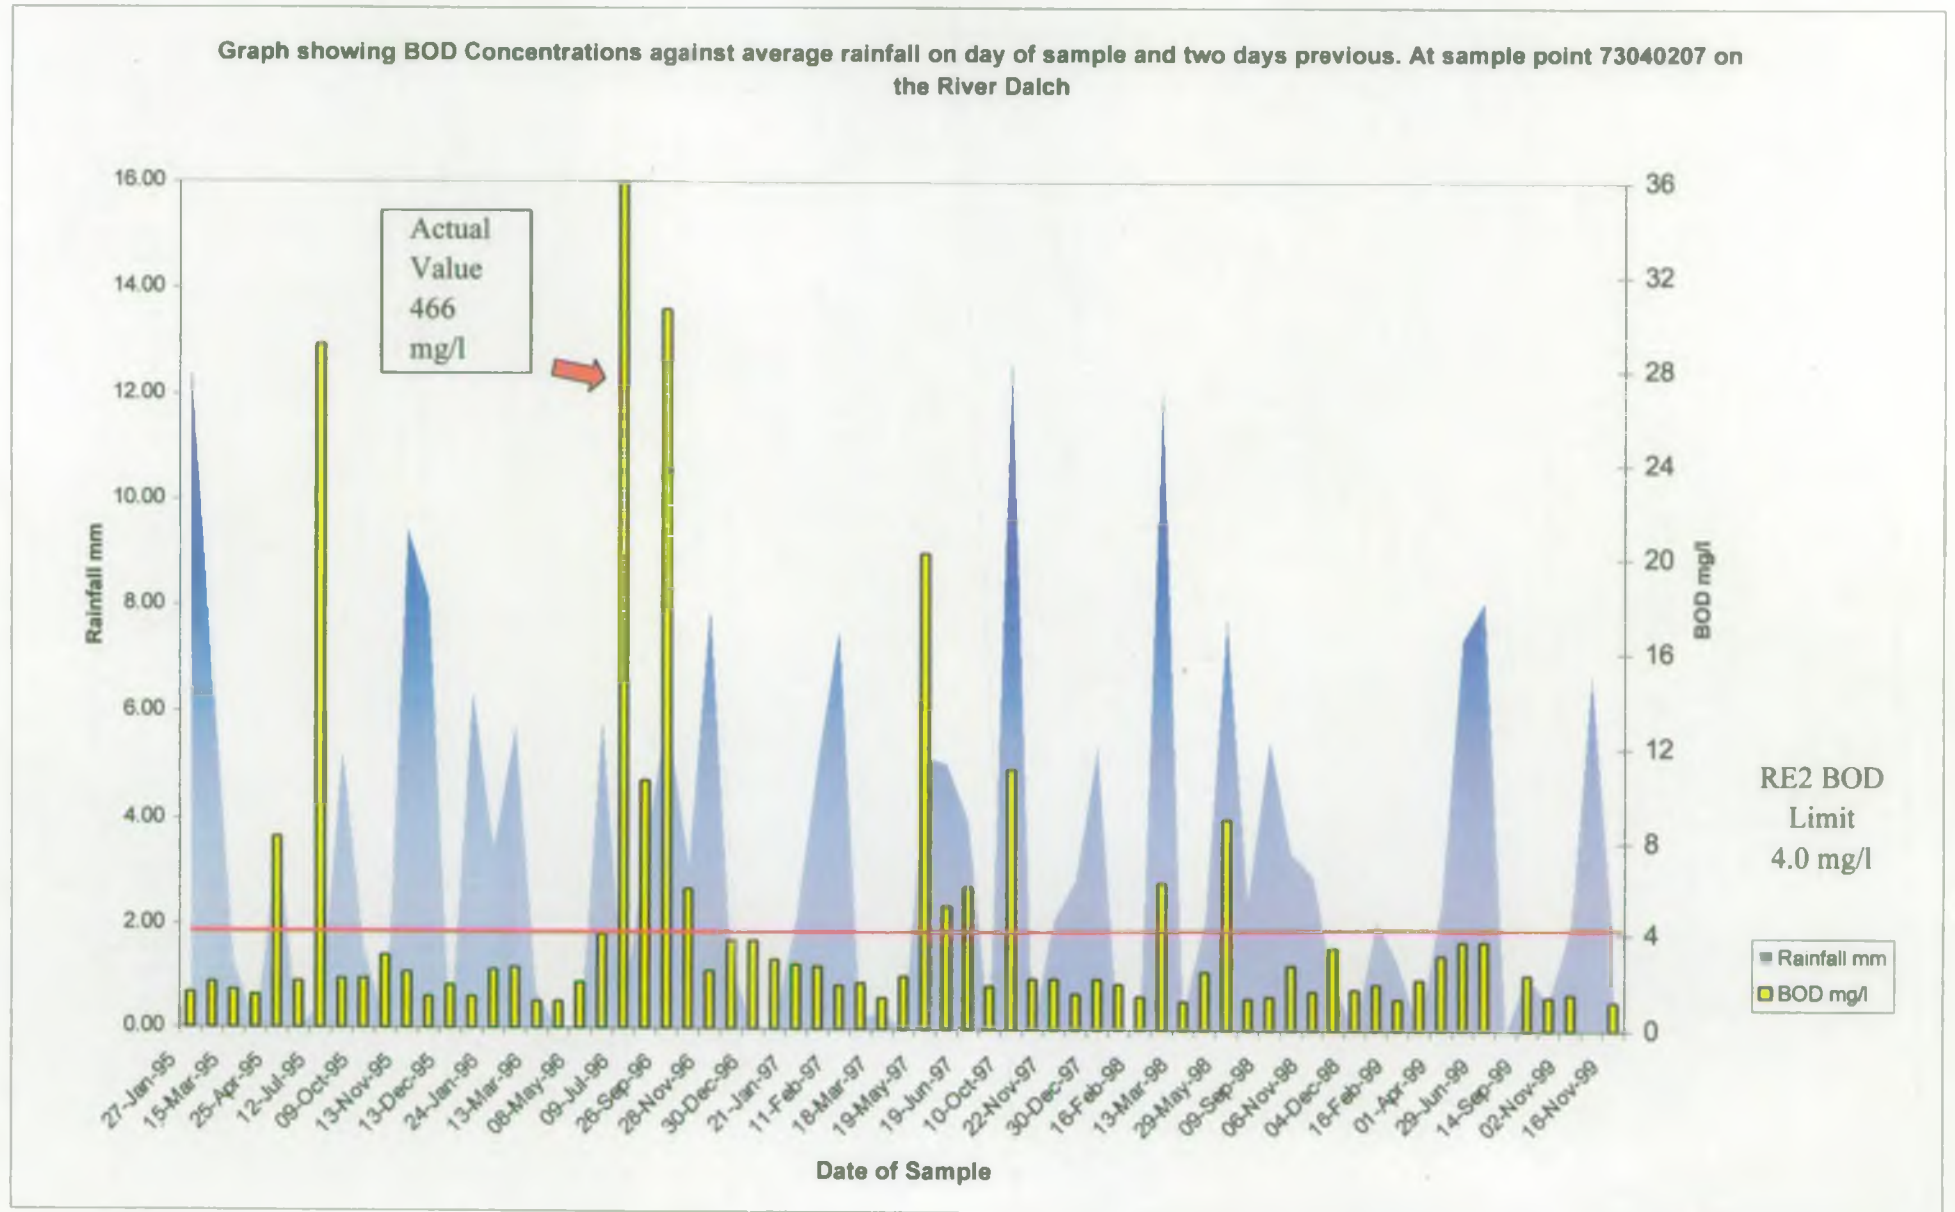
Figure 3

Rainfall data was collected (Devon Area Hydrometrics) from the nearest two Gauging Stations to the River Dalch at Lapford. These were Hollocombe NGR SS 636 110 Gauge ref. 392291 and Washford Pyne NGR SS822 116 Gauge ref. 391497. A graph was plotted to see if there is any correlation between periods of low rainfall (and low flow) and high BOD concentrations and also periods of high rainfall and failures. See figure 3.

As the graphs show it can be seen that there are eleven failures with BOD concentrations over 4.0 mg/l. Three failures clearly are associated with heavy rainfall; 10th October 1997 11.1mg/l, 4th March 1998 6.3mg/l and 29th May 1998 9.0mg/l. Two failures occurred in very dry periods these were 12th July 1996 29.1mg/l and 9th July 1996 466.0mg/l (confirmed with the Lab as it is a very high result). The sample from 19th May 1997 had a BOD of 20.2mg/l, rainfall on the 17th and 18th was 0.3mm and 0.0mm respectively, on the 19th it was 16.3mm. The rainfall day is recorded from 0900 to 0900, the sample was taken at 1050 and may well have been before any rainfall.

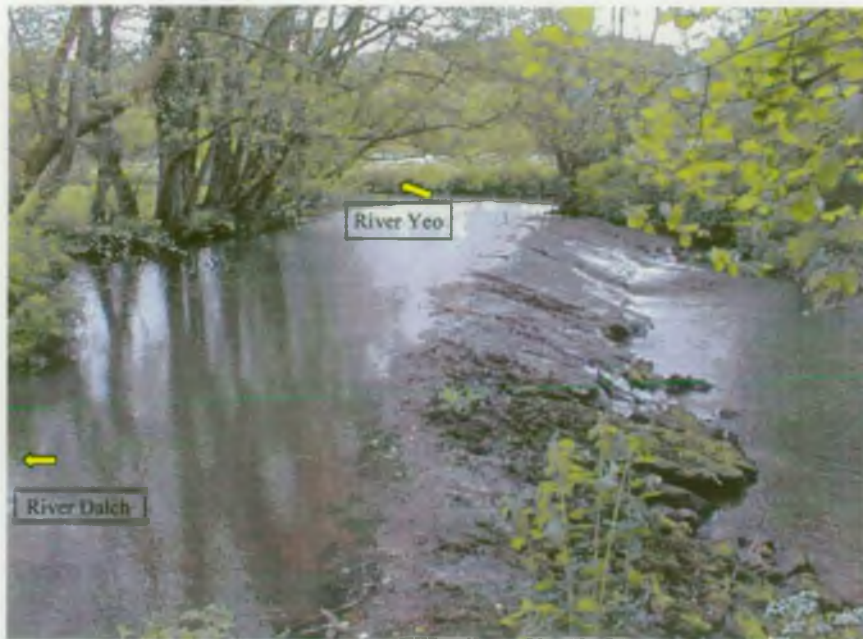
Plate 1

A weir is situated at the confluence of the rivers (see figure 2 & figure 4: plate 1). This has the effect of backing up the rivers forming a pond behind the weir. The final effluent from Lapford STW is discharged approximately 20m above the upstream end of the ponding. A Mill Leat is positioned above the weir and takes water from the River Dalch side of the weir (see figure 4: plate 2).

Weir at confluence of River's Dalch and Yeo

The weir should be repaired, consideration should also be given to the construction of a fish pass on the Dalch side of the weir to increase flow in the Dalch and aid salmonid fish migration.

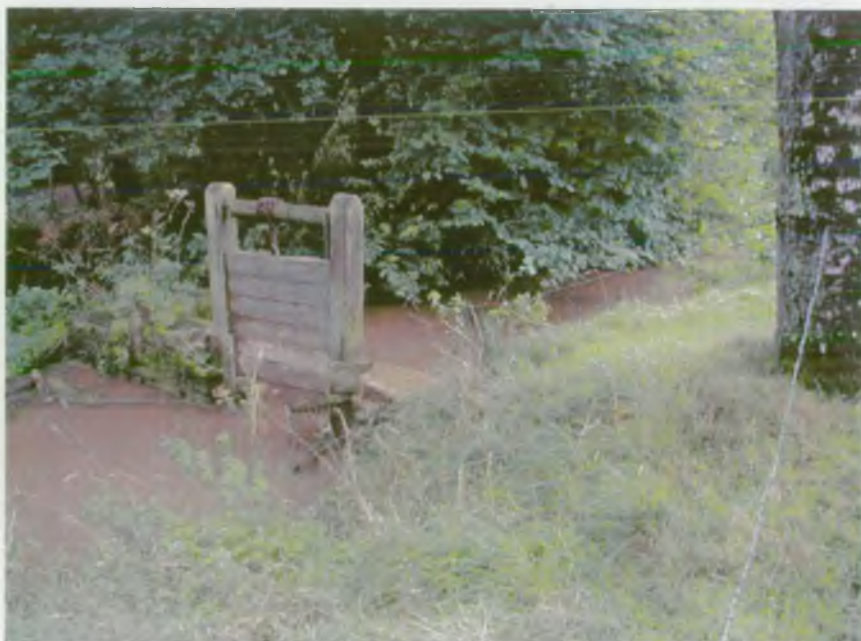
Plate 2

Mill Leat entrance from River Dalch Side of Weir.

The Mill leat should be opened up to increase flows and water movement from the pond. (Site visit on Friday 17th March 2000 revealed that this recommendation had already been undertaken prior to the deployment of the two YSI 6920 water quality monitors).

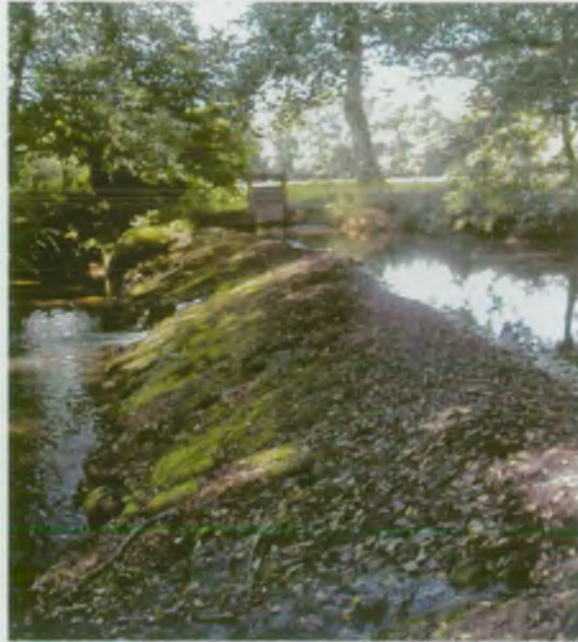
Plate 3

The low flow survey began with very low flows, in fact there was no flow over the weir at all (all flow was through defects in the weir structure, see figure 4: plates 3 & 4), unfortunately a very heavy downpour increased river flow and triggered the STW storm sewage overflow. Consequently only the first run of the survey took place in ideal conditions; the rain did clear

Showing very low flow conditions. No flow over top of weir.

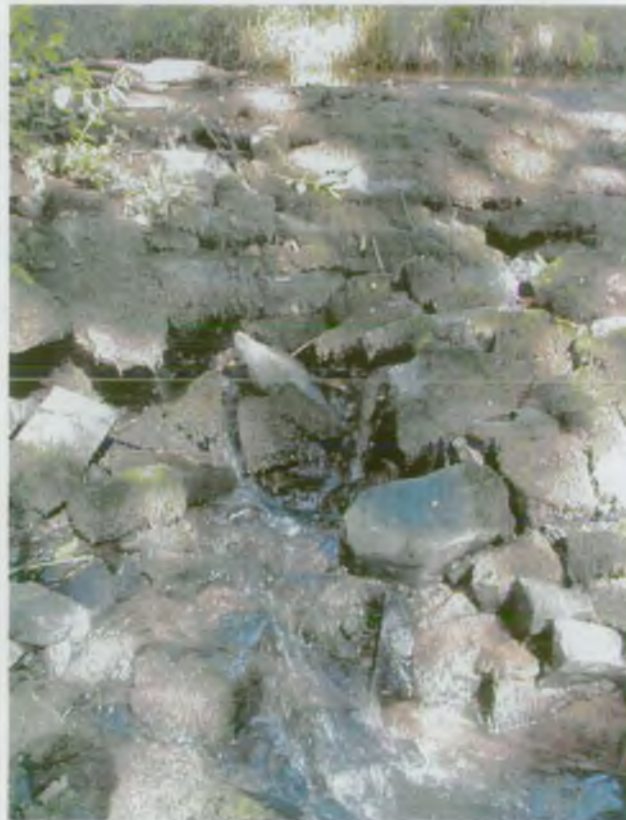
Plate 4

Close up showing breach in weir. During low flow levels all river flow is through breaches not over weir.

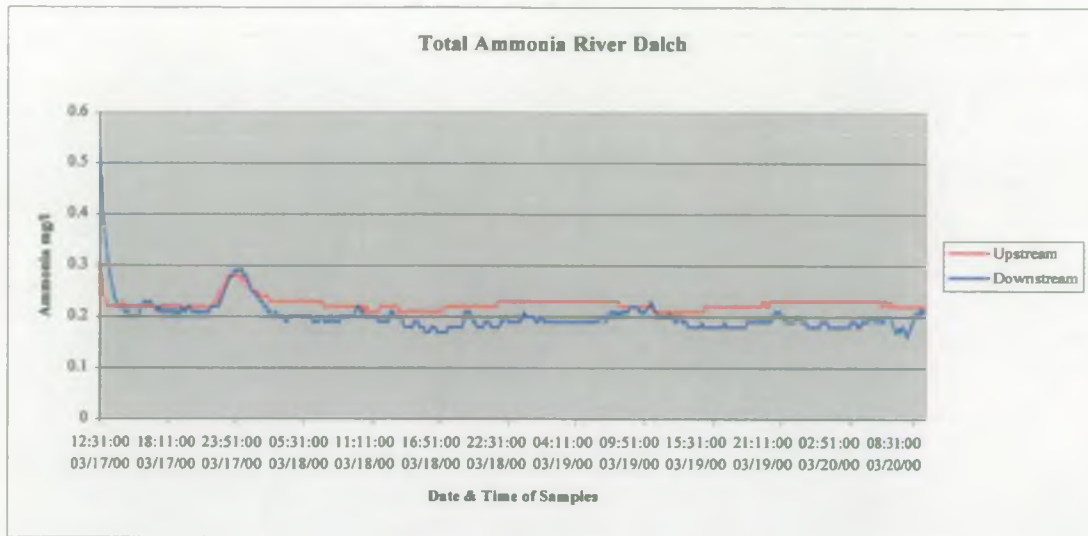
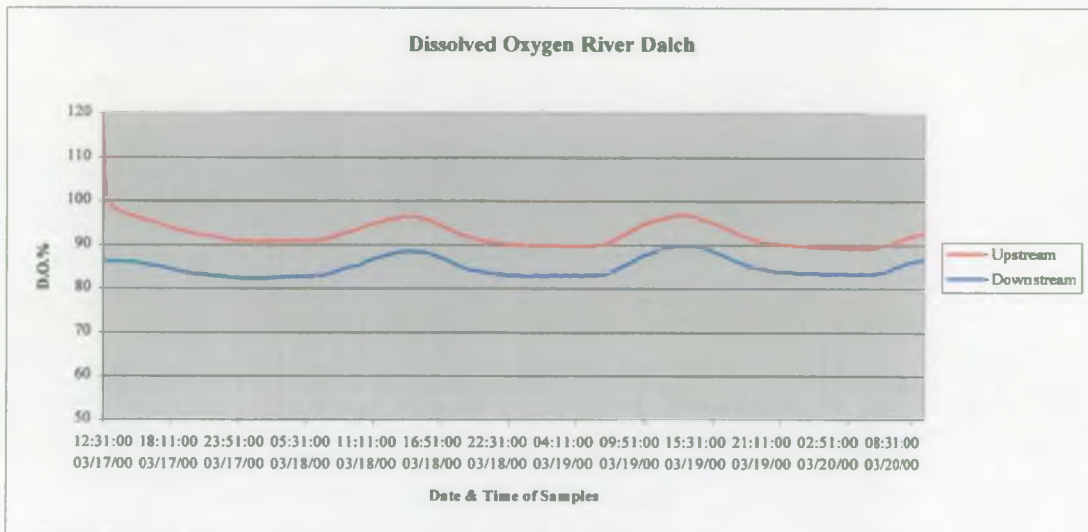
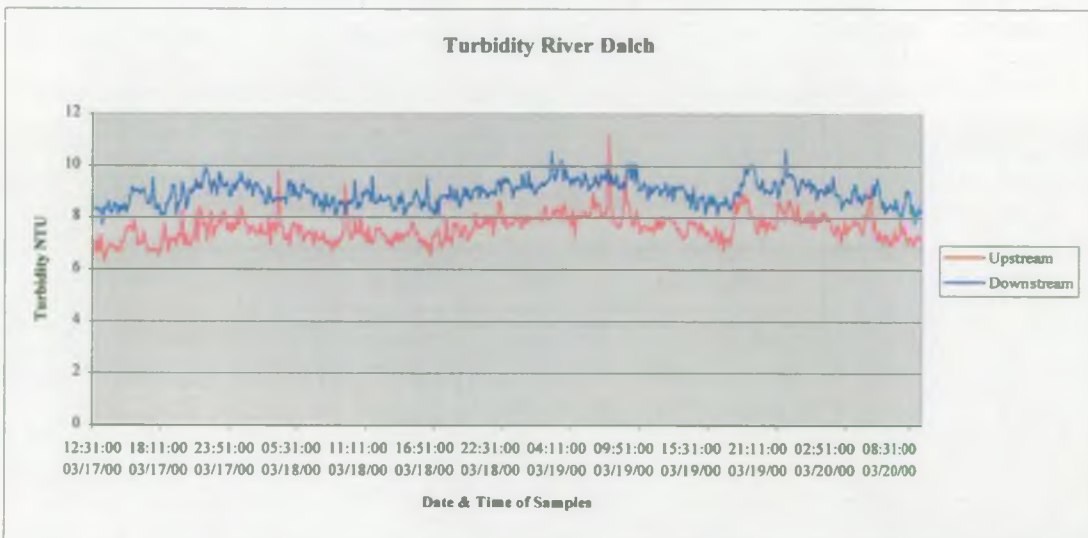
Figure 8

The data collected from the two probes can be seen in figure 8. The upstream and downstream data show very similar trends over the period of deployment. All the results collected were within the RE2 class limits.

The data from the YSI monitors shows that for the period of deployment there was no impact to water quality from the final effluent discharge. The differences in the results are within the margins of error stated for the equipment.

Data from YSI 6920 Water Quality Monitors.
