**ENVIRONMENT  
AGENCY**

**Investigation into the 1999 Failure  
of the European Community  
Bathing Waters Directive at  
Teignmouth Town Beach**

**January 2001  
DEV/EP/03/01  
(CATCHMENT 06A)**

**Author: S. HUNTER  
ENVIRONMENT PROTECTION  
INVESTIGATIONS OFFICER**

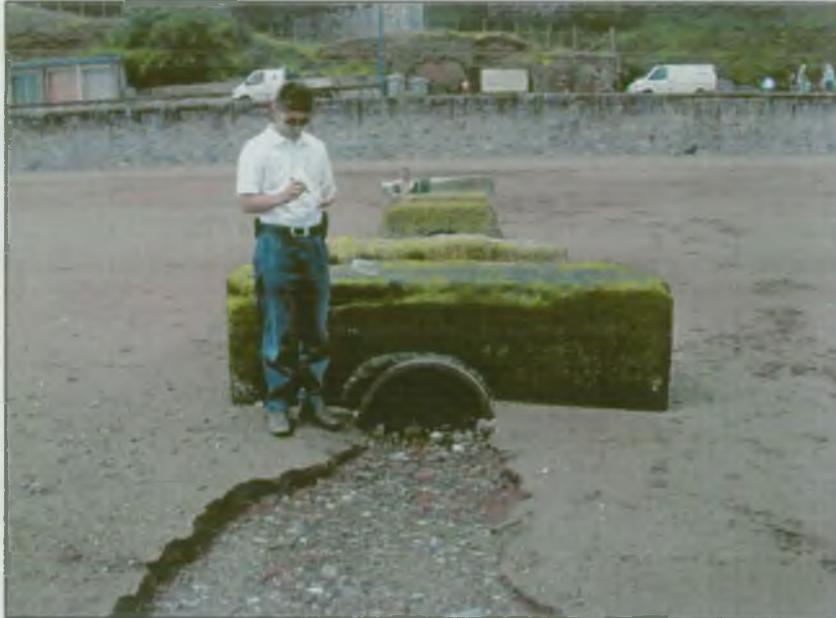
Catchment investigation highlighted a contaminated pipe discharge approximately 450m to the east of the sampling line. Further investigation revealed this flow originated from an abandoned surface water siphon that was found to be still operating; we have located one domestic sewage misconnection into this pipeline. The pipeline discharges to the inter-tidal zone. This contamination could have contributed to the 1999 failure and could potentially lead to further bathing water failures at Teignmouth.

There is a continuous discharge to the inter-tidal zone via a pipe approximately 450 metres to the east of the bathing water sampling line. For the purpose of the investigation this discharge will be referred to as the siphon pipe discharge, see figure 2; plates 1 & 2.

Plate 1, siphon pipe discharge

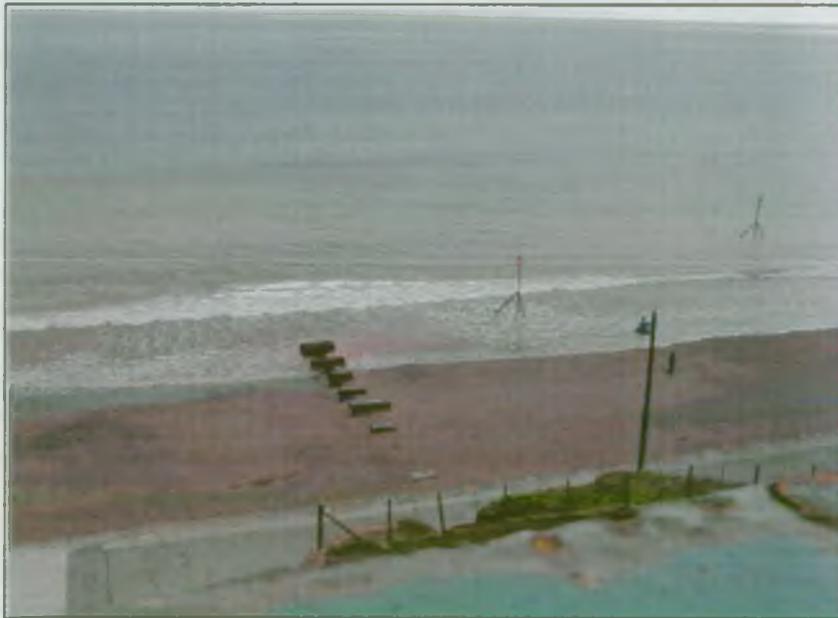
Plate 2, siphon pipe discharge

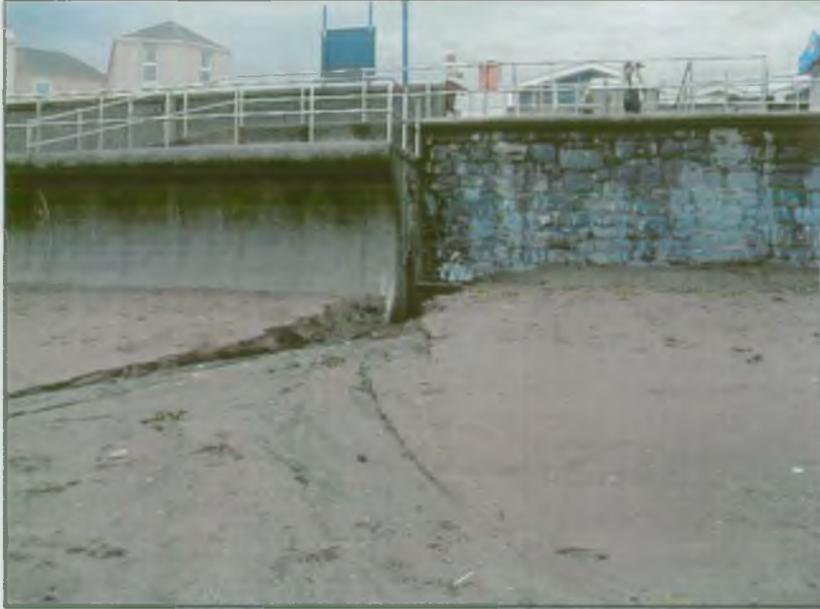
Two storm overflow discharge pipes are located approximately 325 metres east of the sampling point, see figure 2; plates 3 & 4 for photos showing location, the photographs were taken shortly after a storm event. These two discharges result from storm flows in the siphon pipe and a Combined Sewer Overflow (CSO) situated in the Railway Station carpark, see figure 3.

Plate 3, Storm water overflow Teignmouth Town Beach

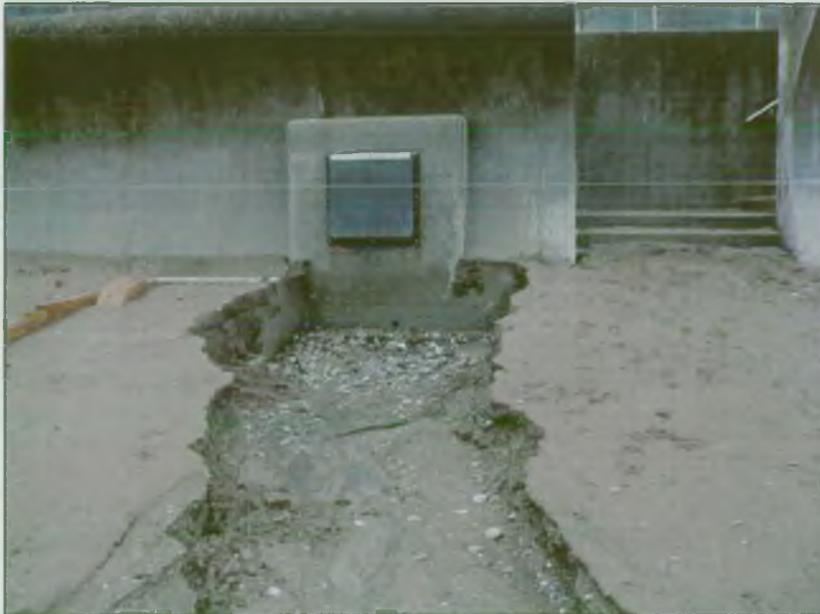
Plate 4, Storm water overflow Teignmouth Town Beach

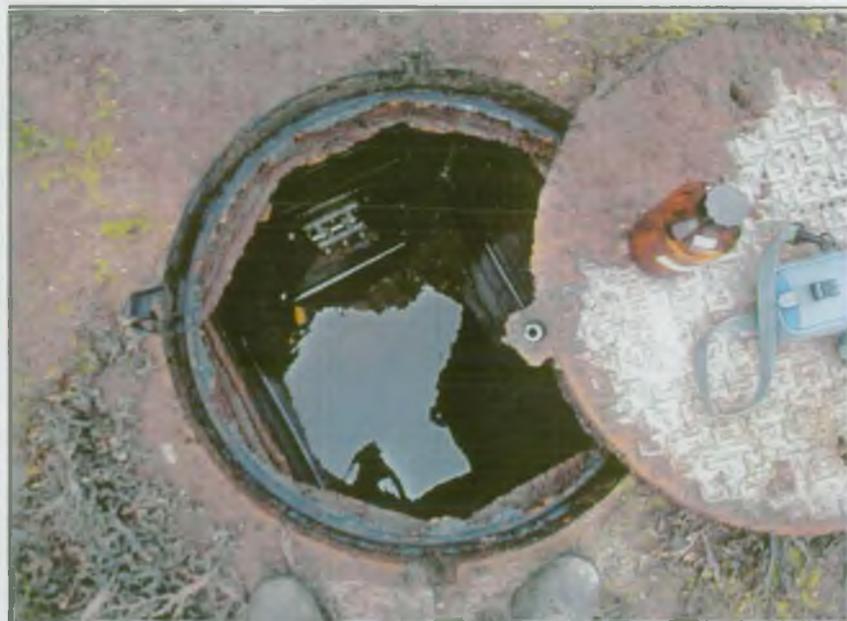
The two previous investigations highlighted a pipe discharge referred to as "P4", discharging opposite Ringmore in Shaldon, as a potential source of contamination to the lower Teign Estuary. Three samples were taken of the discharge from P4 the results of these samples can be seen in table 5. See figure 2 plates 5 & 6.

Plate 5, secured manhole on P4 discharge line showing tidal flap

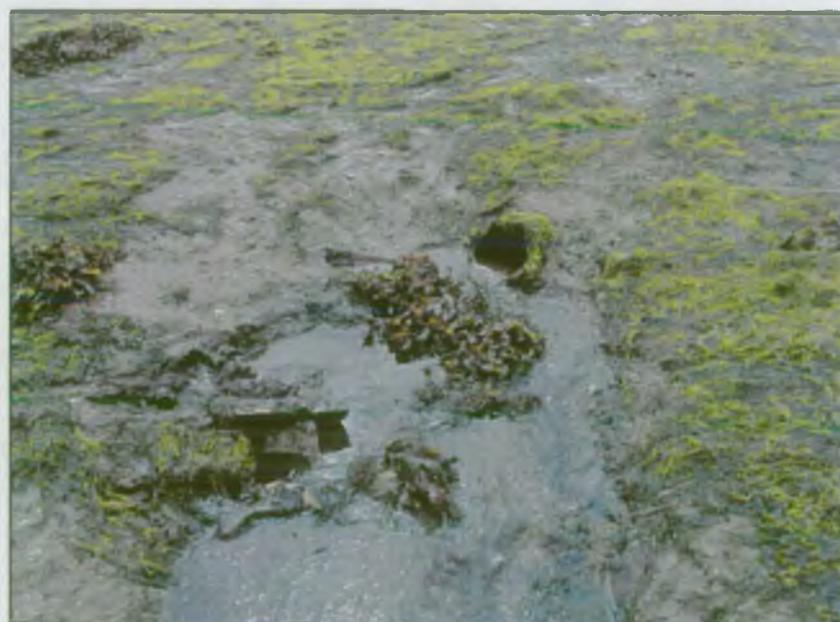
A potential problem raised in previous reports (DEV/E/11/95 & DEV/E/15/96), regarding a contaminated discharge on the salty named P4, appears to have been resolved. Samples of the discharge during this investigation did not show high levels of faecal contamination. The Brimley Brook has a discharge point in the Fishquay at NGR SX 9384 7276. This discharge was sampled once and was found to be contaminated with faecal pollution.

Plate 6, P4 pipe discharge, Teign Estuary

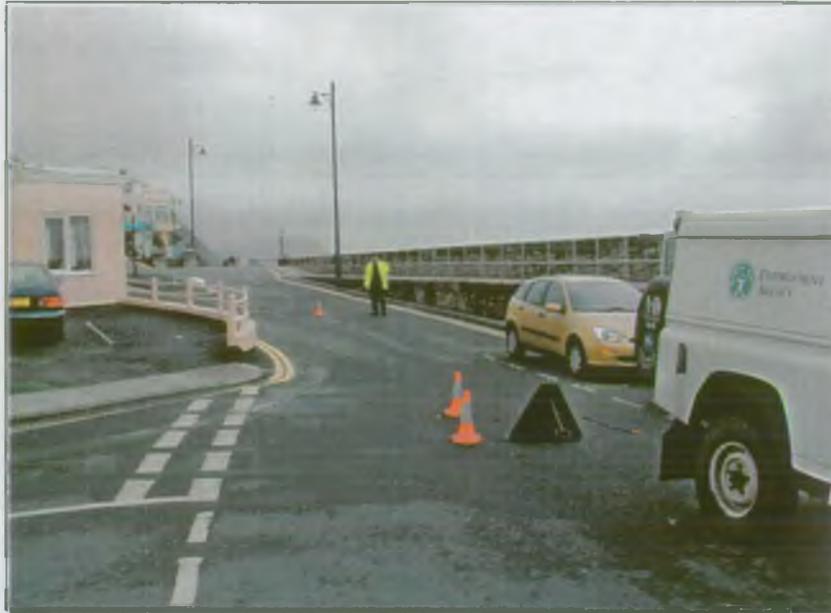
Drainage plans of Teignmouth were obtained from SWWL, the discharge pipe on the beach was found to be absent from these drawings. As the link between the discharge and a manhole adjacent to Eastcliff Hotel (figure 2 plate 7) had been established, an attempt was made to trace the flow back from there. Numerous manholes were lifted but no flow could be found.

Plate 7, showing location of Eastcliff manhole in distance and manhole with weir to overflows on beach in foreground

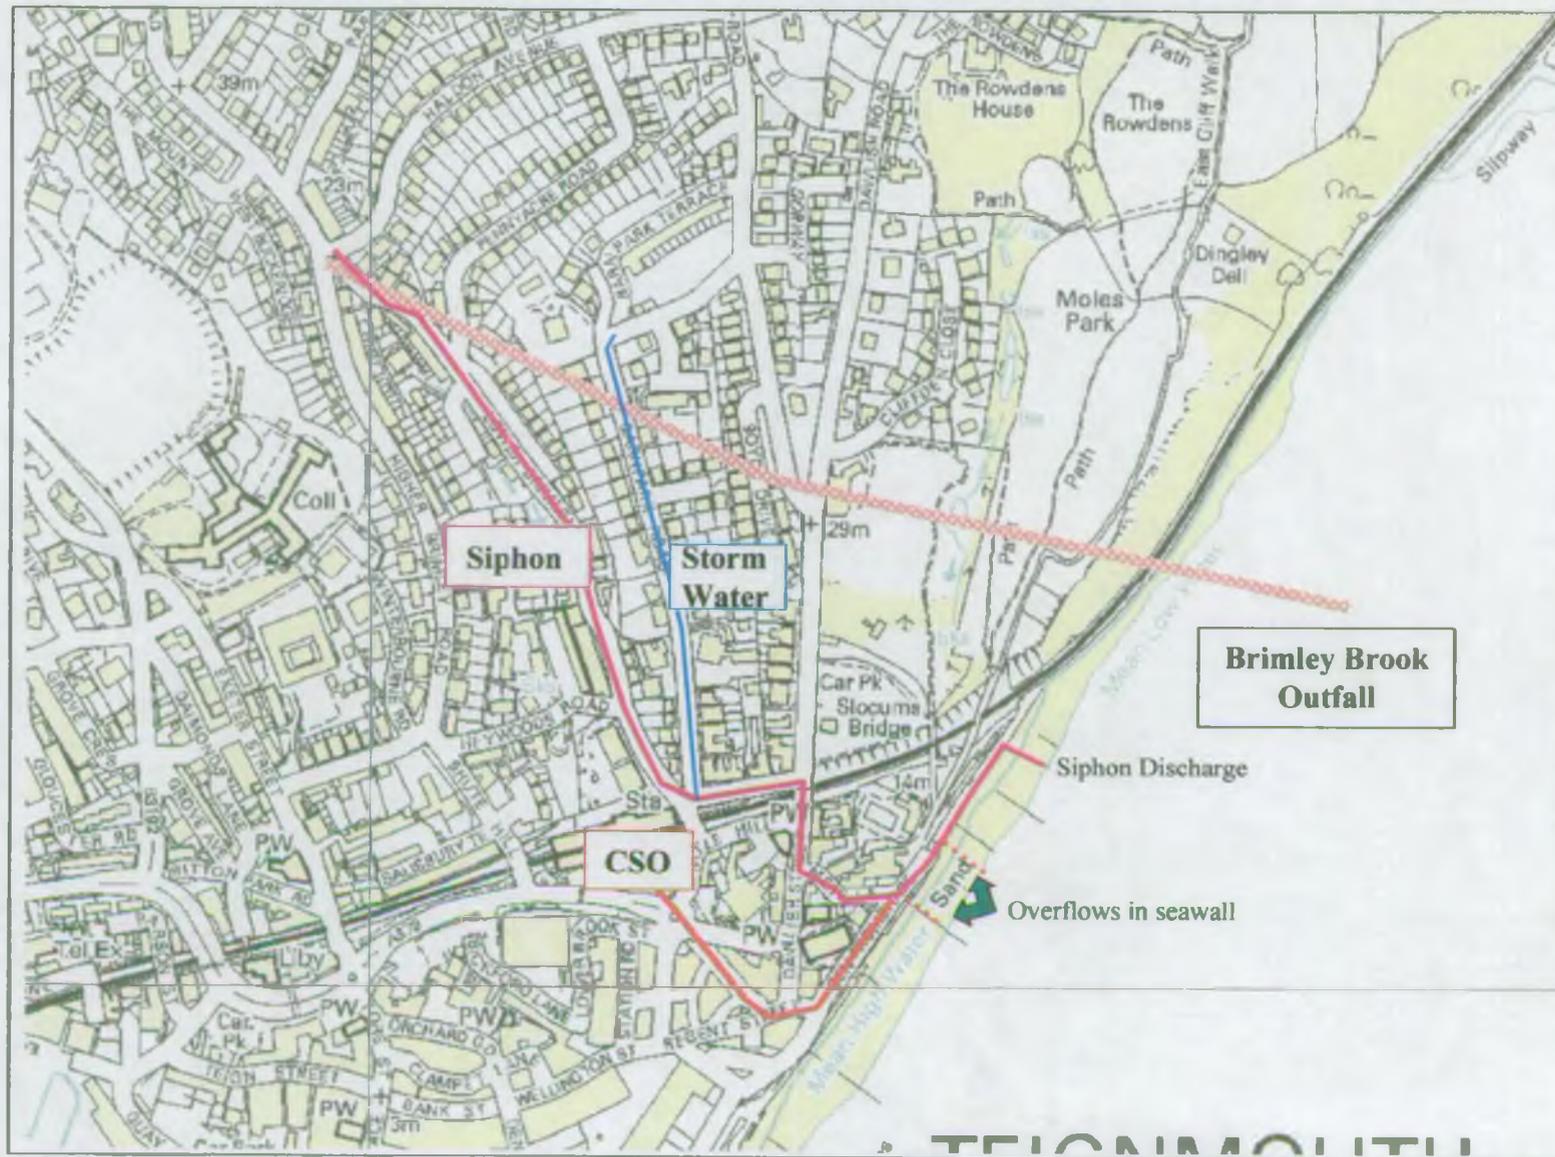
**Teignmouth Plan Showing Brimley Brook Outfall, Siphon and CSO Discharge Point.**

Teignbridge District Council informed us that the siphon had been capped and abandoned when the tunnel and outfall were created. A portion of Brimley Brook continues to flow as a stream as far as the Station Business Park, from here it is culverted and flows to discharge at the Fish Quay. See Figure 4.

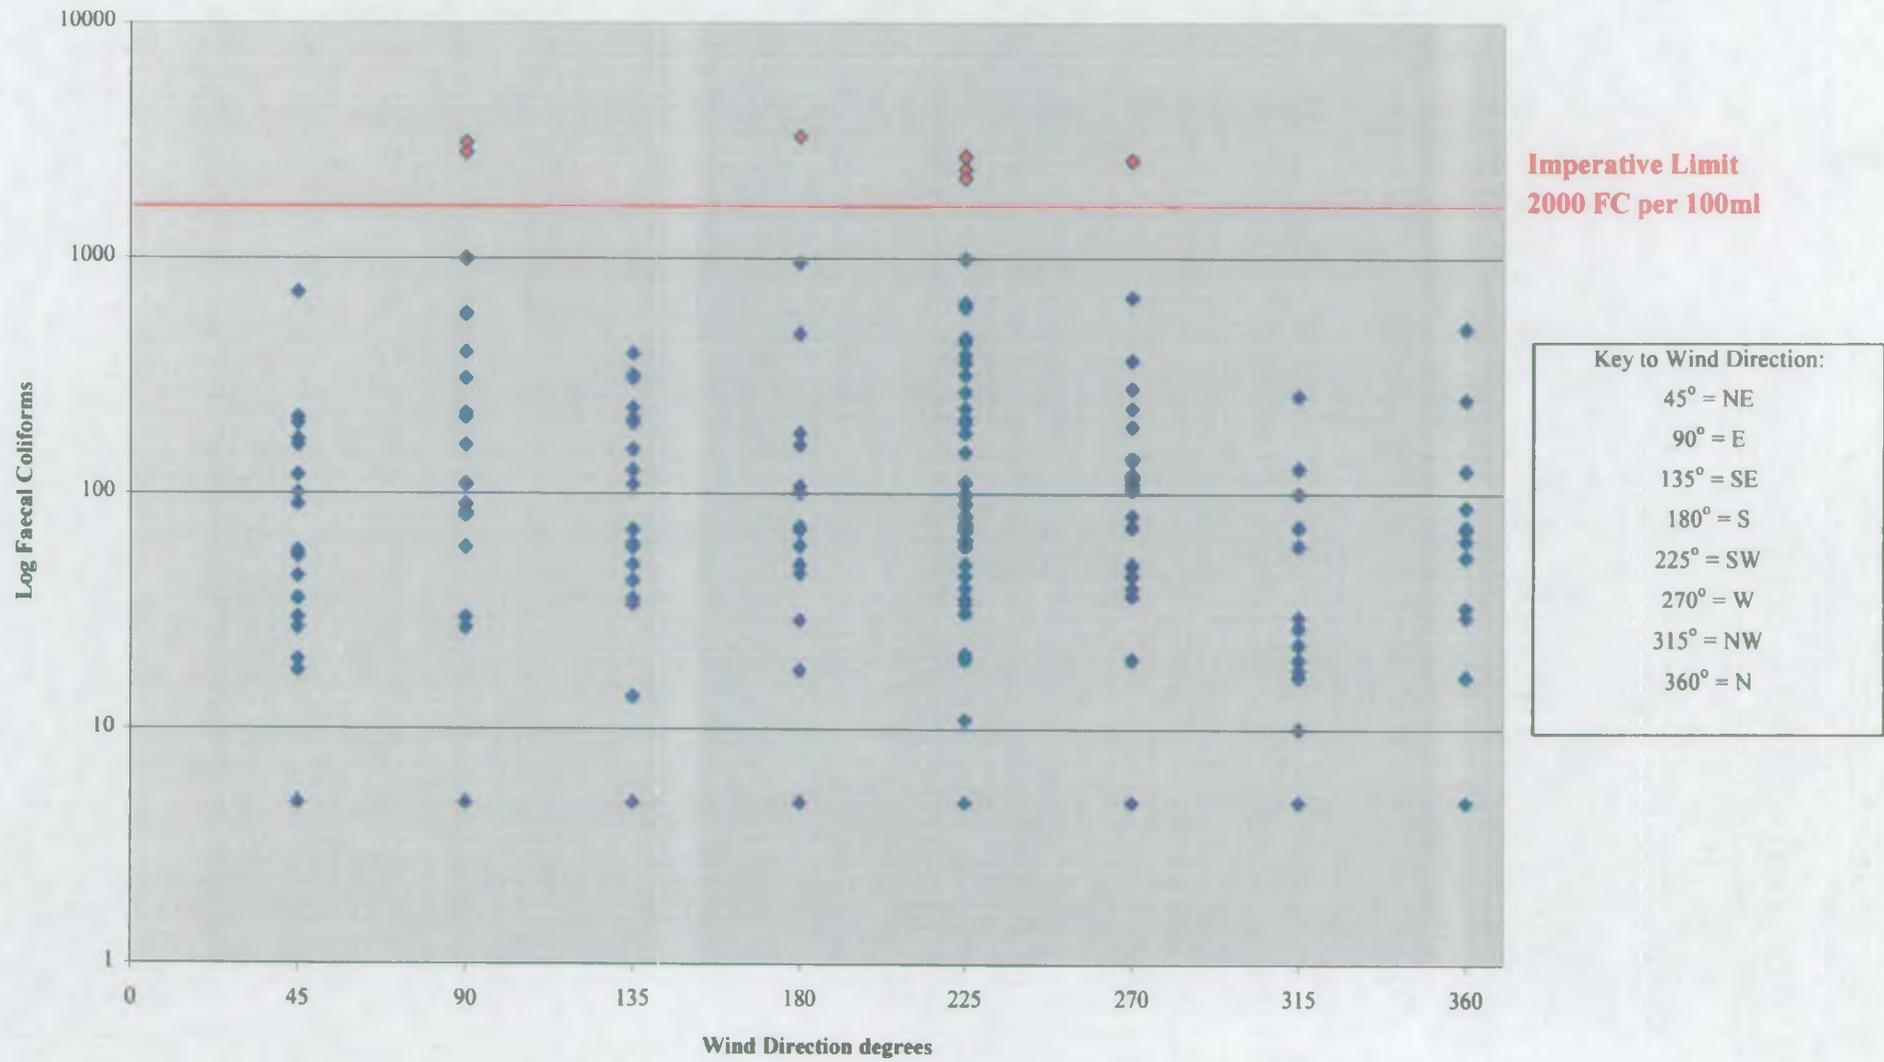
Faecal Coliforms plotted against Wind Direction at Teignmouth Town Beach

At the time the samples that failed were taken wind directions were from the south, west, south-west and east. Wind speeds ranged from 3 to 5 on the Beaufort scale. On the date of the most contaminated sample (3300 FC per 100ml on 08 September 1999) the wind direction was south with a wind speed of 4. A chart showing log FC numbers from 1990 to 1999 plotted against wind direction can be seen in figure 6.
