**FINE SEDIMENT DEPOSITION
IN THE RIVER KEER**

GEOMORPHOLOGICAL ASSESSMENT

Report code T86/12/1

June 1997

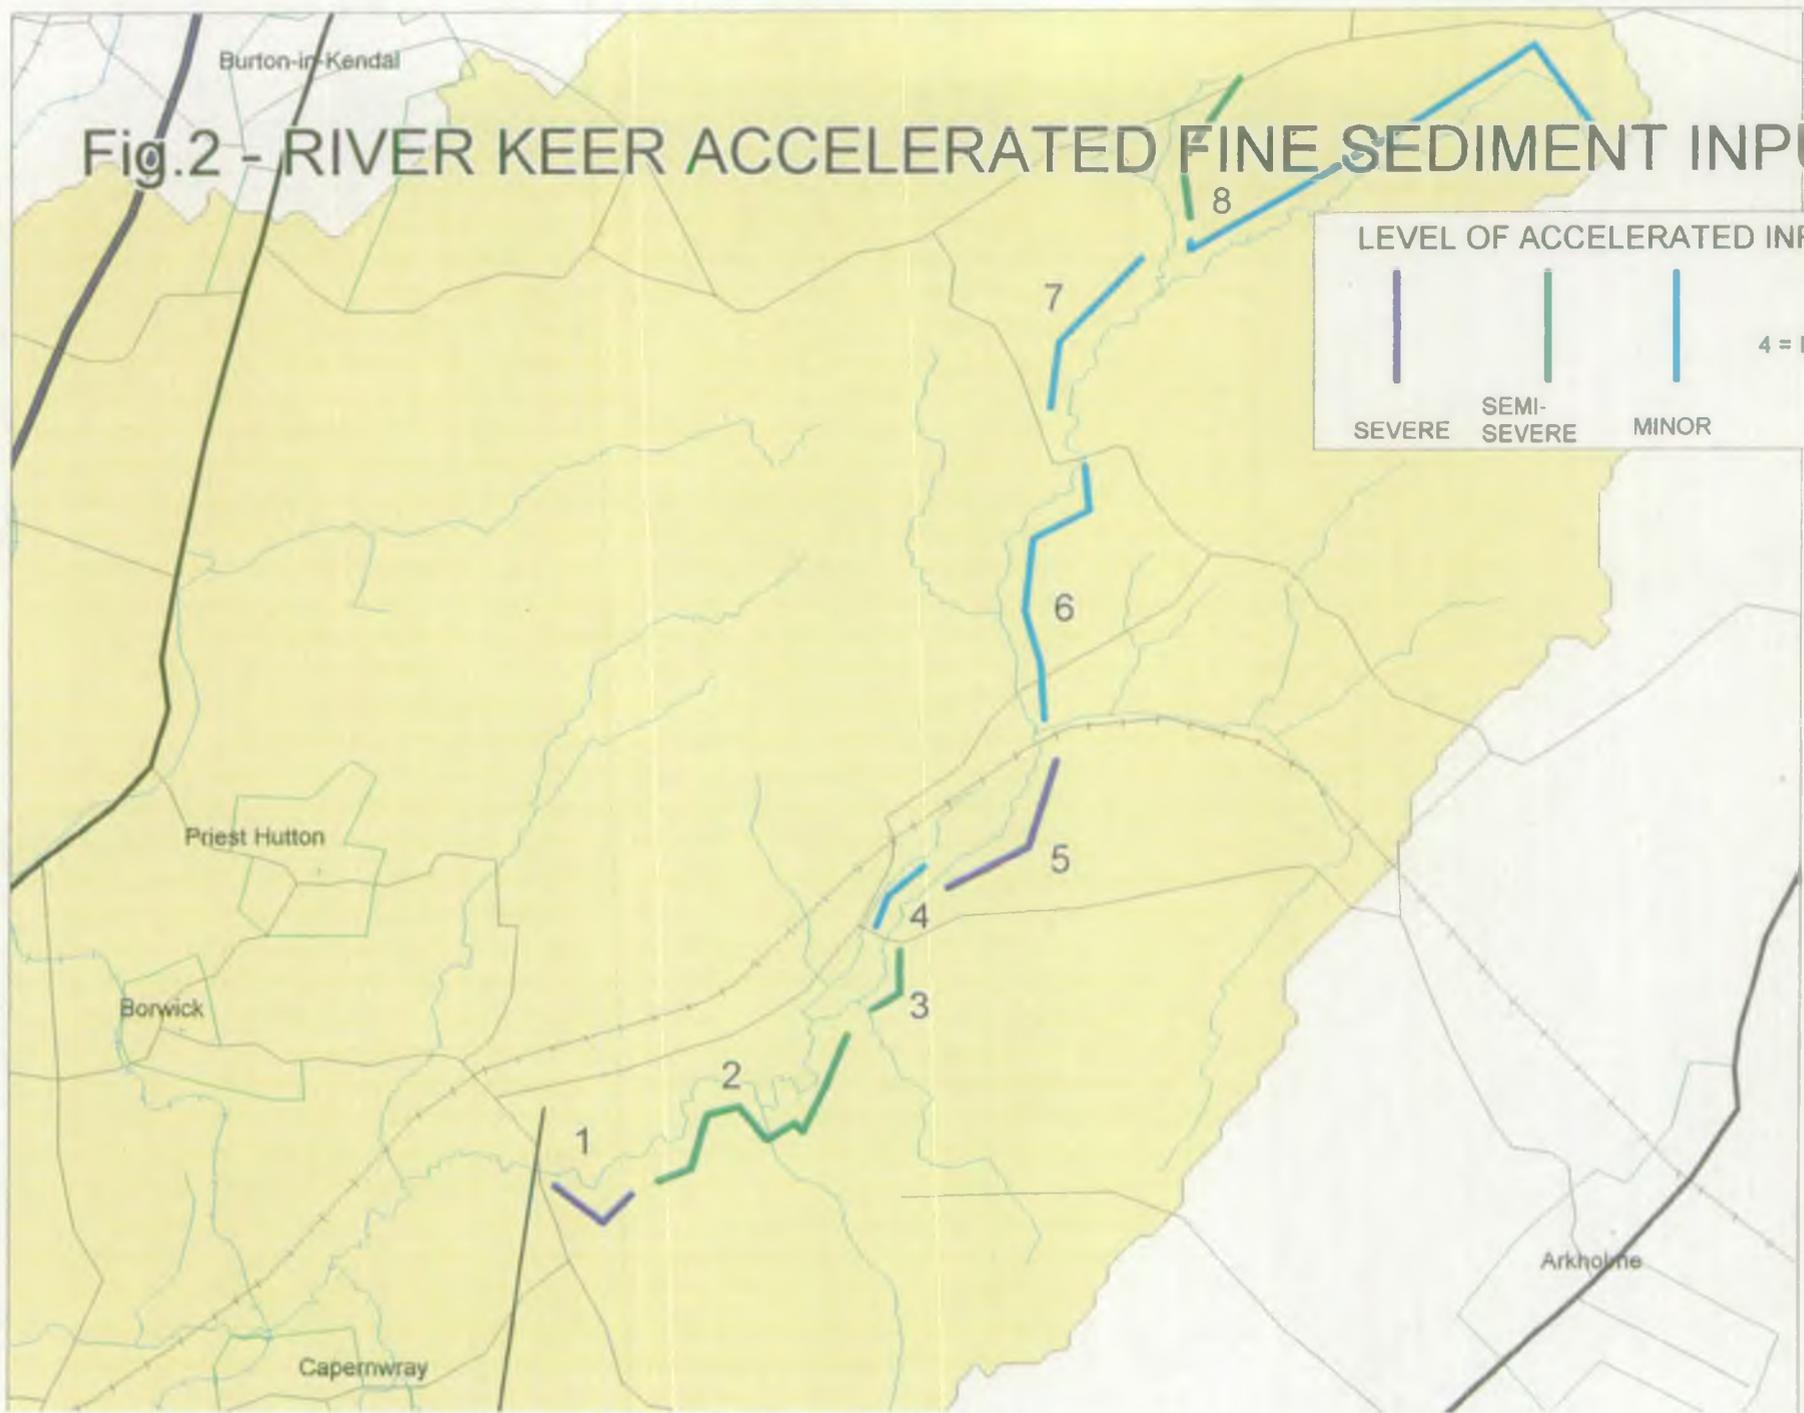
Fig.2 - RIVER KEER ACCELERATED FINE SEDIMENT INPUTS

Dissipated sources of accelerated sediment supply are however of greater significance. In this case these are principally supplied by bank poaching from stock pressure. Inputs are at their highest in reaches 1 and 5, but are also substantial in reaches 2 and 3. The affects of such inputs are continuous, but are focused in the summer months when soil moisture stores are low and thus banks are at their most friable, and stock water demand is highest, with sources away from the channel likely to beat their driest. This is particularly bad in terms of fine deposition, as flows are at there lowest, and largely incapable of transporting fine sediments, which consequently remain in-situ, becoming vegetated in places, which in turn increases their resistance to entrainment.

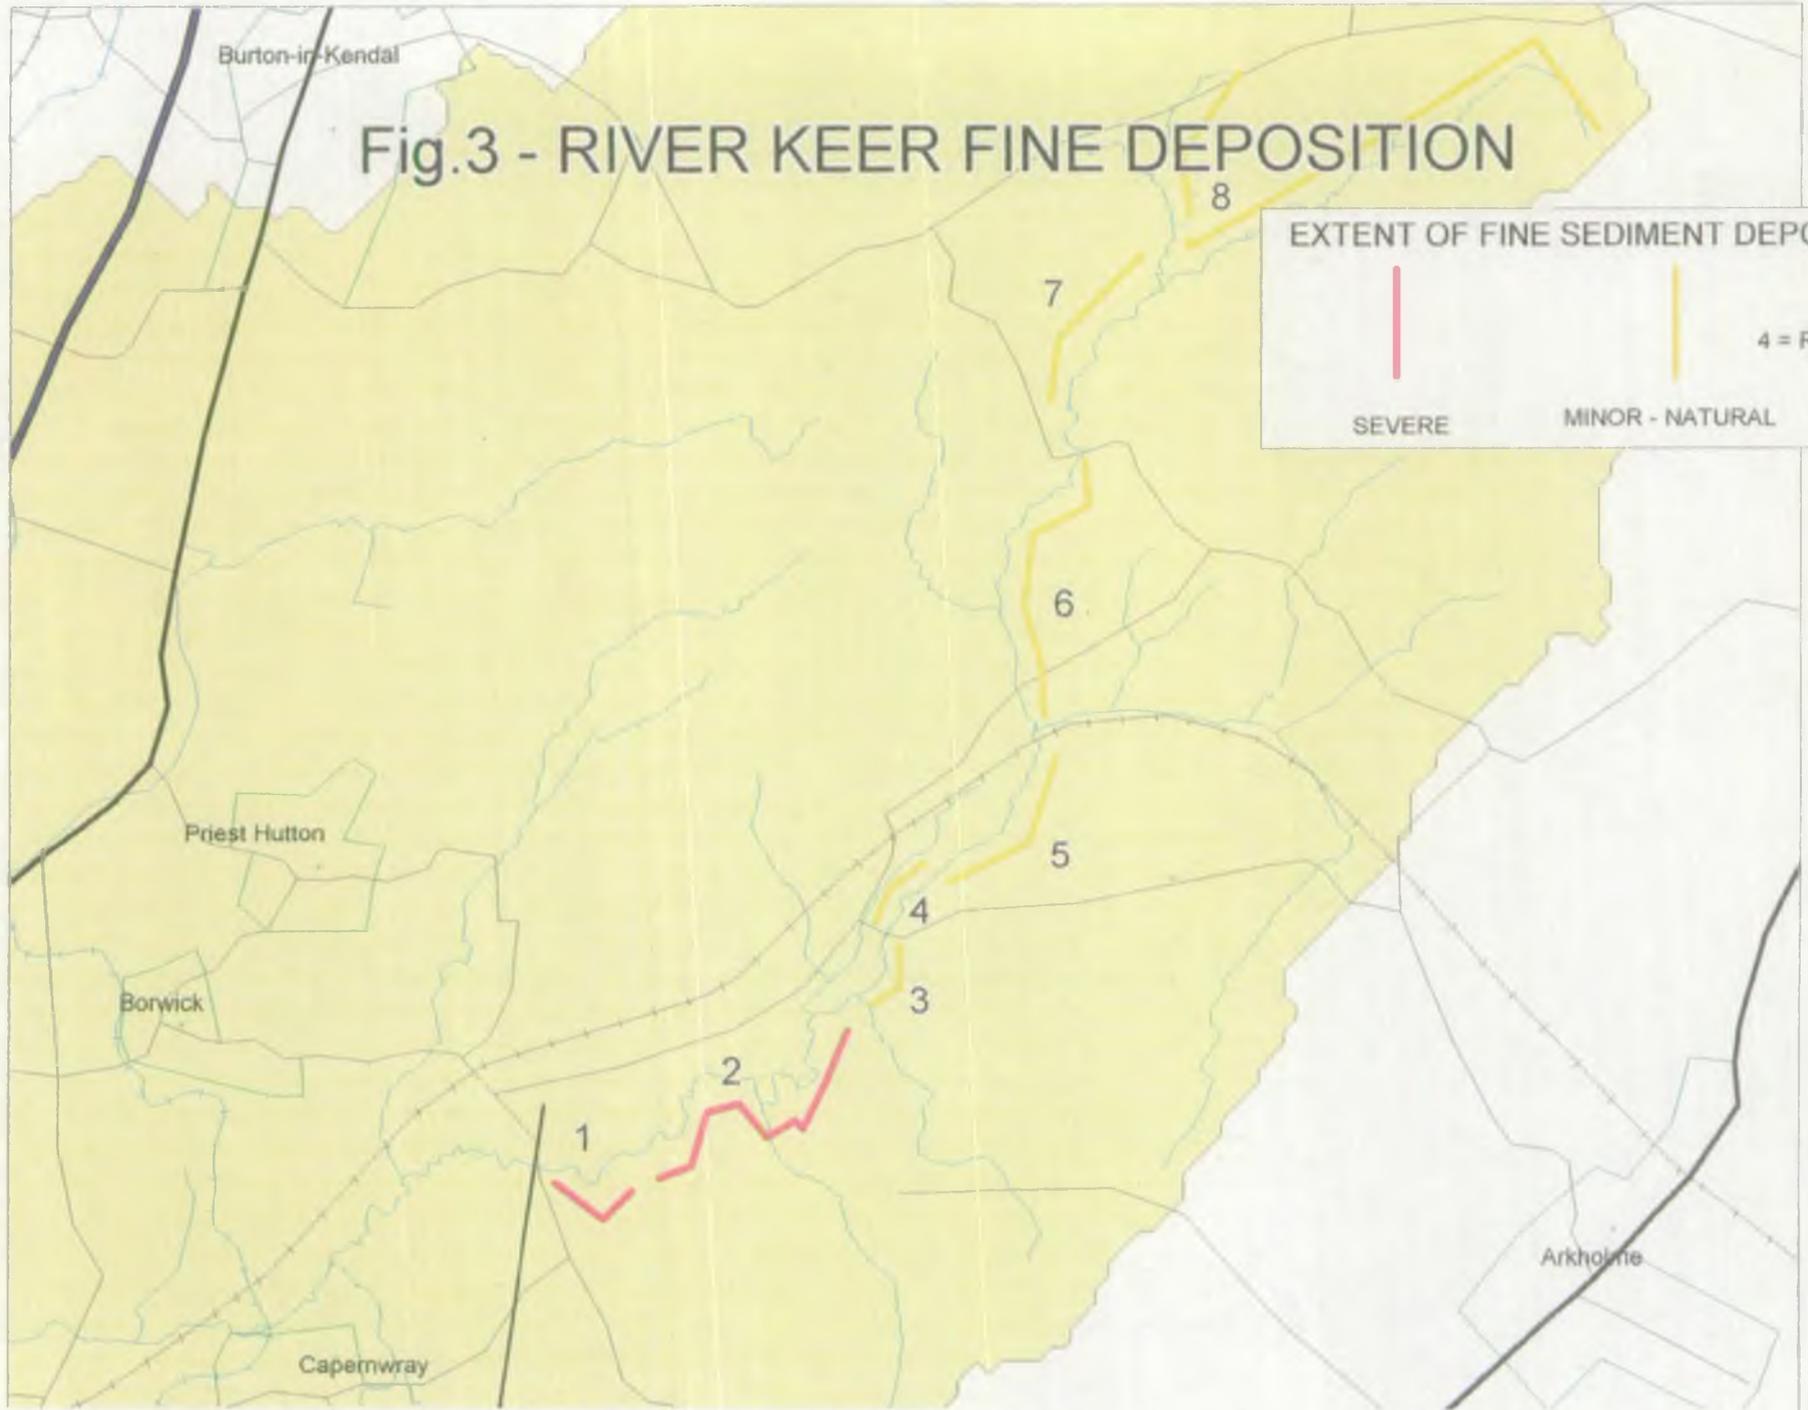
Fig.3 - RIVER KEER FINE DEPOSITION

Fine sediment (silts and sands) cloak the majority of the bed in the downstream section of the focus area (reaches 1 and 2), this depository environment extends to SD 553732, approx. 250m downstream of the Arkholme-Borwick Road Bridge. This point corresponds to a marked downstream increase in sinuosity and a moderate decrease in bed slope, and therefore a consequent drop in stream power and sediment entrainment/carrying capacity. Above this point bed gravels are relatively free of fine deposits, [see photo 5, appendix]. One particular point of note is the area of the main channel in the vicinity of the large garden pond in the grounds of a recently built house near (not marked on the current O.S. 1:25000), close to the right bank in reach 2, identified in table 1 above. Velocities at this point appear to be abnormally low, and in-channel deposition is at its most extreme, with riparian vegetation fast colonising the in-channel deposits of fine sediment. A preliminary examination of licensed abstractions in the catchment does not appear to include this source, this may merit further investigation.

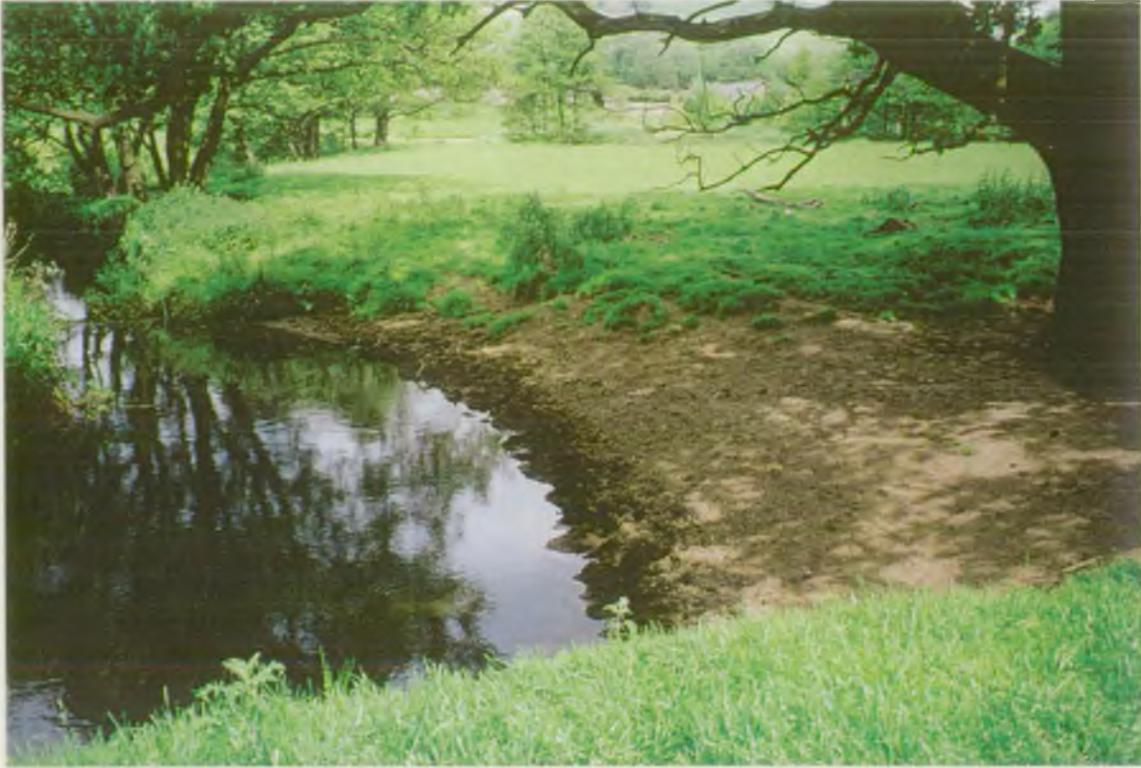
Photos 1 & 2: Examples of Stock Accelerated Bank Erosion.

1. To produce any marked reduction in fine deposition at the bed, accelerated sediment sources must be switched off. Therefore fences should be erected where stock currently have access to the channel from one or both banks throughout the middle and lower reaches of the study areas, up to the downstream extent of Wash Dub Wood, (SD 560744). Controlled offline and/or online drinking provision should be made for stock, [see figs. 4 and 5 below, and N.B. points A & B below]. Additionally, landowners should be approached, and a close watching brief should be kept, in an effort to try and deter any future specific localised inputs of fine sediment, be it from resectioning/land drainage, forestry or any other form of rural industry.

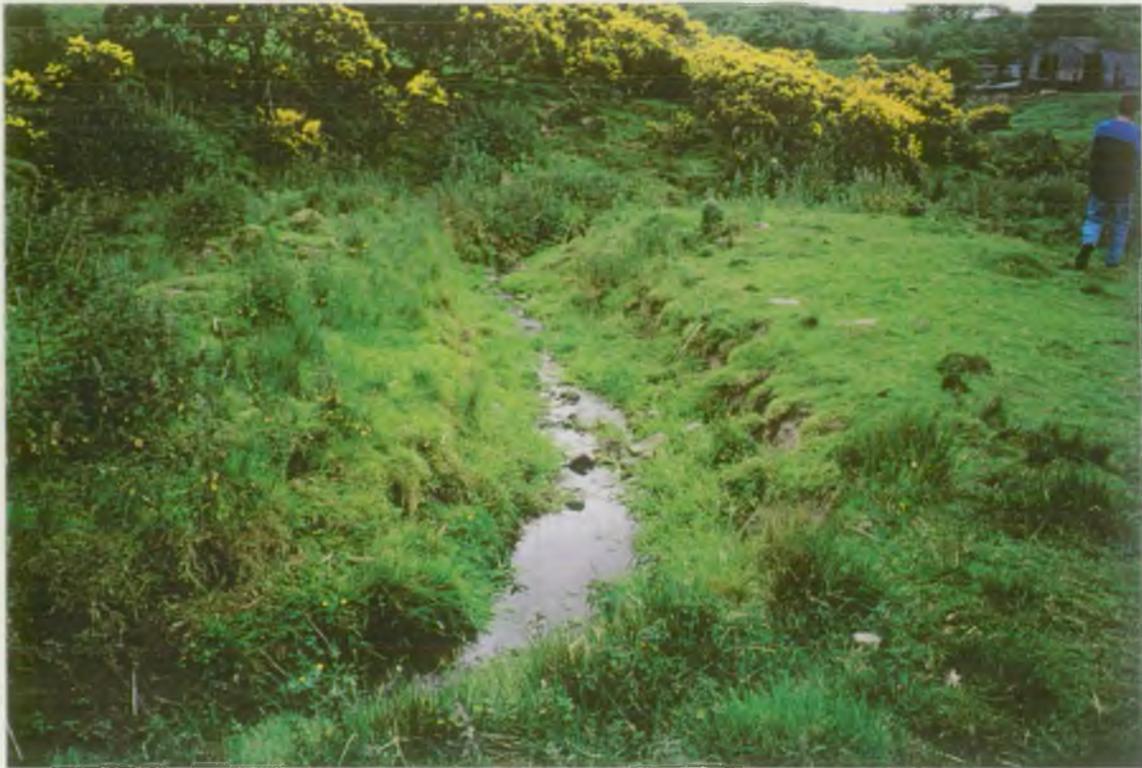
There have been a few localised increases in supply, caused by such effects as the resectioning of the 'Battle House tributary' in Nov. 1994. Such events cause major increases in short term supply (in this case the entrainment of 10% of excavated material for instance, during the works and subsequent to them, when spoil was stock-piled at the bankside, would translate to approx. 80 tonnes of fine sediment). However, such sources of supply are unlikely to remain active for more than a year. Indeed the Battle House tributary site is now well revegetated and the source is totally 'switched off'. Although such events are significant as much of the fines yielded may still be resident in the lower part of the study area.

Photo 3: Channel Resectioning in the Headwaters, (No Longer an Active Input).

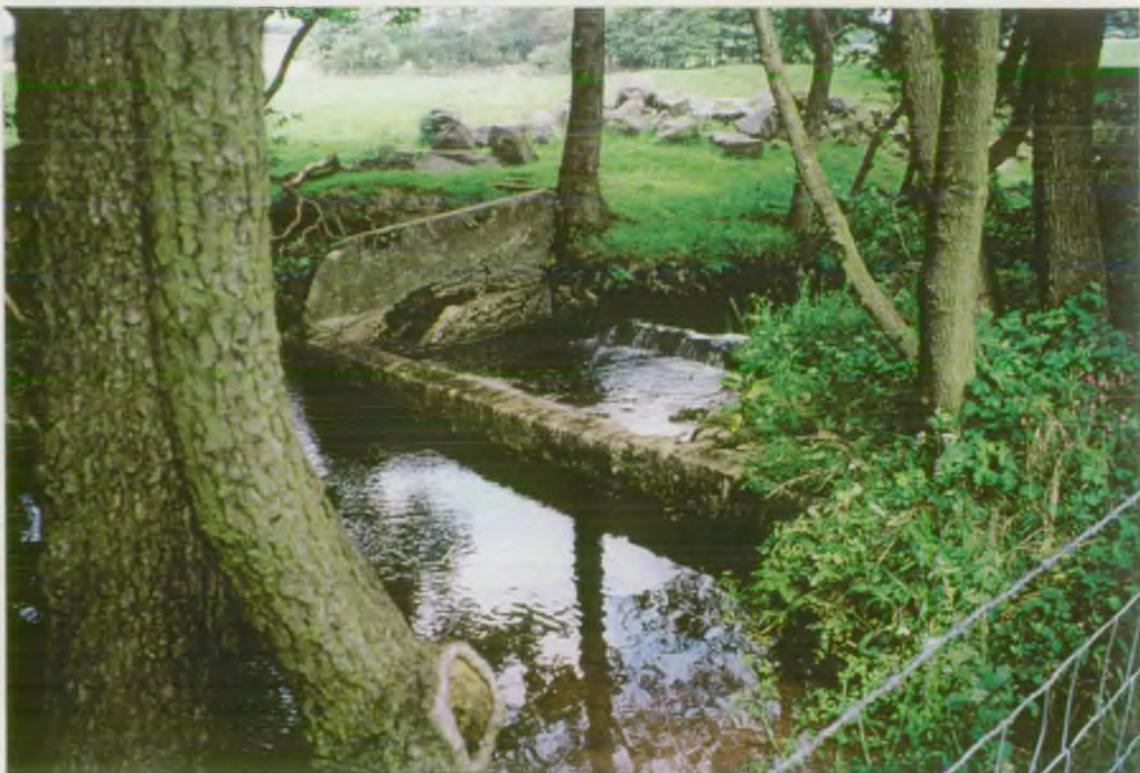
| Reach No. | Accelerated Inputs | Fine Sediment Deposition | Est. Sinuosity | Local Gradient (m/m) | Bankside Landuse | Additional Comments |
|---|---|---|---|---|---|---|
| 1 | Severe | Severe | 1.6 | 0.004 | Heavy grazing | Fencing at left bank only. Lack of pools or deep glides. Dilapidated weir, [photo 4, appendix]. |

Photo 4: The Dilapidated Weir

3. Improvements can be assisted by removing in-channel vegetation which is rooted in fine sediment deposits, [see photo 6, appendix]. Additionally the removal of the dilapidated weir in Reach 1 would locally increase the rate of fine sediment transport. Improvements can also be made by locally reducing channel width, and thus increasing velocities, with flow deflectors, such as locally derived boulders. (Indeed an incidence of opposite bank collapse at one location, leaving a narrow channel which has a restored gravel bed, gives an existing example of the applicability of the method). Longitudinally this technique should be employed sporadically at points of greatest deposition, creating intermittent reaches of higher velocity flow to encourage a wider improvement of the bed.

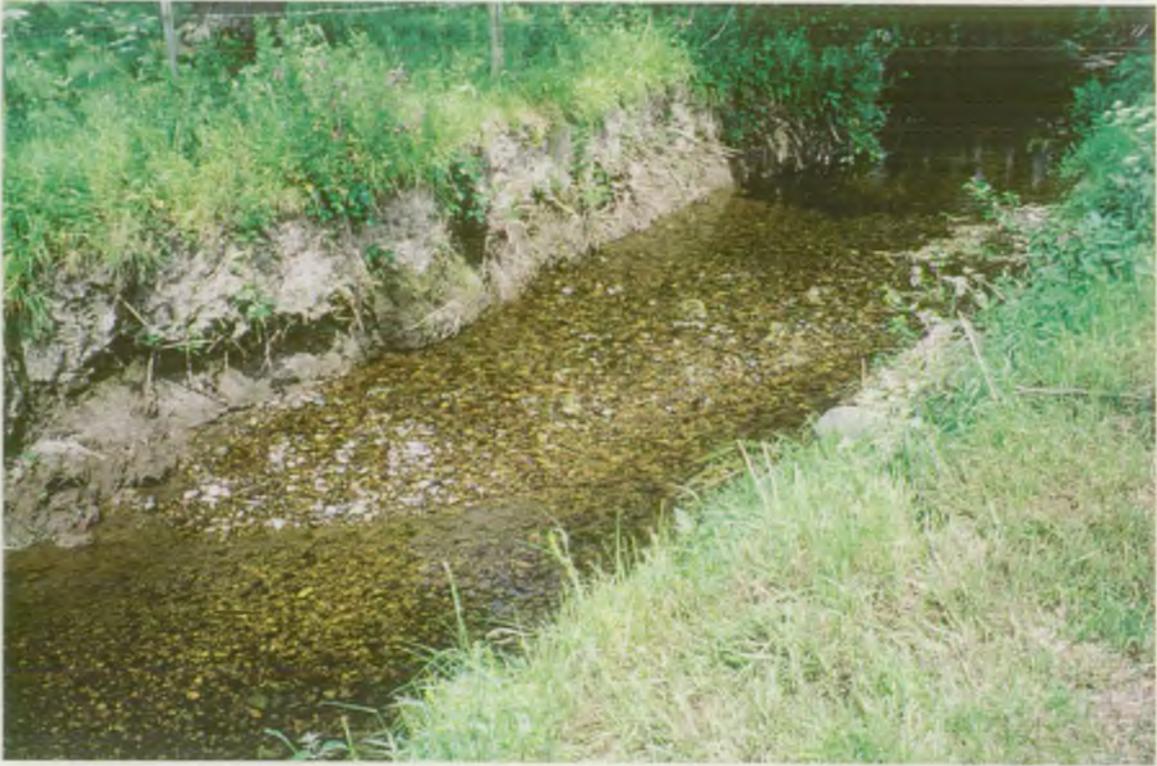
| 3 | Semi-Severe | Natural to Minor | 1.3 | 0.006 | As Reach 2 | Intermittent deposition, majority of gravels clear of fines |

Photo 5: The Bed in Reach 3, Uncloaked by Fine Sediment

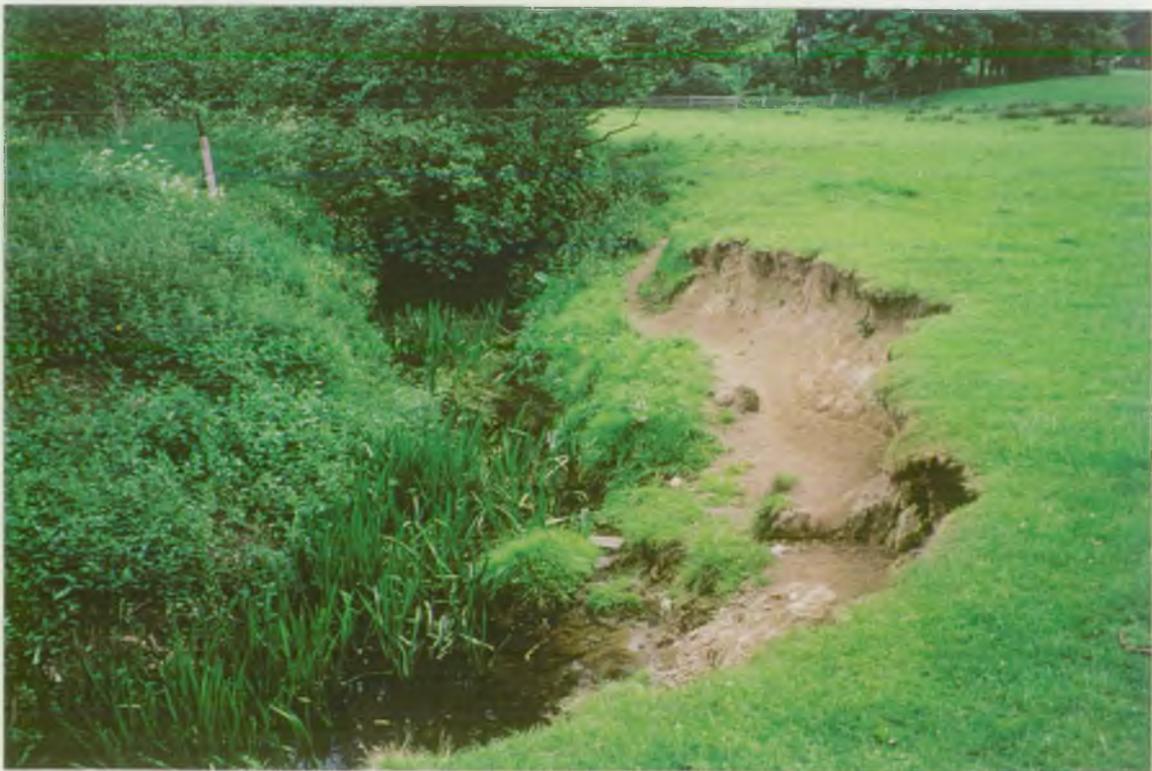
Photo 6: In-channel Vegetation Resulting from Accelerated Erosion and Bank Collapse
