ENVIRONMENT
AGENCY

**FURTHER MONITORING OF THE
IMPACT OF CROWDALE WASTE
WATER TREATMENT WORKS FINAL
EFFLUENT ON WATER QUALITY**

**April 1997
COR/97/007
Author: Peter Long
Investigations Technician**

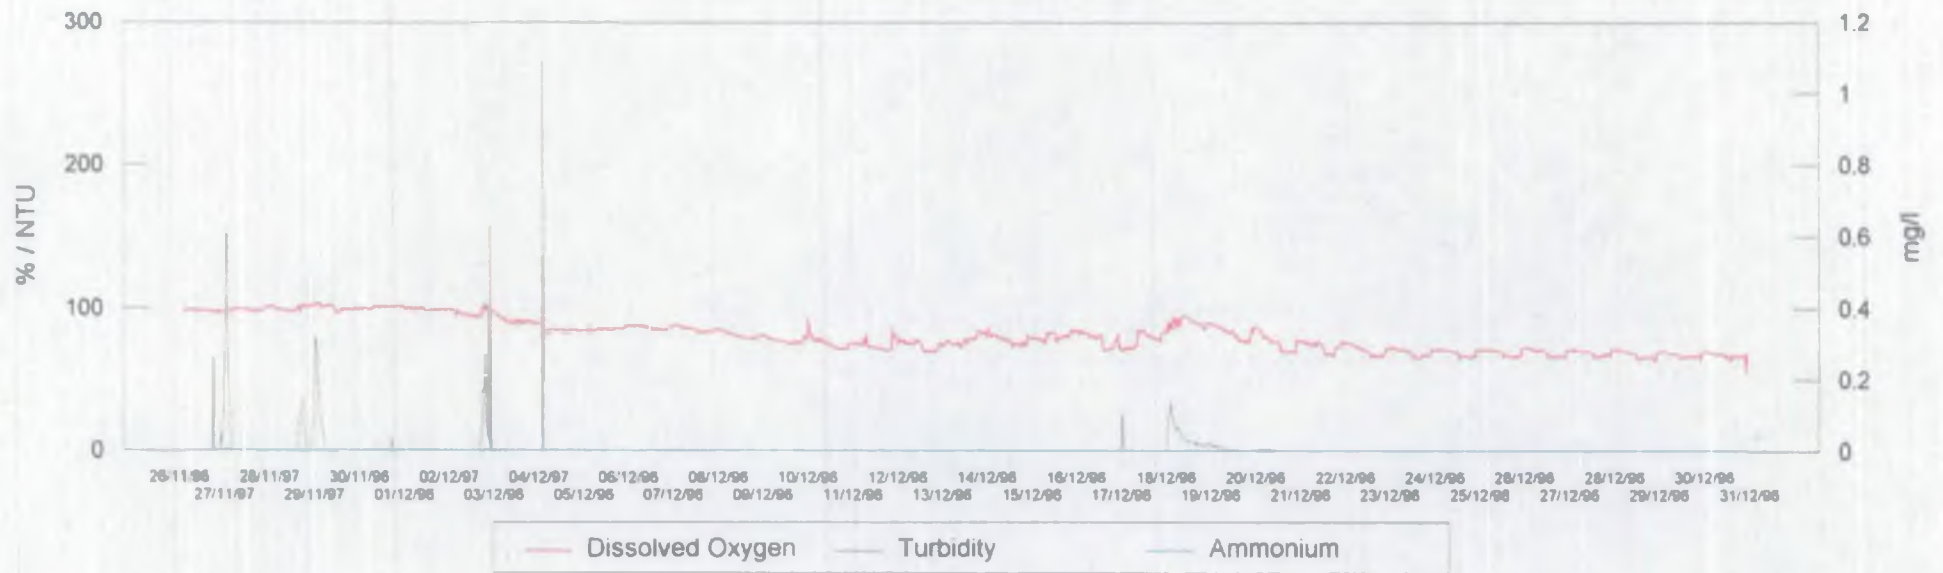
Figure 2. Downstream (a)

- 4.1 At no point during the period of monitoring was any ammonium recorded at either the upstream or downstream sites (figures 2 and 4). Neither the final nor the storm overflow effluents were seen to have caused a reduction in downstream water quality during the study period.
