**FINAL DRAFT REPORT**

**MILLENDREATH STREAM  
EC BATHING WATERS  
BACTERIAL CONTAMINATION  
INVESTIGATION 1995**

**March 1996**

**COR/96/001**

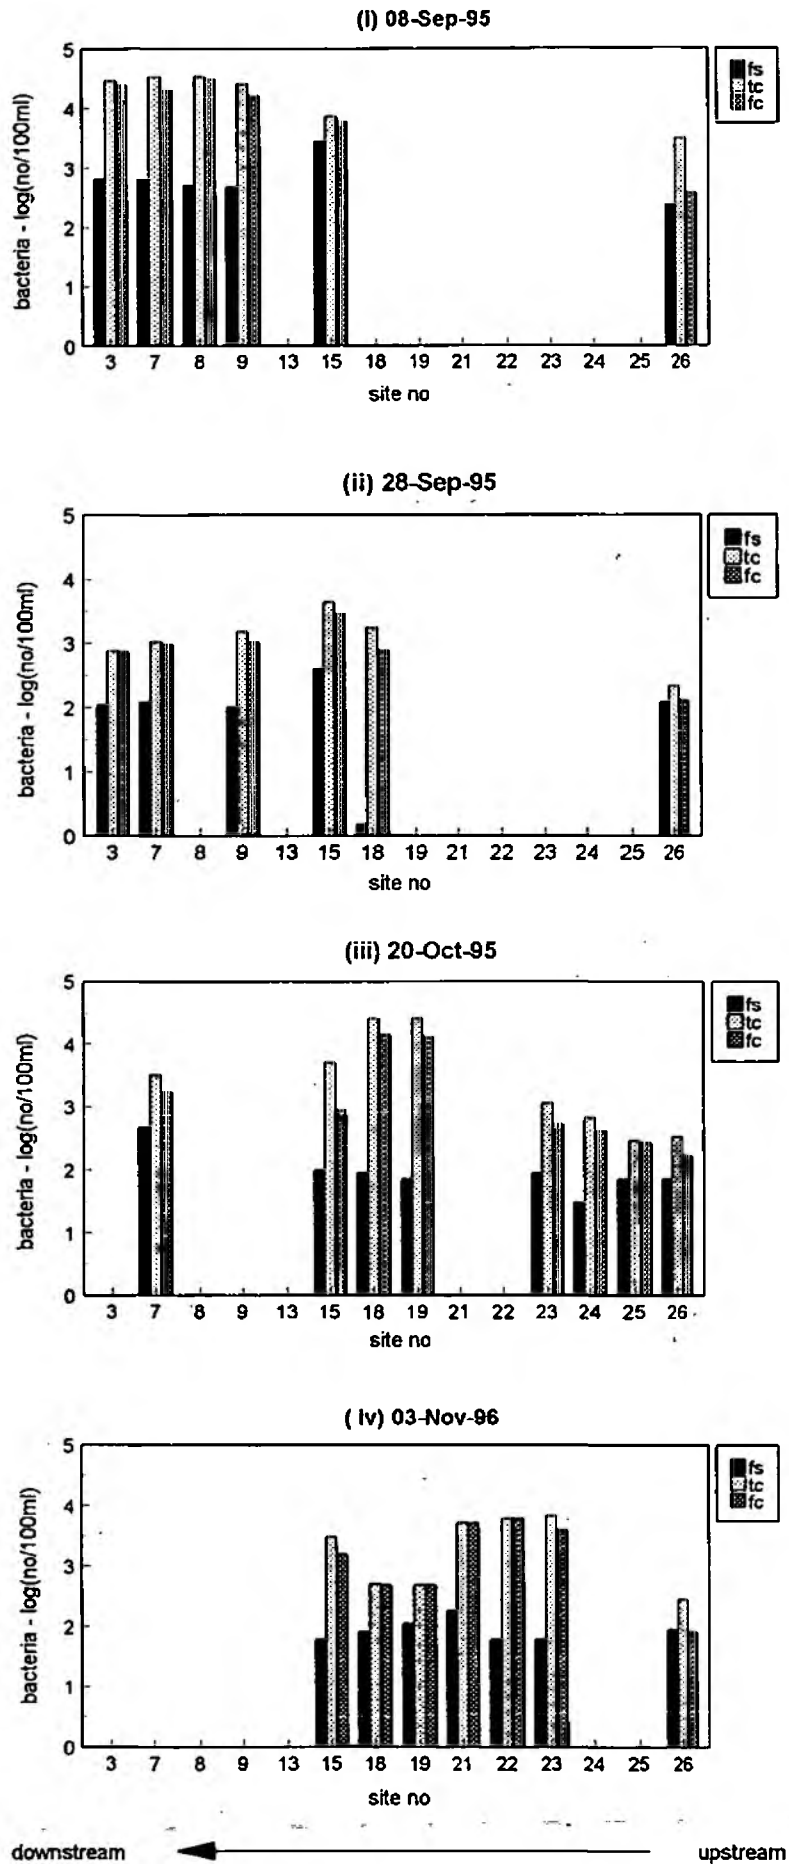
Further upstream The Spinney, a private residence, was found to be making an unconsented discharge directly to the stream. This was sampled on a number of occasions (site 17) and found to be heavily contaminated (Table 1). Sewage fungus and sanitary debris were evident at the site and sampling showed an impact on water quality downstream of the discharge (Figure 3, Table 1).

Sampling results indicated that further contamination continued between site 17 and the 'control' site 26. Three intensive surveys of this upper reach between The Spinney and Churchabridge confirmed that some contamination occurred within this reach although no source could be identified (Figure 3).

Figure 3.  
 Log bacterial numbers for sites  
 on the Millendreath Stream on  
 four selected dates.

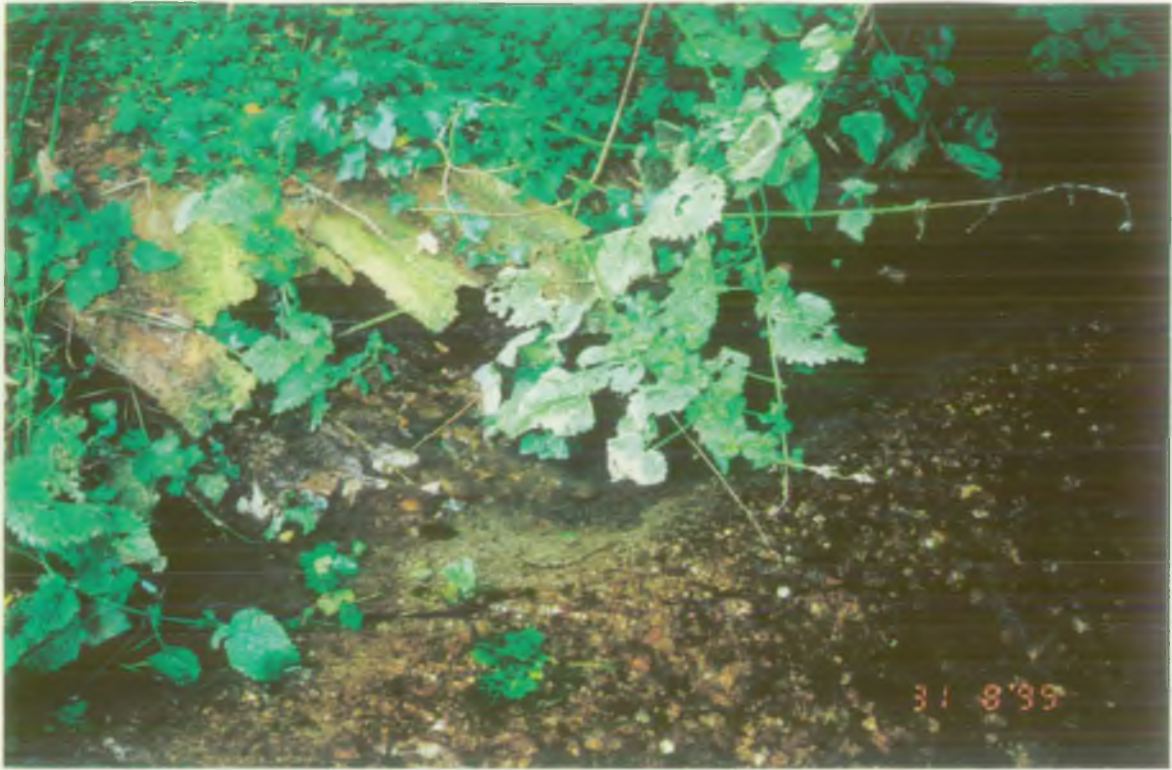
The caravan site at Chubbs Mill appears to make a number of unconsented discharges directly to the stream. Several of these appear to originate from the fixed site caravans although none were found to be running. A toilet block also discharges directly into the stream (Plate 2). Again this was never seen to be running but there was evidence of sewage fungus at the point of discharge.

- (iii) Chubbs Mill caravan site appears to be making several unconsented discharges of waste water, including untreated sewage, directly to the Millendreath Stream.

Plate 1. Point of suspected untreated discharge from Chubbs Mill caravan site toilet block.

- (i) A new bathing waters monitoring site to be included, in addition to ECBR0460, on the Millendreath Stream prior to the culvert (SX 2687 5454).  
Action: Richard Walmsley.
- (ii) Discharges from Chubbs Mill and The Spinney to be investigated by Water Quality.  
Action: Dave Trewolla.
- (iii) Repeated survey of Millendreath Stream during 1996 bathing season to assess impact of actions and to further investigate any continuing contamination downstream of Churchabridge.  
The continuing contamination of the beach stream should also be investigated and the source of the contamination identified.  
Action: Tim Geatches.

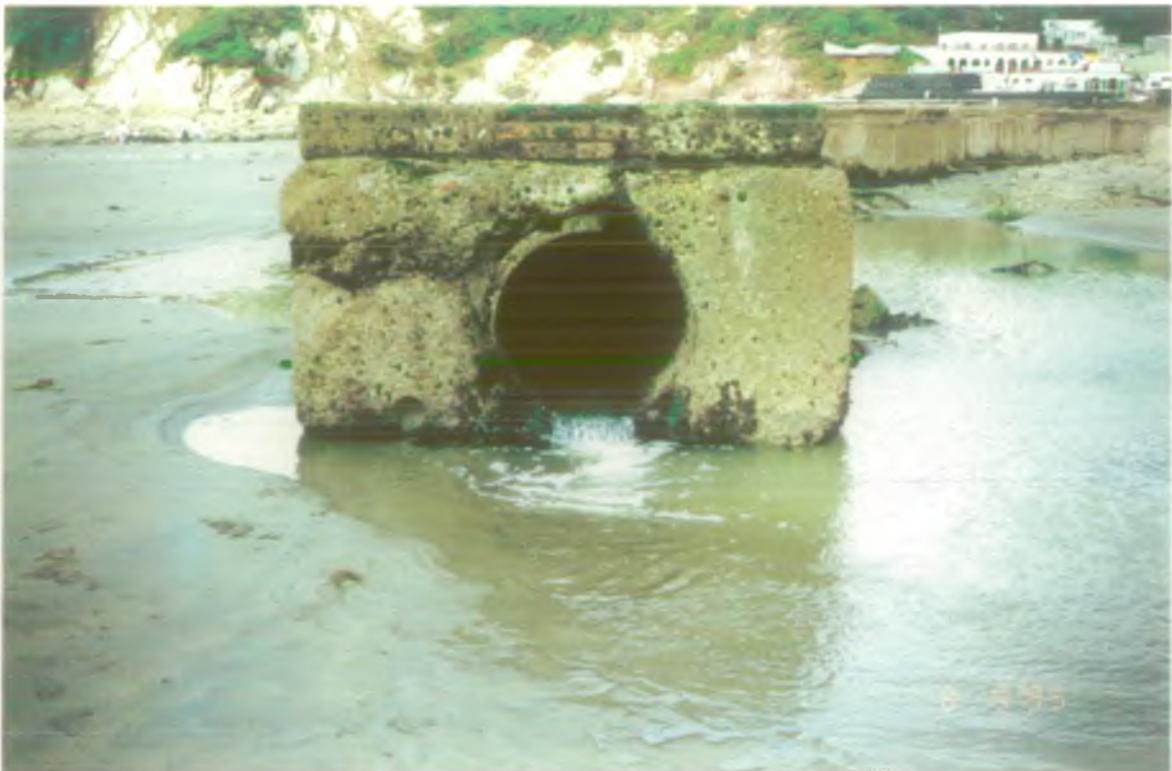
In the course of the investigation it became apparent that the Millendreath Stream is culverted in its lower reach, commencing at site 7, upstream of Millendreath Holiday Village STW. The culvert discharges to the sea just above the low water mark on Millendreath Beach, alongside effluent from the Millendreath Holiday Village STW (Plate 1). As a consequence the beach stream is little more than residual land drainage and is not continuous with the Millendreath Stream (see Figure 1).

- (ii) The Millendreath Stream was found to be culverted in its lower reach. The main stream discharges into the sea via the culvert, whilst the stream that crosses the beach is residual drainage from the end of the valley and is unrelated to the main water course. This beach stream also shows evidence of bacterial contamination for which no source has been identified.

Plate 2. The Millendreath Stream culvert discharge onto Millendreath Beach at low water.
