**DEVON AREA  
INTERNAL REPORT**

**AN INVESTIGATION INTO  
THE SEWAGE SYSTEM AND  
STORM OVERFLOW AT  
BEER**

**MAY 1997  
DEV/WQ/9/97**

**Author: W. LOXTON.  
INVESTIGATIONS TECHNICIAN**

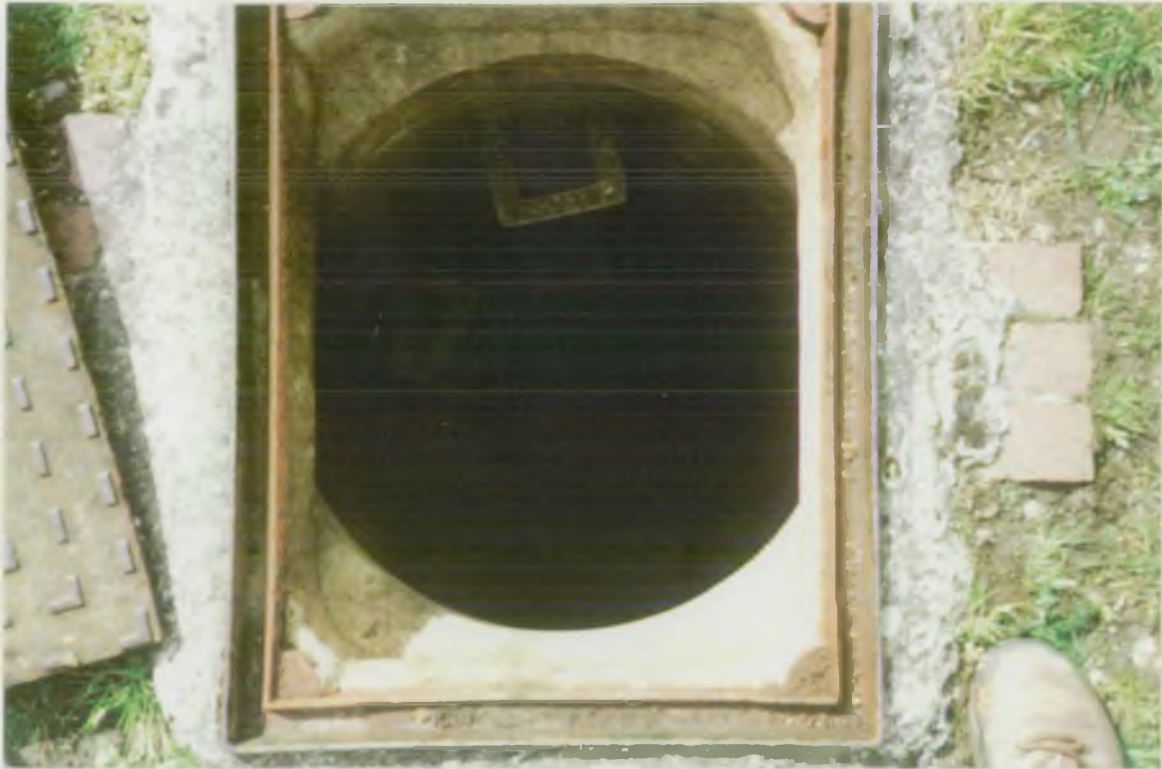
I was also informed, that what is commonly called the "reception chamber," is not in fact a retaining tank, but a small manhole chamber where the storm overflow discharges into the stream (Appendix 2 photo 1).

Discussions with Trevor Nott (SWWSL) suggest that there is no storm tank at Beer, only an access chamber. This access chamber is situated just below the monument in Beer (photograph 1 and Appendix 2). This chamber is approximately thirty-five feet down and six feet square. There is an overflow from this access chamber that has a one inch metal screen. This screen has been recently refitted because it was out of alignment.

**Photograph 1 Inspection chamber**

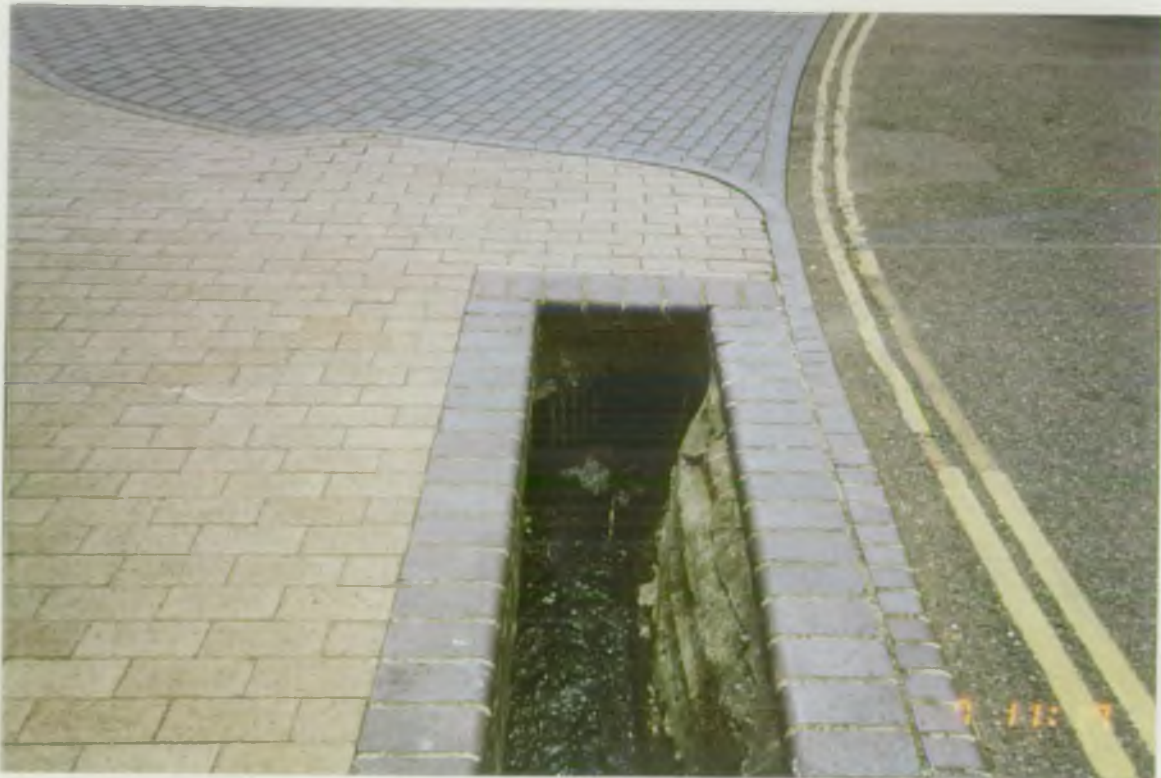
East Devon District Council and Devon County Council have no plans of Beer Brook where it is covered by footpaths or the road as it runs through Beer to the Beach. At the end of Fore Street the stream goes under the road and splits into two pipes ( Appendix 2 photograph 2).

**Photograph 2 Stream splits and goes underground**

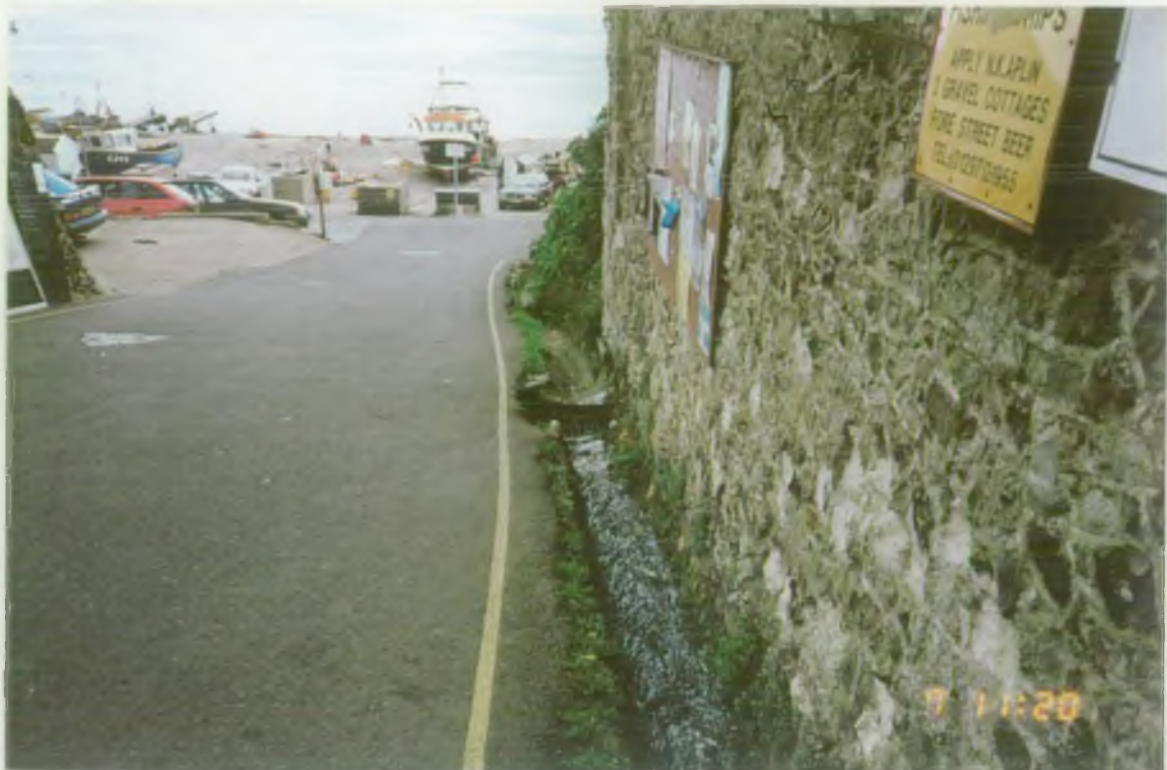
A grid has been fitted where the brook goes under the road opposite the fish shop. This was done because of rumours that fish offal was being dumped into the stream (photograph 3).

It was believed that this offal would be washed down the pipe and decay in the shingle on the beach. The shingle at the top of the beach by the reception chamber has recently been removed and replaced with clean. It is this area of beach that is of most concern to the beach users and where visible pollution is alleged to have gathered.

Photograph 3 Grid fitted to stream

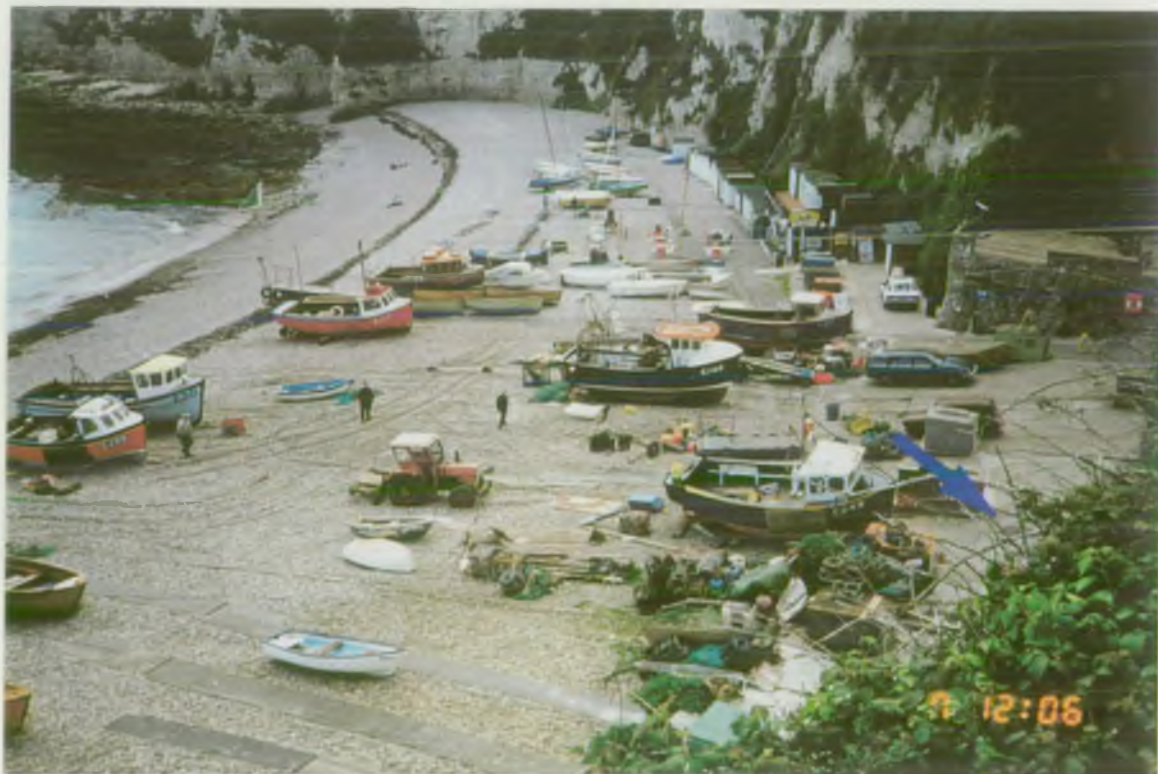
This manhole chamber is the site of the routine stream samples for the Bathing Waters Directive. From the reception chamber the brook runs through a pipe under the beach, issuing below the high water mark.

Local information indicates that the pipe on the beach frequently becomes blocked with beach shingle and debris. When this pipe becomes blocked or is unable to cope with high flows, water will back up the pipe, overflowing at the reception chamber and over the top of the beach. If the main sewer overflow is actively discharging while this backup is taking place, crude sewage will be discharged over the beach along with the brook water.

Photograph 4 Reception chamber

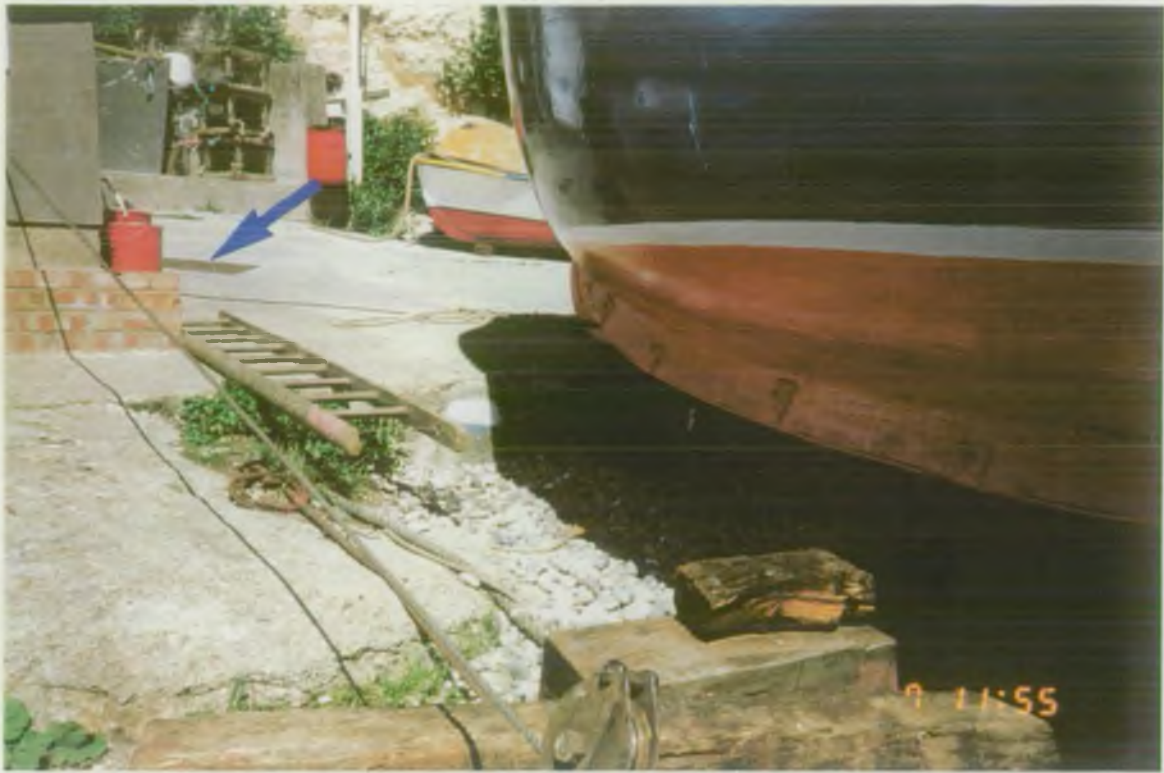
Photograph 5 Reception chamber

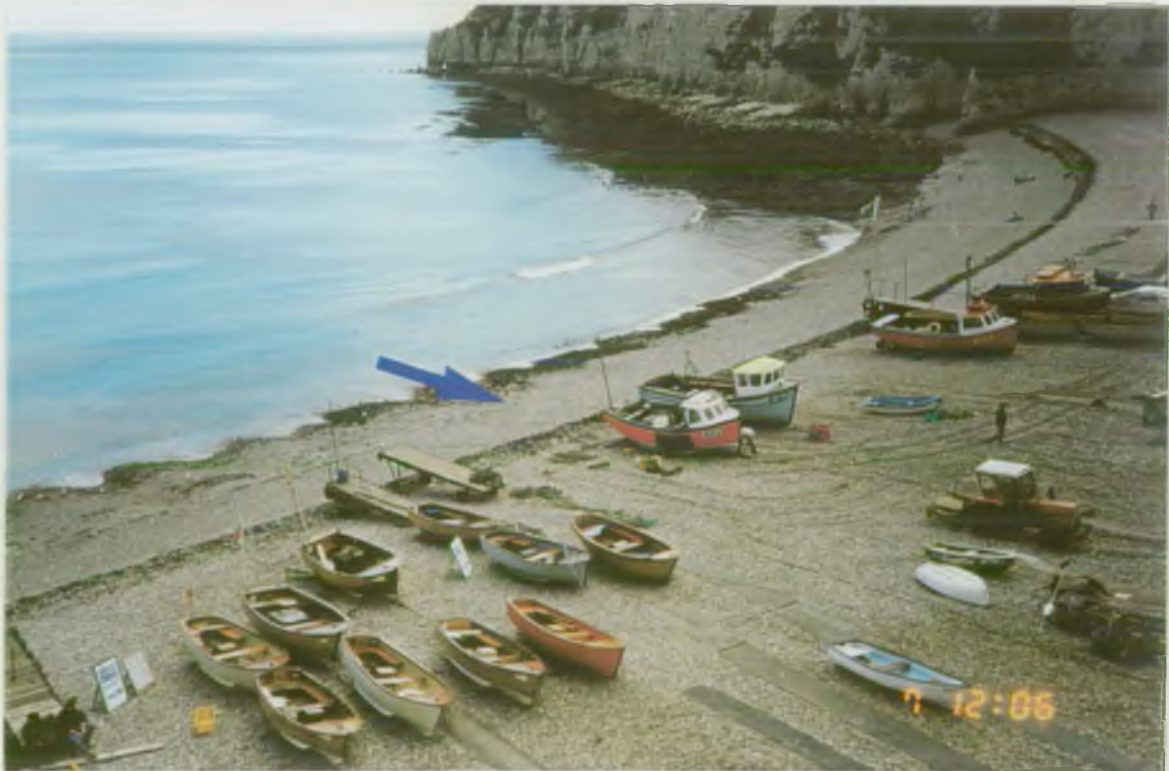
During the site visit, I was informed by Robin Taylor (EDDC) that the end of the discharge pipe on the beach has been located, and markers have been installed to indicate its position (approximately 75 metres out from the reception chamber).

A JCB has been used to dig out around the end of the pipe and the area is now clear. Mr Taylor has stated that this was a simple operation that will be repeated again when required.

Photograph 6 Pipe discharge point

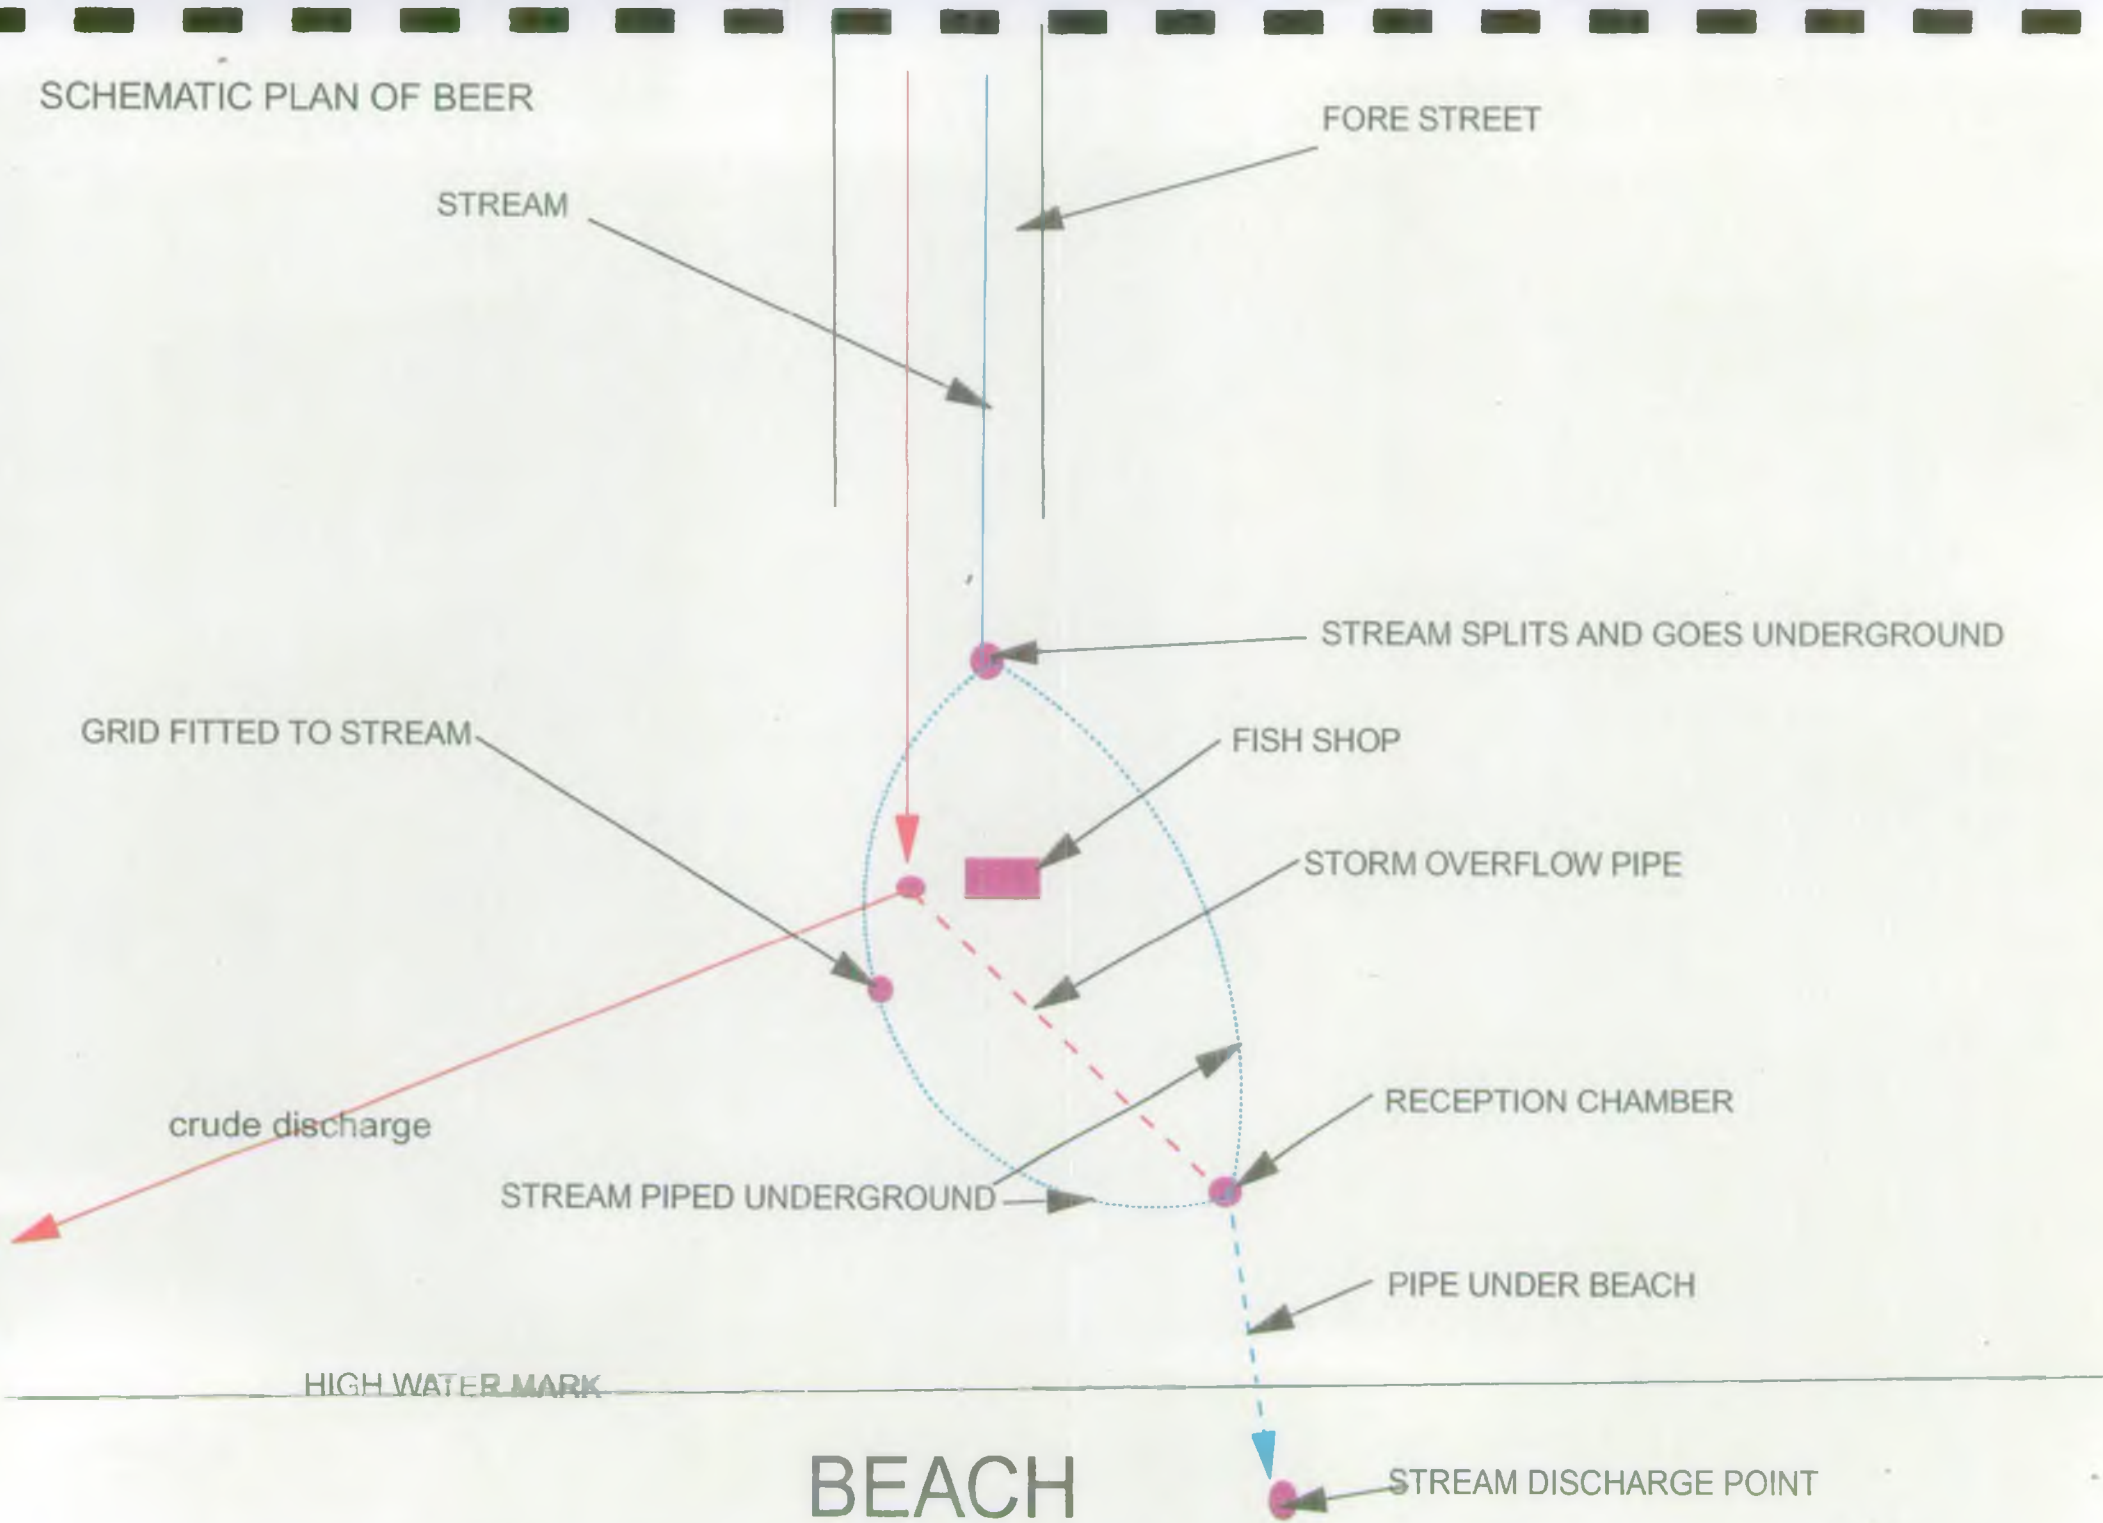
SCHEMATIC PLAN OF BEER

A Schematic plan of Beer (Appendix 3) gives an idea of the lay out of the towns stream and sewage system referred to in the discussion.
