ENVIRONMENT
AGENCY

**ENVIRONMENT PROTECTION DEPARTMENT
CORNWALL AREA**

MOUNTS BAY CATCHMENT SURVEY

August 2001

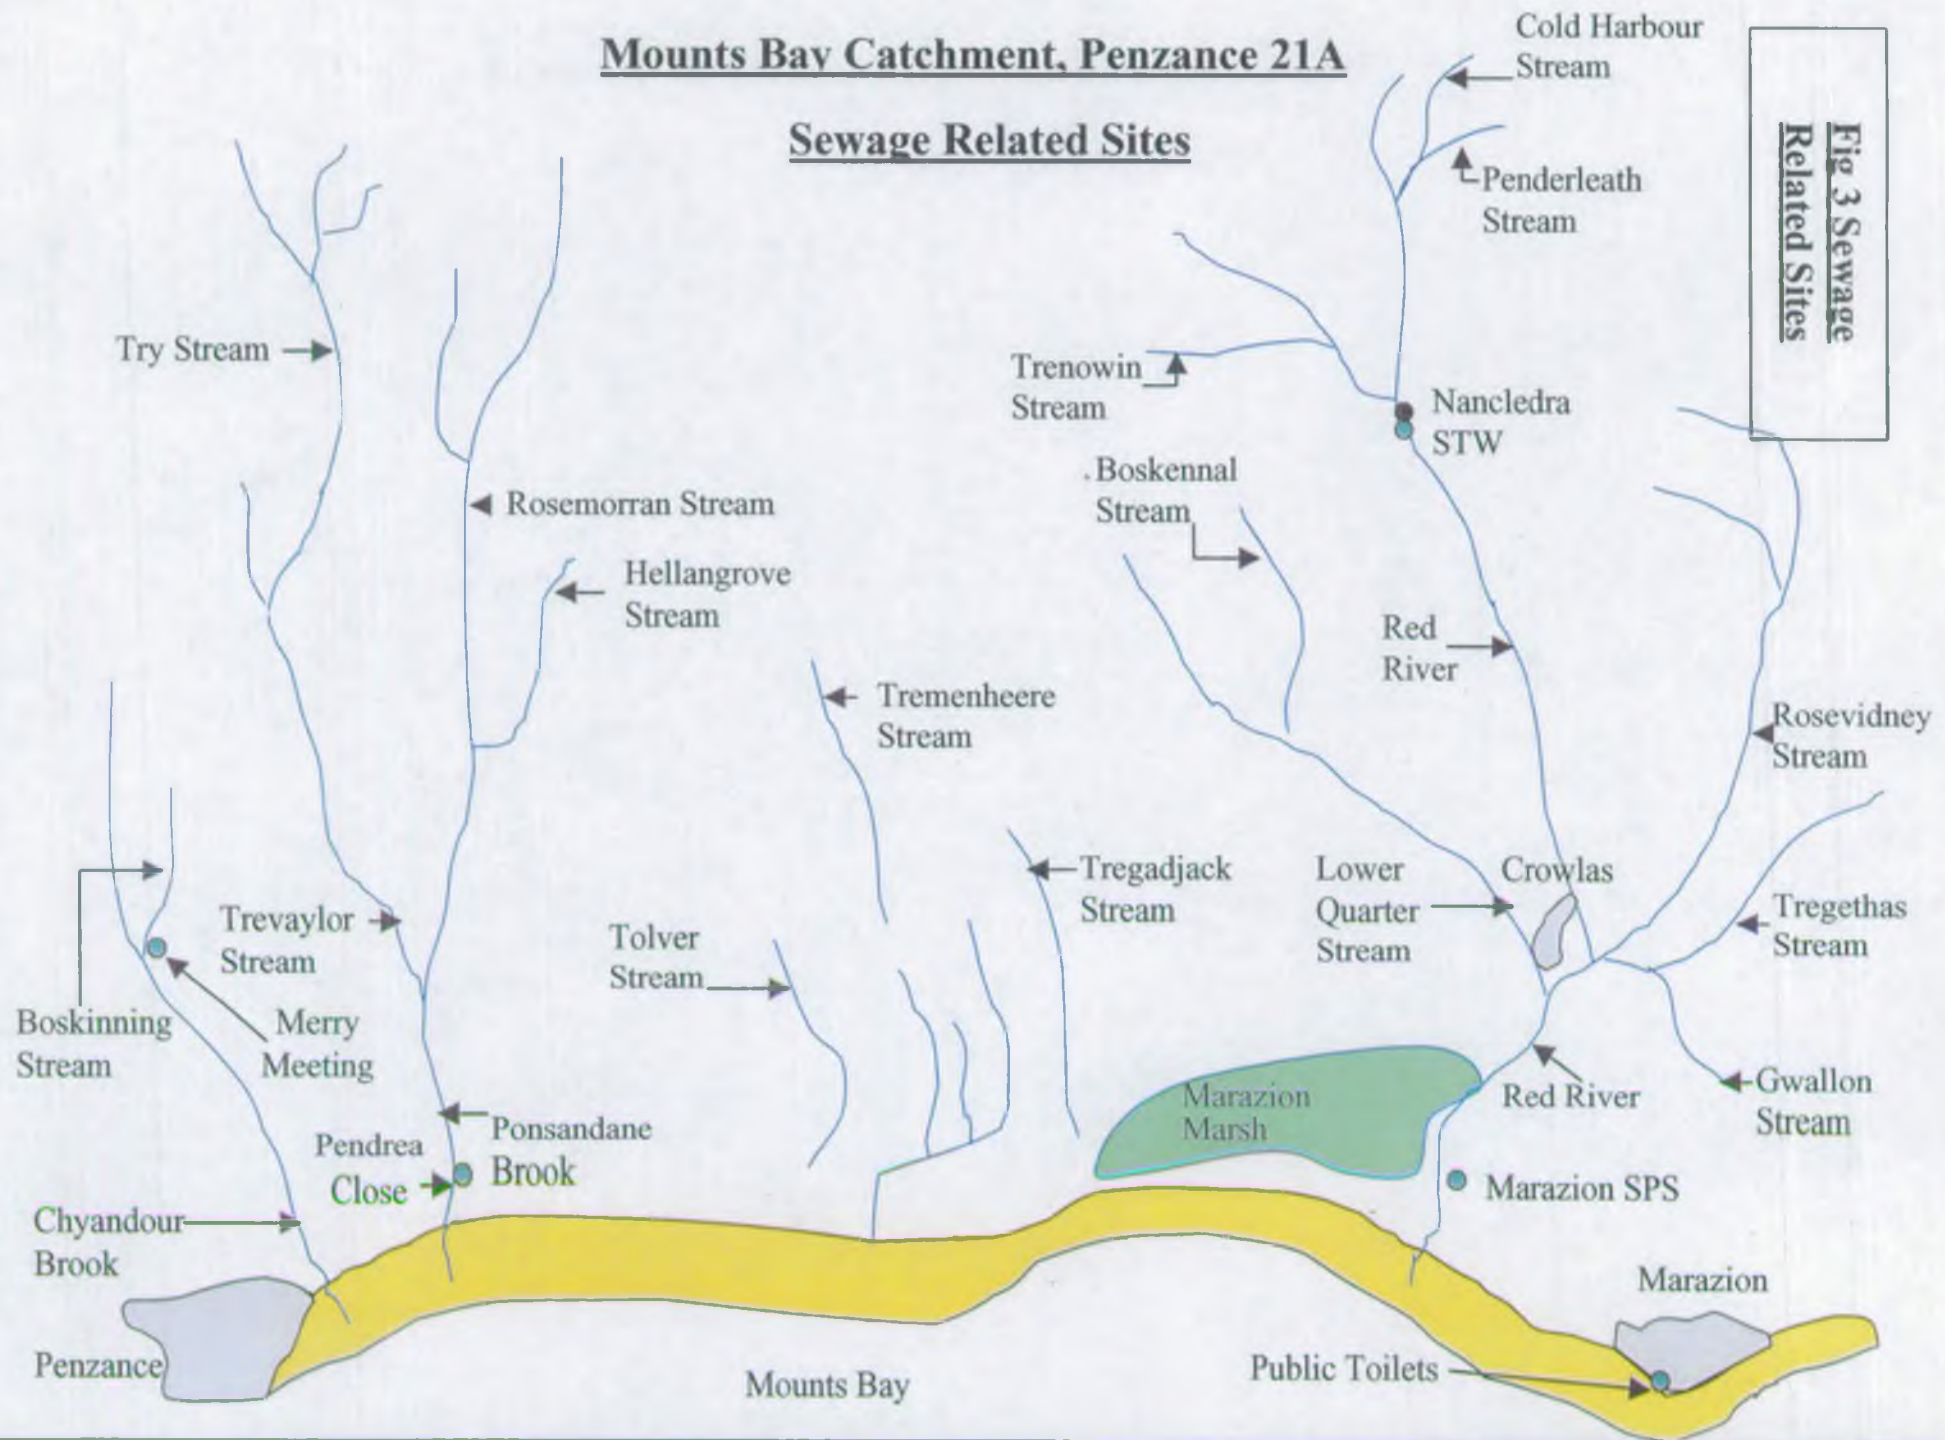
Fig 3 Sewage Related Sites

Location/Type	Problem	Recommendation/Action	Photo Ref.
Behind No. 12 Pendrea Close. Sewage entering Ponsandane Brook. Shared Septic Tank. NGR SW 4790 3145	Ponsandane Mews is a group of 12 properties further up the hill from Pendrea Close. They share a septic tank that has been overflowing all summer (2001) into a surface water drain, which then enters Ponsandane Brook.	Problem is being investigated by EA, Penwith District Council and SWW. Local EPO to check progress.	P3,4,5
Merry Meeting, Bone Valley, Heamoor. Septic Tank. NGR SW 4611 3166	Effluent from a private septic tank is discharging into a blind ditch. The neighbours have complained that the area has smelled of sewage all summer. The Discharge Consent shows that the discharge pipe should reach Chyandour Brook but it stops short in a scrubby area next to the road.	Local EPO to undertake a pollution prevention visit to ensure compliance with consent conditions.	P1,2

Marazion Public Toilets NGR SW 5182 3058	Sewage effluent is leaking onto the beach directly from public conveniences. Dye tracing proved direct leak to beach in <20 minutes	Local EPO to investigate and contact SWW and Penwith District Council	P10-14,16, 30

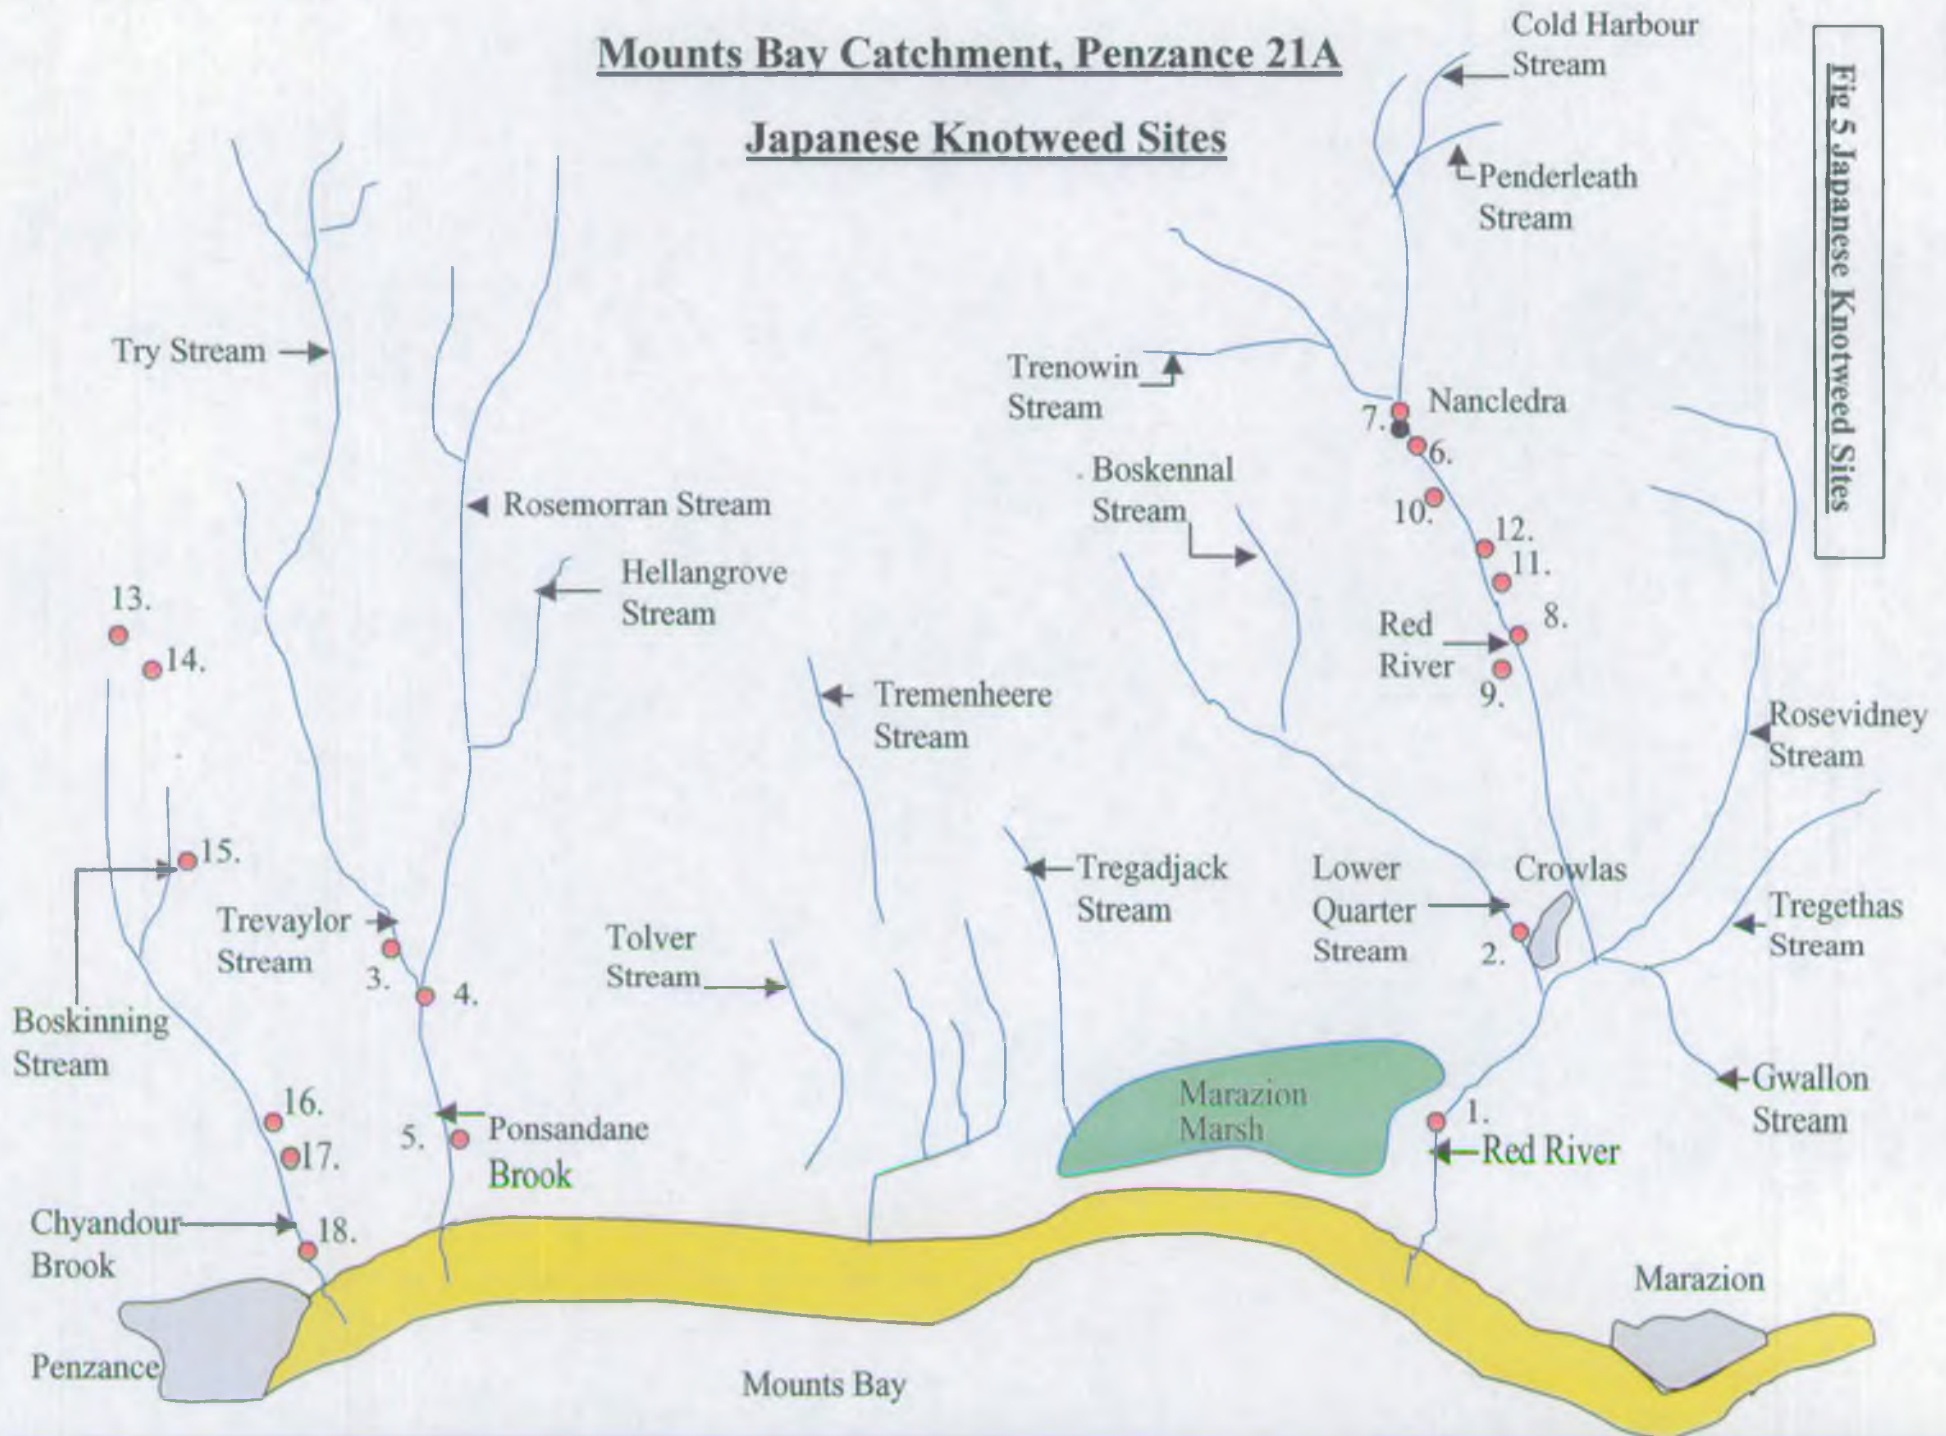
Fig 5 Japanese Knotweed Sites

There is a large amount of the invasive plant Japanese Knotweed growing adjacent to the watercourses and the roads throughout the entire catchment (Fig 5.)

1. @ NGR SW 5136 3116 Marazion Marsh
2. @ NGR SW 5109 3322 Lower Quarter Crowlas
3. @ NGR SW 4769 3179 Bleu Bridge Gulval
4. @ NGR SW 4783 3173 Ridgevale Lane Gulval
5. @ NGR SW 4805 3135 Branwell Lane Gulval
6. @ NGR SW 4964 3586 Nancledra STW
7. @ NGR SW 4941 3615 Alamebra Rd Nancledra
8. @ NGR SW 5042 3478 Cucurrian Mill
9. @ NGR SW 5058 3458 Cucurrian Valley Cottage
10. @ NGR SW 4981 3567 Nancledra Boundary Stone
11. @ NGR SW 5018 3515 Ashtown Farm
12. @ NGR SW 5011 3531 South of Bostampys
13. @ NGR SW 4459 3488 Tredinneck, Nr Boskednan
14. @ NGR SW 4473 3460 North of Mission House
15. @ NGR SW 4613 3233 Tremearne, Boskinning Stream
16. @ NGR SW 4693 3153 A30 Roundabout Nr Higher Trannack
17. @ NGR SW 4724 3144 A30 Between Higher and Lower Trannack
18. @ NGR SW 4776 3111 Chyandour Lane
