# **DEVON AREA INTERNAL REPORT**

FURTHER INVESTIGATIONS INTO PIPE DISCHARGES IN THE LOWER TEIGN ESTUARY.

MARCH 1996 DEV/E/15/96

# FURTHER INVESTIGATIONS INTO PIPE DISCHARGES IN THE LOWER TEIGN ESTUARY

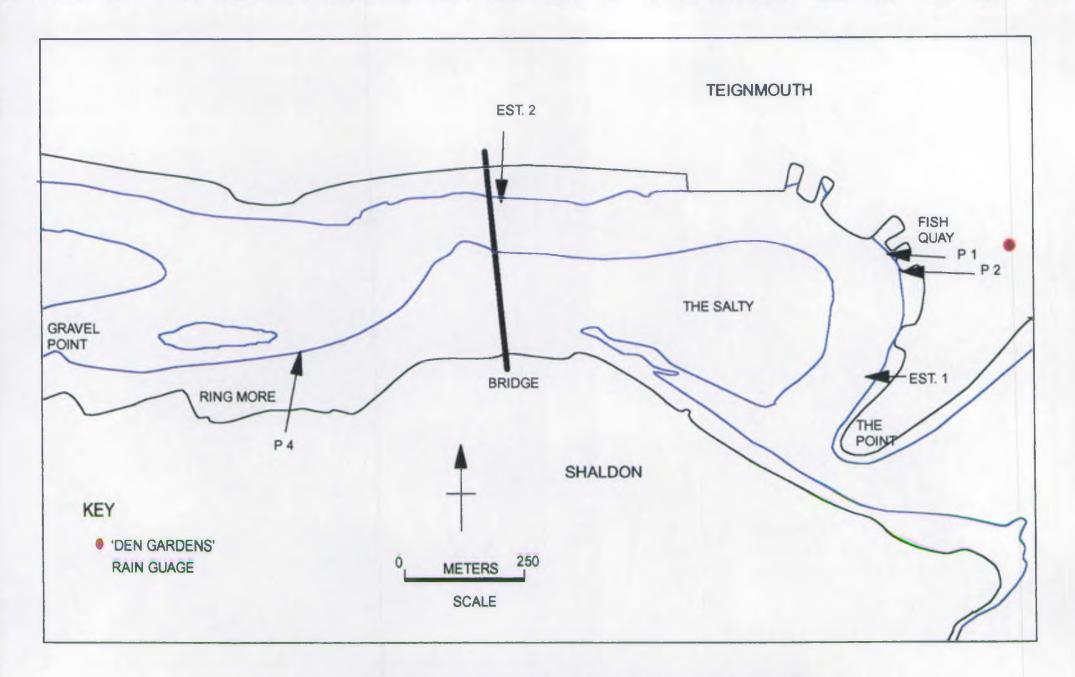
FIGURE 1: THE LOWER TEIGN ESTUARY SHOWING SAMPLING SITES

This investigation was carried out on 05/01/96 and the sites sampled are shown on figure 1 and the results in Table 1 (Appendix I).

The pipe (P4) at Ringmore was discharging with a high flow and the bacterial levels were high. This pipe has been identified as a PSEO/CSO (consent details NRA-SW-2864, King Georges field), and by the channel cut through the mud it would appear to be discharging most of the time.

There was a boil to the SE of the fish quay from a 10" cast pipe that was sampled and the bacterial levels were high. This site would need to be investigated under low river flow and on a spring tide.

There are two discharges that could lead to high bacterial levels in the lower estuary, one above Shaldon bridge and one at the Fish quay.

Contact needs to be made with SWWSL to confirm that the pipe located above Shaldon bridge (pipe P4) is a PSEO/CSO.

Investigate if there is a flow from pipe P4 under dry conditions.

Investigate the boil at the Fish Quay.
