DEVON AREA INTERNAL REPORT

INVESTIGATIONS OF DISCHARGES INTO THE RIVER LEMON AT NEWTON ABBOT

DEV/E/02/96
JANUARY 1996
Author: T CRONIN
INVESTIGATIONS OFFICER

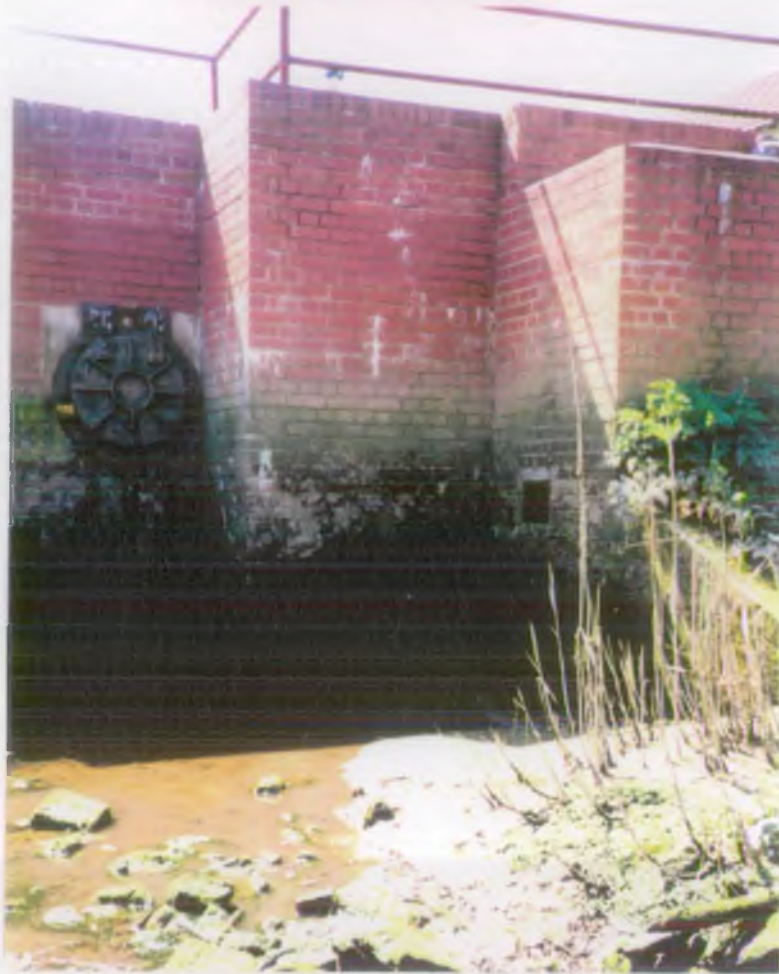
PHOTO No 1

PLATE NUMBER	DESCRIPTION
1 AND 2	A LARGE STORM FLAP ON THE RIGHT HAND BANK.
3	A HOLE IN THE BANK ALLOWING WATER TO DRAIN FROM BEHIND BANK.
4 AND 5	TWO TEN INCH STORM DRAINS.
6	TEN INCH STORM DRAIN LEACHING OCHRE DEPOSIT.
7	STORM DRAIN FROM ROAD.
8	FOUR INCH PLASTIC PIPE FROM DOMESTIC PROPERTY.
9 AND 10	DISCHARGE FROM A STORM FLAP.
11 AND 12	FOUR INCH TERRACOTTA PIPE WHICH APPEARS TO HAVE HAD A DISCHARGE OF OIL.
13	DRAIN FROM UNDER AN INDUSTRIAL PREMISES.
14	WHAT APPEARS TO BE A BRICK MANHOLE IN BED OF RIVER.
15 AND 16	DISCHARGE FROM STORM FLAP.

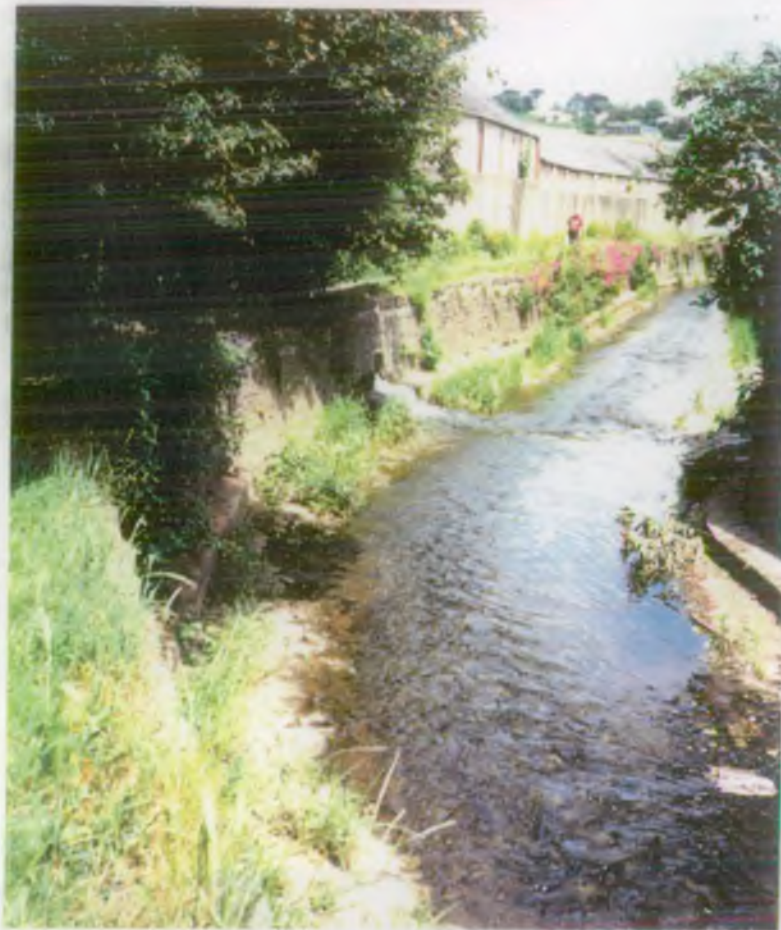
PHOTO No 9

On one of these occasions (August 11 1995) three pipes at different sites were found to be discharging. Samples of these discharges were taken, the full results of which are shown in Table 1. as sites 4,7,10 and their location are shown in Figure 3, again as sites 4,7,10. The pipes are depicted in Appendix A plates 9,12,14.

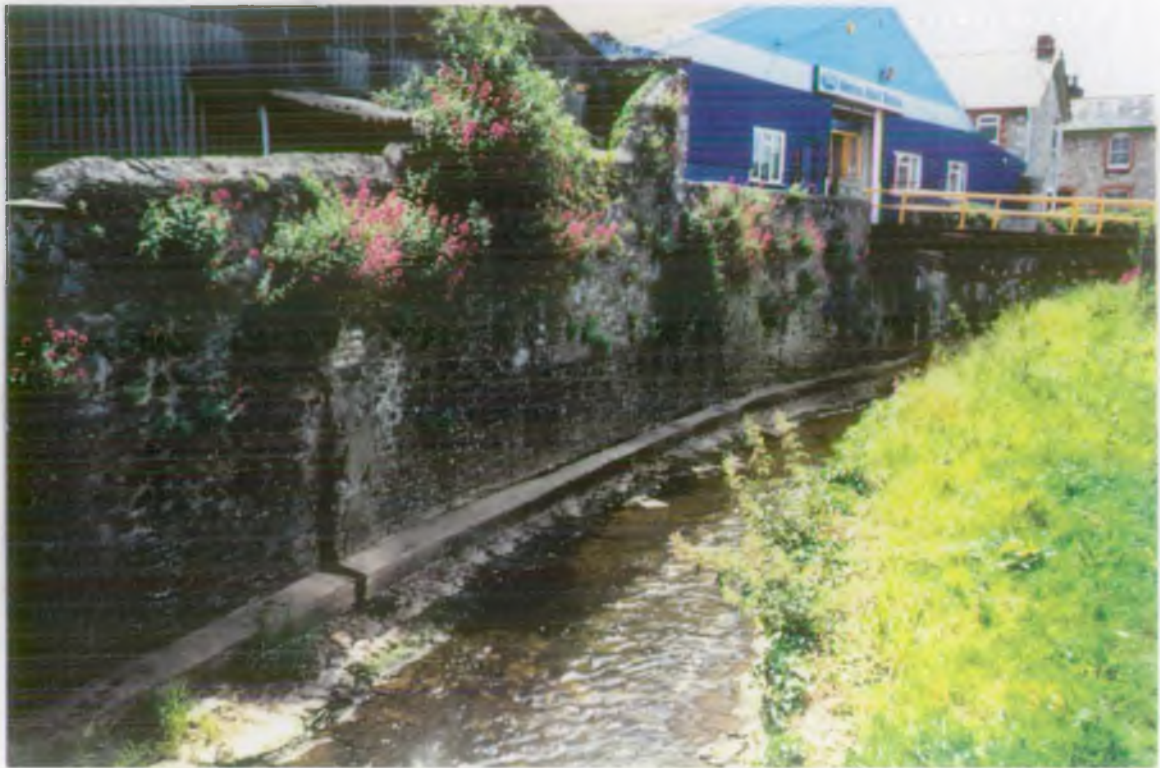
PHOTO NO 11

The oil stain from the pipe in photographs 11 and 12 (Appendix A) appear to be dry and it is difficult to determine how long ago the discharge took place, it is possible that the discharge was a one off incident.
