**A Litter Assessment of Two Major
Tributaries of the Taff, The Cynon
and the Rhondda
Surveyed March - April 1990
Report No. EAE/91/1**

**By: Gillian L. Davies & Dawn C. Boden
S.E. Environmental Appraisal Unit
Rivers House
St. Mellons Business Park
St. Mellons
Cardiff.**

May 1991

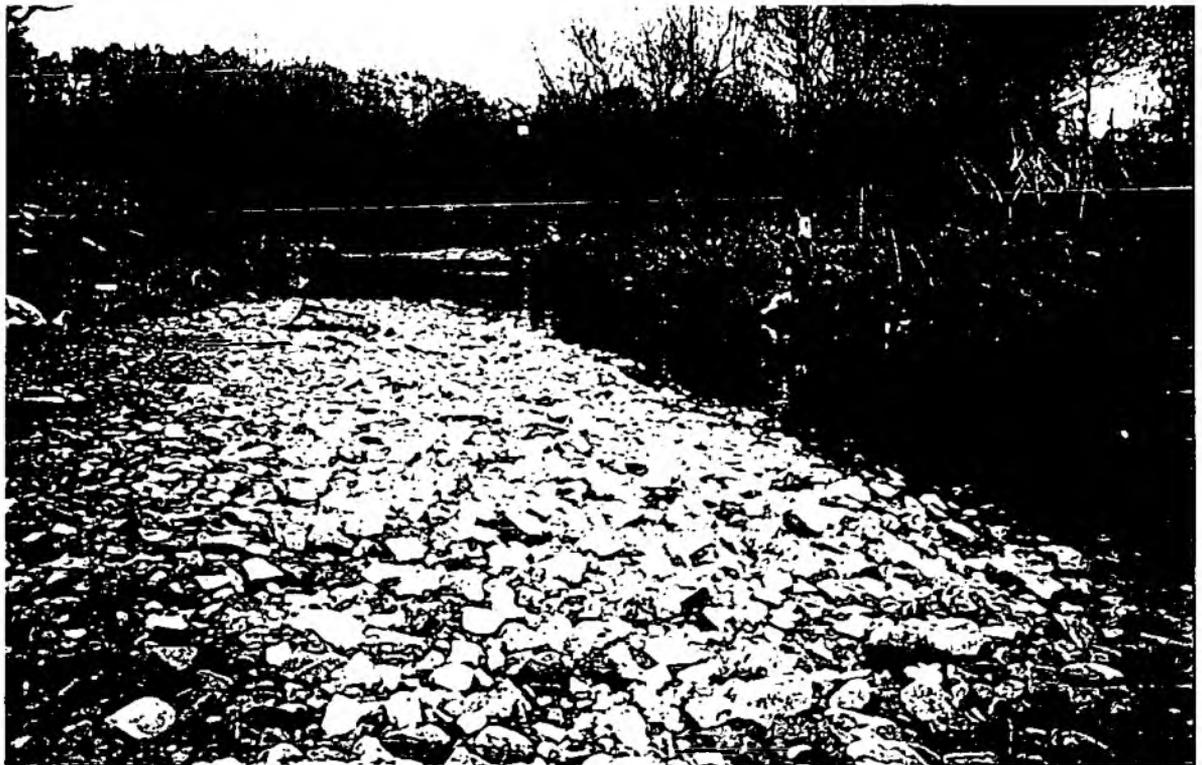
Site C3: A littered site 4Km lower in the catchment.

Mainly affected by building site litter and clay solids from the excavation of the site with a background of sewage derived litter.

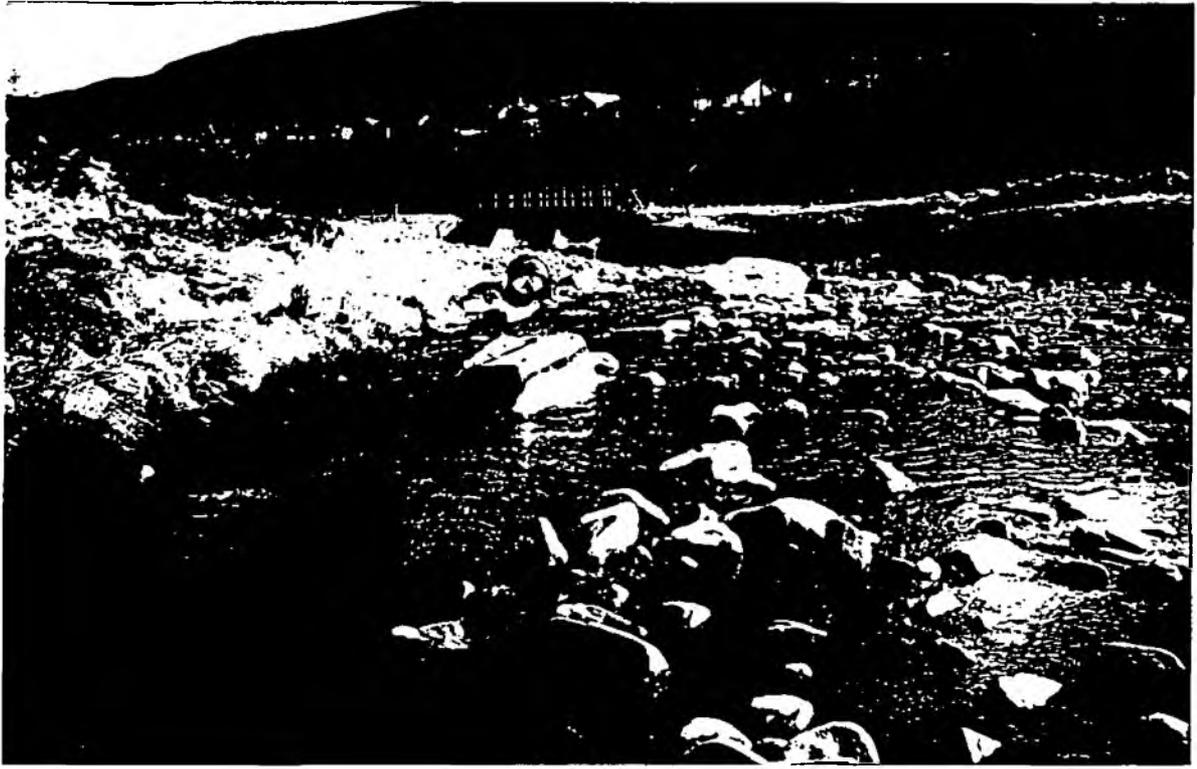
Site RFC2: Above the reach sampled at Maerdy - one of the more unusual items of litter in the river channel!

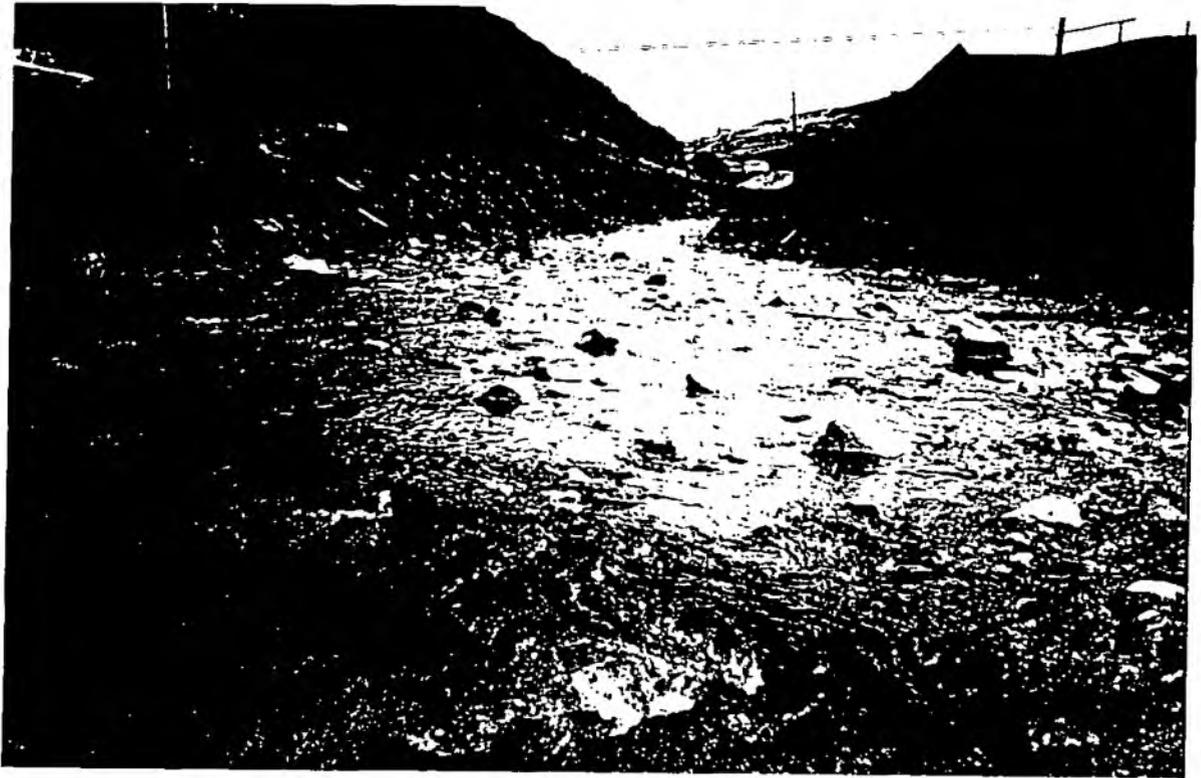
Site RFC3: Downstream of the roadbridge at Blaenllechau - river channel littered.

Steeply sloping banks (possibly a reclaimed coal tip). Lots interesting pipes discharge at this point, possibly SWO's, but could have been culverted streams. Not much evidence of sewage derived litter but fly-tipped objects in abundance (toys, floor-covering, metal objects and builders rubble).

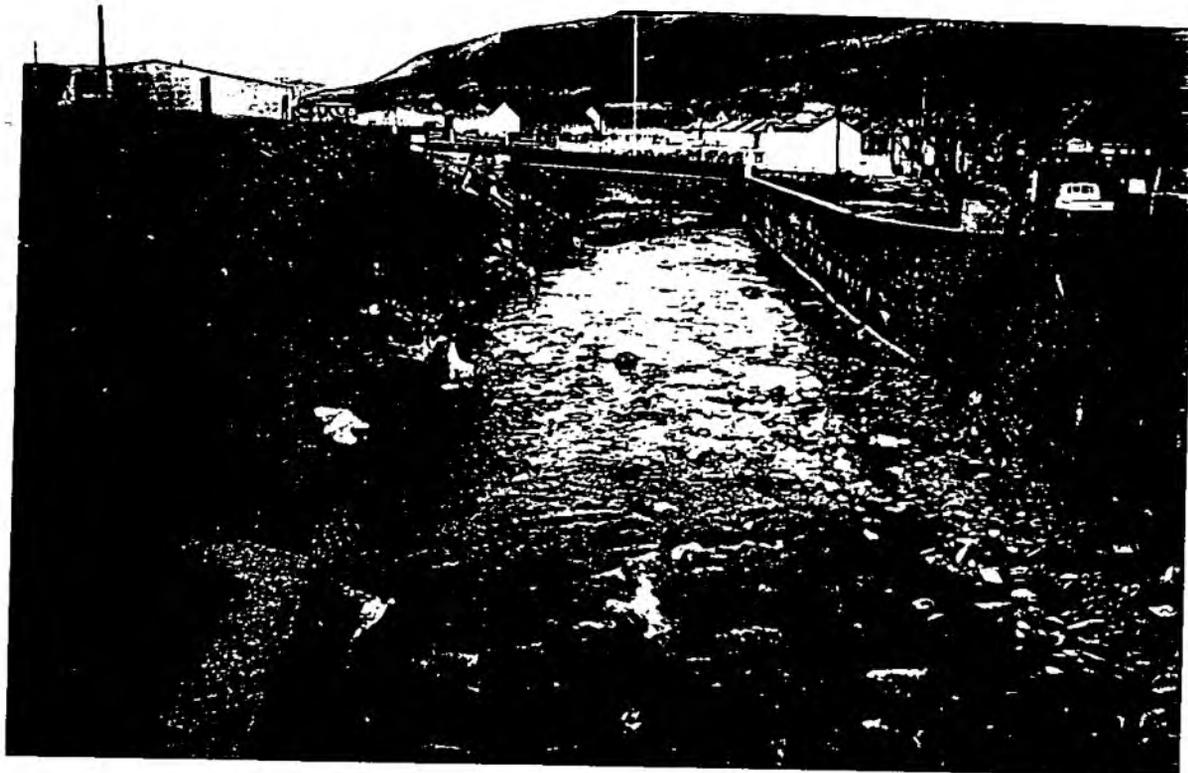
Site RFW3: Rhondda Fawr at Ynyswen. Large packing material is probably derived from factory units.

Very steep grassy bank (right) and walled (left). Large packing material in abundance on the right bank, probably derived from nearby factory units (see slide).

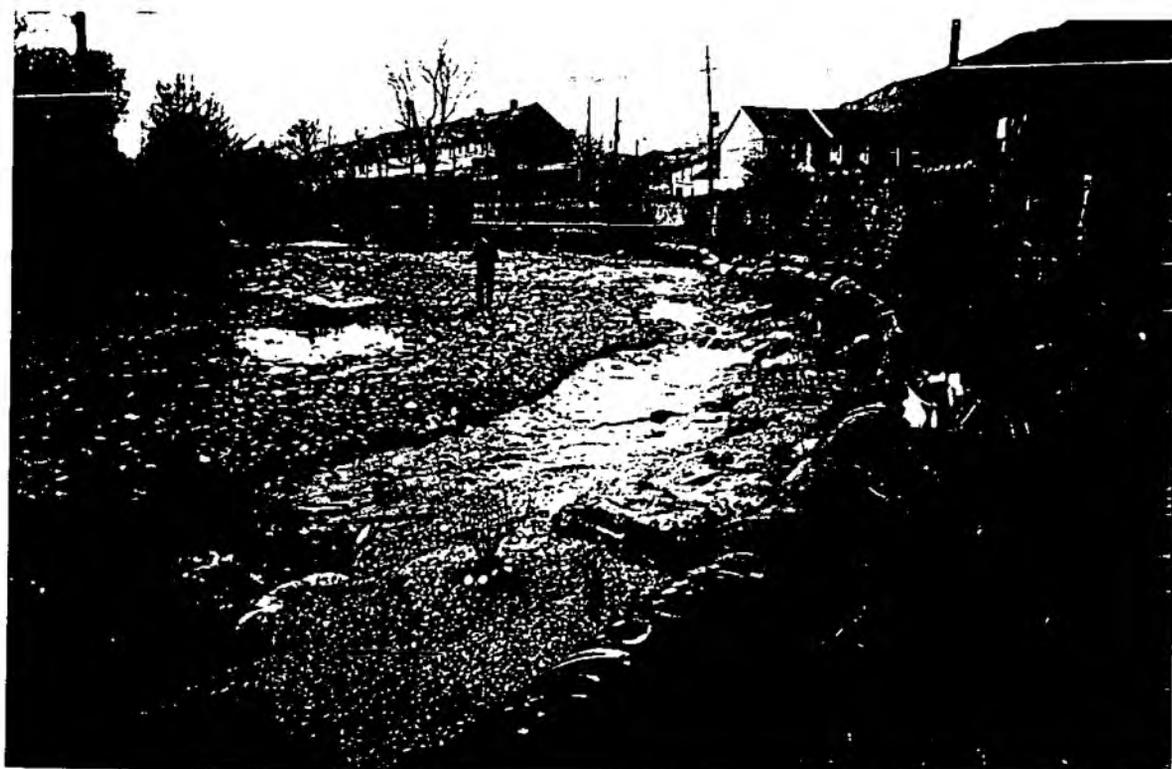
Site RFW4: Rhondda Fawr at Pentre - the trunk sewer is very prominent here.

The trunk sewer is very prominent here with an above ground pipe running along the left bank. The river is quite fast-flowing in this reach but with some ponding and riverine derived litter on the right bank.

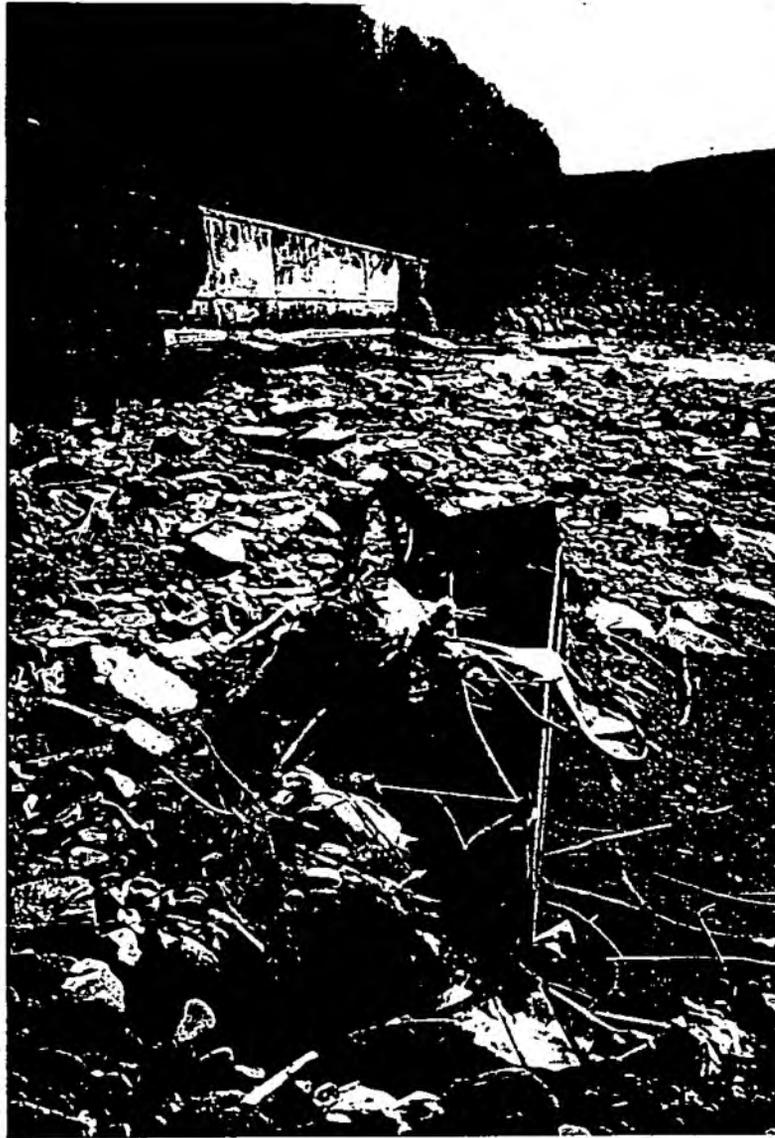
Site RFW9: Rhondda Fawr at Trehafod showing riverine litter at a downstream site.

Quite remote within a very steep gorge. The river bed is mainly bedrock and boulders and the litter is mainly riverine.
