NATIONAL RIVERS AUTHORITY  
(THAMES REGION)

BRIDGE MILL - WHEATHAMPSTEAD

SURVEY AND ANALYSIS OF CULVERTS

February 1990

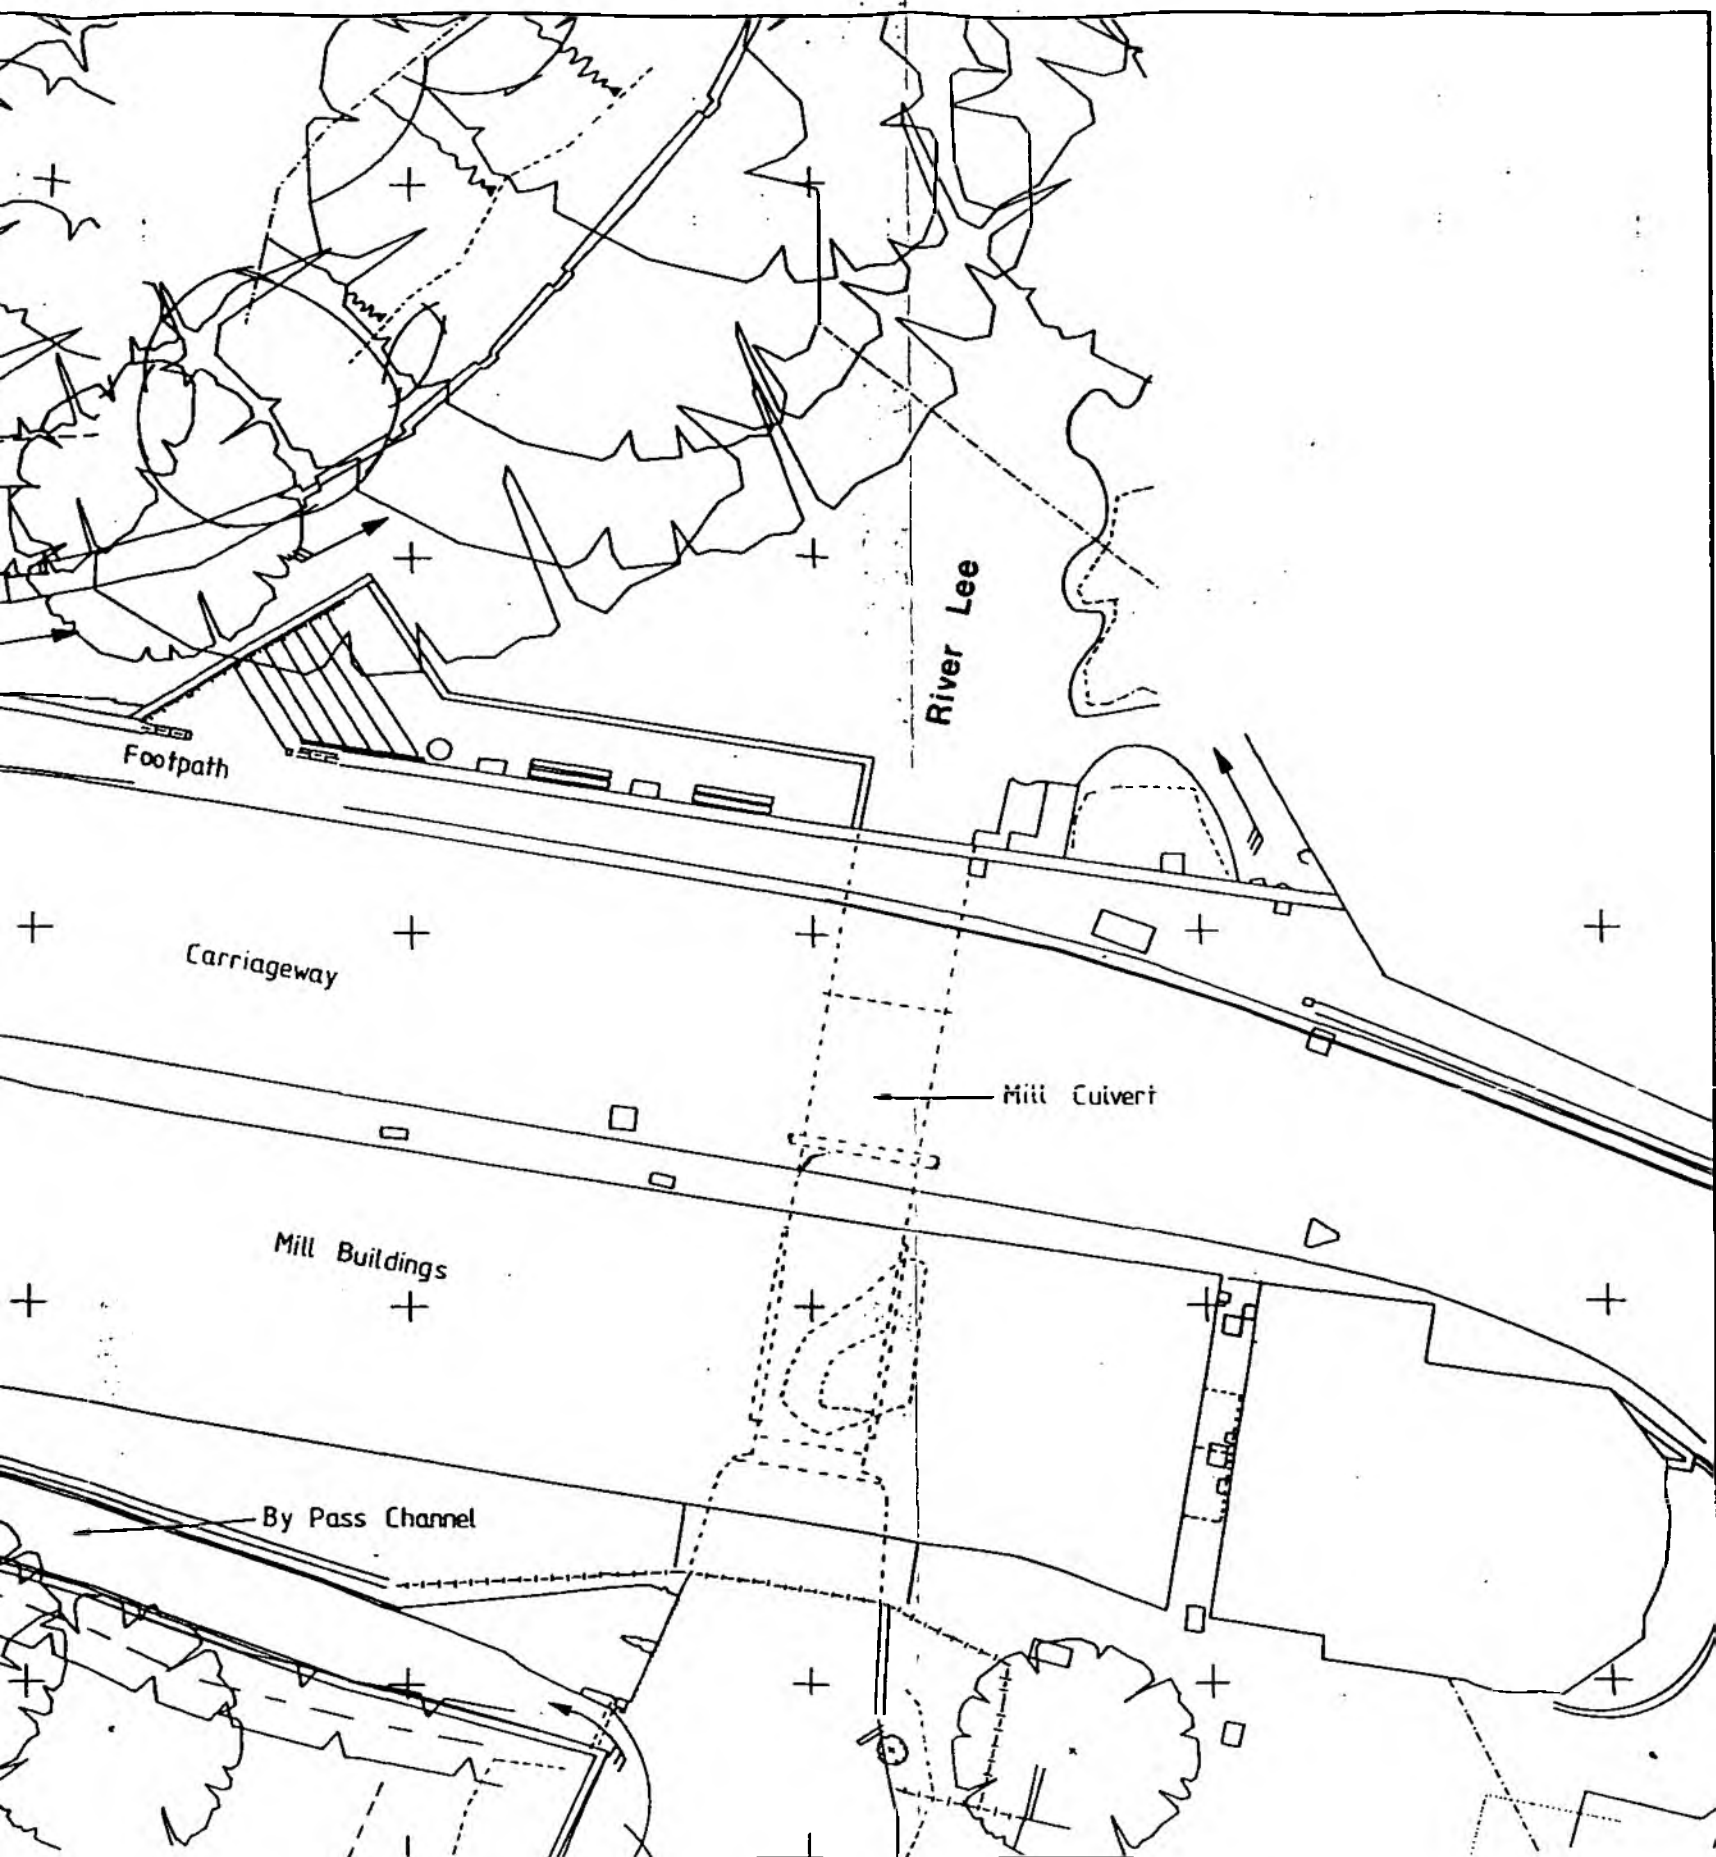
| <p><i>Flynn &amp; Rothwell</i><br/> <b>CONSULTING ENGINEERS</b><br/> 45-47 South Street.,<br/> Bishops Stortford Herts.</p> | | <p>Wheathampstead Main Culvert Survey<br/> General Arrangement</p> | |

(R.C. Culvert Good Condition)

Brick invert (fair condition)  
P.C. Slab roof / R.C. & Brick walls (Good Condition)

Brickwork in fair condition.

1800 Wide x 1200 High  
Insitu R.C. roof.  
Walls and Invert of same, all in good condition.

1800 Wide x 1100 High Rectangular Culvert  
Pre-Cast Concrete roof slab & insitu concrete walls are in good condition.

The invert & lower 400mm of Brick work are in fair condition

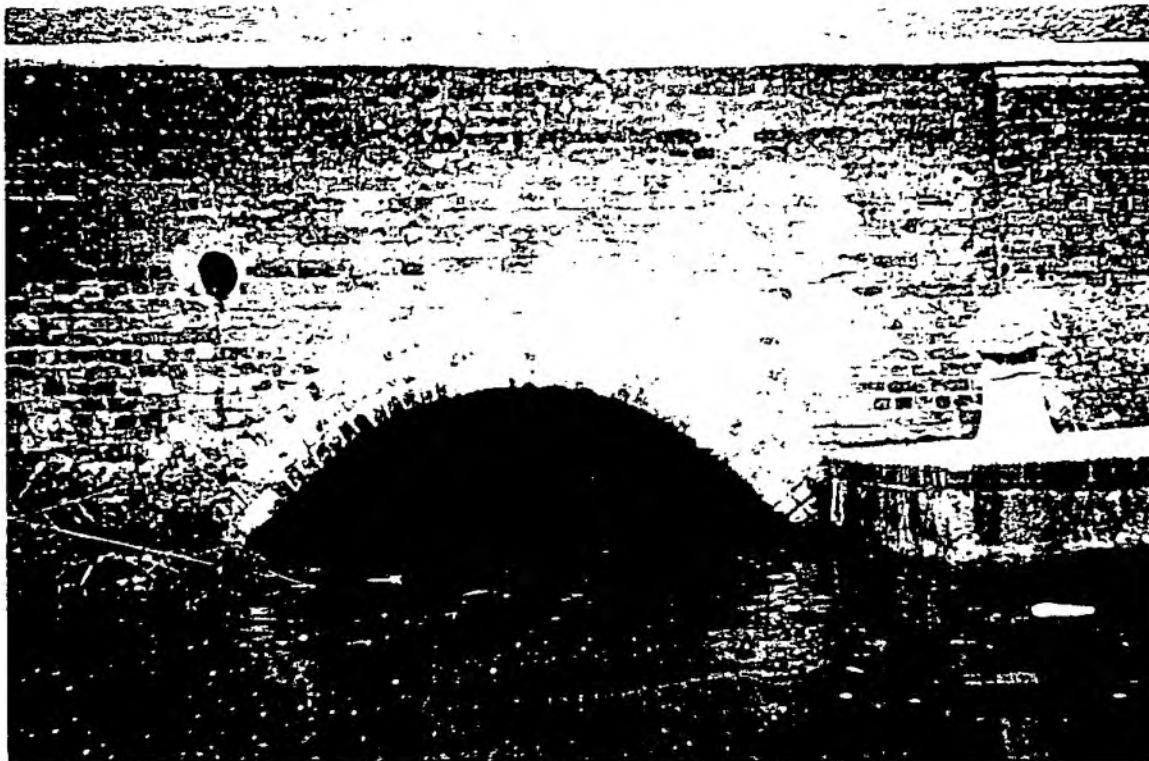
The downstream exit consists of a brick arch, headwall and parapet. There are no cracks in the arch ring or headwall, and the pointing is fair (photograph 1). The culvert opening is 2950 mm wide by 1200 mm high. The arch springing points are 1000 mm below the arch soffit and 200 mm below the downstream water level (77.80 m AOD at the time of the survey).

Photograph No. 1. A chainage 0 m. Downstream exit of tail culvert, showing brick headwall and parapet in fair condition.

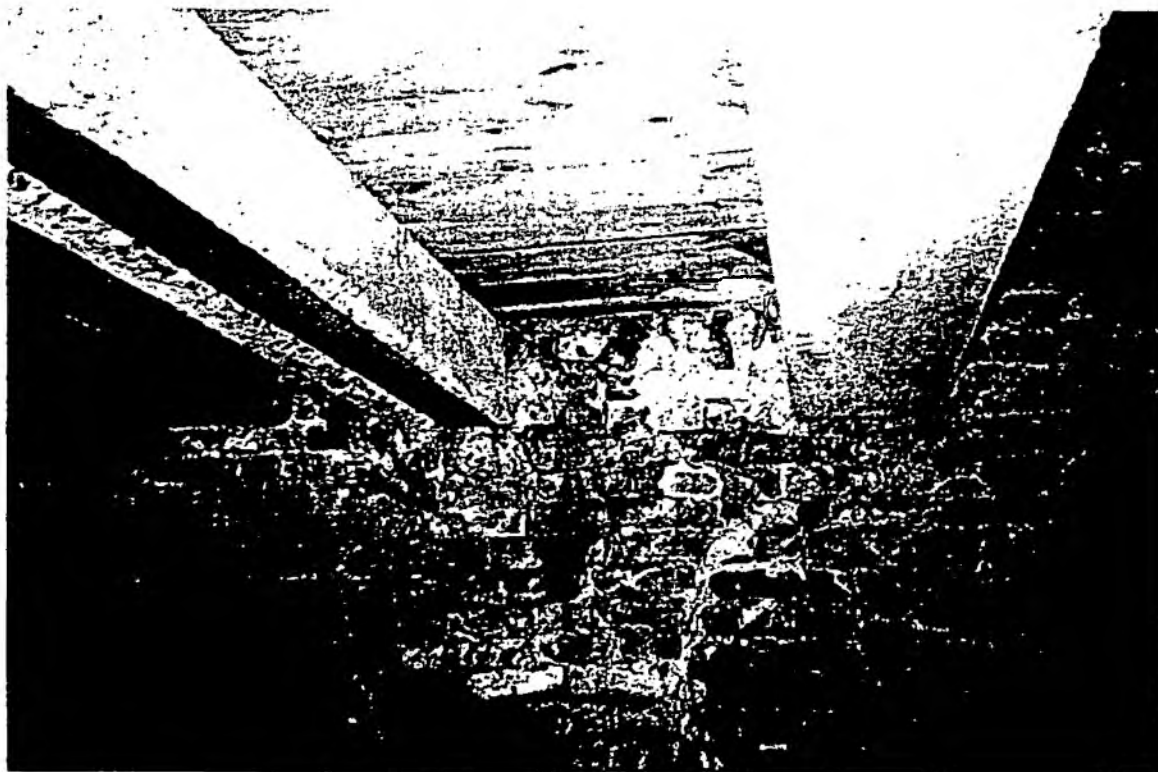
At chainage 10.8 m, the tail culvert opens into the wheel chamber, which is 3150 mm wide (photograph 4). The depth of water over the brick invert is 500 mm. The mill wheel is no longer in place. The resulting hole in the floor above has been closed with wooden floorboards on concrete-cased steel joists, which span between the side walls of the chamber. Joists Nos. 2, 5, 6, 7 and 8 (numbered from the downstream end) are in poor condition, with varying degrees of corrosion to the steel and spalling of the concrete casings (photographs 5, 6, 7, 10 and 11).

The beam casing is cracked and spalled in many places and this concrete should be reinstated and repaired. When the damaged concrete has been broken out, the beams should be inspected for decay and their residual life and strength estimated.

Photograph No. 6. At chainage 15 m. View of right-hand end of Nos. 5 and 6 joists (numbered from downstream), showing spalling concrete.

- Break back overhanging brick invert to expose void and refill using dense concrete
- Restore brickwork invert
- Repair/reconstruct right-hand upstream brickwork wing wall at the entrance to the culvert.
- Restore the timber coping and secure with new bolts. Make good all defective pointing in the brickwork apron and side walls.
- Break out casing around roof members and examine the steel sections to determine their structural condition. Replace I beams where necessary and reconstruct concrete casing.

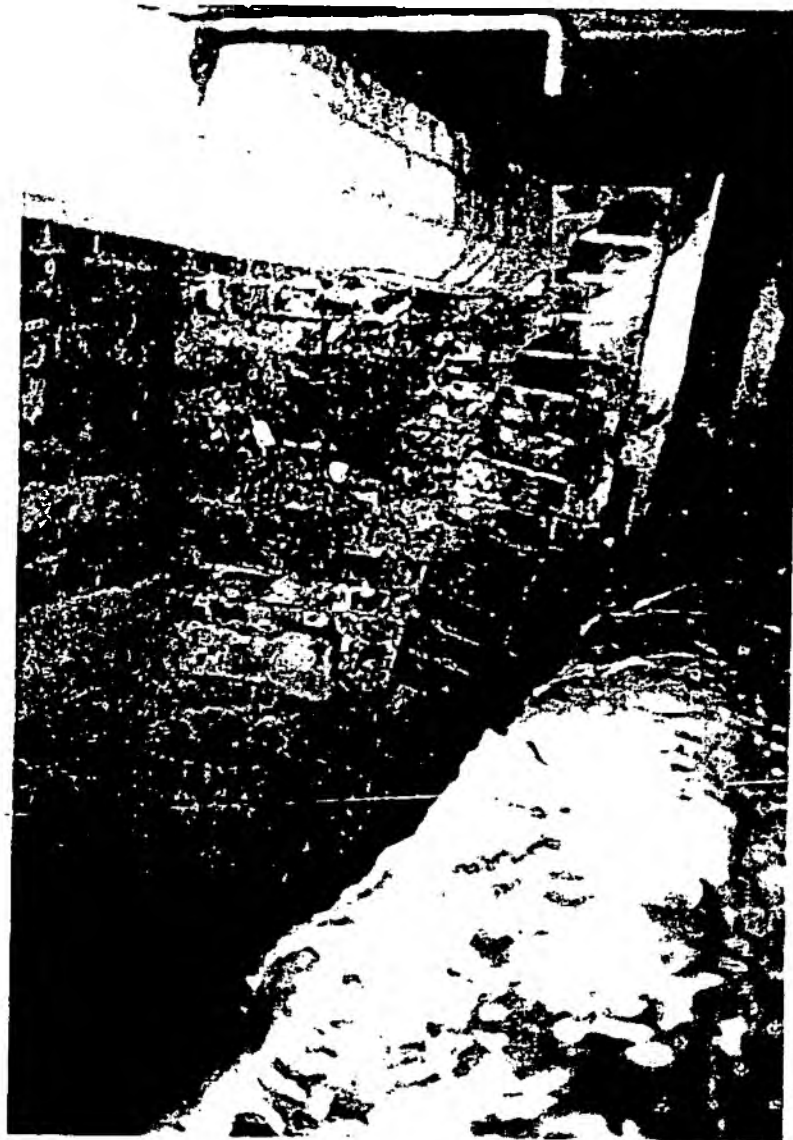
The timber coping at the weir has deteriorated and some boltheads are projecting. The pointing to the brickwork apron and the sides is in bad condition and needs to be repaired.

Photograph No. 9. View along timber facing to downstream side of entrance sill.

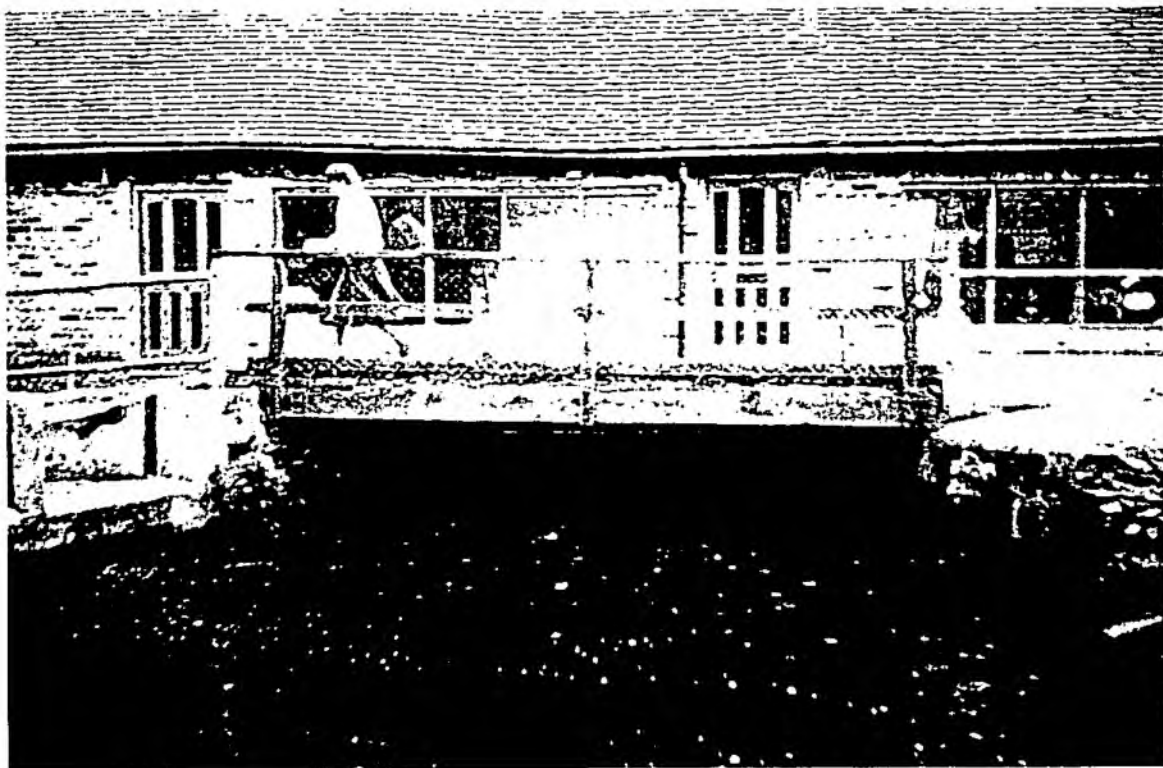
The stream enters the mill culvert under a timber footbridge (photograph 12). The right-hand upstream bank is retained by a brickwork wing wall, which is in very poor condition (photograph 13). On the left-hand side, there is a brick and concrete sluice which is in fair condition (photograph 14). Under low flow conditions, such as on the day of this survey, all river flow is diverted via this sluice and through a by-pass culvert.

Photograph No. 12. View of upstream entrance to mill culvert, showing timber footbridge.

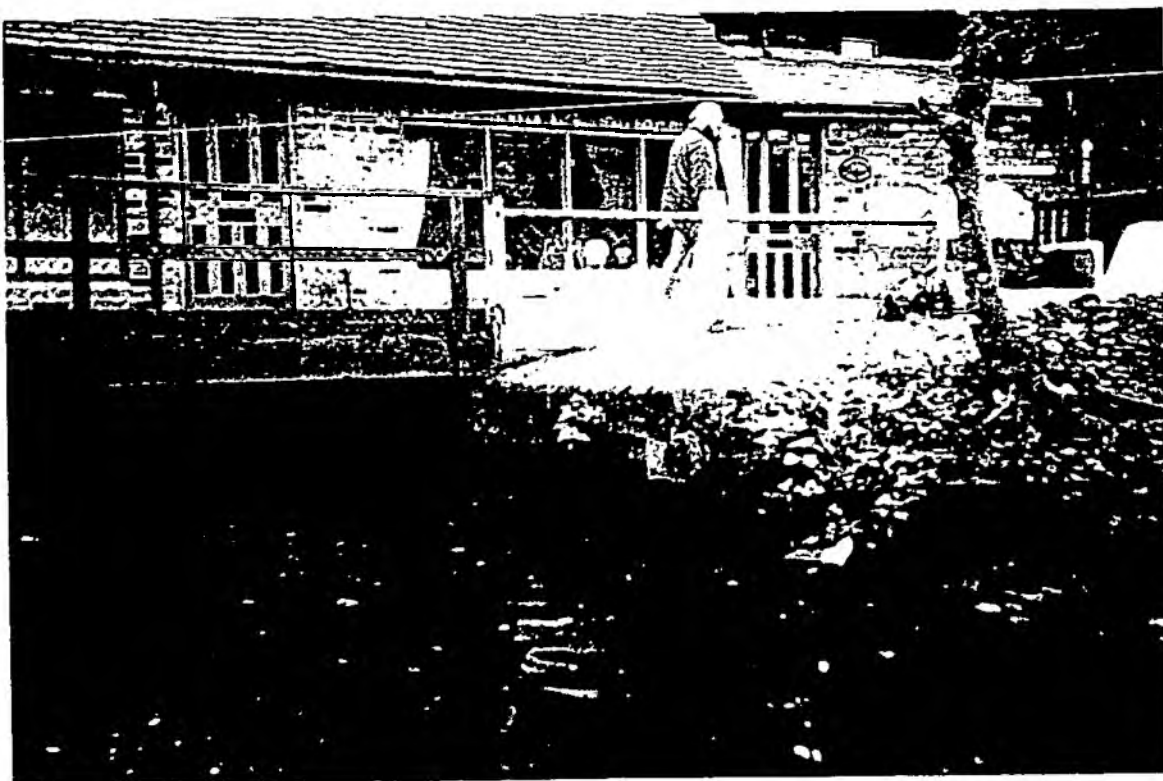
The right hand brickwork wing wall is in very poor condition and needs to be restored.

Photograph No. 13. Right-hand upstream bank, showing brick wall in poor condition.

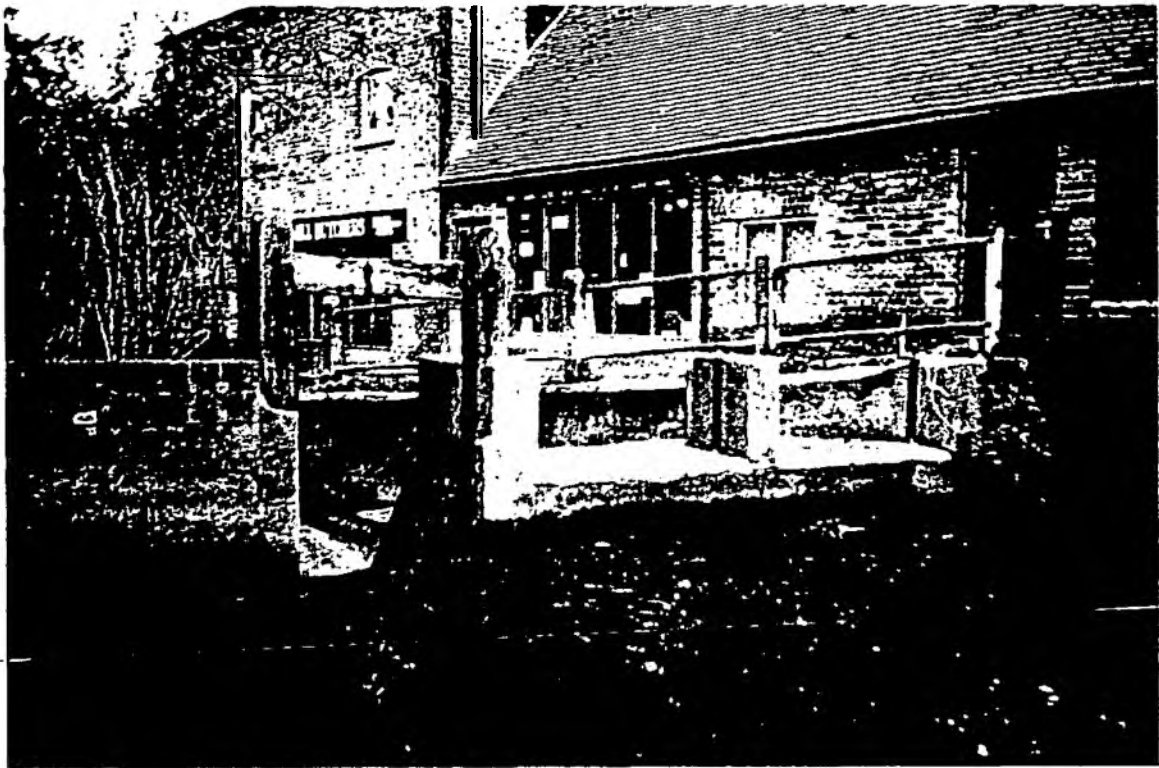
Photograph No. 14. Left-hand upstream bank, showing sluices to by-pass channel.

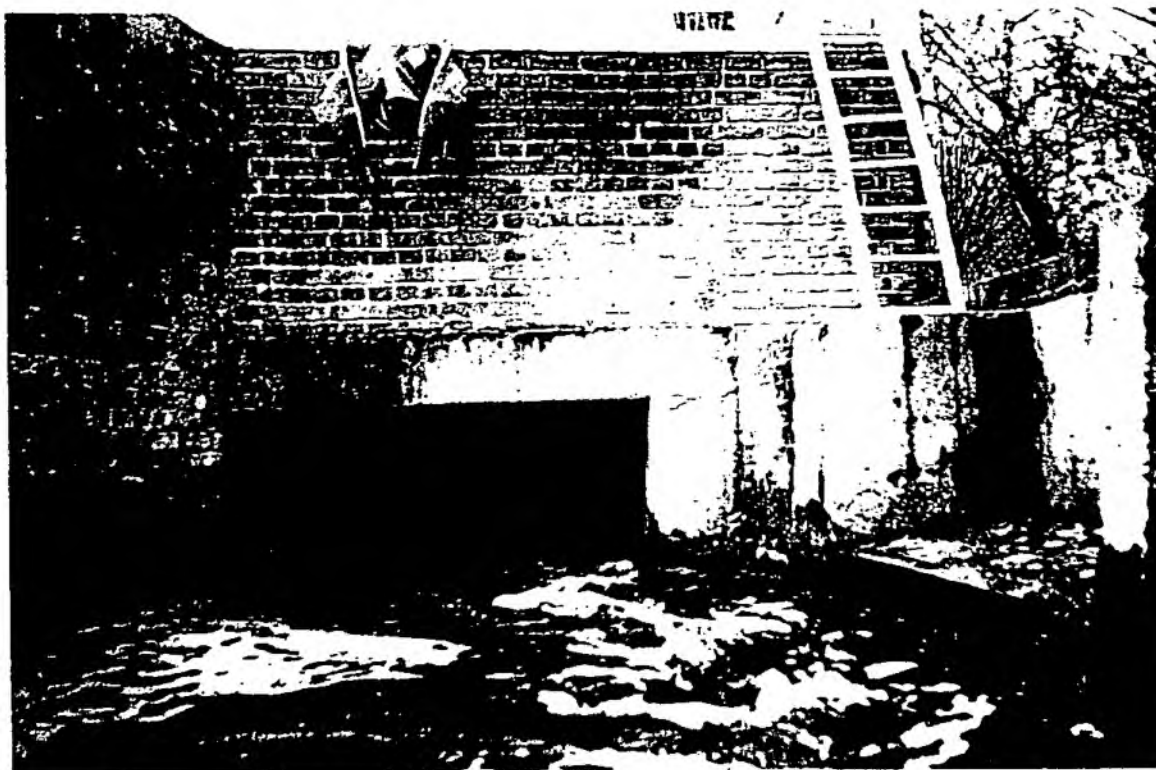
At the downstream exit, the culvert consists of a reinforced concrete roof and walls, with a brick headwall/parapet above (photograph 1). The bottom 400 mm of the culvert walls and the culvert invert are brickwork, as are the side walls downstream of the exit. The reinforced concrete and brickwork are in fair condition, except for the right-hand wall 1500 mm downstream of the culvert exit, where poor

Photograph No. 1. By-pass culvert downstream exit.

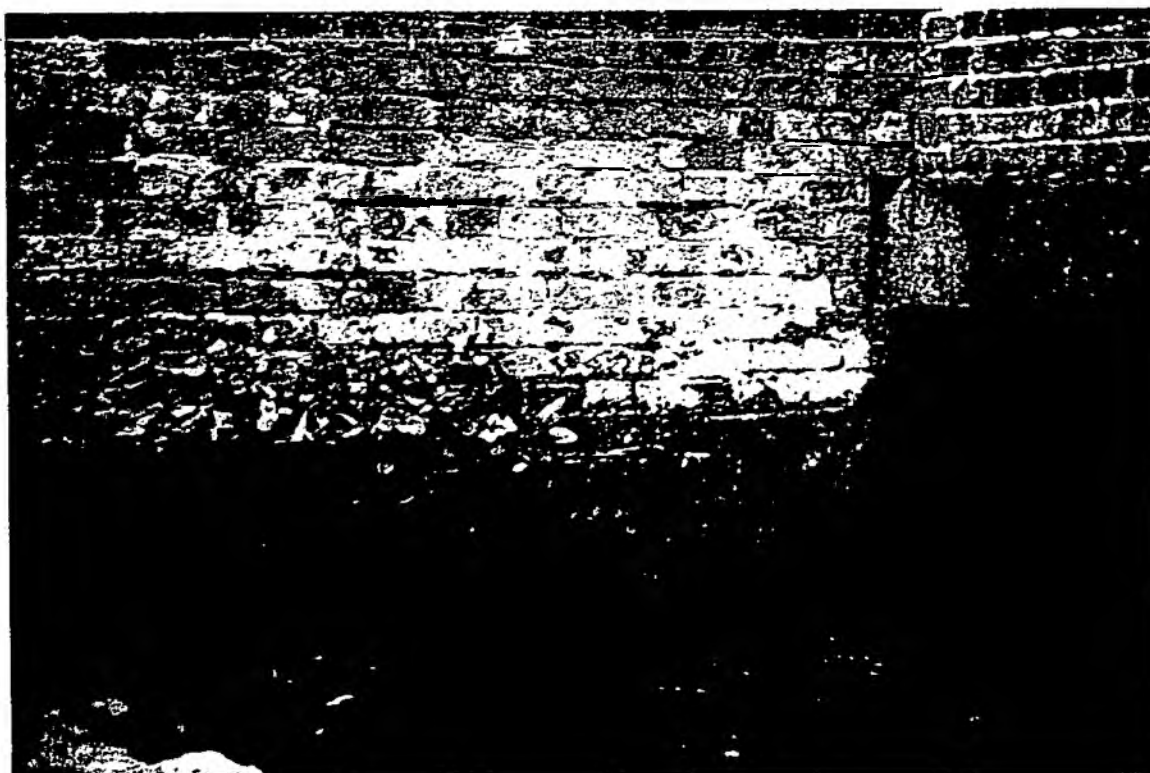
pointing has resulted in the loss of a brick 300 mm above water level (photograph 2). The downstream exit measures 1800 mm wide by 1100 mm high, and the water depth at the time of the survey was 500 mm.

Photograph No. 2. At chainage 0 m. Right-hand side wall at downstream exit, showing poor condition of brickwork.

- Repoint and repair damaged brickwork on the right-hand wall 1500mm downstream of exit.
- Repair the right hand side of the upstream entrance where there is evidence of damage at the entrance to the two 650mm pipes.

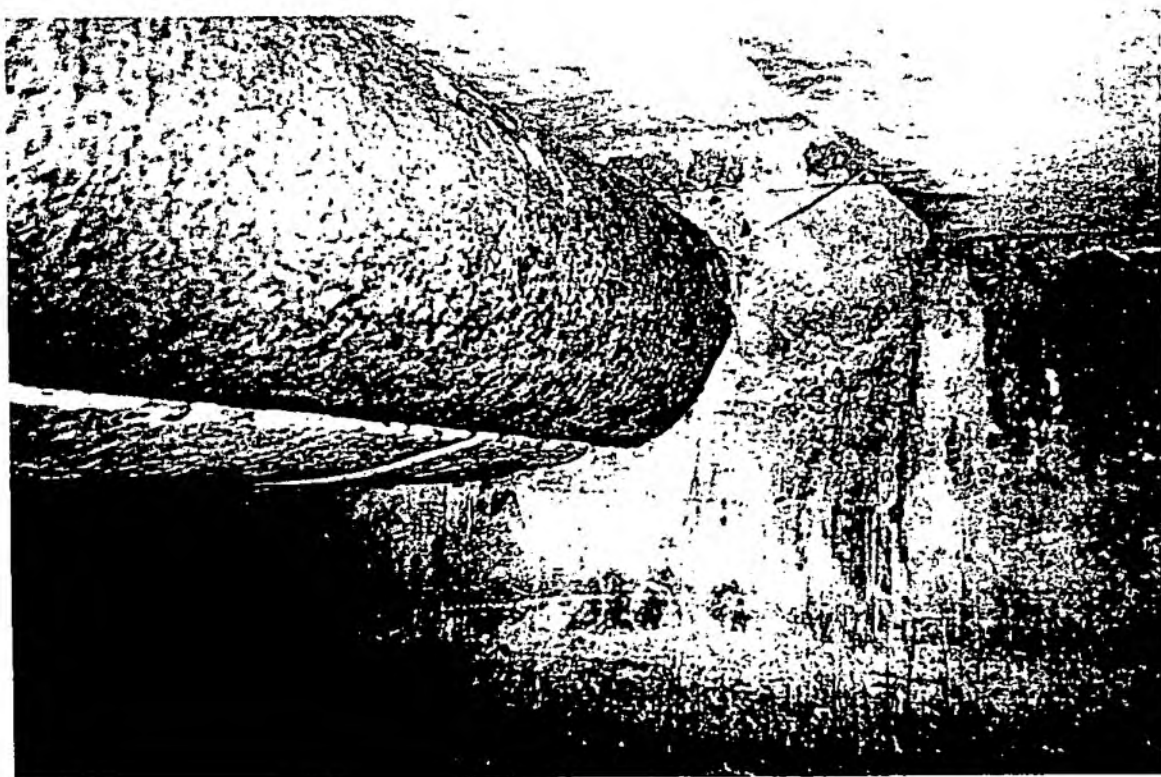
Photograph No. 8. Detail of 300 mm diameter pipe crossing at chainage 20 m.

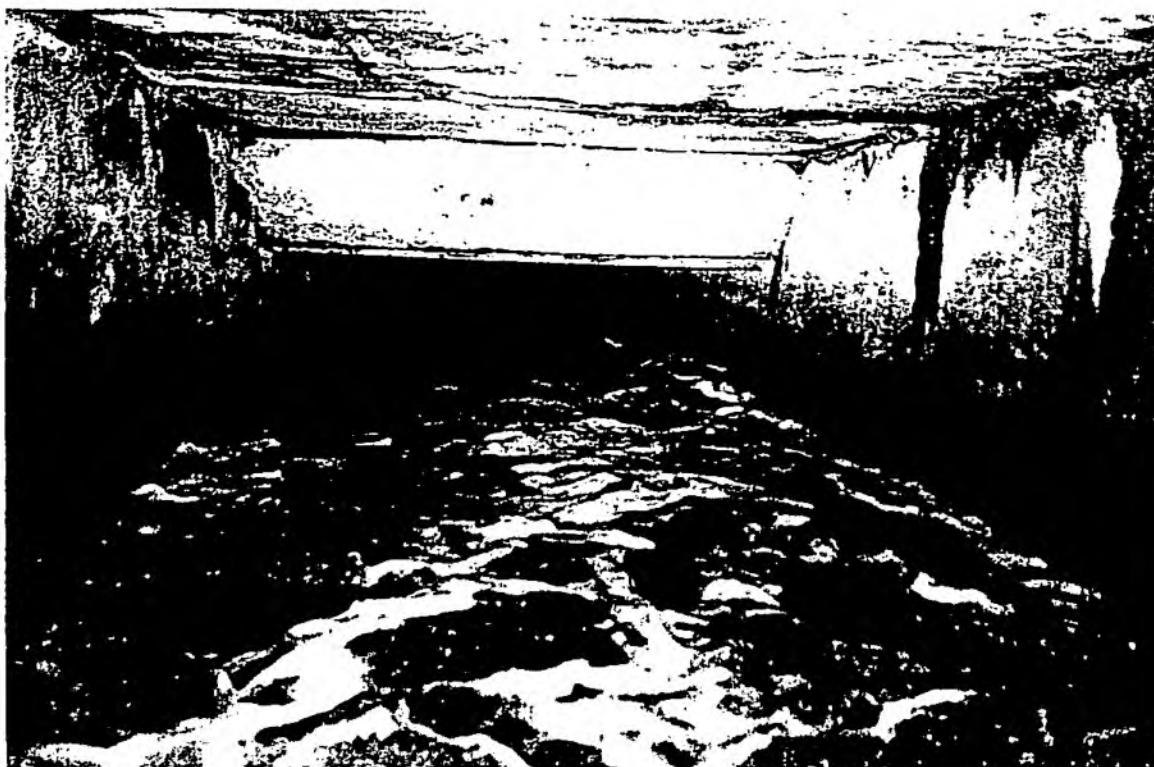
Photograph No. 9. 200 mm and 300 mm diameter pipes crossing at chainage 20.6 m and 20.0 m, with concrete part-surround, viewed from upstream.

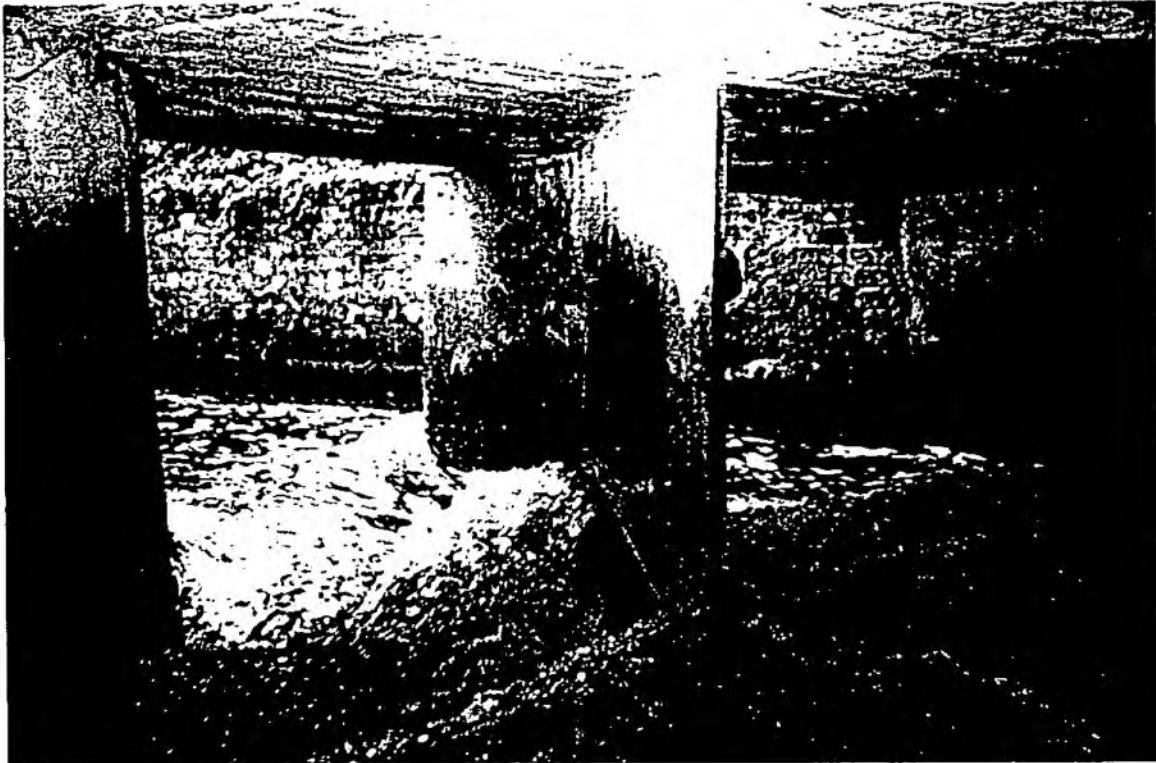
From chainage 28.4 m to the upstream entrance at chainage 31.5 m, the culvert bends through approximately 80 degrees. There is a curved concrete cutwater at this bend (photographs 11, 12 and 14).

Photograph No. 11. View of culvert entrance from downstream, showing curved cutwater.

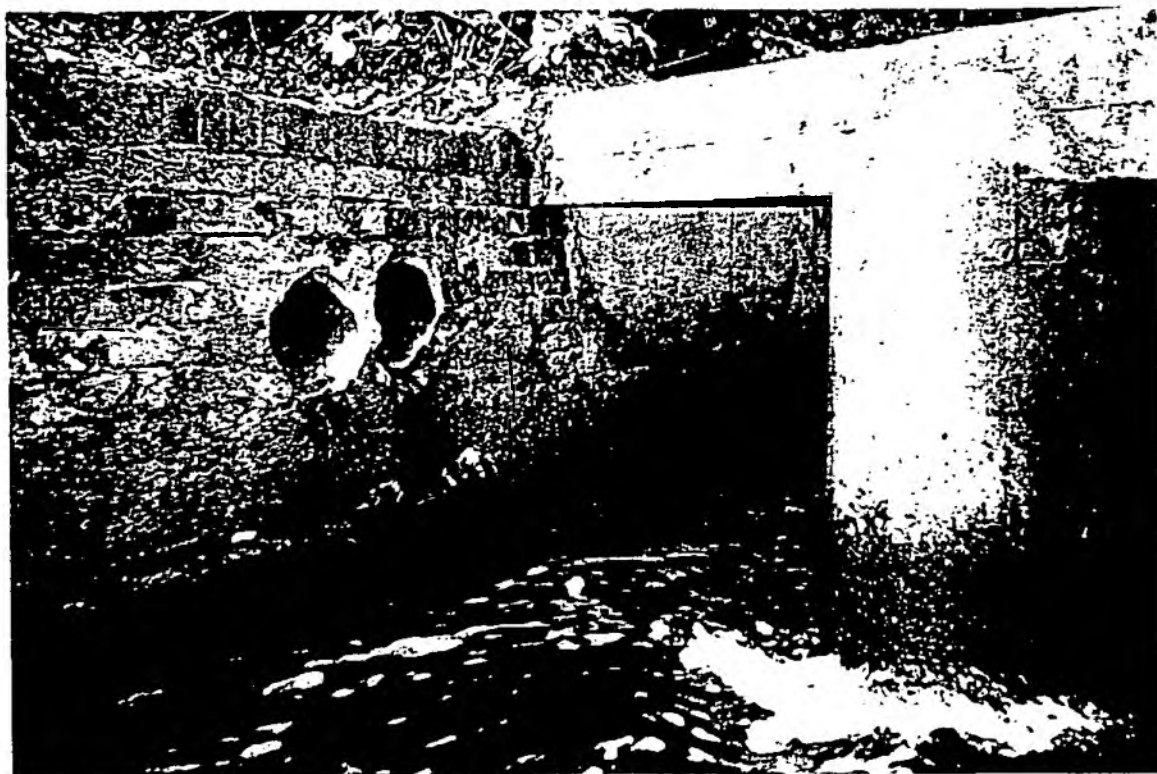
Photograph No. 12. Left-hand side wall, showing two 200 mm diameter pipe outlets in left-hand wall of by-pass channel at chainage 32 m.

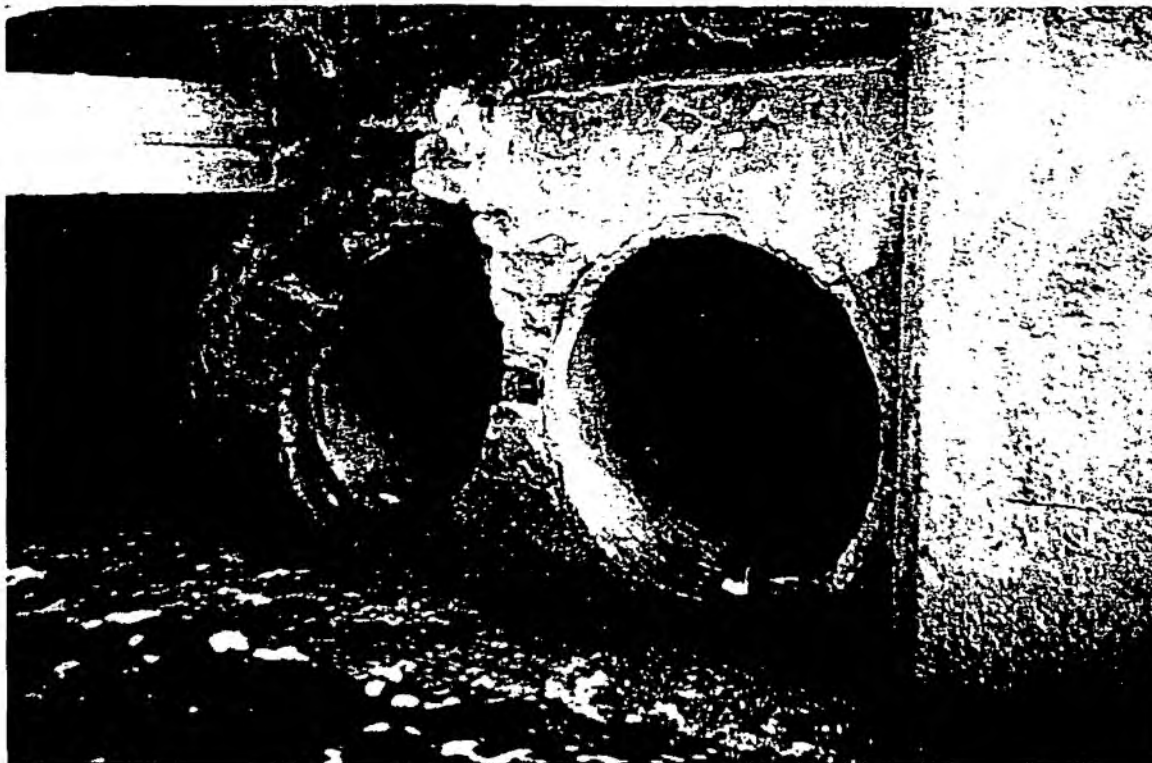
The stream enters the by-pass culvert from a brick and concrete channel (photograph 14). The left-hand upstream bank is retained by a brickwork wall, which is in fair condition (photograph 14). On the right-hand side, there are two 650 mm diameter pipe entrances (photographs 13 and 14).

Photograph No. 13. Detail of 650 mm diameter pipe entrances at chainages 32 m and 33 m.

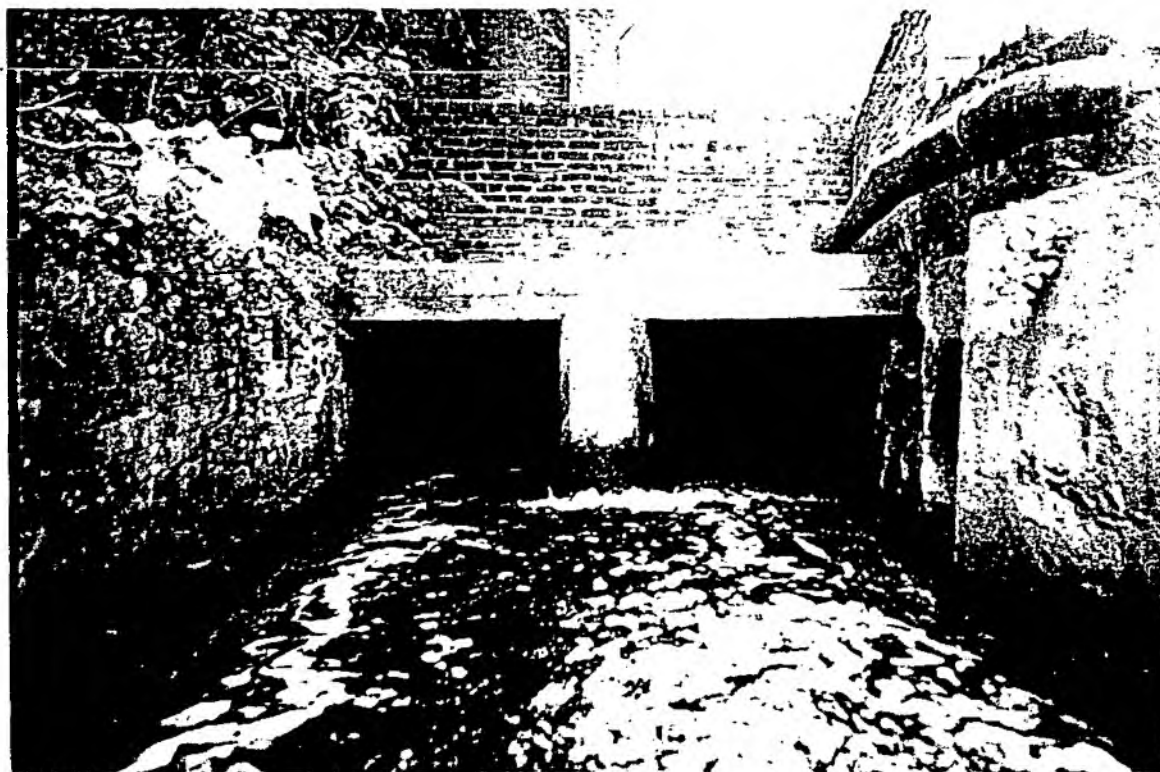
Photograph No. 14. View down by-pass channel, showing upstream culvert entrance at chainage 31.5 m and two 650 mm diameter pipe entrances in right-hand wall of channel.

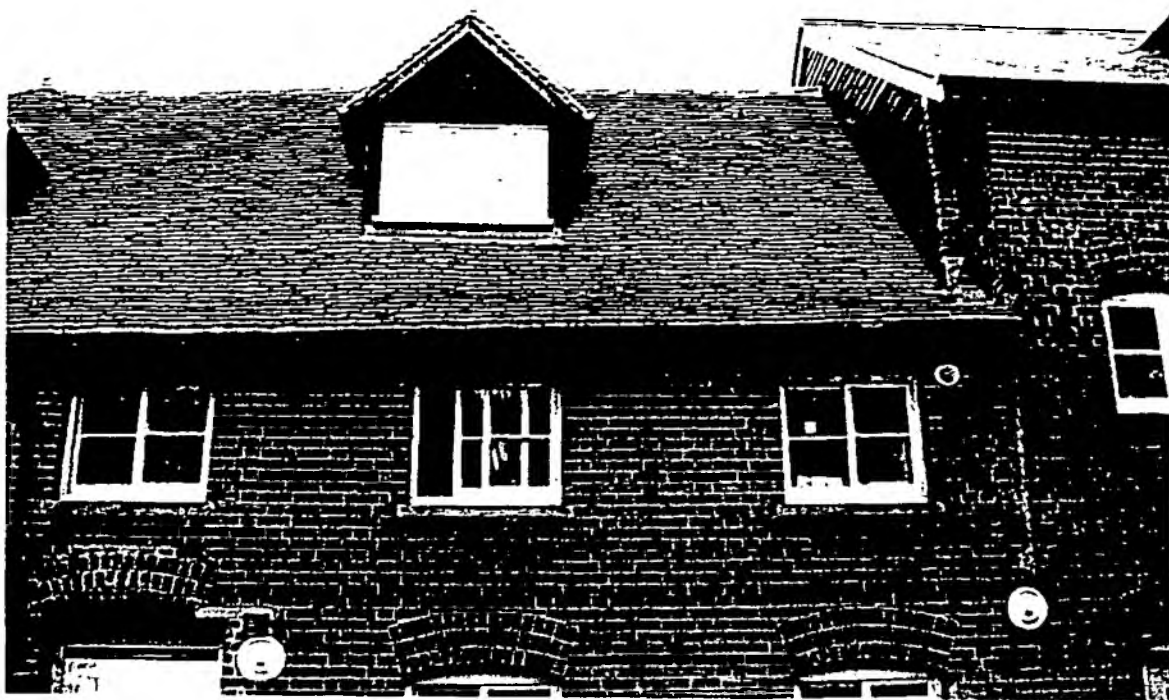
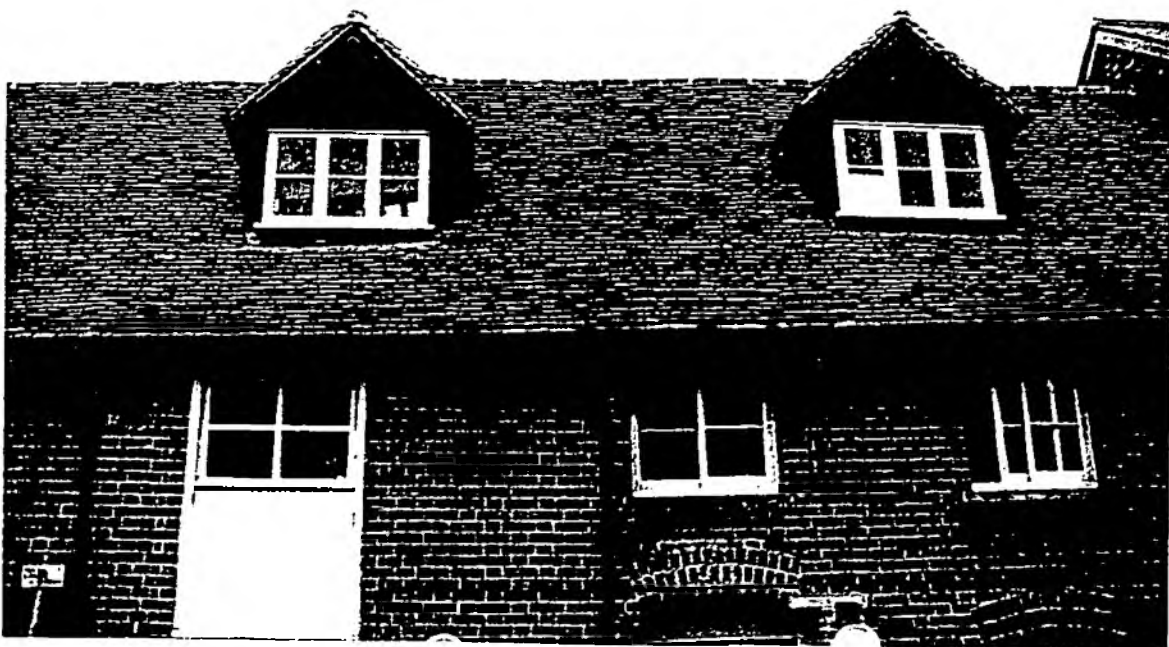
2.01.1 The general condition of the roof is good, typically shown in FIGS. 3 & 4. There is no evidence of sagging or displacement of the tiles.

FIG. (3) The roof structure, east face (1)

FIG. (4) The roof structure, east face (2)

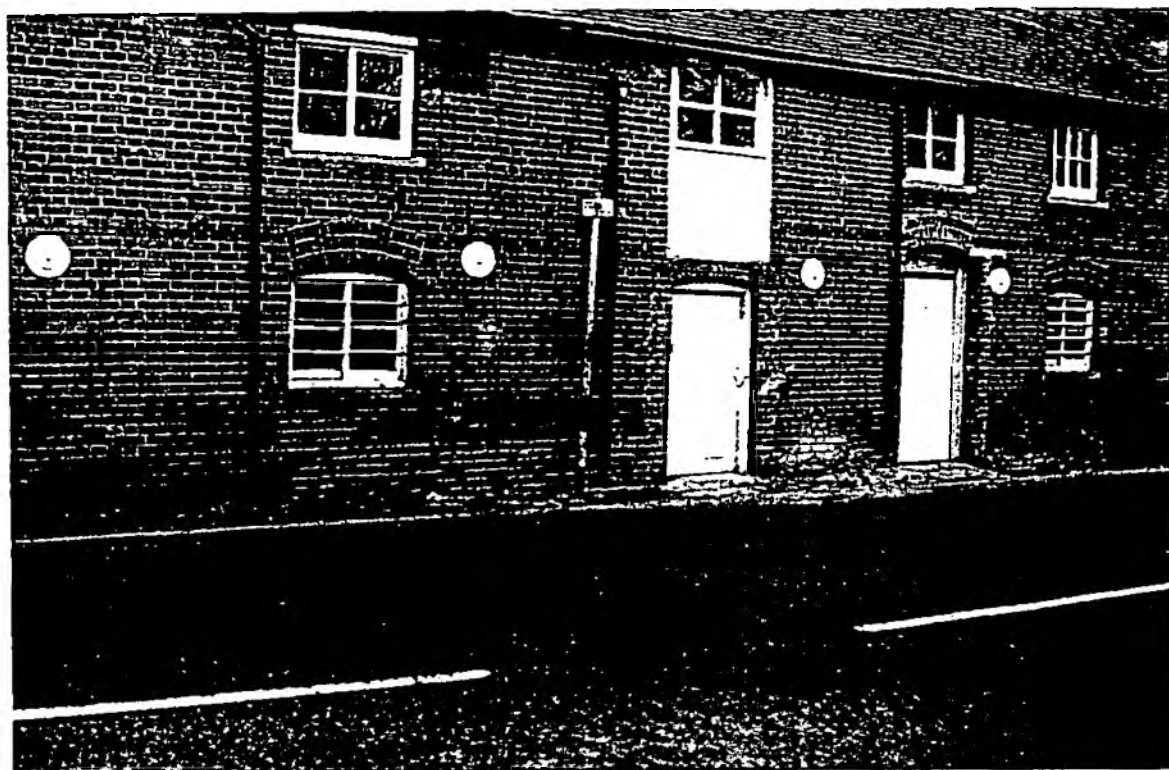
2.01.2 The general condition of the external brick walls is also good and there is no evidence of cracking. However, it can be seen from FIG. 5 that the east wall adjacent to the B651 is tied back by means of wall plates to the internal framework, FIG. 6.

FIG. (5) East face of building with wall plates

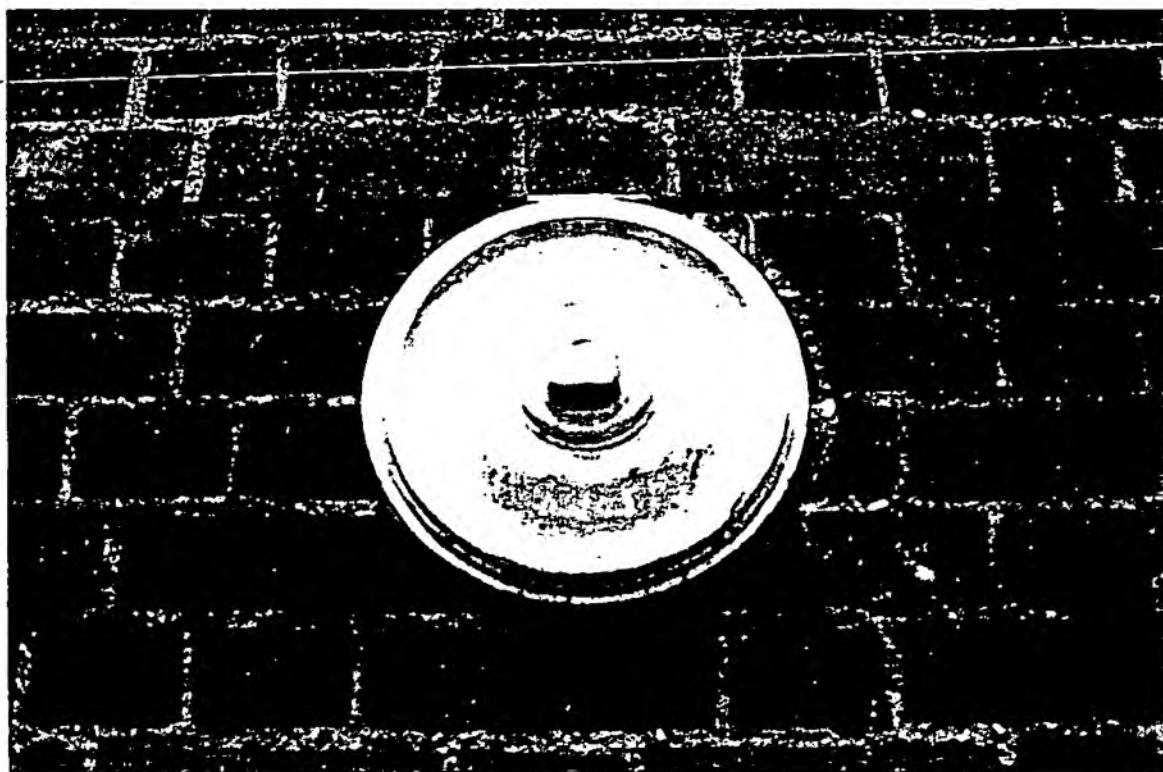
FIG. (6) Close-up of wall plates

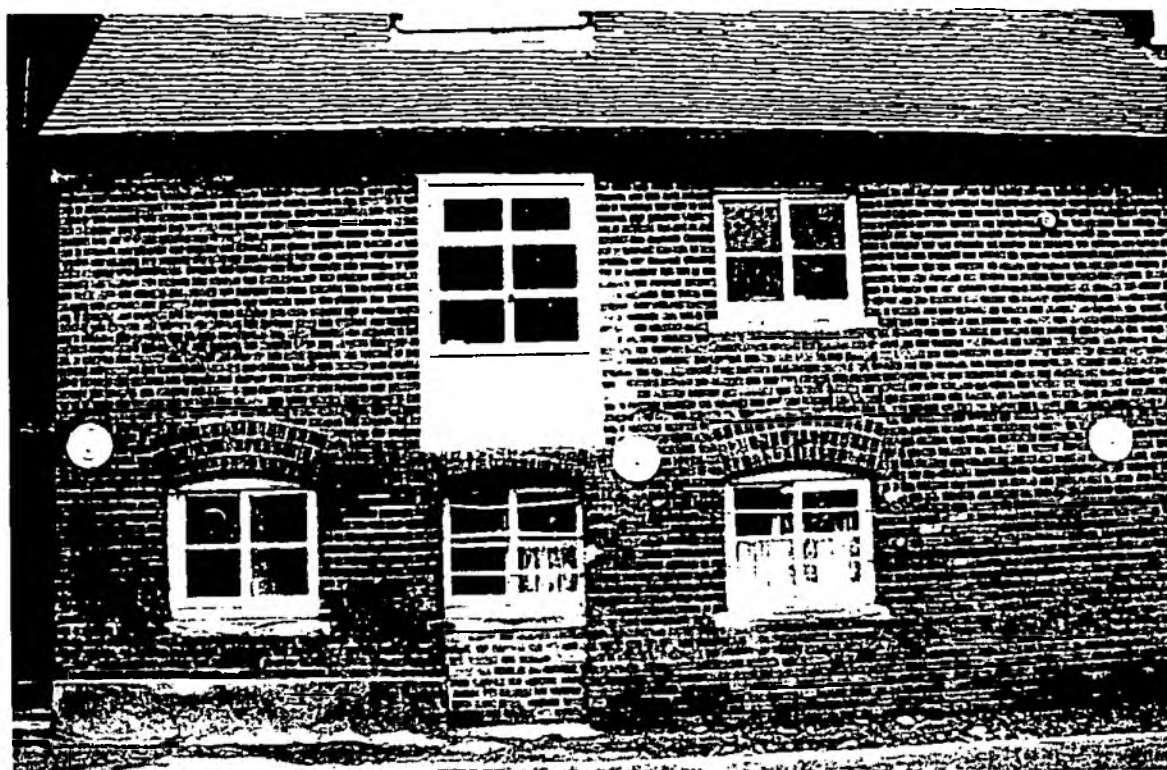
FIG. (7) Rising damp on east wall

- 3.02 Although the damp wall on the east face is separated from the shops and offices by a 1.0 m wide corridor, provision for remedial treatment is recommended for other than short term (up to two years) occupation.

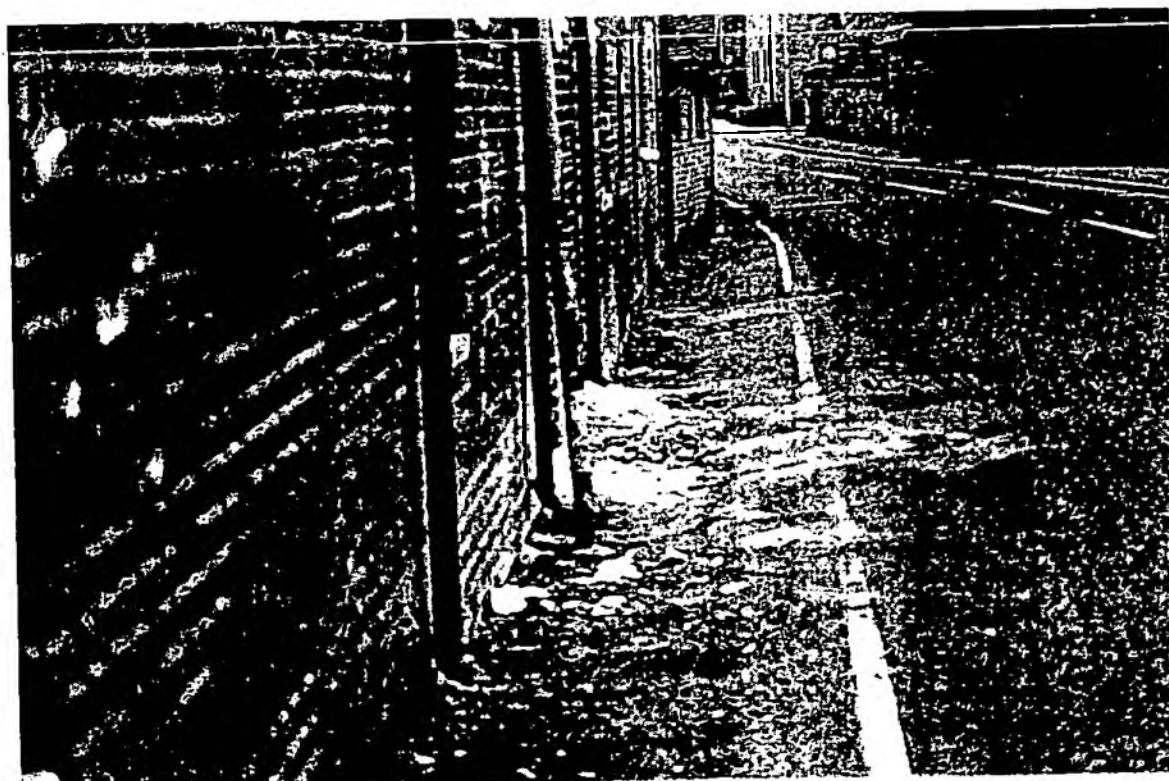
FIG. (8) Lack of provision for drainage, east wall
