UPPER NENE STRUCTURES STANWICK

DETAILED APPRAISAL REPORT

MARCH 1992

SURVEY REPORT - STRUCTURAL CONDITION

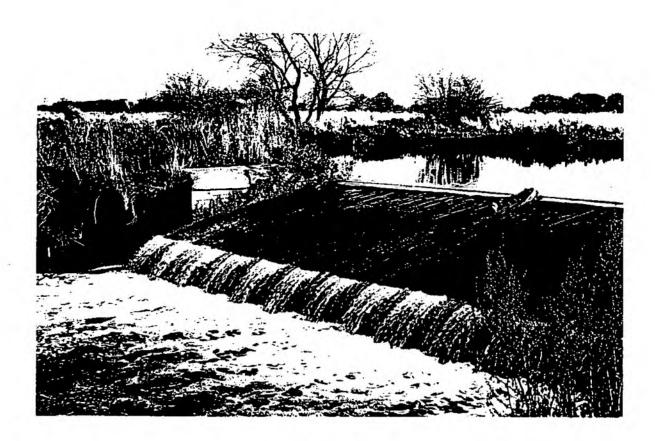
Weir No. 1

3.1 This weir, which allows overflow from the main river channel, appeared in good condition. The upstream face was underwater and so no comments can be made about it. The top surface, whilst weed covered, appeared in good condition. The downstream sheet piles appeared in good condition.

- 3.2 The south west side brick retaining wall was in good condition. However the north east side brick retaining wall was cracked and the coping had moved. The damaged parts of the wall need replacing before the situation becomes worse.

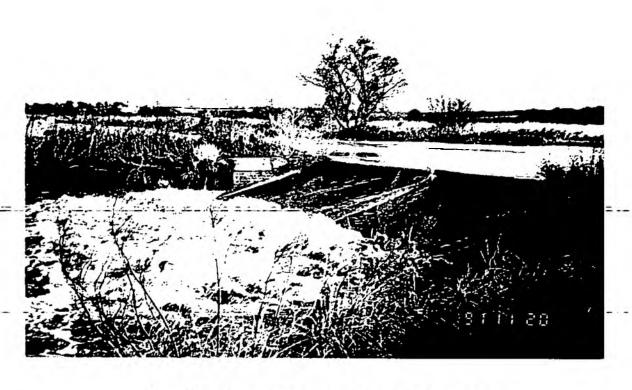
Weir No. 1 - high river flows on 20.11.91

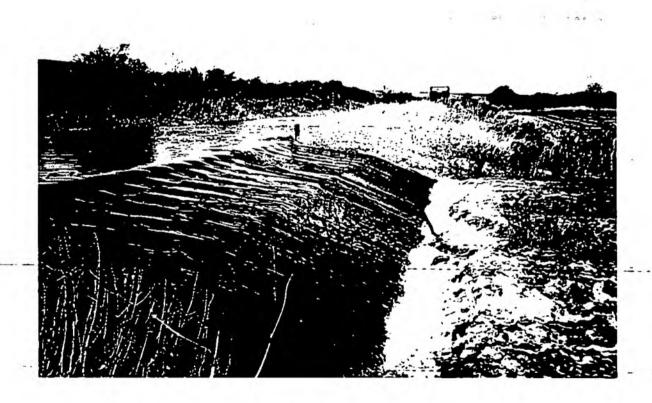
Weir No. 2 - high river flows on 20.11.91

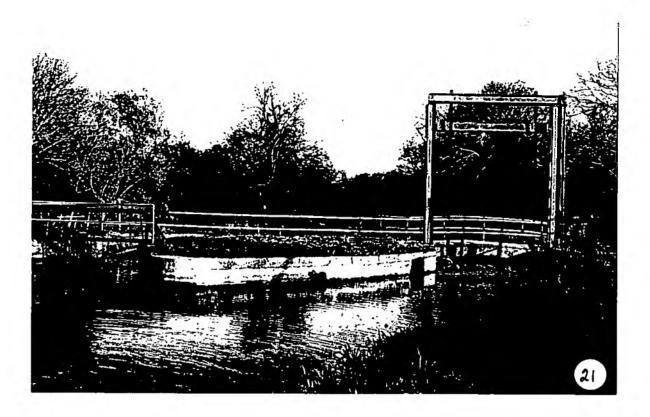
Stanwick Sluices - viewed from upstream

- 2.1 Areas of the vertical sluice walls were in poor condition as the facing concrete had fallen off, and this had allowed deterioration of the brickwork to occur. Also there were vertical cracks in the concrete which will allow the entry of water and possible further deterioration.

- 2.2 Whilst the damage noted above is repairable there will be an ongoing maintenance cost as other parts weaken. This is borne out by the presence of past repair work.

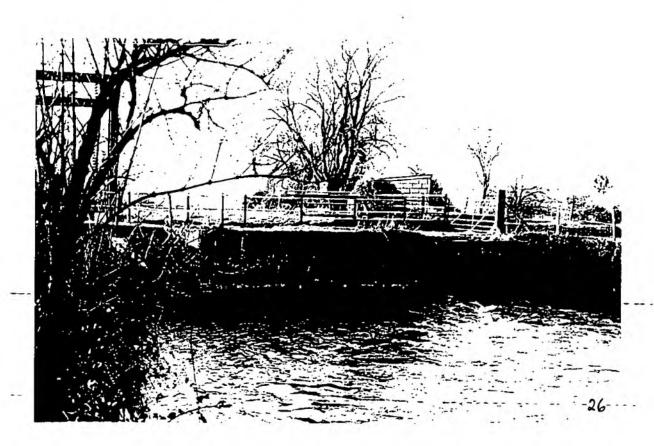
Stanwick Sluices - viewed from downstream

- 2.6 The righthand downstream springing of the arch and the wall adjacent to it contained loose and broken stones. These should be replaced and repointed in the immediate future.

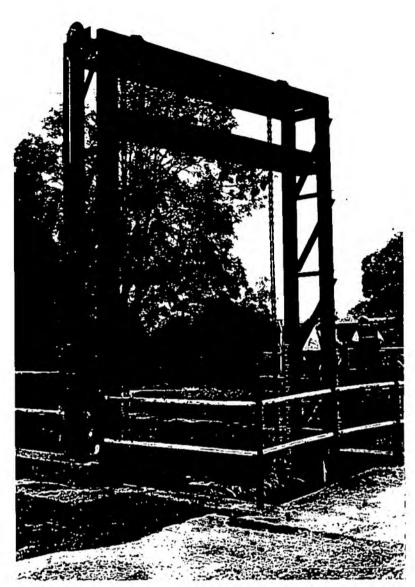
Stanwick Vertical Gate Sluice

General condition good apart from leaking side seals (unable to check the flexible coating on the seal tube).

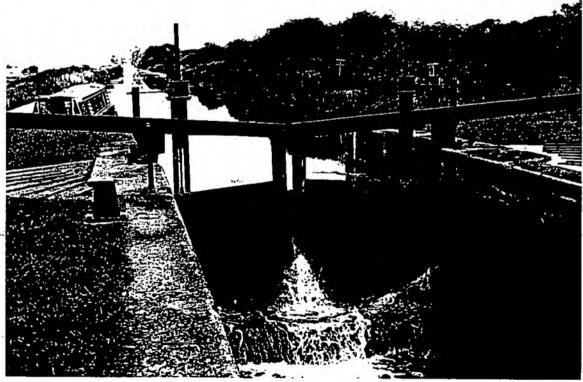
Irthlingborough Lock - note leak through mitre gates - upstream water level lowered for inspection

2.3 The steel fabricated mitre gates leak badly at centre, sides and penstock valves.
