SOUTH LINCOLNSHIRE LIMESTONE AQUIFER: SEALING OF WILD BOREHOLES

Final Report

April 1993

HALCROW

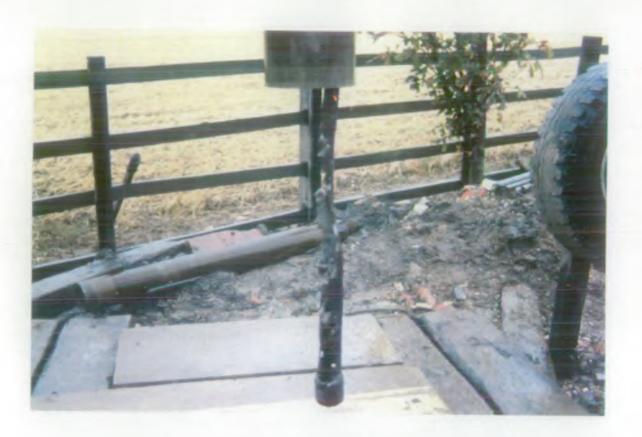
2" casing reduced to typical Lacework structure by acid attack. Note: thicker casing collar (at bottom of casing) resists attack.

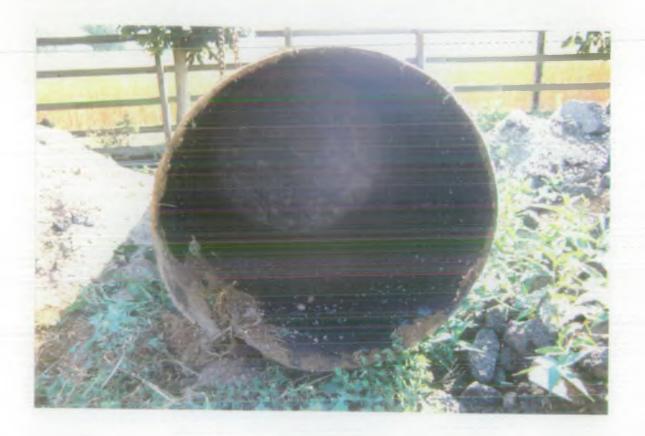
Failure of previous repair.

Corrosion gash (bottom left) an effect of acid attack. Pitted inner surface as a result of anaerobic corrosion. Pre-cast concrete plug in top 1 metre of 3 metre long pipe prior to repair.
