NRA Anglian 129

WQP LIB
ESTUARY

PITSEA CREEK

MAY 1990

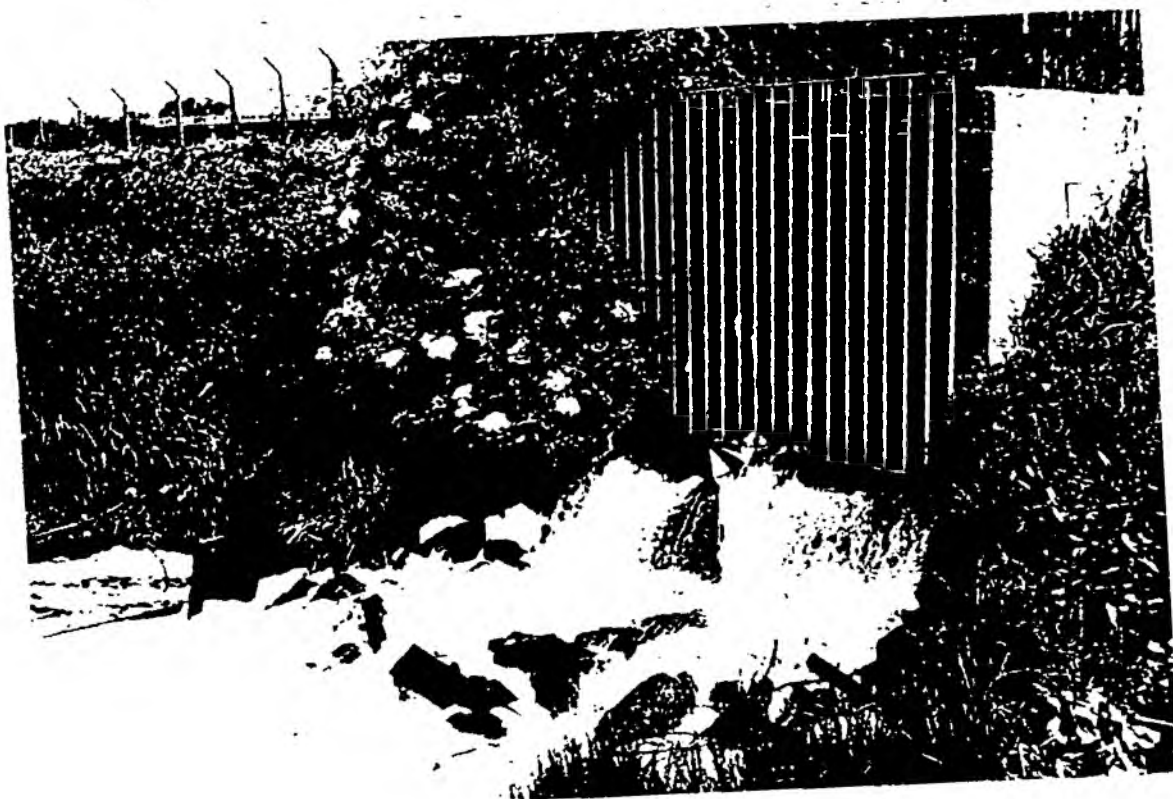
Situated about three and a half km. due north of the discharge point into the head of Pitsea Creek (Photograph 11), Basildon Sewage Treatment Works serves Basildon, Crays Hill, Billericay, South Green and Great Burstard. The works uses a diffused air system of activated sludge. The D.W.F. for this works is $18000 \text{ m}^3/\text{d}$ of which approximately 900 m^3 is trade effluent.

Photo. 11 Basildon STW Outfall - Head of Pitsea Creek

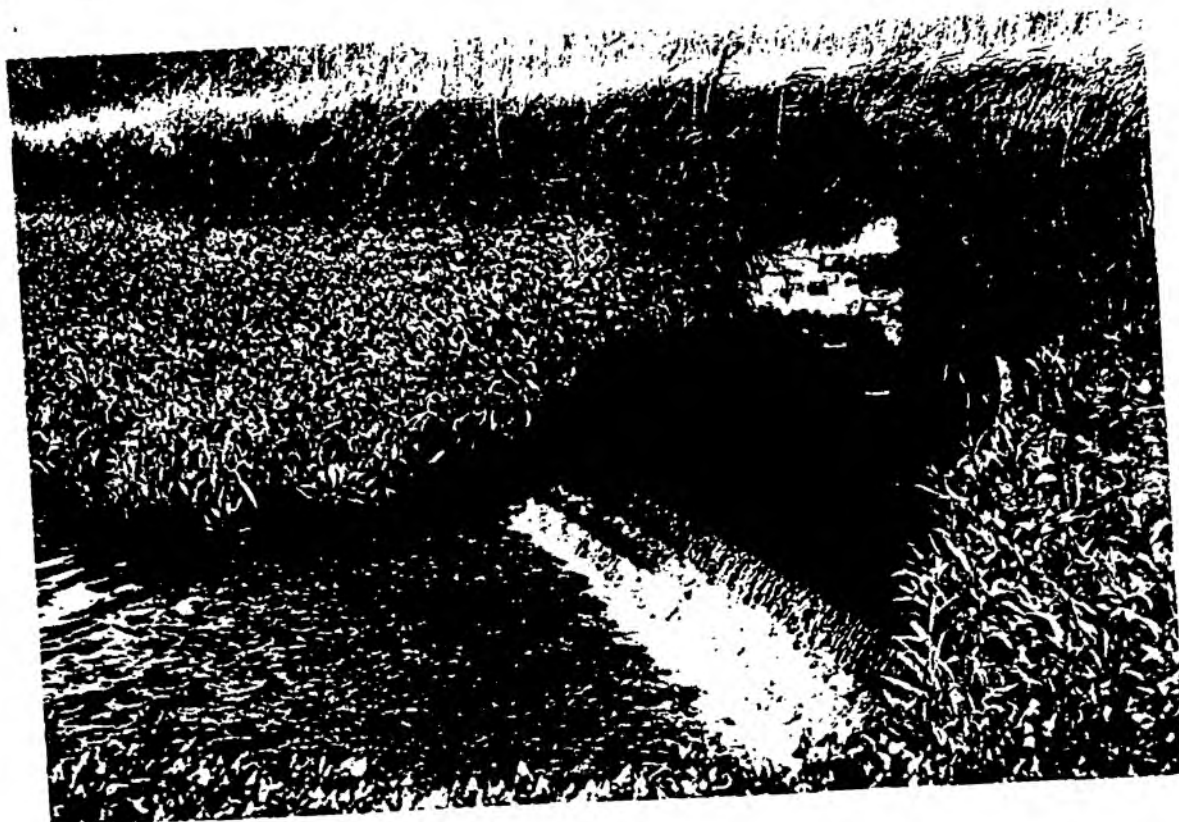
Discharging at the head of Timberrans Creek (Photograph 12), this works serves the towns of Bowers Gifford and Vange. It uses a percolating filter process. No trade effluent is received. The D.W.F. for the works is $6060 \text{ m}^3/\text{day}$.

Photo. 12 Pitsea STW Outfall - Head of Timberrmans Creek

At the time of sampling, low water conditions existed in Timbermans Creek (Photograph 9) so the flows were attributed to sewage effluent from Pitsea STW. The results obtained would suggest that Timbermans Creek quality relies on Pitsea STW performance.

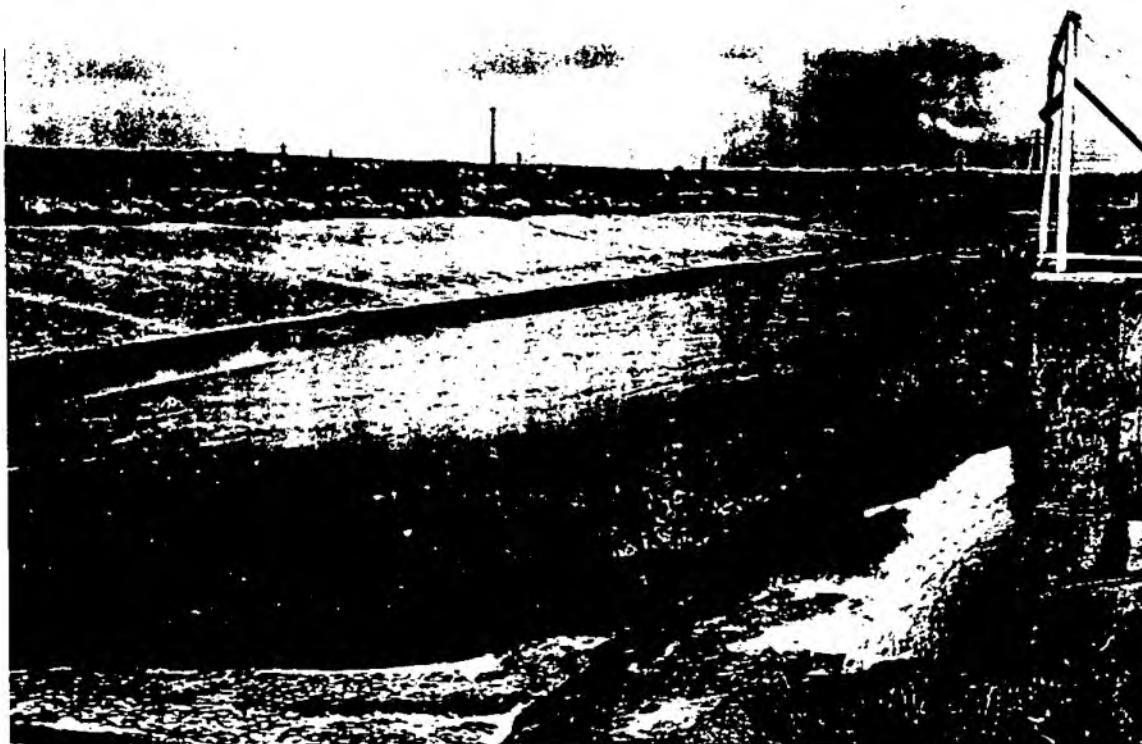
This works discharges to Benfleet Creek (Photograph 13). It uses a percolating filter system. The D.W.F. is $6138 \text{ m}^3/\text{d}$ of which approximately 90 m^3 is trade effluent.

Photo. 13 Benfleet STW Outfall - Benfleet Creek
