**AN INVESTIGATION INTO THE
WATER QUALITY OF THE RIVER
WALDON DURING WET WEATHER**

**JUNE 1996
DEV/E/17/96**

AN INVESTIGATION INTO THE WATER QUALITY OF THE RIVER WALDON DURING WET WEATHER 25 MARCH 1996.

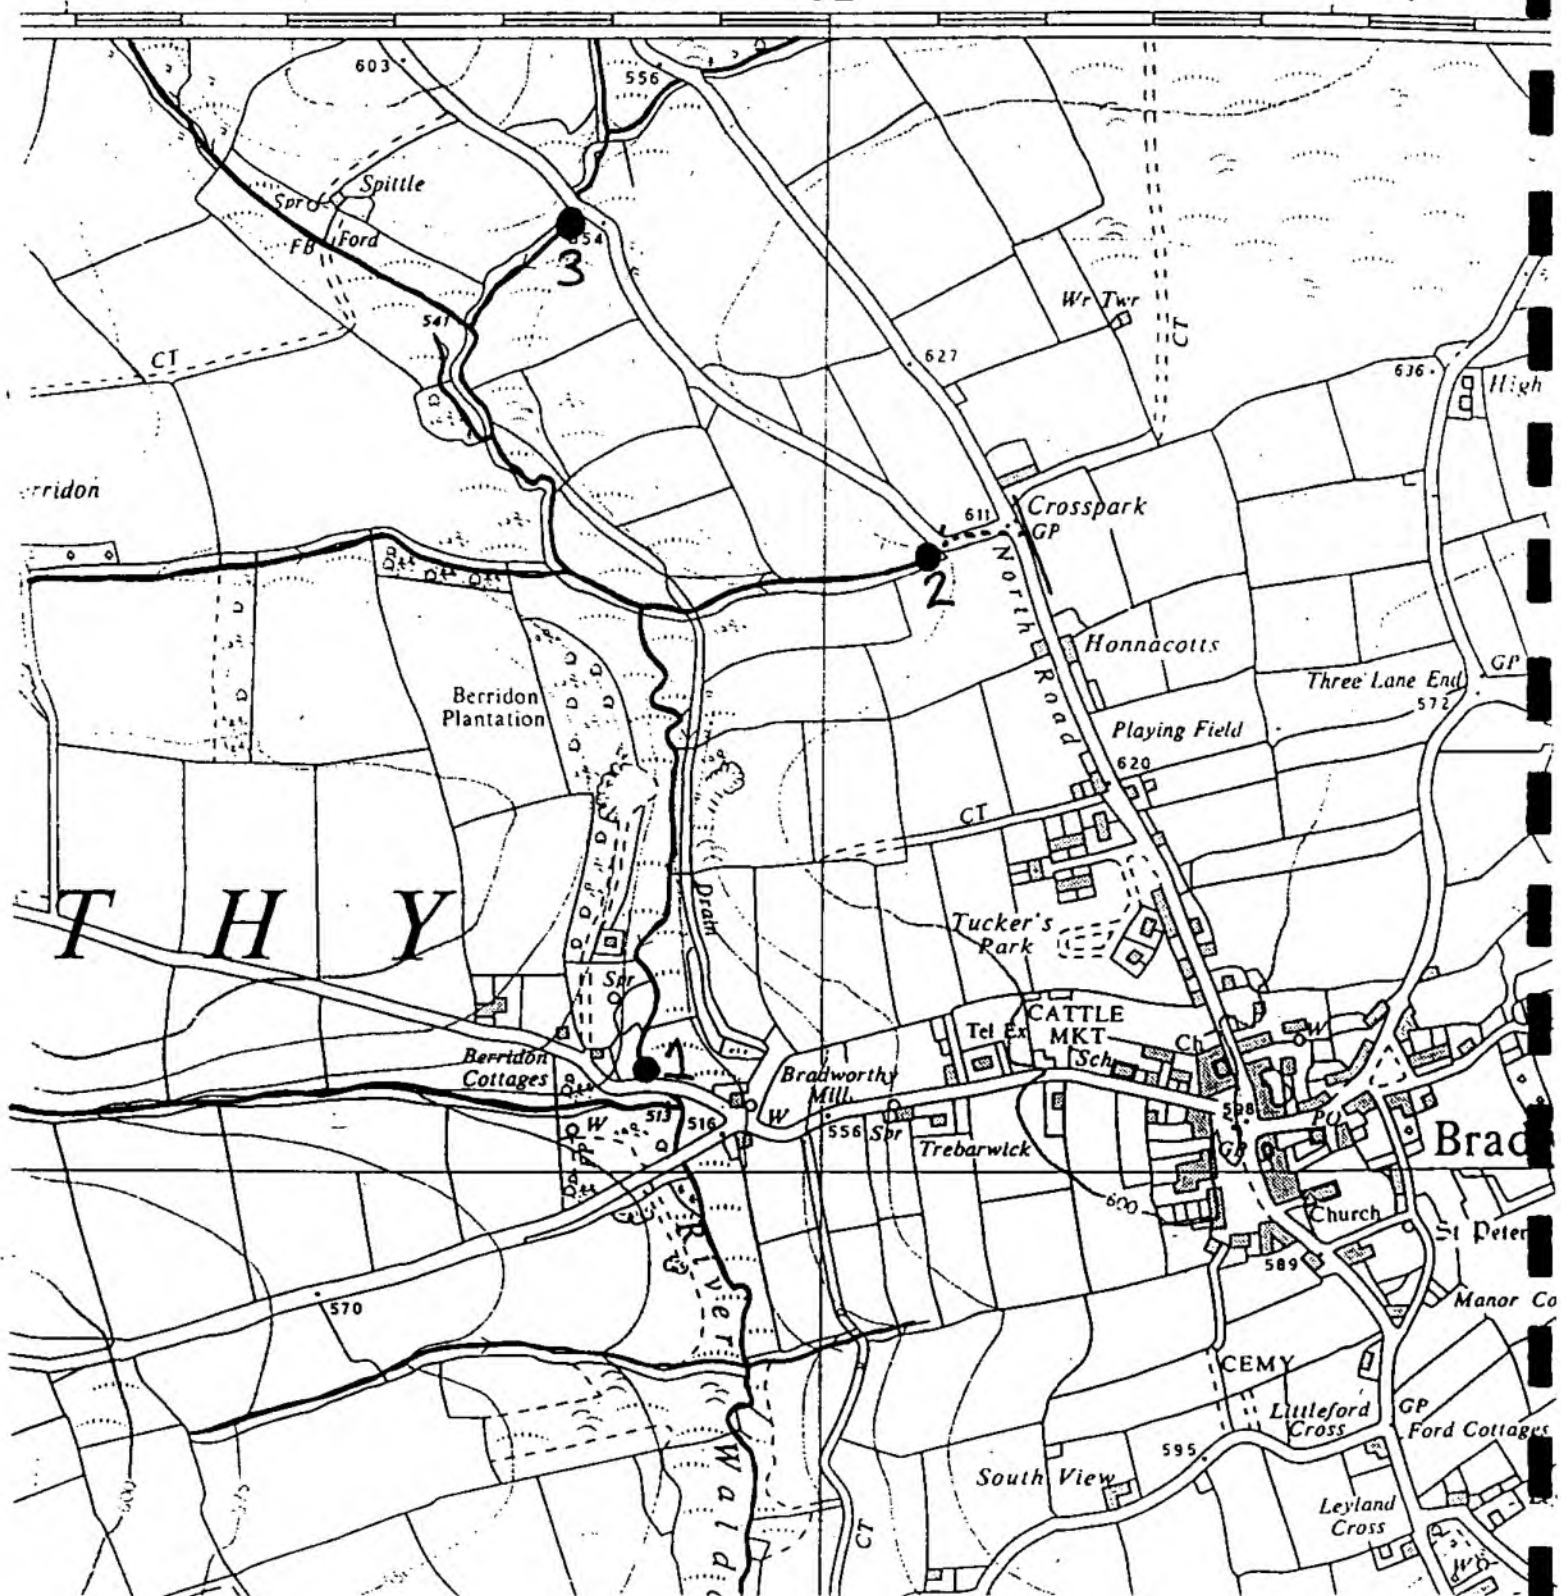
SITE	Crossparks / Honnacotts area		
WATERCOURSE	Tributary River Waldon		
NGR	SS 2312 1455		
EVIDENCE OF WATER QUALITY PROBLEM			
Coloured water entering tributary via road drain.			
Chemical samples taken as part of the wet weather survey indicate the drain was having an impact in the tributary but not in the River Waldon downstream .			
25 March 1996		*	**
Site Description	Site No.	TA mg/l	BOD mg/l
River Waldon D/S of Trib.	1	0.06	1.6
Crossparks / Honnacotts Trib.	2	9.60	69.2
River Waldon U/S of Trib.	3	0.06	1.6
RE Class 2 standards			
*Total Ammonia (TA) = 0.60 mg/l

**BOD = 4.0 mg/l			
SOURCE OF PROBLEM			
Effluent in a ditch along the side of the road by Crossparks and Honnacotts farms was entering a road drain. The drain was in-turn entering the tributary.			
IMPLICATIONS			
During the wet weather survey the impact was localised to the tributary and was not detected D/S in the River Waldon. At the time of sampling, there was little water in the tributary and the subsequent dilution effect of entering the main river effectively prevented any further impact.			
It is still conceivable that with such a direct route for farm effluent to enter the watercourse, should there be a major effluent release from the farms, impact would probably be detectable at Berridon Cottages the next RMS downstream (R29C010 at NGR SS 3184 1408).			
This area was also identified during the appraisal of February 1995.			
RECOMMENDATIONS			
The Water Quality Officer should be aware of the potential risk that this area poses to the water quality of the River Waldon

Action - Water Quality Officer.

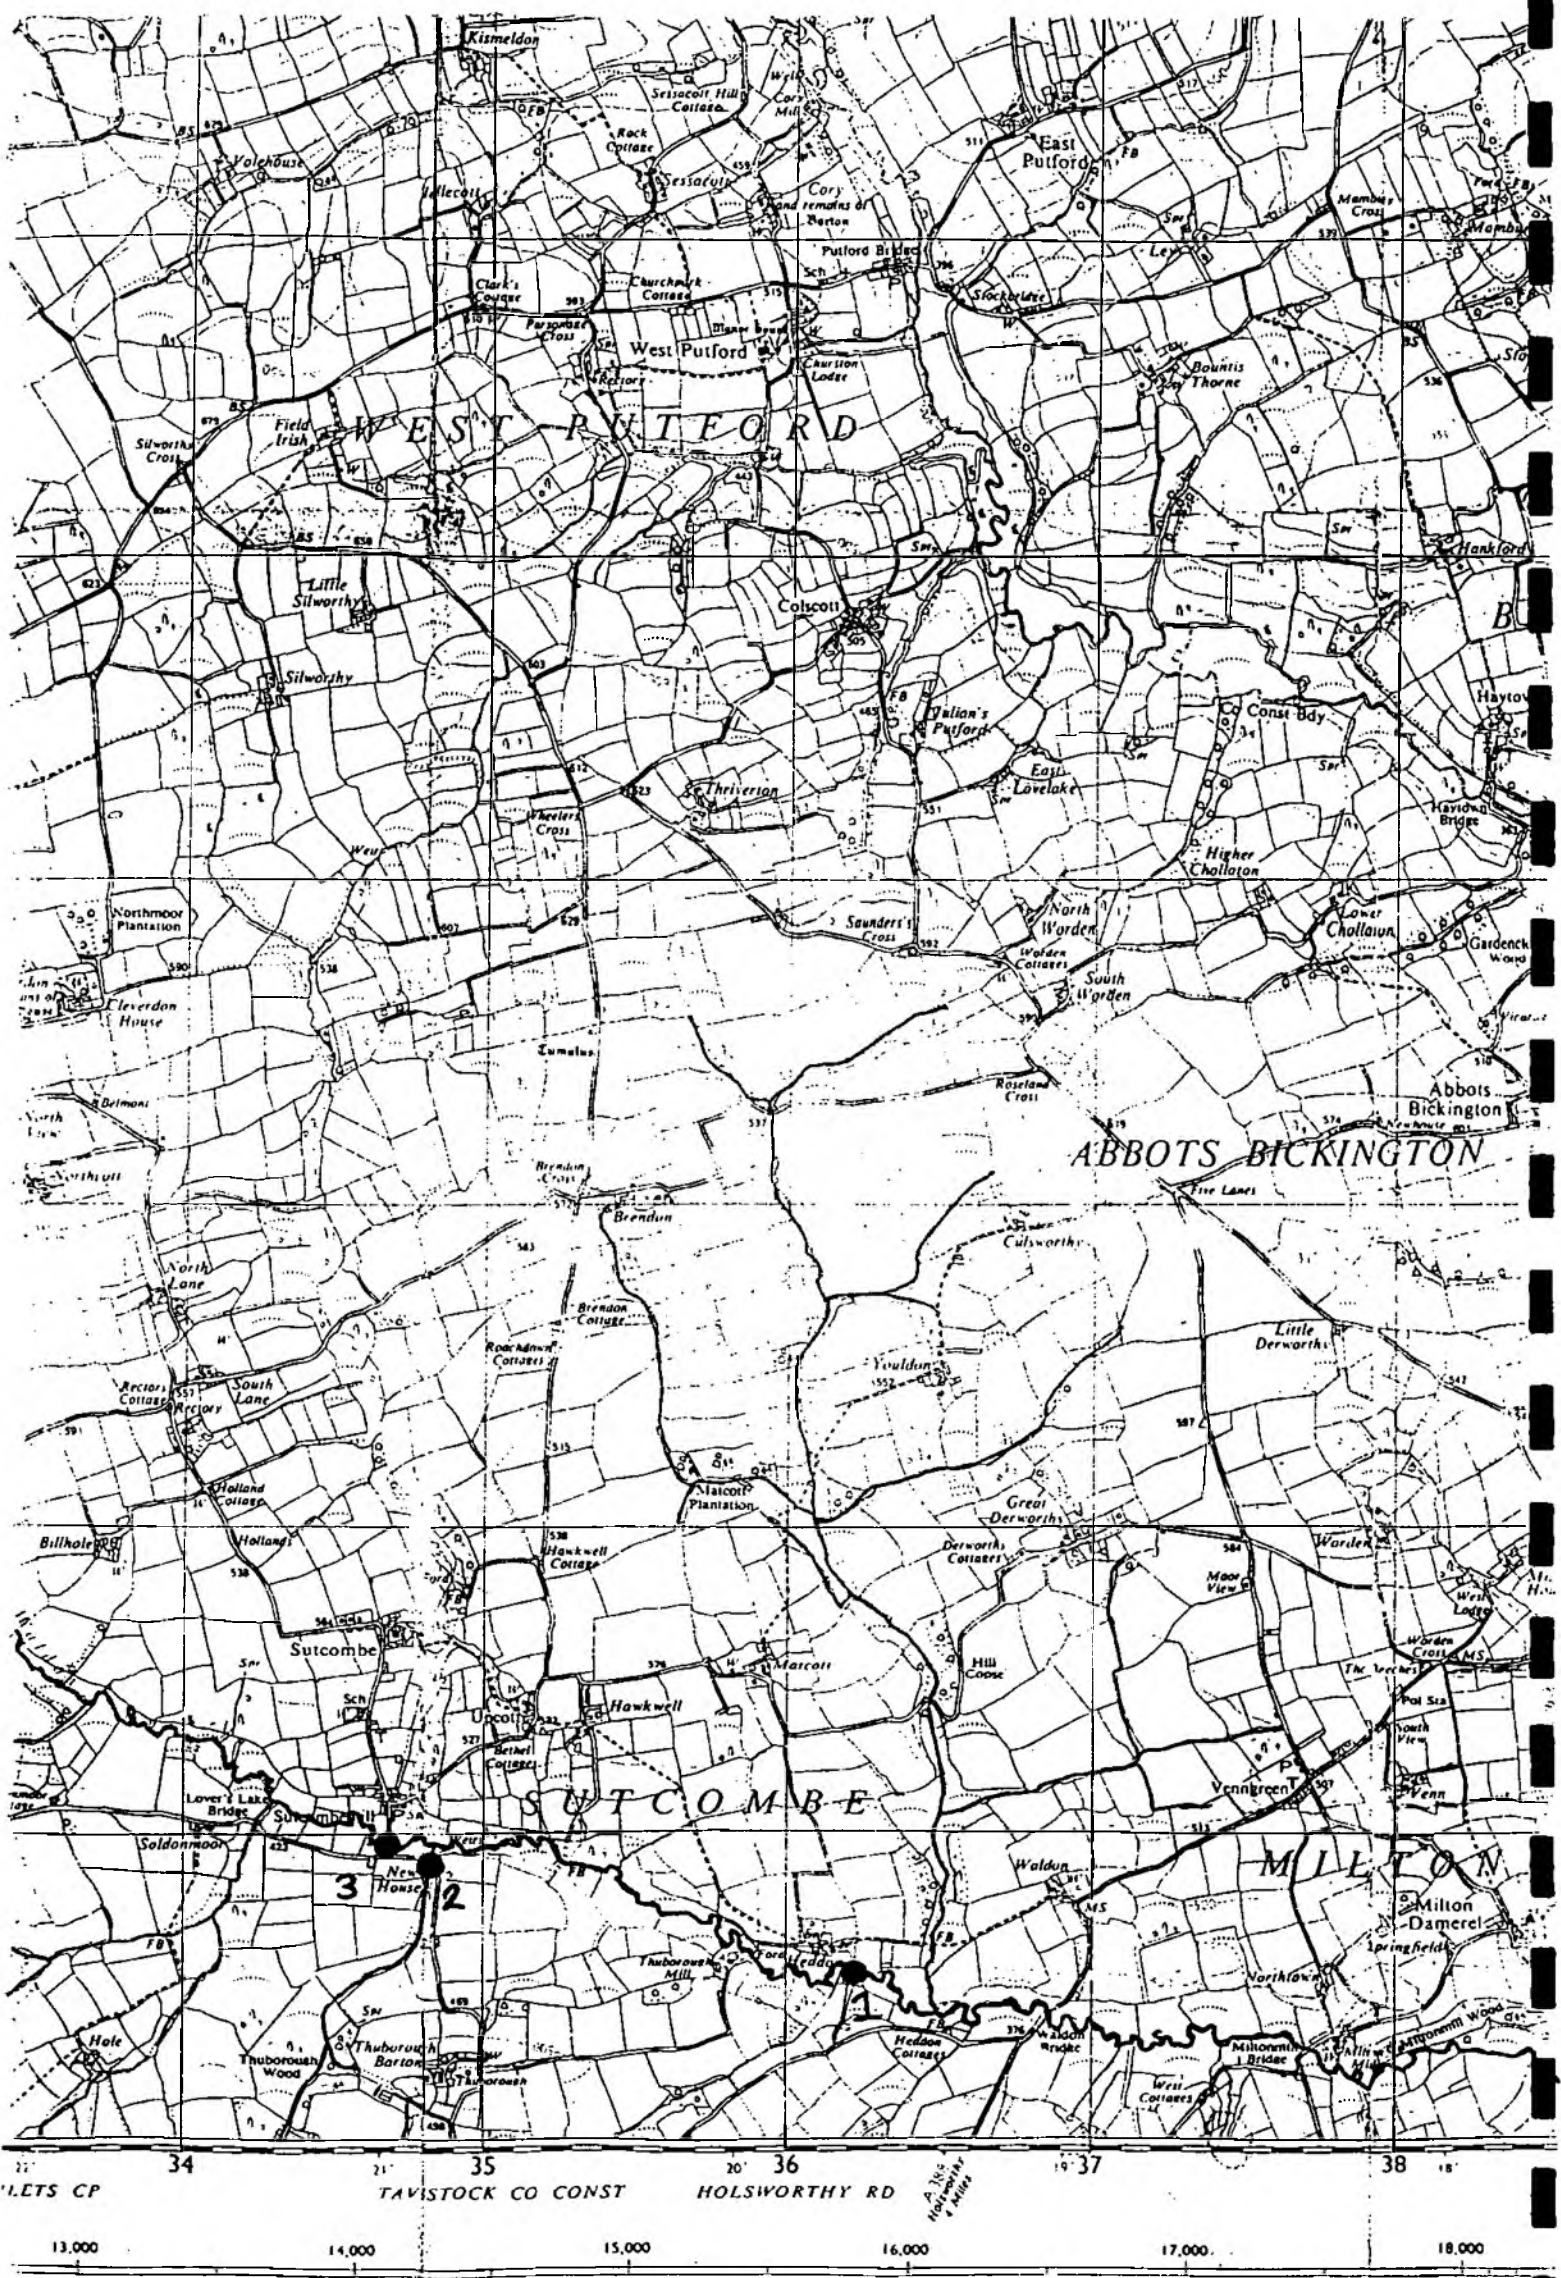
SITE	New House area		
WATERCOURSE	Tributary River Waldon		
NGR	SS 3485 1090		
EVIDENCE OF WATER QUALITY PROBLEM			
Chemical samples taken as part of the wet weather survey show the tributary to exceed a standard for an RE class 2 river.			
25 March 1996		*	**
Site Description	Site No.	TA mg/l	BOD mg/l
River Waldon D/S of Trib	1	0.11	2.8
New House Trib.	2	0.74	3.6
Sutcombe Mill U/S of Trib.(R29C030)	3	0.08	1.8
RE Class 2 standards			
*Total Ammonia (TA) = 0.60 mg/l

**BOD = 4.0 mg/l			
SOURCE OF PROBLEM			
No input was obviously identifiable during the survey as being responsible for the exceeded value. However, during the appraisal of February 1995, effluent was found flowing down the road and entering the tributary at New House Bridge. The effluent was traced back to an un-named yard at NGR SS 3482 1063. It is likely that was also the source during the wet weather survey.			
IMPLICATIONS			
The exceeded value was marginal, the impact was localised and did not result in exceedances of RE class 2 standards downstream in the River Waldon.			
RECOMMENDATIONS			
The Water Quality Officer to visit the area.			
Action - Water Quality Officer.

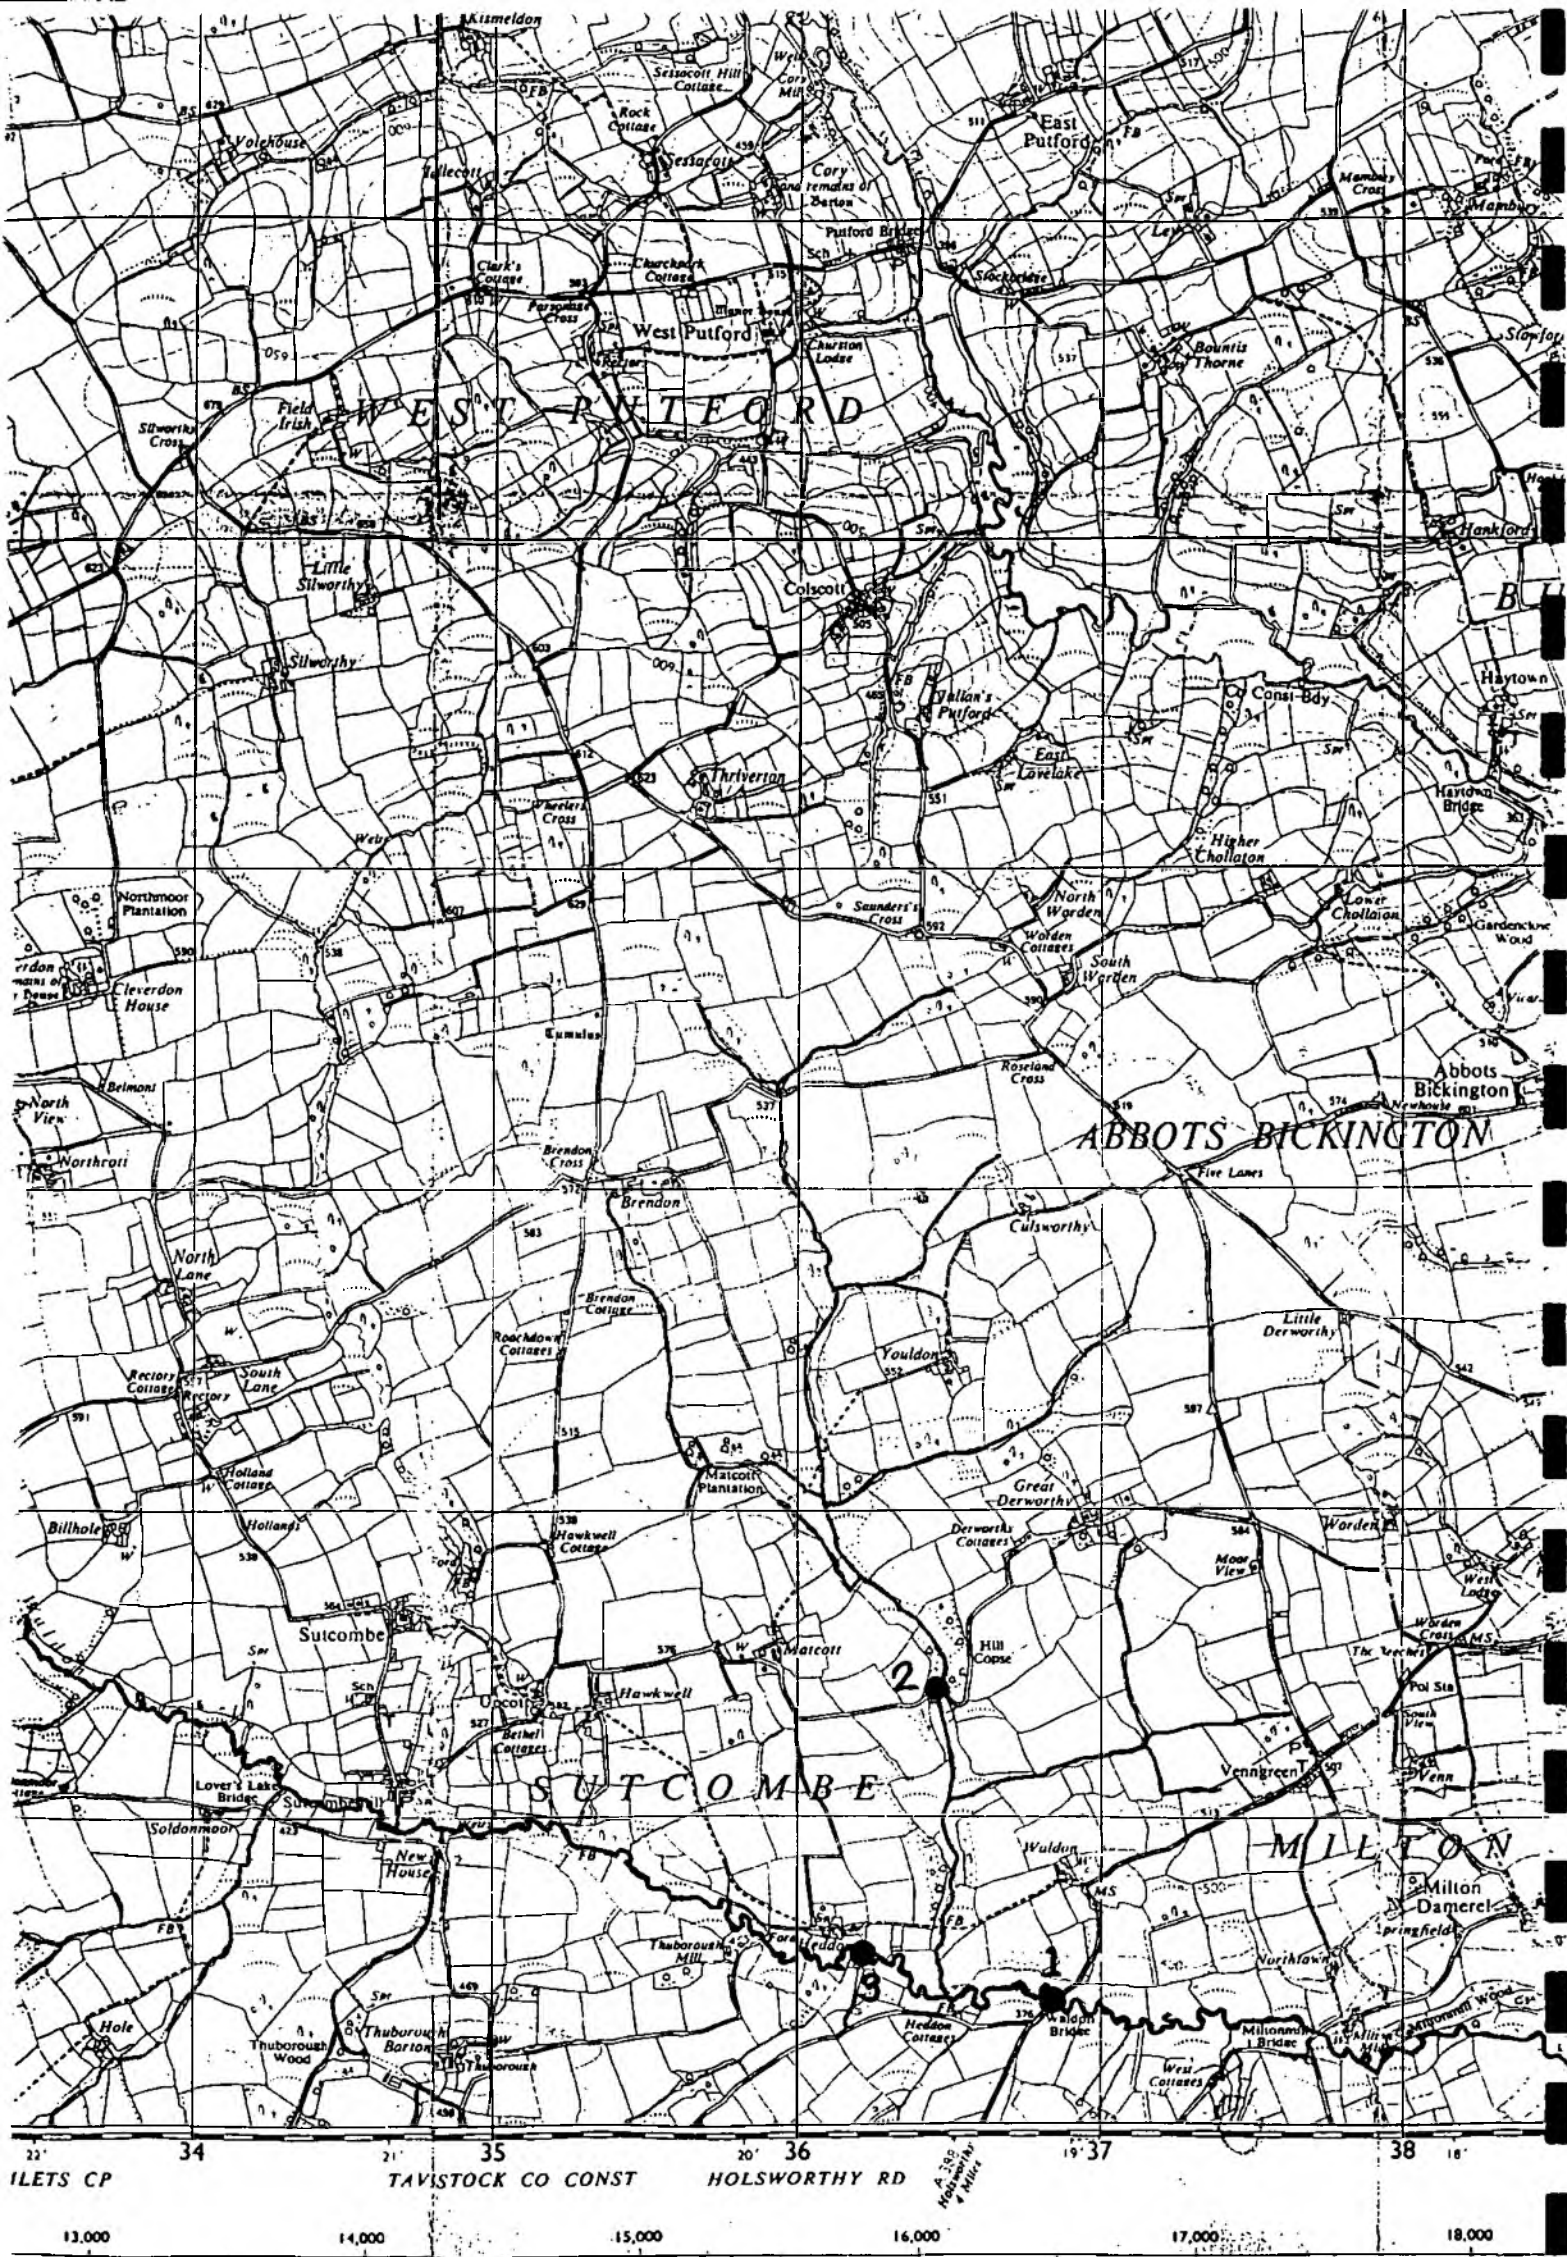
SITE	Abbots Bickington tributary		
WATERCOURSE	Tributary River Waldon		
NGR	SS 3650 1140 sample location		
EVIDENCE OF WATER QUALITY PROBLEM			
Chemical samples taken as part of the wet weather survey show the tributary to exceed a standard for an RE class 2 river.			
25 March 1996		*	**
Site Description	Site No.	TA mg/l	BOD mg/l
Waldon Bridge D/S of Trib (R29C011)	1	0.15	2.3
Abbots Bickington Trib.	2.	0.12	4.4
River Waldon U/S of Trib.	3	0.11	2.8
RE Class 2 standards			
*Total Ammonia (TA) = 0.60 mg/l

**BOD = 4.0 mg/l			
SOURCE OF PROBLEM			
This area was investigated during the previous appraisal and gave no cause for concern. The biological community was good and the total ammonia concentration (via field test kit) was very low (0.03 mg/l). As such, no further work was carried out U/S in the tributary.			
The marginal BOD exceedance indicates an U/S input to the tributary at the time of the wet weather survey and as such the area should be investigated further			
IMPLICATIONS			
The exceeded value was very marginal, the impact was localised to the tributary and did not result in exceedances of RE class 2 standards downstream at Waldon Bride (R29C011), the next RMS on the River Waldon.			
RECOMMENDATIONS			
Since the tributary was not fully covered in the earlier appraisal, further work needs to be carried out to determine areas of potential risk to the water quality.			
Action - Investigations Devon Area.

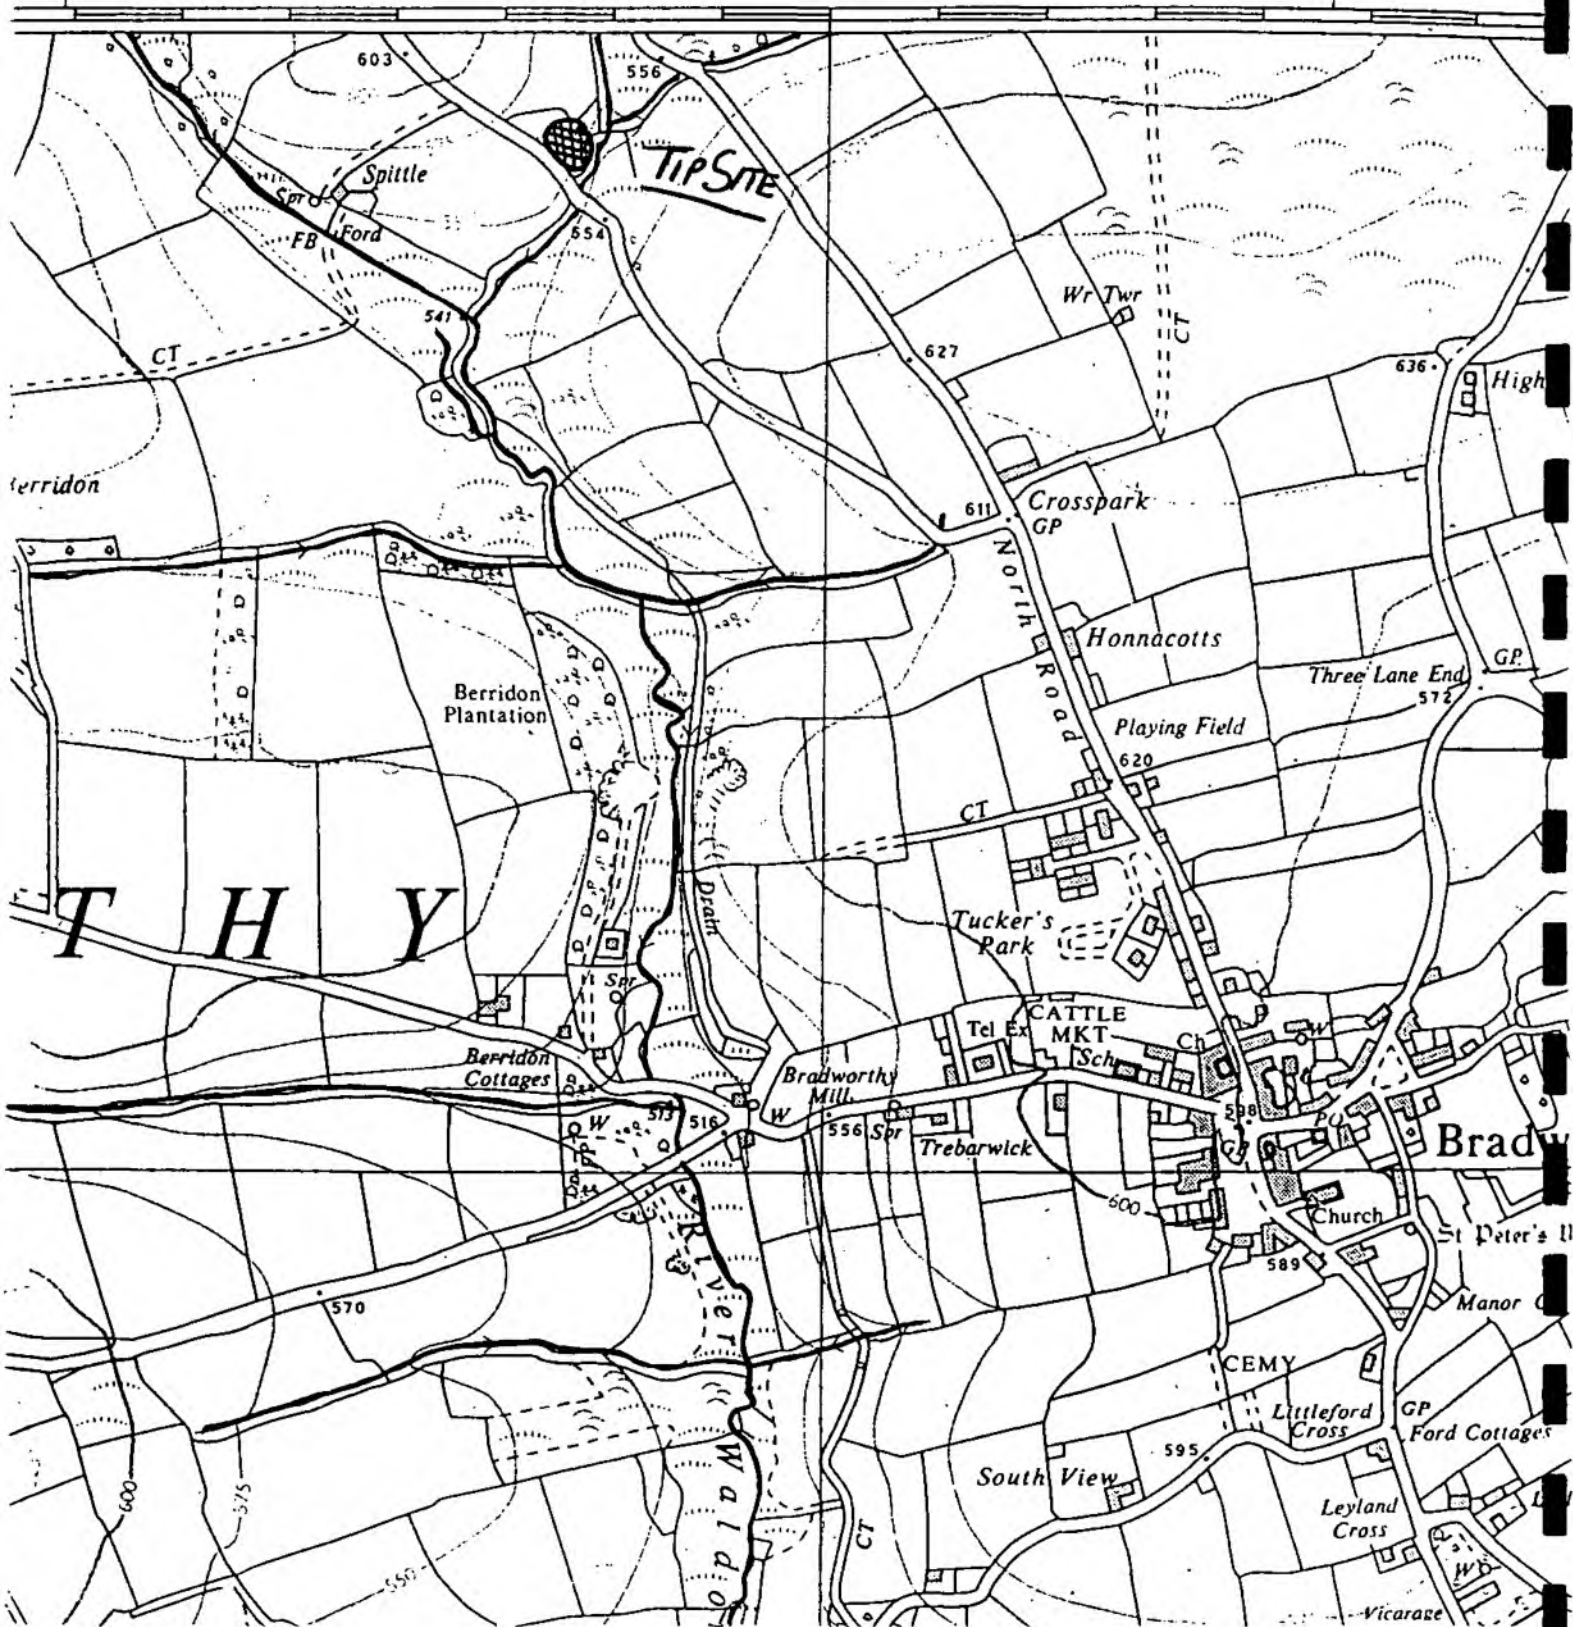
SITE	Spittle Farm area
WATERCOURSE	Tributary River Waldon
NGR	SS 3162 1490
AREA OF CONCERN	
<p>A tip site was found by the side of a tributary of the River Waldon. No chemical impact was detected at the time of the wet weather survey.</p> <p>The tip site area was large (20 by 30 meters by 4 meters high in places; all measurements approximate) and consisted of scrap metal, tyres, half buried silage bales, carpet and house-hold waste.</p>	
BACKGROUND	
<p>The Waste Regulation section has been informed but is unable to proceed due to restraints of the current waste legislation.</p> <p>The owner of the land insists the waste is his own agricultural waste and as such does not require a site licence. An explanation of the domestic refuse is that it is a temporary storage area so as to prevent damage to the bags by dogs if it were placed by the road side for collection. He also insists the site has been used historically as a tip for the village for some 20 years.</p>

IMPLICATIONS	
<p>It is possible that this waste could present a hazard to the water quality of the tributary in the future from contamination via debris or subsequent leachate (nature of buried material as yet unknown). As such the Water Quality Officer should visit the site and determine what remedial action needs to be taken.</p> <p>Action - Water Quality Officer.</p>
