NRA Water Quality 34

Dioxins and the River Doe Lea

Plain English Report

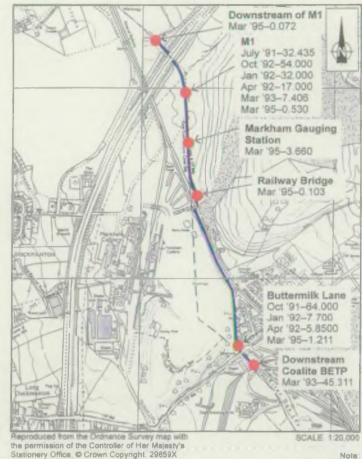
As work on the project got under way, further samples were taken concentrating on the stretch of river between Buttermilk Bridge and the M1. The results showed a great reduction from previous levels and were as follows:-

Note All results in I-TEQ All samples in March '95 < 2mm particle size

Samples taken in 1995	Location ng/kg	iTEQ ng/kg
1 March '95	Stainsby Mill	3
2 March '95	Glapwell	11
3 March '95	Upstream of Buttermilk Lane	18
4 March '95	Buttermilk Lane	1211
5 March '95	Railway Bridge	103
6 March '95	Markham Weir	3660
7 March '95	Upstream of M1	529
8 March '95	Downstream of M1	72
9 March '95	Mastin Moor	467

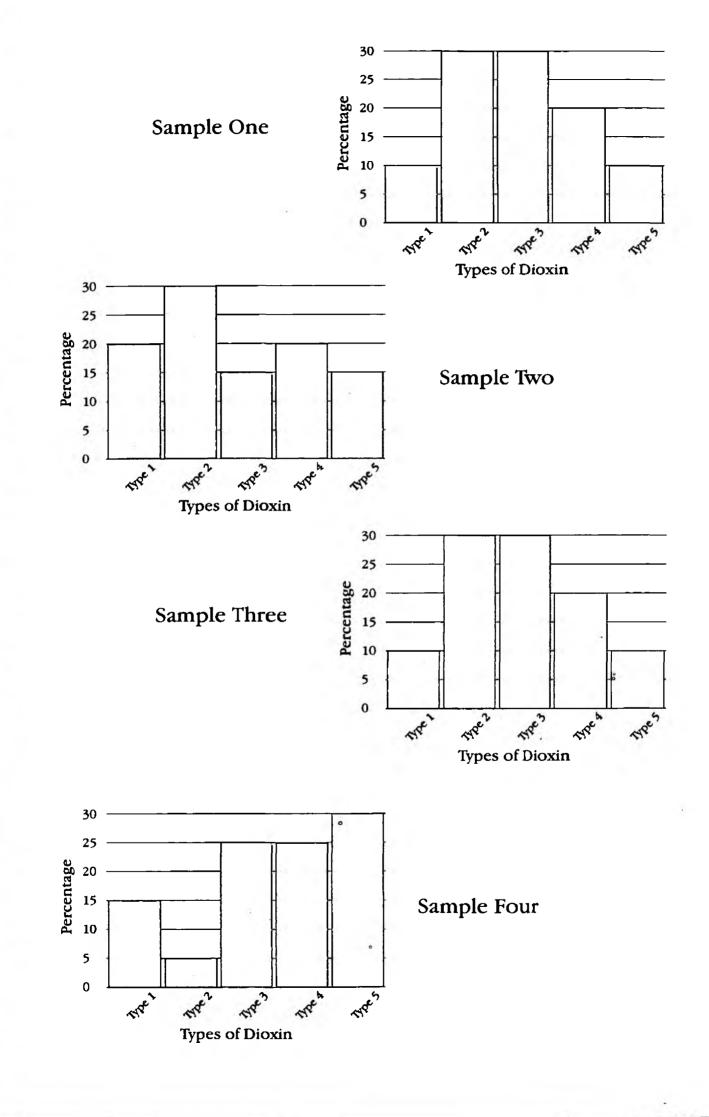
Showing these figures as bar charts demonstrates which are from the same source and which are not.

The bar charts for these examples (which are not from real life) are on the next page.

Samples 1 and 3 have the same congener profile and will come from the same source.

Other samples have similar proportions of individual dioxins but do not match completely (eg Samples 1 & 2 for dioxin types 2 & 4). They will not come from the same source.
