Environmental Protection Report

RIVER TAW – HABITAT REHABILITATION 1992

March 1993
Fisheries Section

ENVIRONMENTAL IMPROVEMENT WORKS - RIVER TAW CATCHMENT - 1992

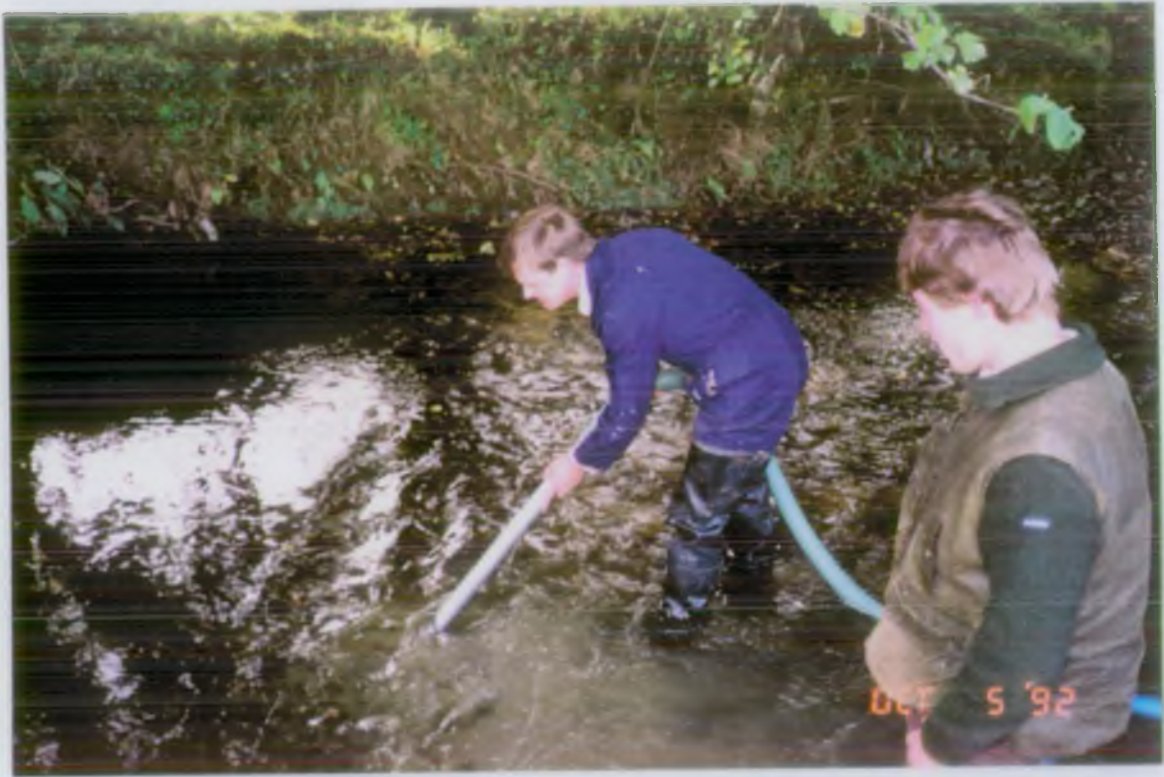
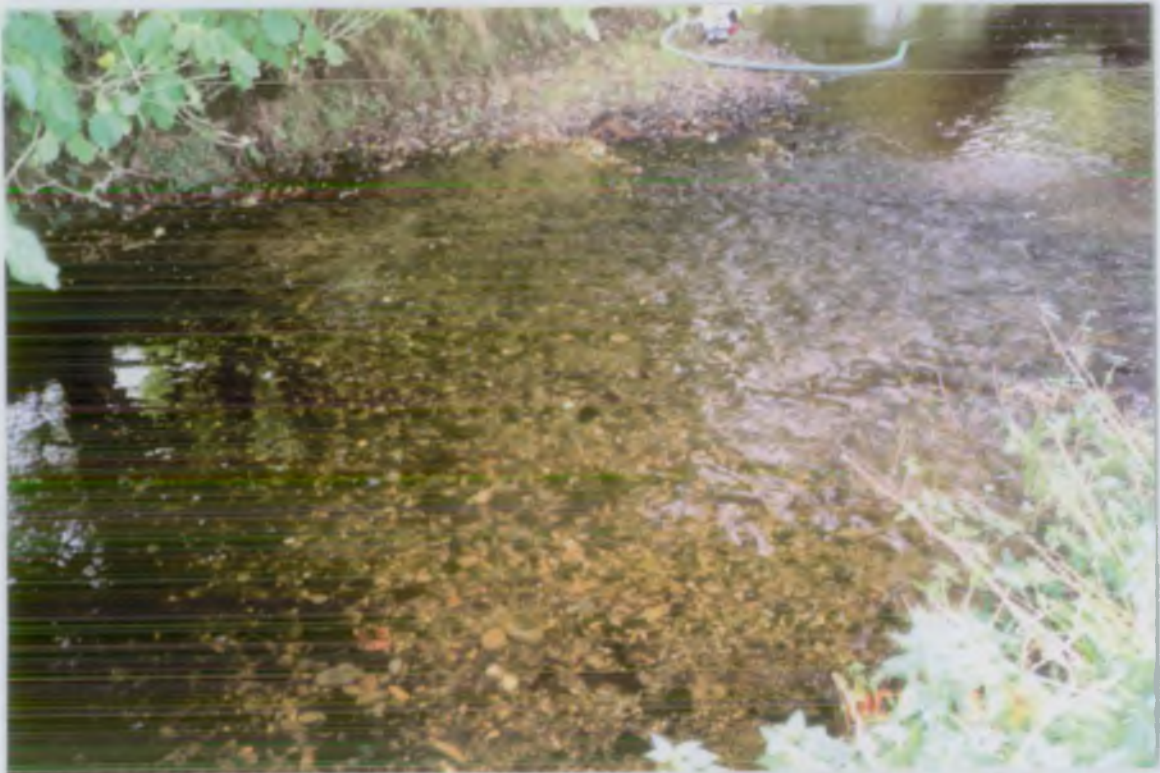
JULY 1992

Trash dam clearance was carried out in the Crooked Oak during July, in the same section of river where gravel improvements were later undertaken (See Plate 3). Some trash was removed here during October when the gravel work was underway. The work was done by Warden Bickley and colleagues.

TRASH DAM CLEARANCE

CROOKED OAK RIVER BISHOPS NYMPTON

WARDENS BICKLEY / BOYD

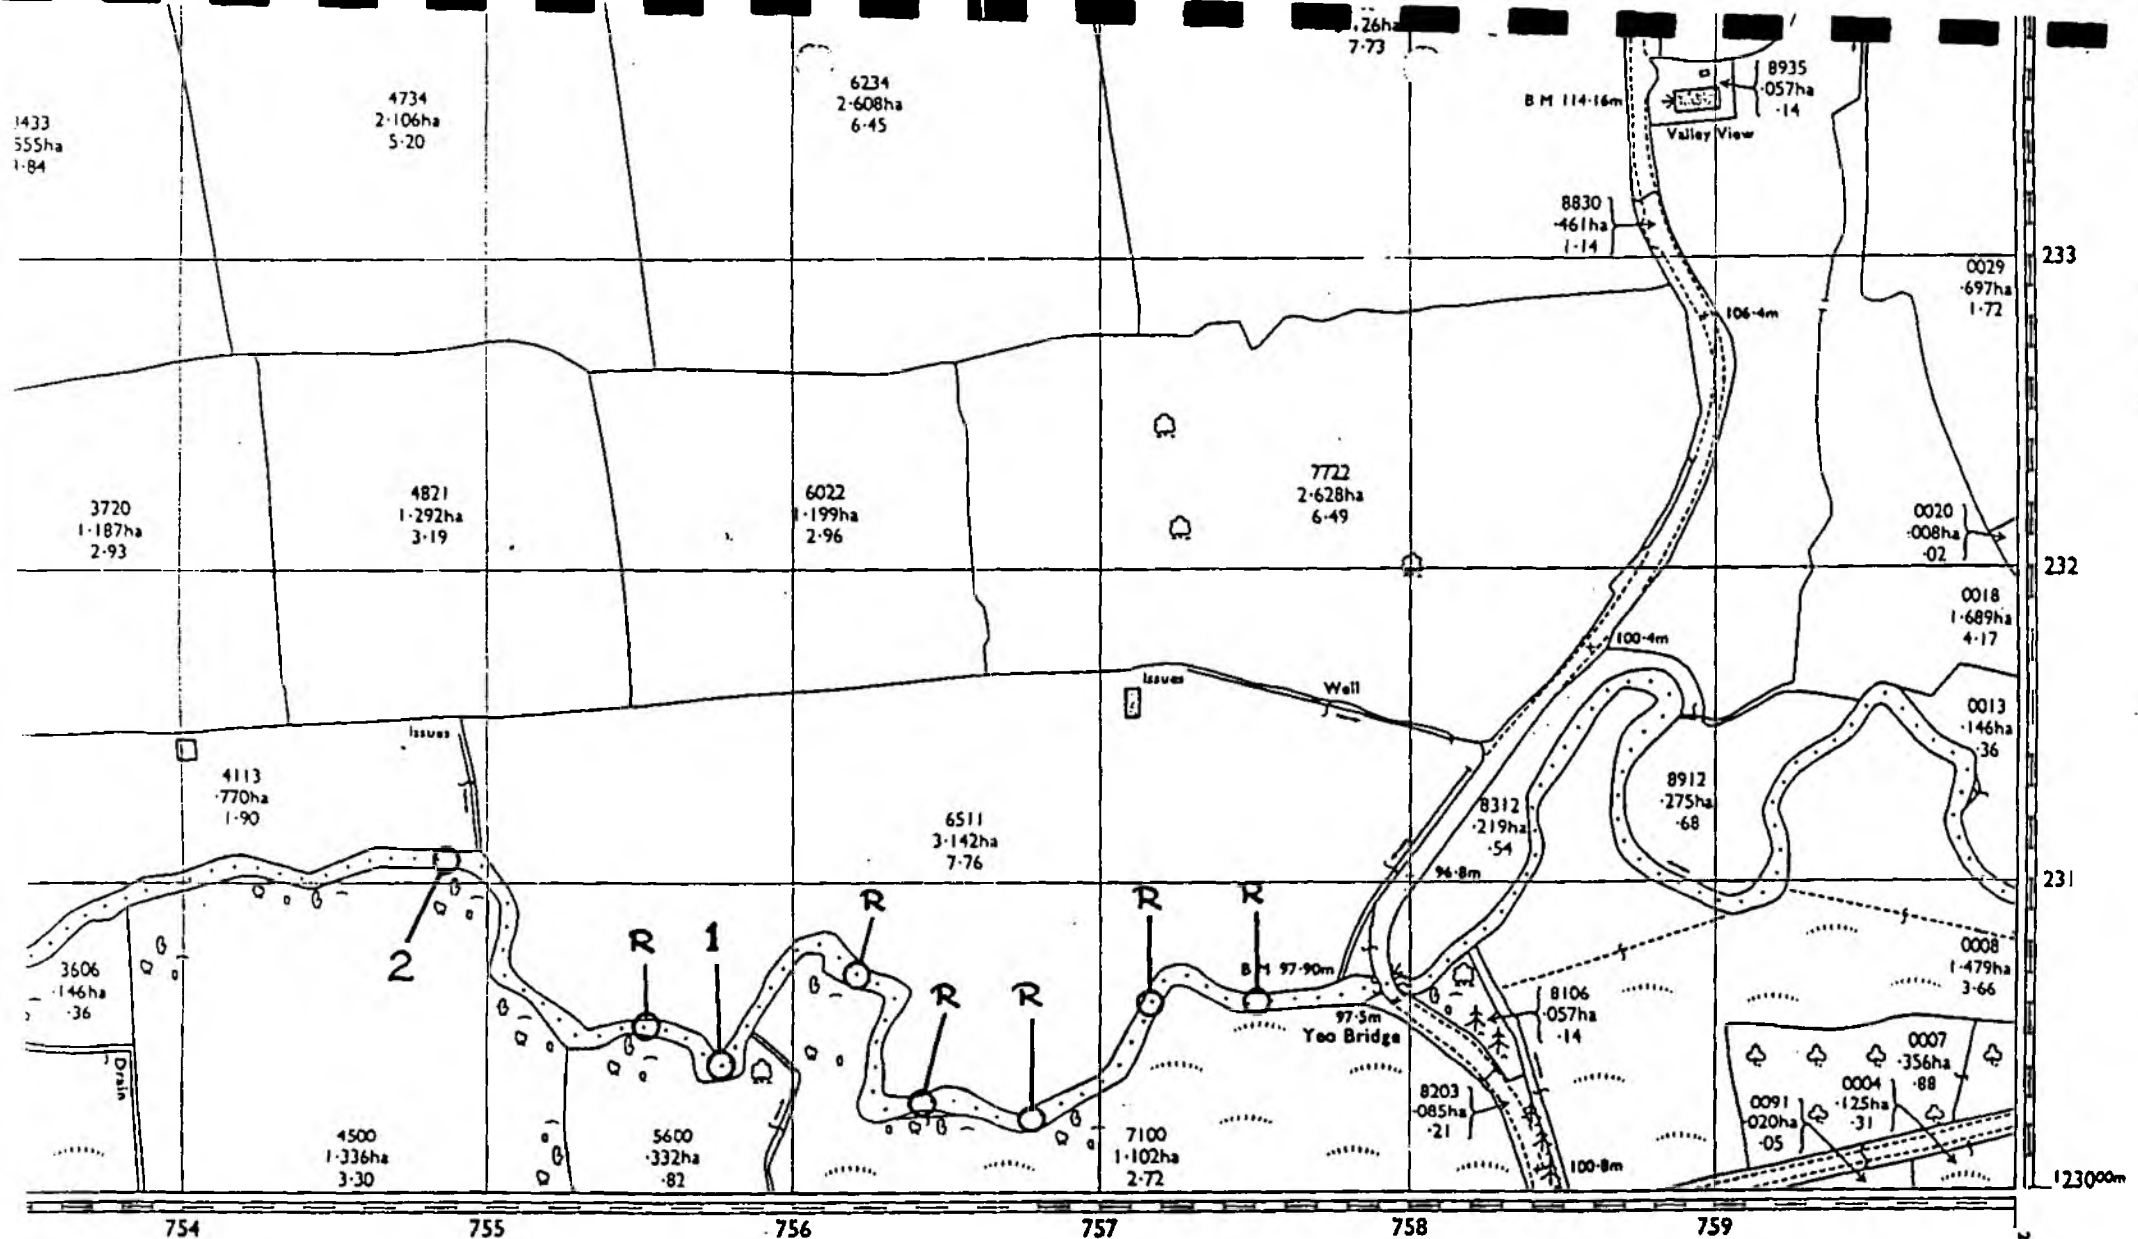
CROOKED OAK — NR. BISHOPS NYMPTON PAGE 1

In the Bishops Nympton area the following actions were identified and approved. Numbers relate to the attached map. In addition, riffles marked R on the plan were selected for gravel rehabilitation.

1. Large ash across river. Cut off flush with left bank and remove section from channel.
2. Trim back small bush catching trash.
3. Large shoal to be broken up and redistributed. Access exists via ramp/cattle drink. Some light tree trimming required if plant to be used.
4. Remove small, dead alder.
5. Large trash dam. Break up and remove material to form stick pile on left bank.
6. Remove small stump
7. Trim overhanging trees lightly and cut off old stump.
8. Trim dead branches.
9. Remove trash and coppice overhanging willows.
10. Remove loose trash from channel.
11. Remove stumps and coppice willow.
12. Remove trash.
13. Cut alder stump back hard.
14. Cut back branches and remove.
15. Remove debris and coppice willow.
