protecting Clevedon

Tidal defences for Clevedon,
North Somerset

This leaflet describes our work on the Land Yeo outfall and Marshall's Bank, carried out in 2005/2006, and the Blind Yeo sluice, carried out in 2004.

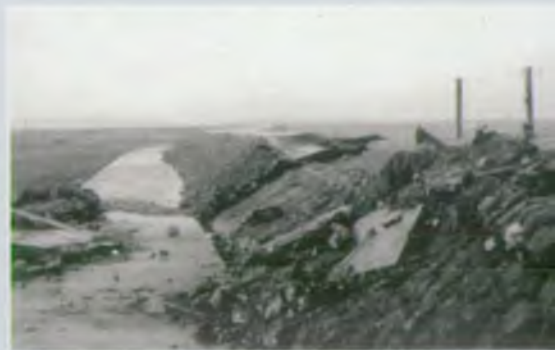
Damage to the western end of Clevedon sea wall following the storm of December 1981

The most recent flooding happened in December 1981, when a large surge on a modest spring tide flooded 305 properties and land up to two kilometres from the sea. Since that time many hundreds of properties have been built in the tidal floodplain.

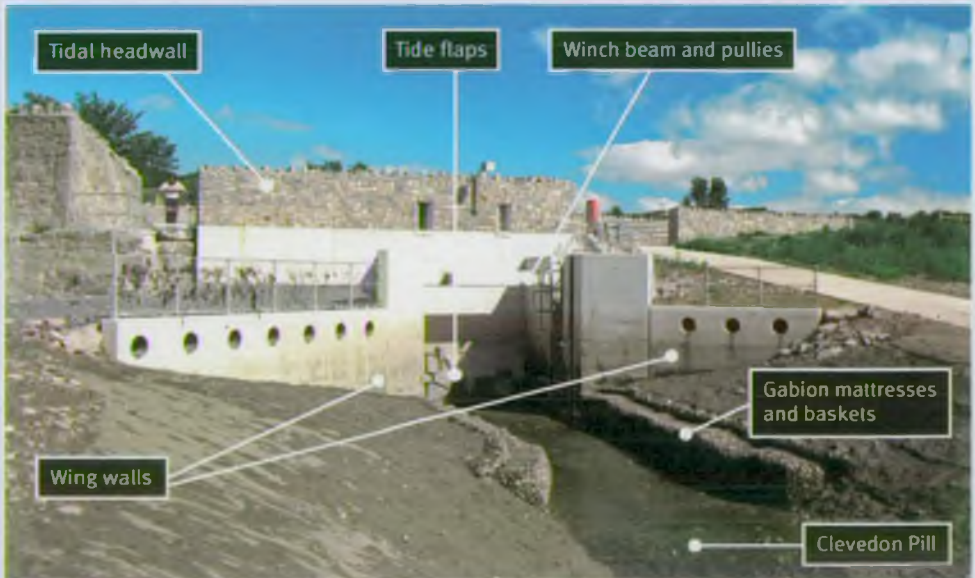
Tidal outfall structure

At the **Land Yeo outfall** we installed:

- tide flaps that prevent tidal flooding of the Land Yeo and Clevedon, but allow the river to discharge once the tide has receded
- powered automatic sluice gate (penstock) in case the tide flaps should block or fail
- a tilting weir to maintain water levels in the Land Yeo through Clevedon. This can be lowered to allow high river flows through the outfall
- water level monitoring equipment to allow automatic and remote control of the sluice gate (penstock) and tilting weir
- a trash screen to collect debris and prevent blockages to the new equipment
- vehicular and pedestrian access for maintenance purposes.

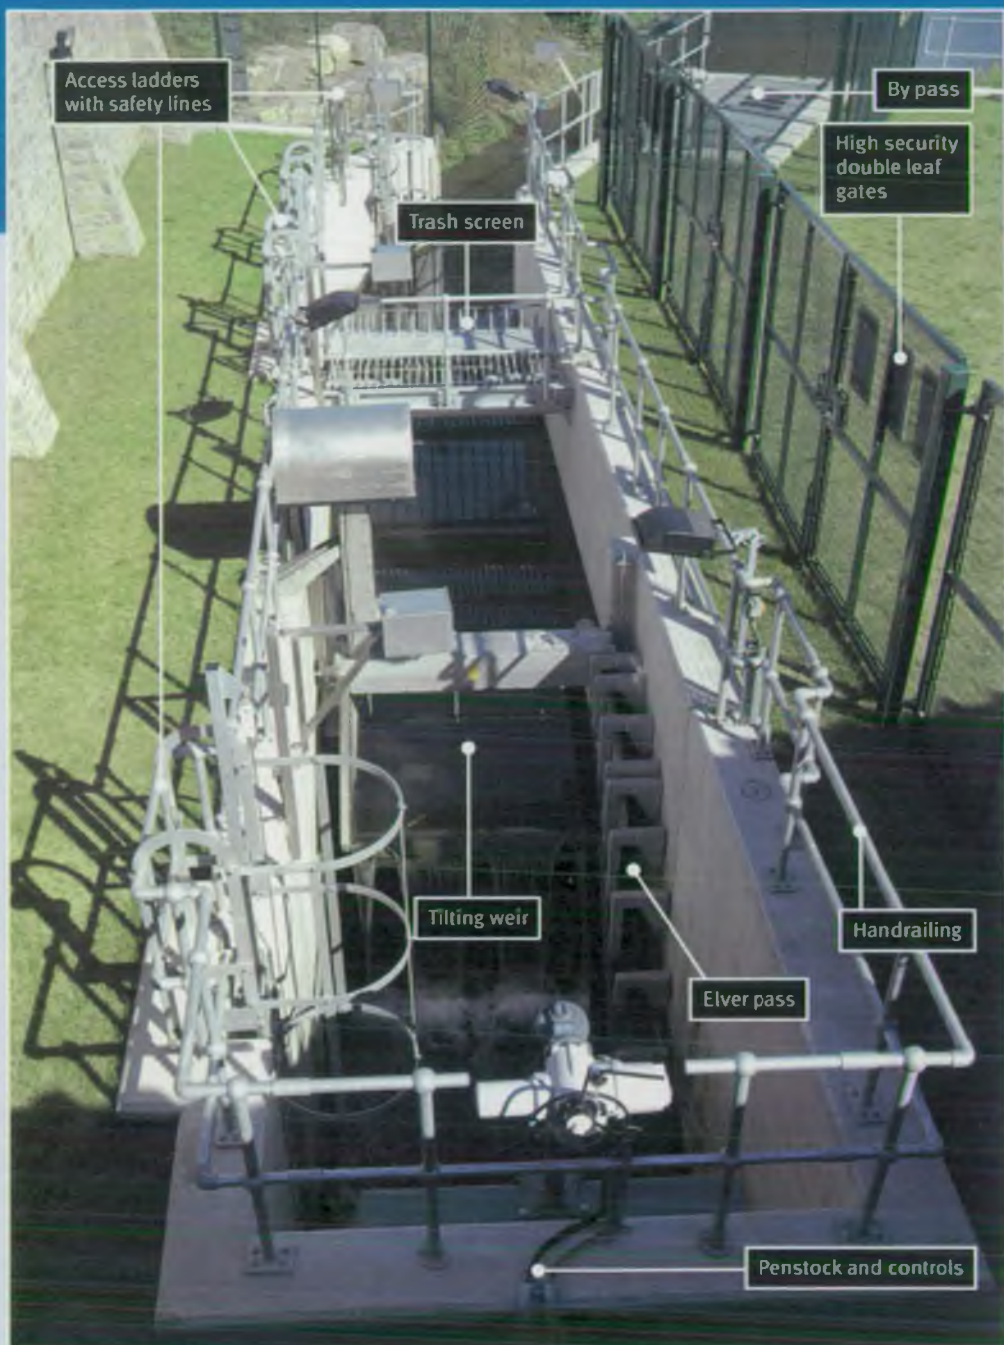
Access ladders
with safety lines

Trash screen

By pass

High security
double leaf
gates

Tilting weir

Handrailing

Elver pass

Penstock and controls

Downstream view of river intake structure

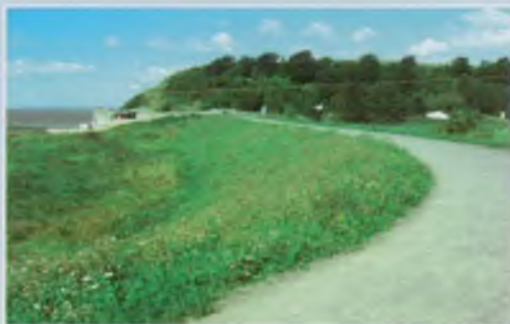
A footpath runs along the crest of Marshall's Bank

- raised 500 metres of the bank and surfaced its crest in crushed stone to minimise erosion and make a new footpath
- provided vehicular and pedestrian access for maintenance purposes
- provided an access ramp - suitable for disabled access - onto the bank and into Marshall's Field.

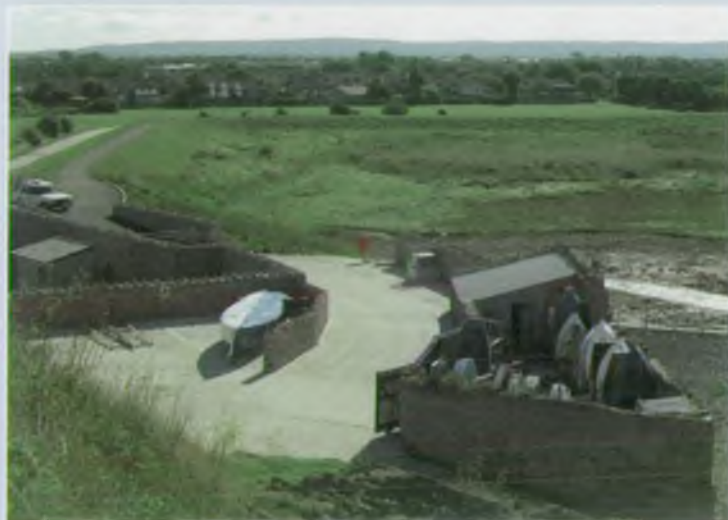
Local limestone was used to match existing boat store

Floodwalls were constructed around the outfall and linked with the higher ground at Wain's Hill to the west and Marshall's Bank to the east. The new walls were raised and faced with natural limestone and cock and hen coping to match the nearby boat store.

Where possible local materials were used in construction - hence local limestone was used around the Land Yeo outfall to match the local boat store. Numerous trees and shrubs were planted.

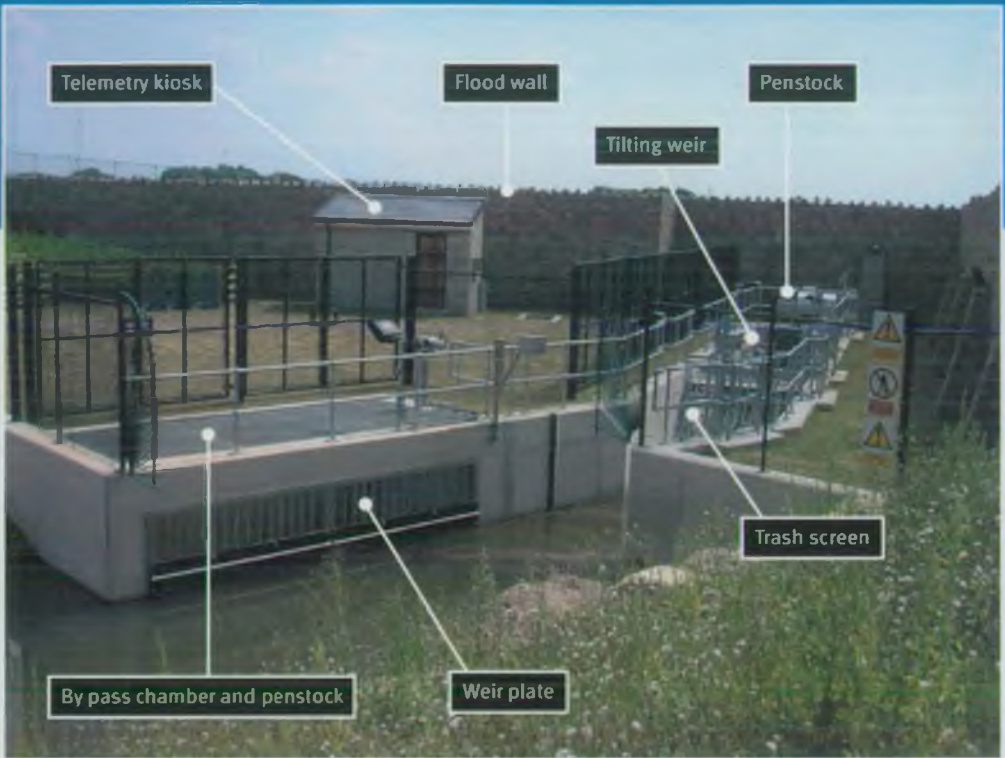
Land Yeo river intake structure
