**ENVIRONMENT
AGENCY**

**WATER QUALITY SECTION
CORNWALL AREA**

**RIVER TAMAR
ANNEX 1A INVESTIGATION**

COR/96/010

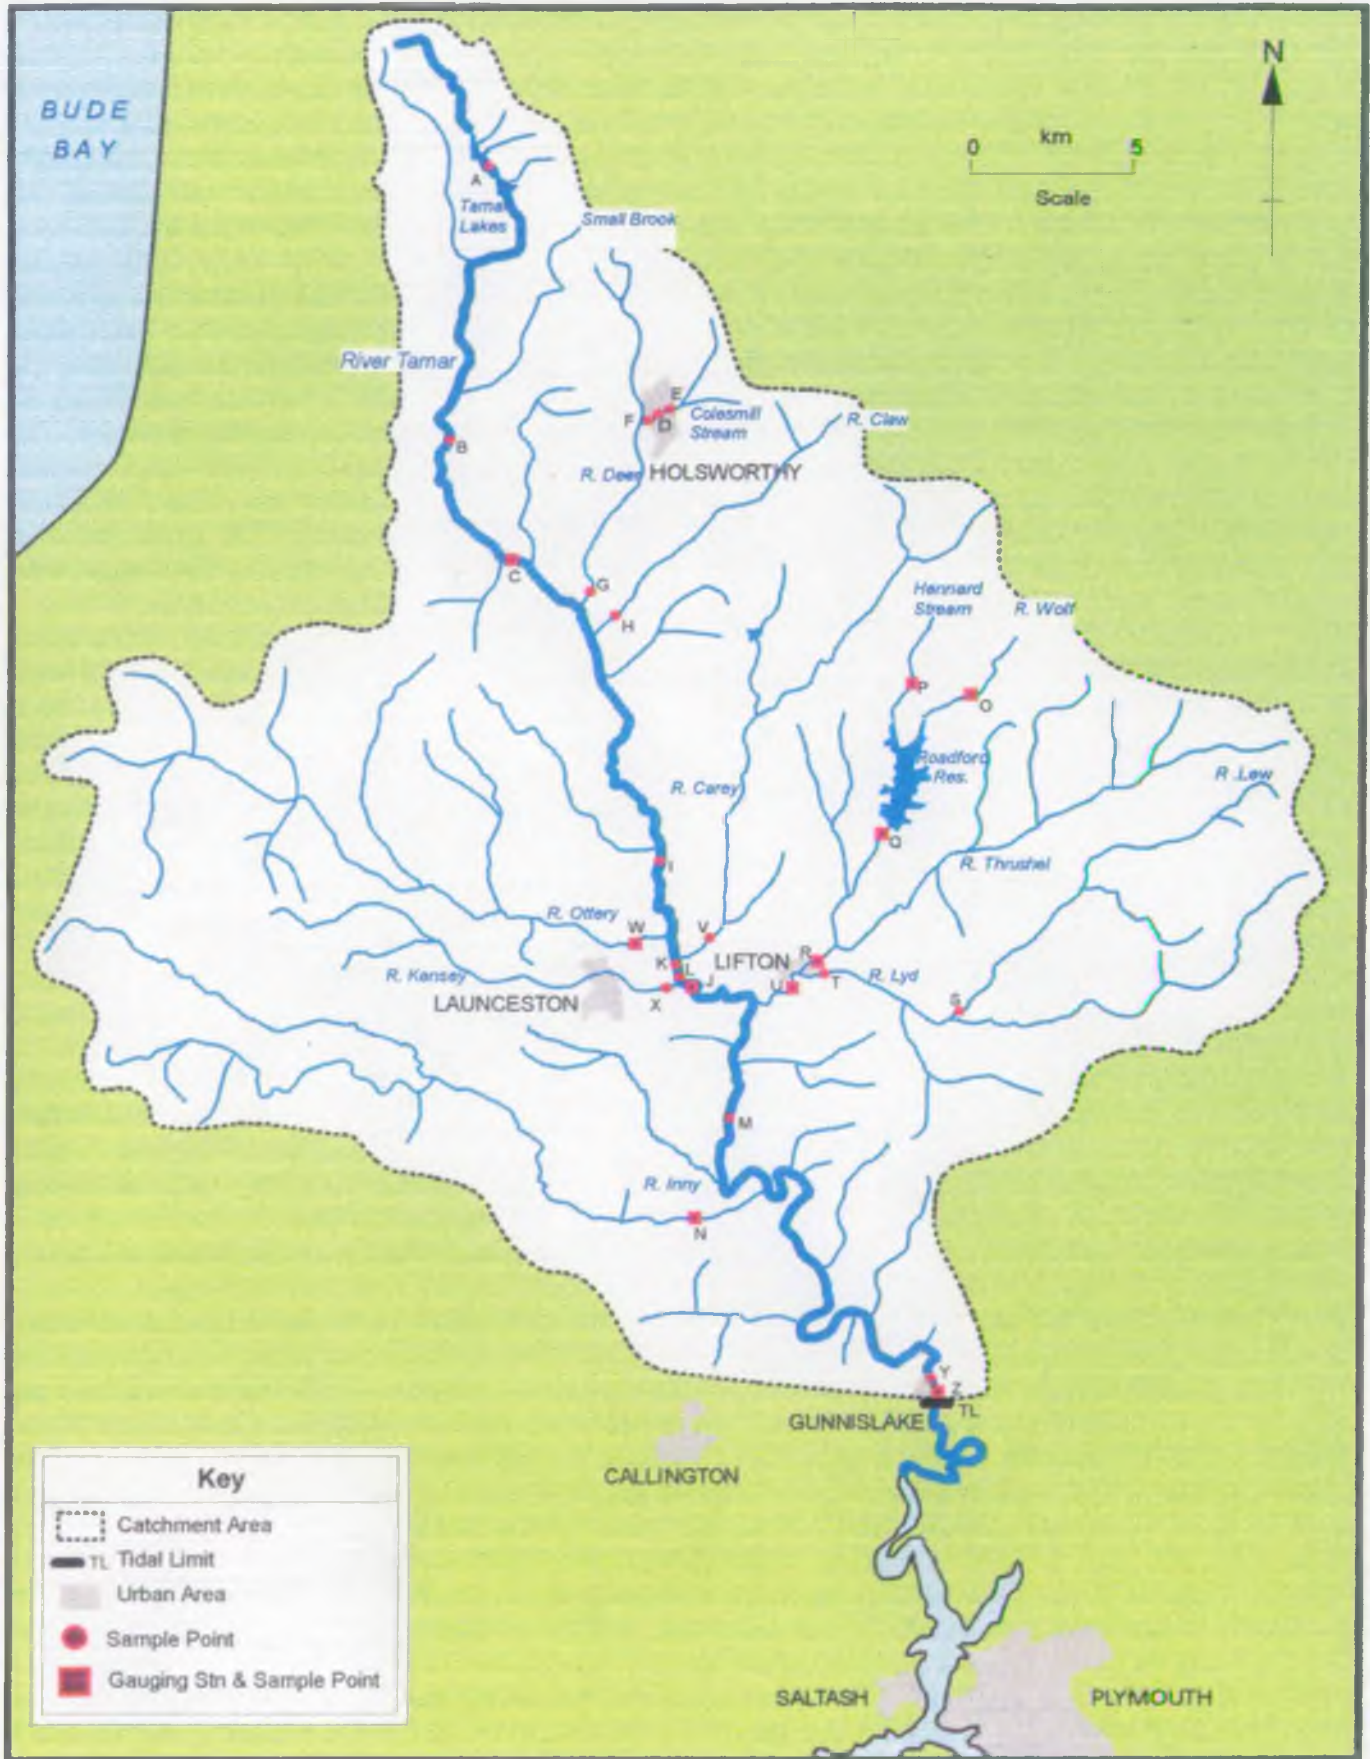
Figure 1 - Freshwater Tamar Catchment

Sampling sites and gauging stations are shown in figure 1. Summaries of the four chemical surveys conducted are shown in Tables 1 to 4. Where gaps are present in the tables, concentrations were below detection limits. Results from the two samples taken from farm dirty water systems are shown in appendix 1 and 2.

Since 1991 loadings of Annex 1A substances have been detected in the River Tamar at the harmonised monitoring site at Gunnislake Bridge (R12E003). The routine monitoring data shows there are sources throughout the Tamar catchment. Holsworthy (Derriton) Sewage Treatment Works (STW) and Launceston (St.Leonards) STW are known to be point sources but in low concentrations. Figure 1 shows the River Tamar freshwater catchment identifying the Gunnislake Bridge site, STW's, the sampling points and gauging stations used in the investigation.
