ENVIRONMENT AGENCY

Local Flood Defence Committee

Annual Inspection

26 June 1998

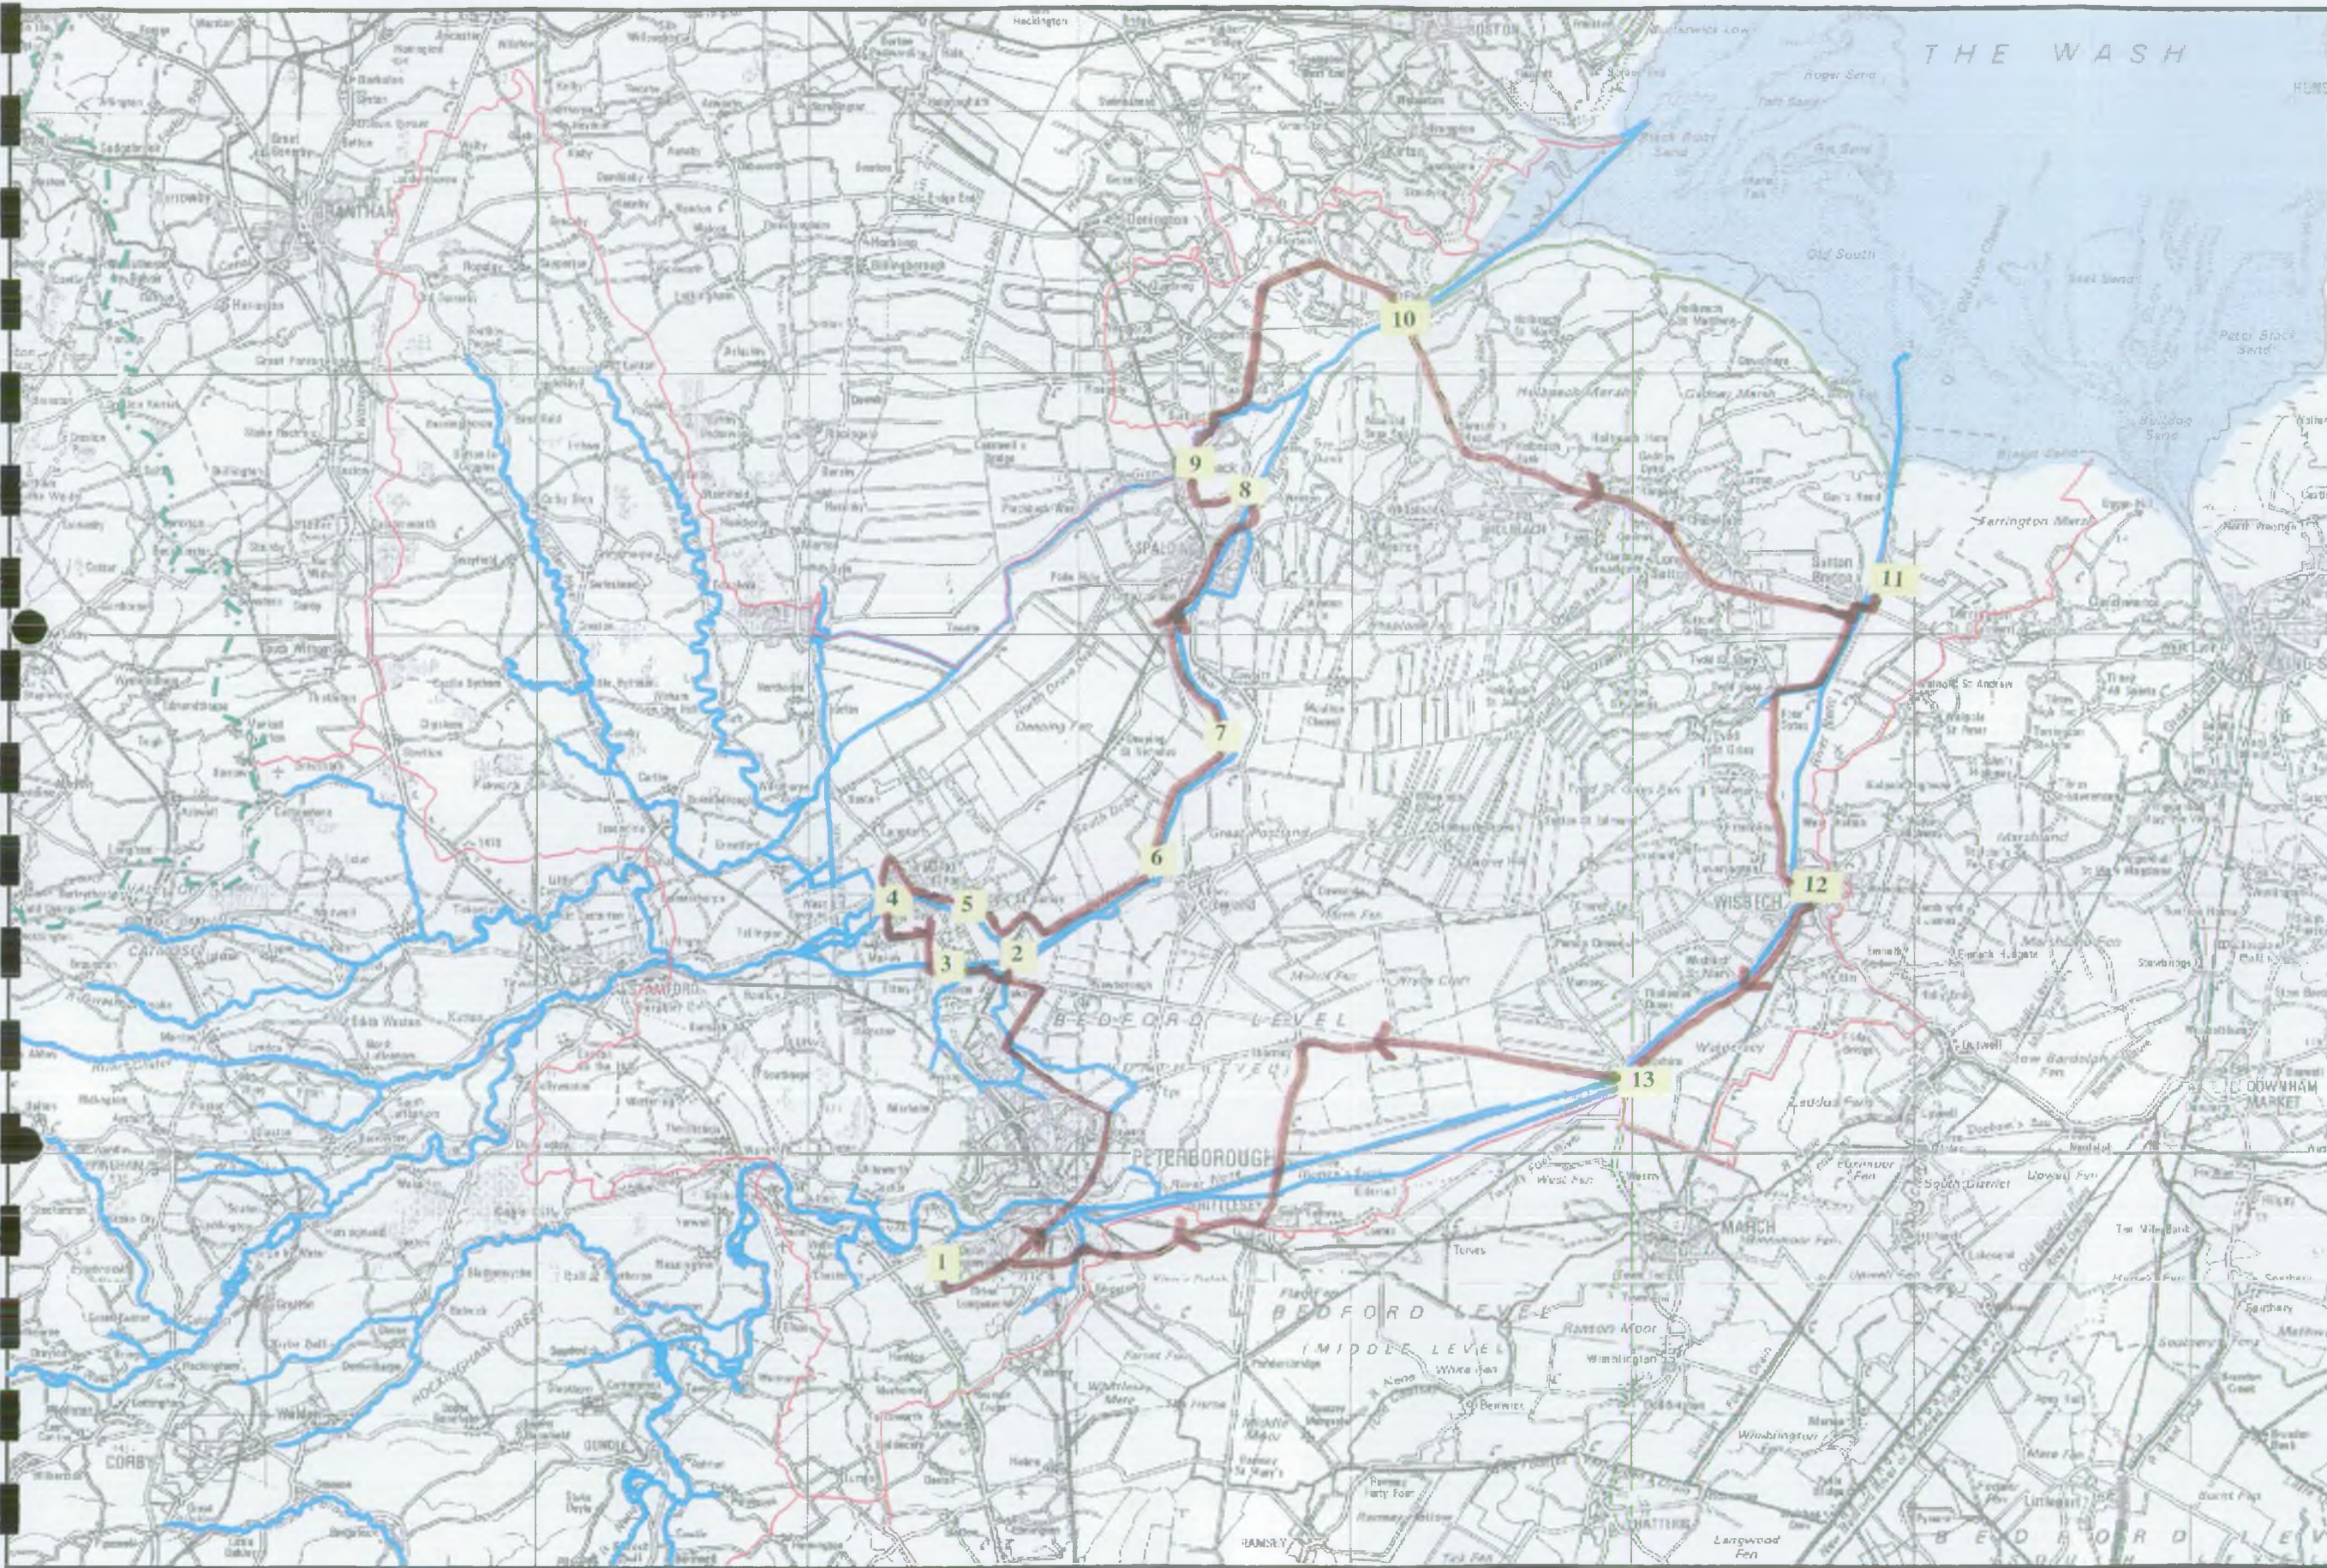
FIG 1

WELLAND AND NENE LFDIC INSPECTION ROUTE

The route plan is shown on fig.1.

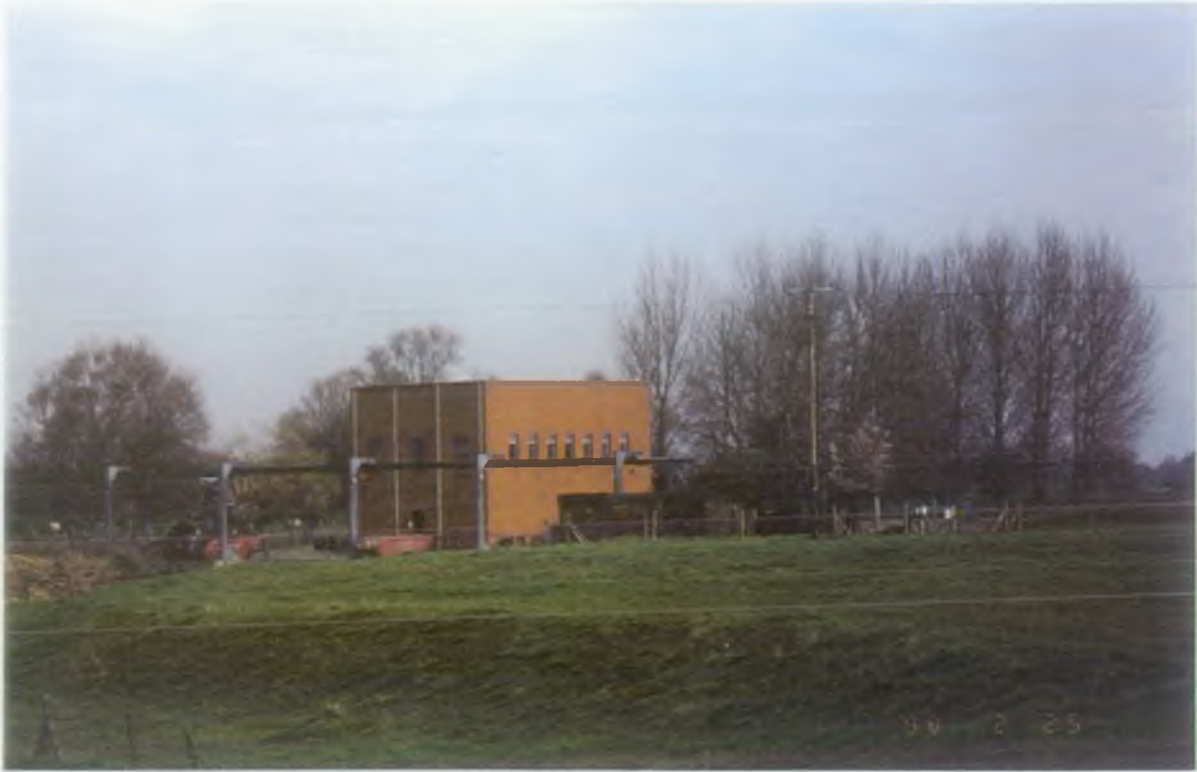
Figure. 2b : Peakirk Pumping Station

Peakirk pumping station was constructed in 1973 as part of a major Folley River/Brook Drain improvement scheme. It is the outfall structure for the Peterborough Brooks. These brooks convey the drainage from the northern part of Peterborough and surrounding villages. The pumping station discharges into the Wide Welland just downstream of the Maxey Cut outfall. Three diesel pumps were added to the existing three electric pumps in 1985 to provide a combined discharge capacity of 9 cumecs. The electric pumps are started automatically as the upstream level rises, the diesel pumps are manually operated in high flow conditions.

An automatic weedscreen cleaner was installed in 1992 to attain more effective removal of weed and other blockages in front of the weedscreen. The operation of the pumping station and possible improvement of the weedscreen cleaning process is currently being considered as part of the ongoing Peterborough Brooks improvement feasibility study. This study covers all main river within the catchment of Peakirk pumping station. The study includes the development of a hydraulic model to appraise the performance of the system under pre-set flow conditions and the need for improvement works. The preliminary report is due this summer.

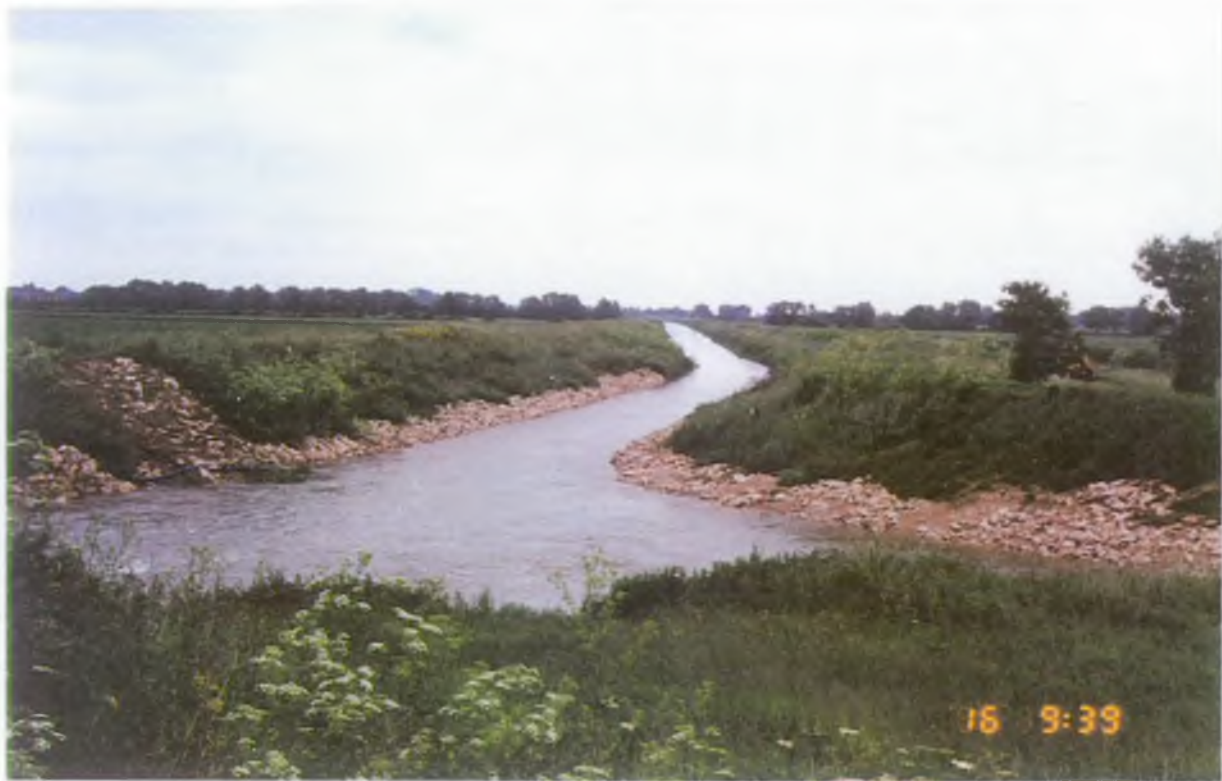
Figure. 3 : Maxey Cut Stoning Works, Downstream Of Nine Bridges.

In the mid 1980's a major capital scheme was carried out to stabilize the banks from Tallington to Nine Bridges with enkamat. The unprotected length between Nine Bridges and Peakirk are still affected by erosion. During May and June this year, repairs to 500 metres of erosion damage was carried out using machine placed stone at the toe of the banks between Nine Bridges and the outfall (see fig. 3).

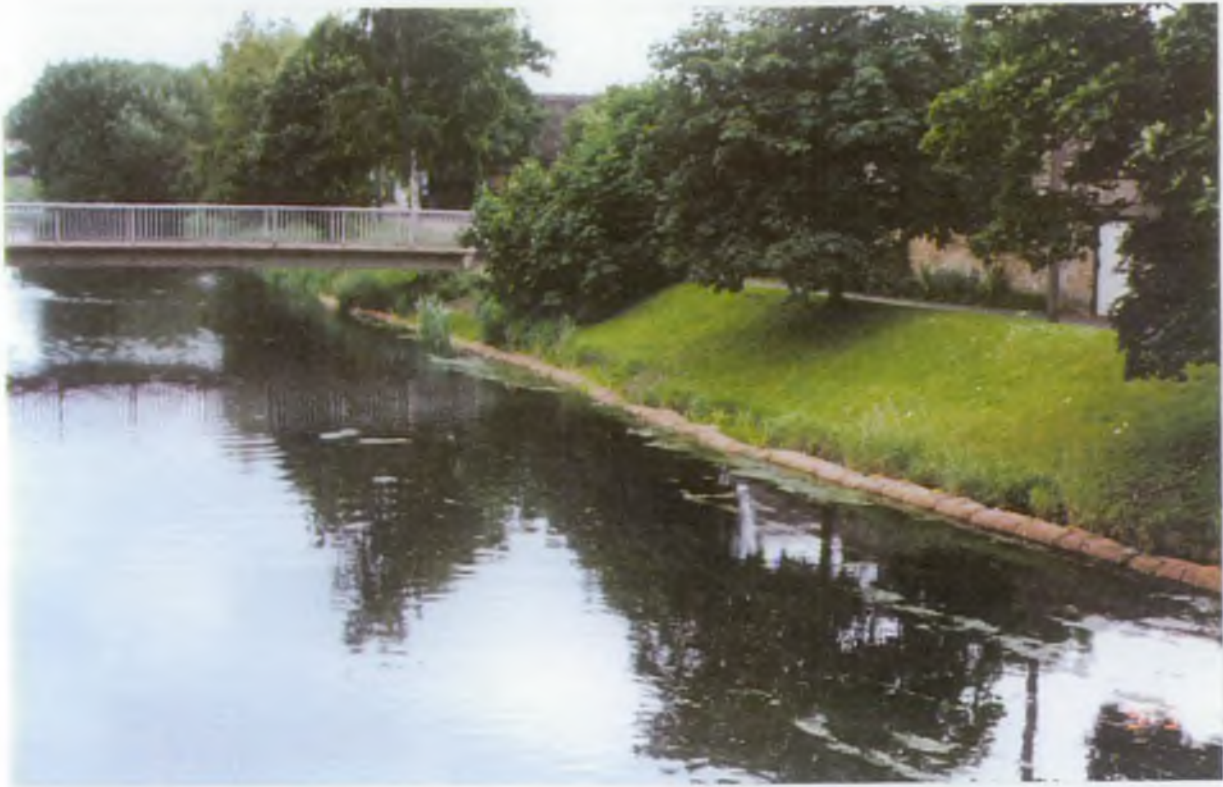
Figure. 5b : Reed Roll Revetment, Undertaken May 1998

During last Easter, very high flows were experienced along this length which tested the defences. Apart from some seepage under the defences, they withstood the flows throughout its peak period. The Agency had carried out works to protect the berms and bank. Some of our recent works are shown on fig. 5b. Figs. 5c and 5d show the extent of the last Easter flows on the Welland through Deeping St. James.

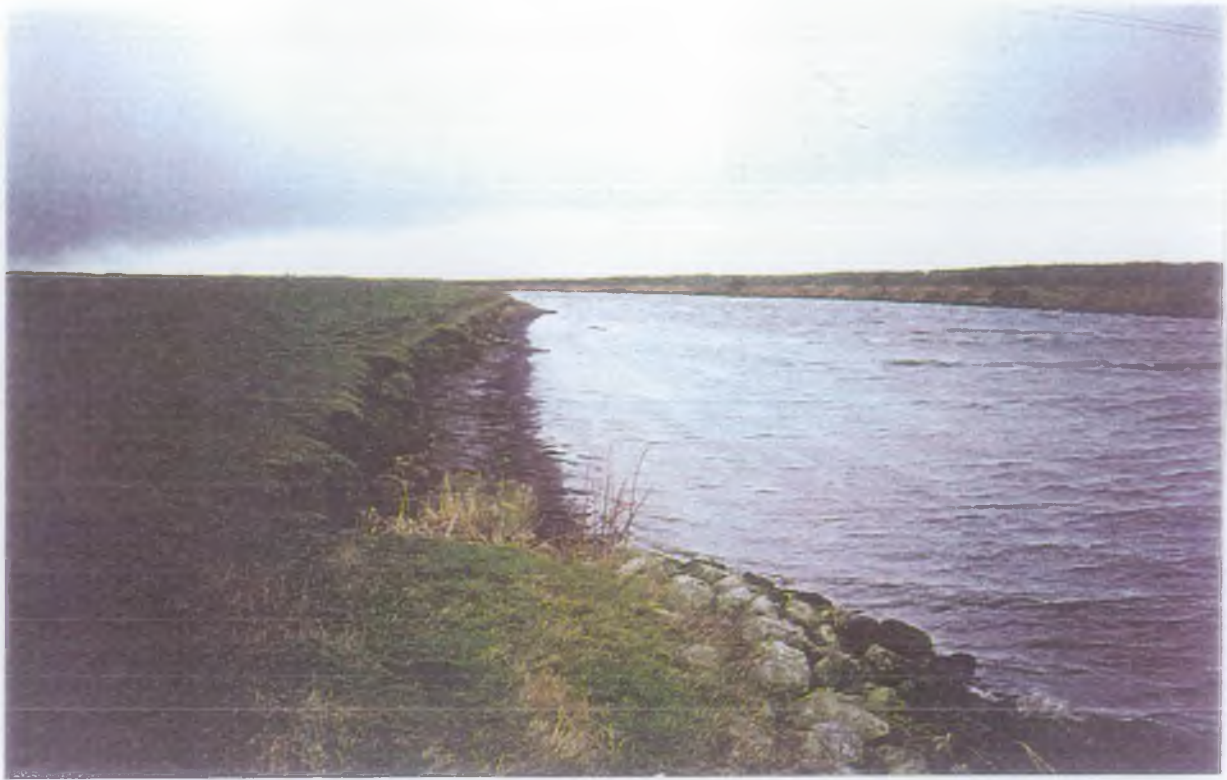
Figure. 6b : River Welland Upstream Of Crowland Bridge, Prior To Stoning Works

The Agency has also recently completed the stoning of 350 metres of the Cradge Bank just upstream of Crowland bridge to stop the erosion there. Fig. 6b shows the high erosion rate since the end of the capital scheme completed in 1994 while fig. 6c shows the newly completed works.

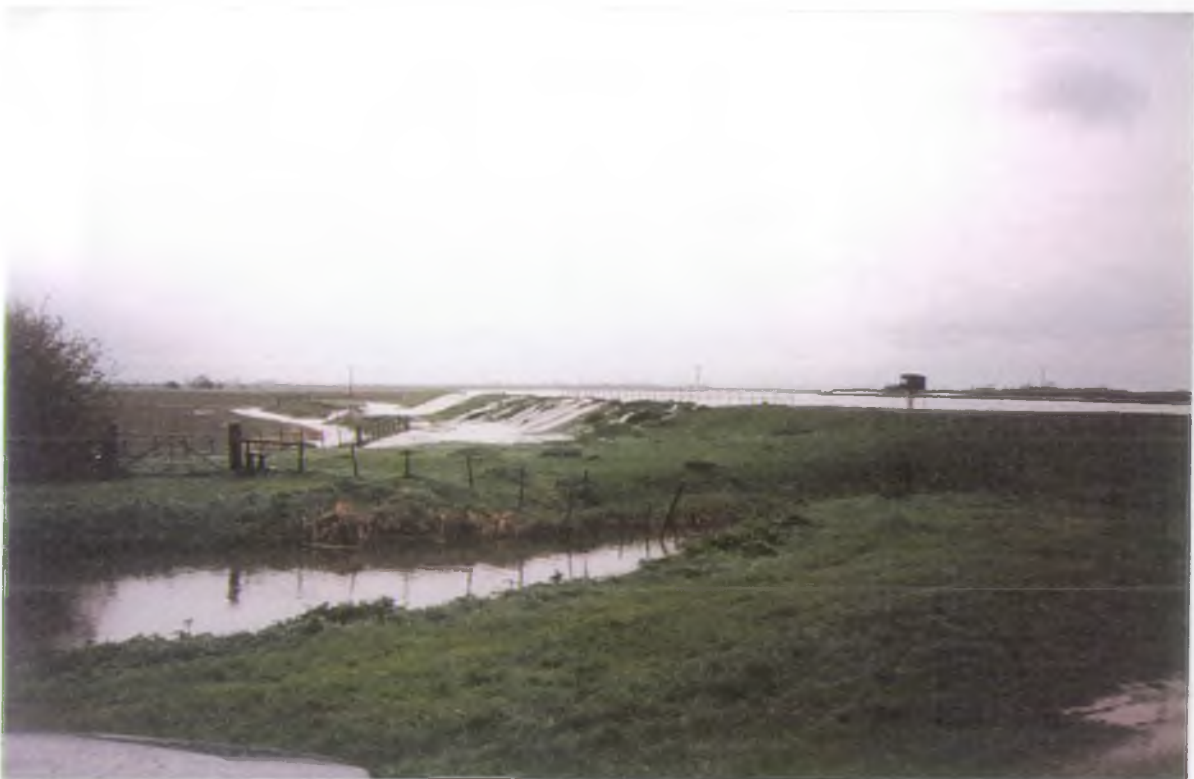
Figure. 6e : Water Spilling Over The Bank Upstream Of Crowland Bridge, 11/04/98

Water was stored on a small part of the Wash during the last Easter floods from overtopping of the Cradge bank at a few low spots. Records from the flood levels showed that both syphons were within about 40 mm of their trigger levels. (See figs. 8b and 8c). These are the highest known levels reached in the Welland since the 1950's after the completion of the Welland improvement scheme in the 1950's. A study is to be undertaken to verify the levels at which the syphons would discharge and the level of the cradge bank.

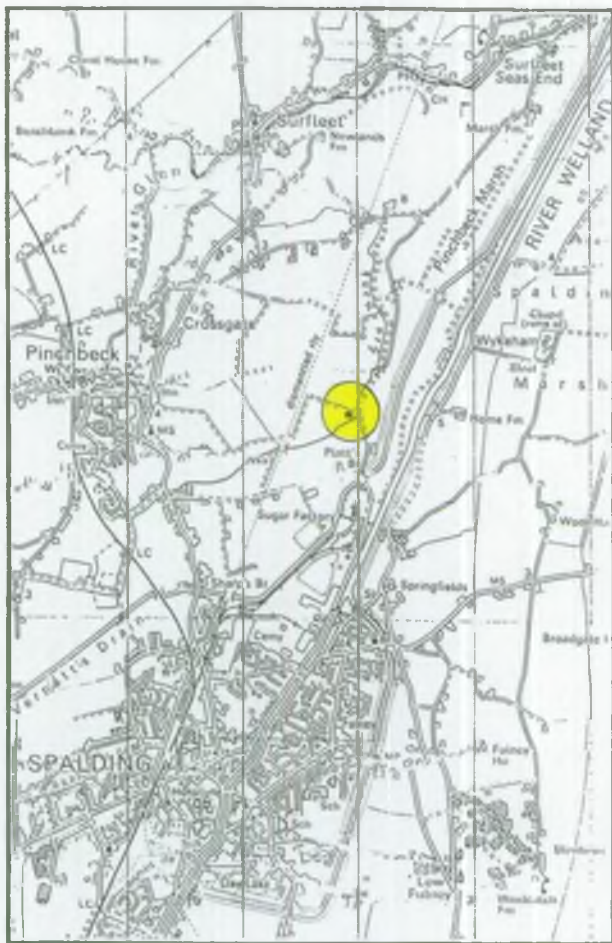
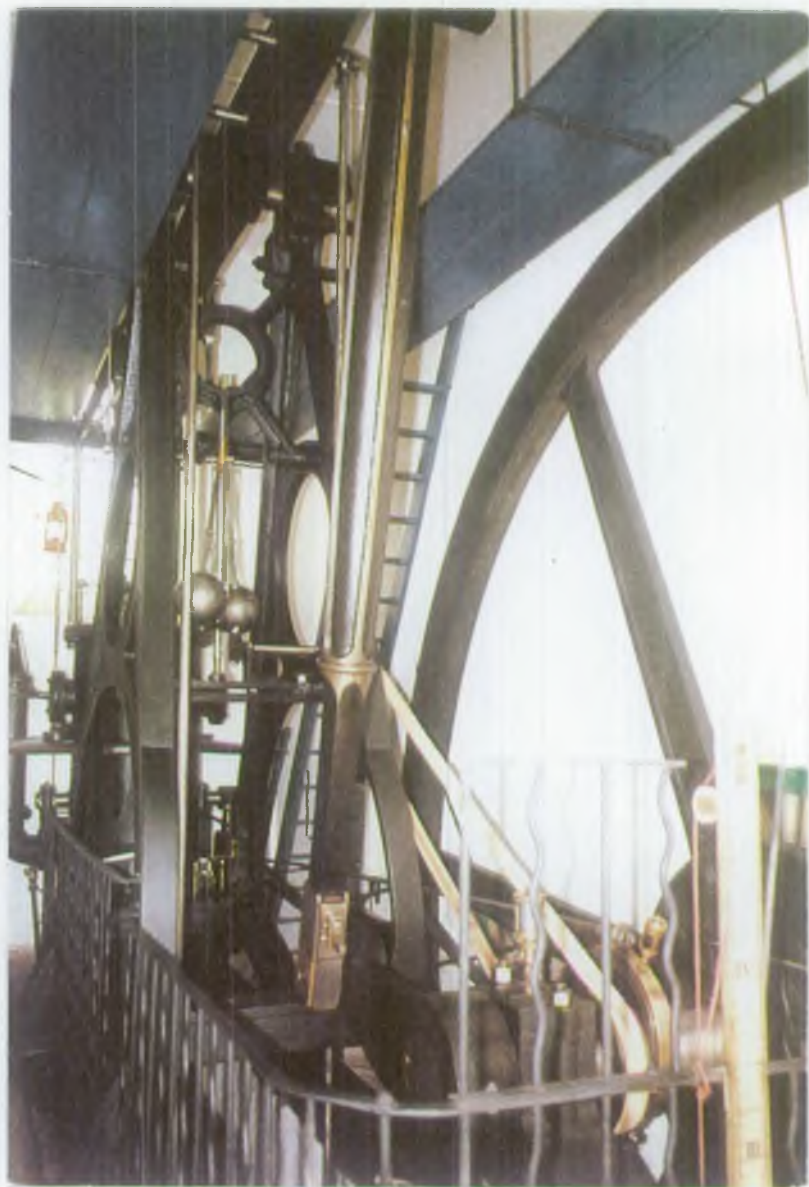
Figure. 9

The Pinchbeck Engine was built in 1833 enabled by an Act of 1832 to improve the drainage of the lands of Spalding and Pinchbeck. The improved drainage method was needed as the windmills were unable to cope with the pumping required to drain water from the rapidly shrinking fens. It had the capacity to pump 20 cusecs/hour using 1 cwt. of coal.

The Pinchbeck engine worked until 1952 when it was replaced by a new electrically powered station in 1952. Due to its importance in the drainage of the Fens it was then preserved by the Welland and Deepings Internal Drainage Board. The last ten years has seen its restoration in partnership with South Holland District Council to create a Land Drainage Museum. (See fig. 9).

Pinchbeck Engine

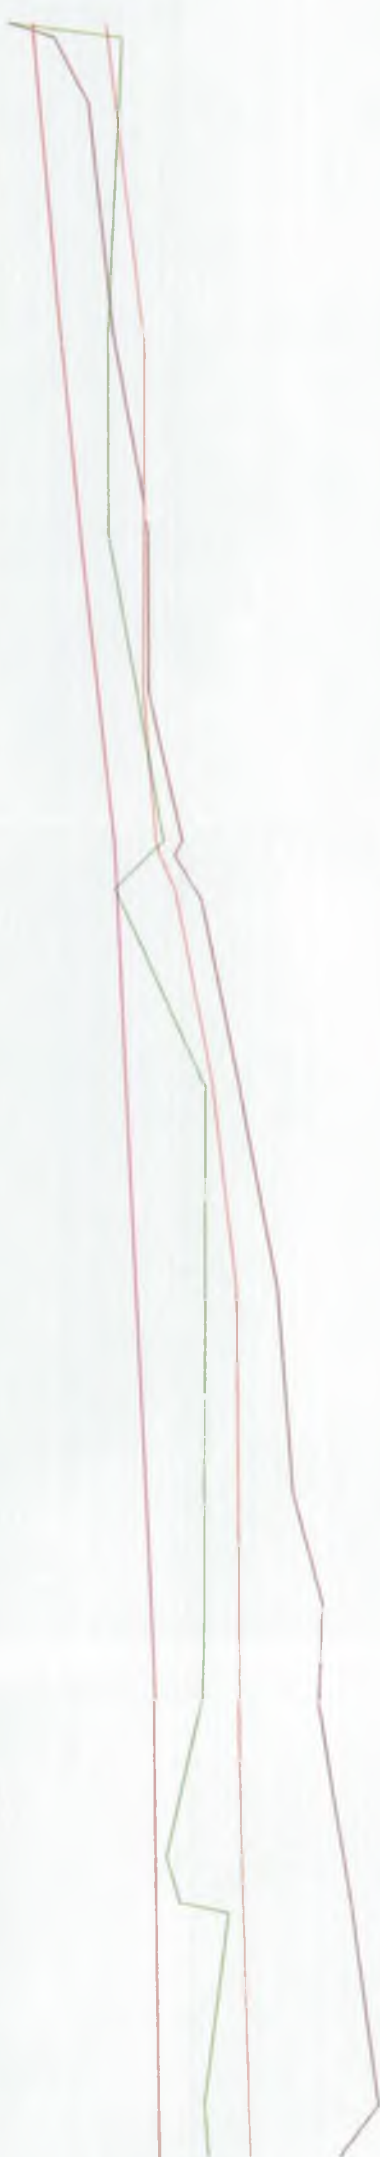
15th JUNE 1998. Figure. 13b

COMPARISON SURVEYS JUNE 1997, MARCH 1998 AND MAY 1998.

Earlier this year, the Environment Agency carried out the dredging of a kilometre length of the tidal Nene around Cross Guns pumping station as this was the downstream limit of significant siltation. The channel behaviour along this length is being monitored. Figs. 13b and c show the bed levels at the middle of the tidal channels over the last year. Figs. 13d and e show the tidal dredging at Cross Guns and at Mortons Leam outfall onto the Nene at Guyhirn.

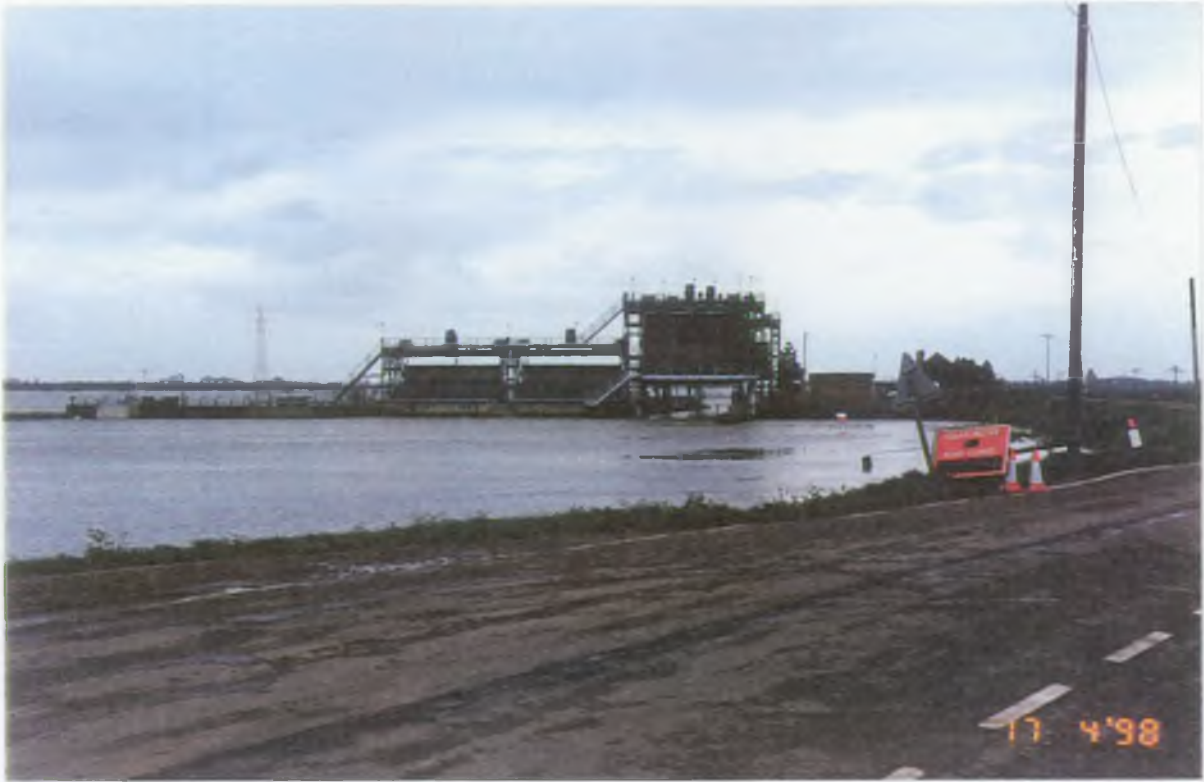
Figure. 14a : Tidal Nene Immediately Downstream Of The Tidal Limit At Dog In A Doublet Sluice

The Washes were filled via Stanground Sluice during the last Easter floods to a level of about 4.0 metres ODN. While the defences were under heavy attack from waves, they held up without any breaches. Figs. 14a and 14b show the Washes in flood.
