FISHERY SURVEY OF THE CONGRESBURY YEO 1994

CONGRESBURY YEO 1994

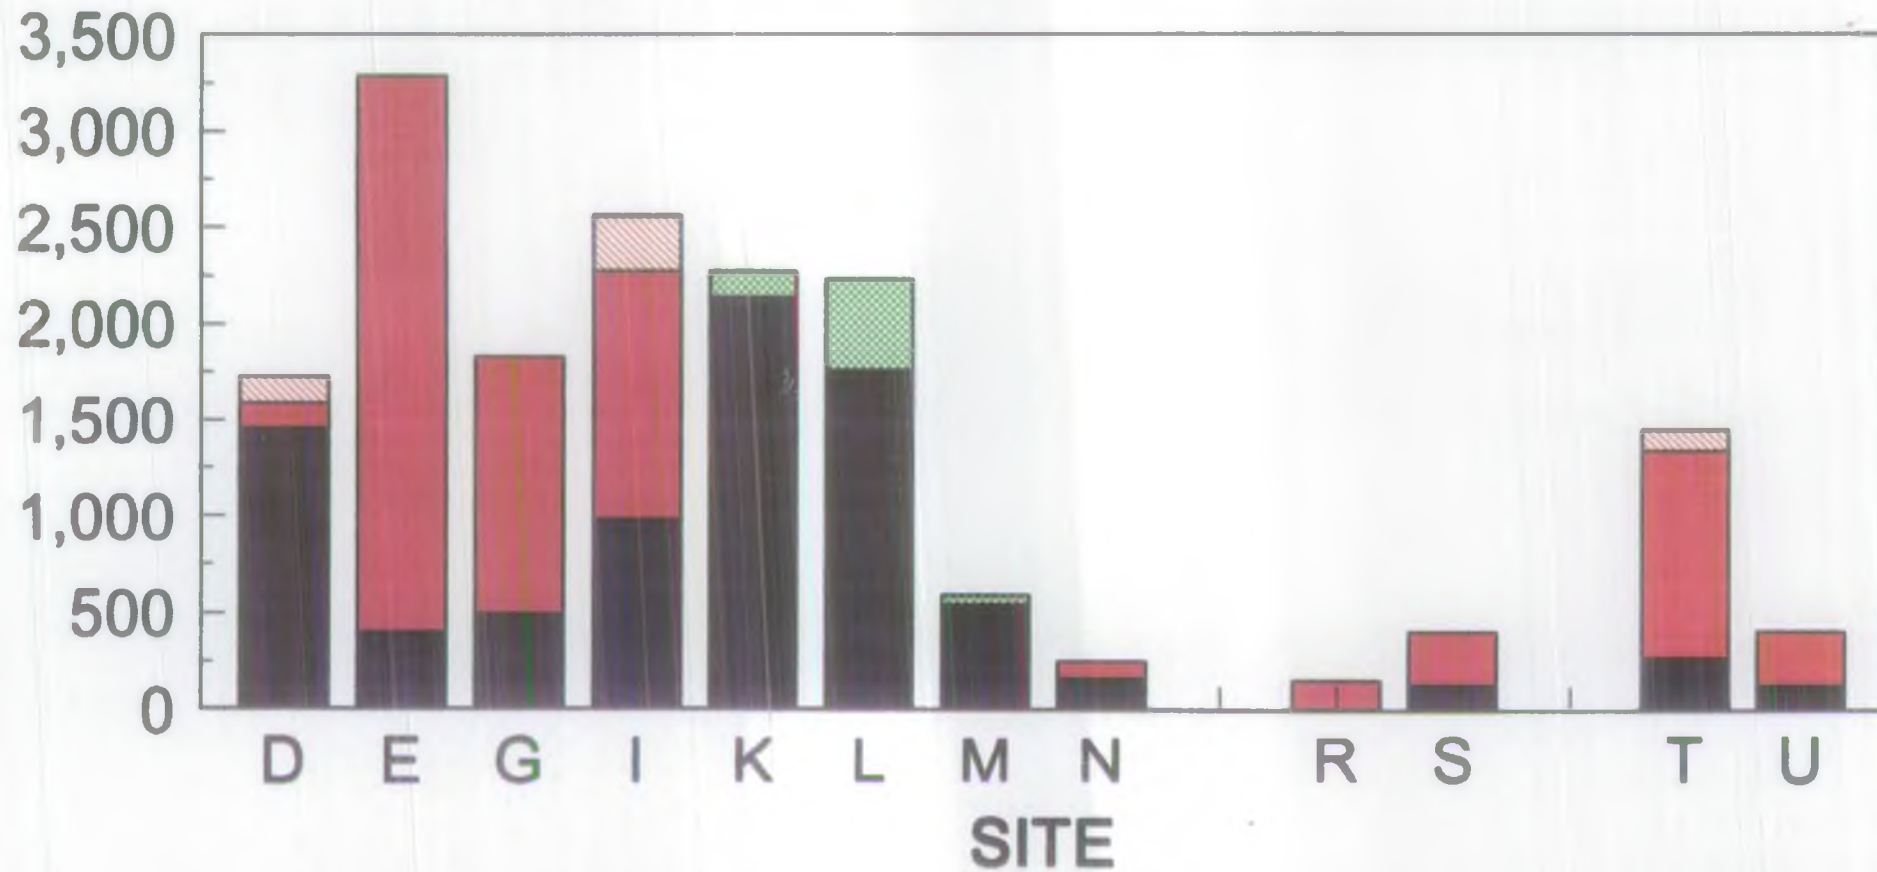
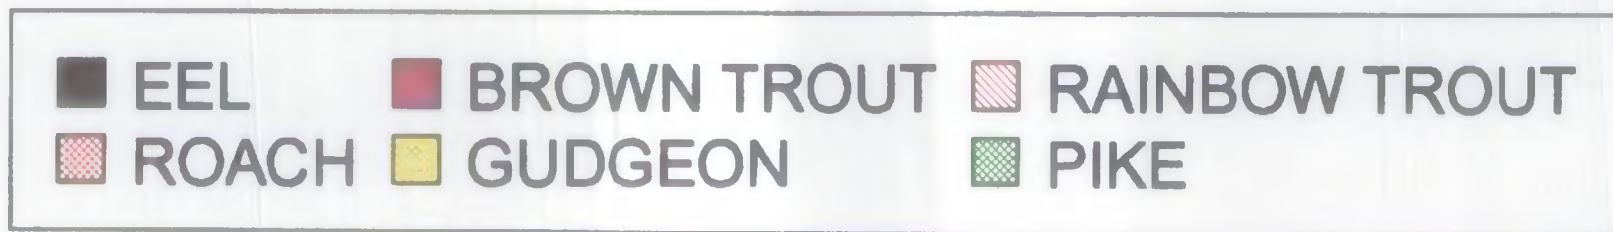
FIGURE 1

6.1 Figures 1 and 2 show respectively the biomass and population of all fish over 10 centimetres in length caught at each site. Each bar on Figures 1 and 2 is subdivided to indicate the species composition. Each species is indicated by a consistent colour and shading style.

BIOMASS OF ALL FISH > 10 cm LENGTH

BIOMASS (gms per 100 square metres)

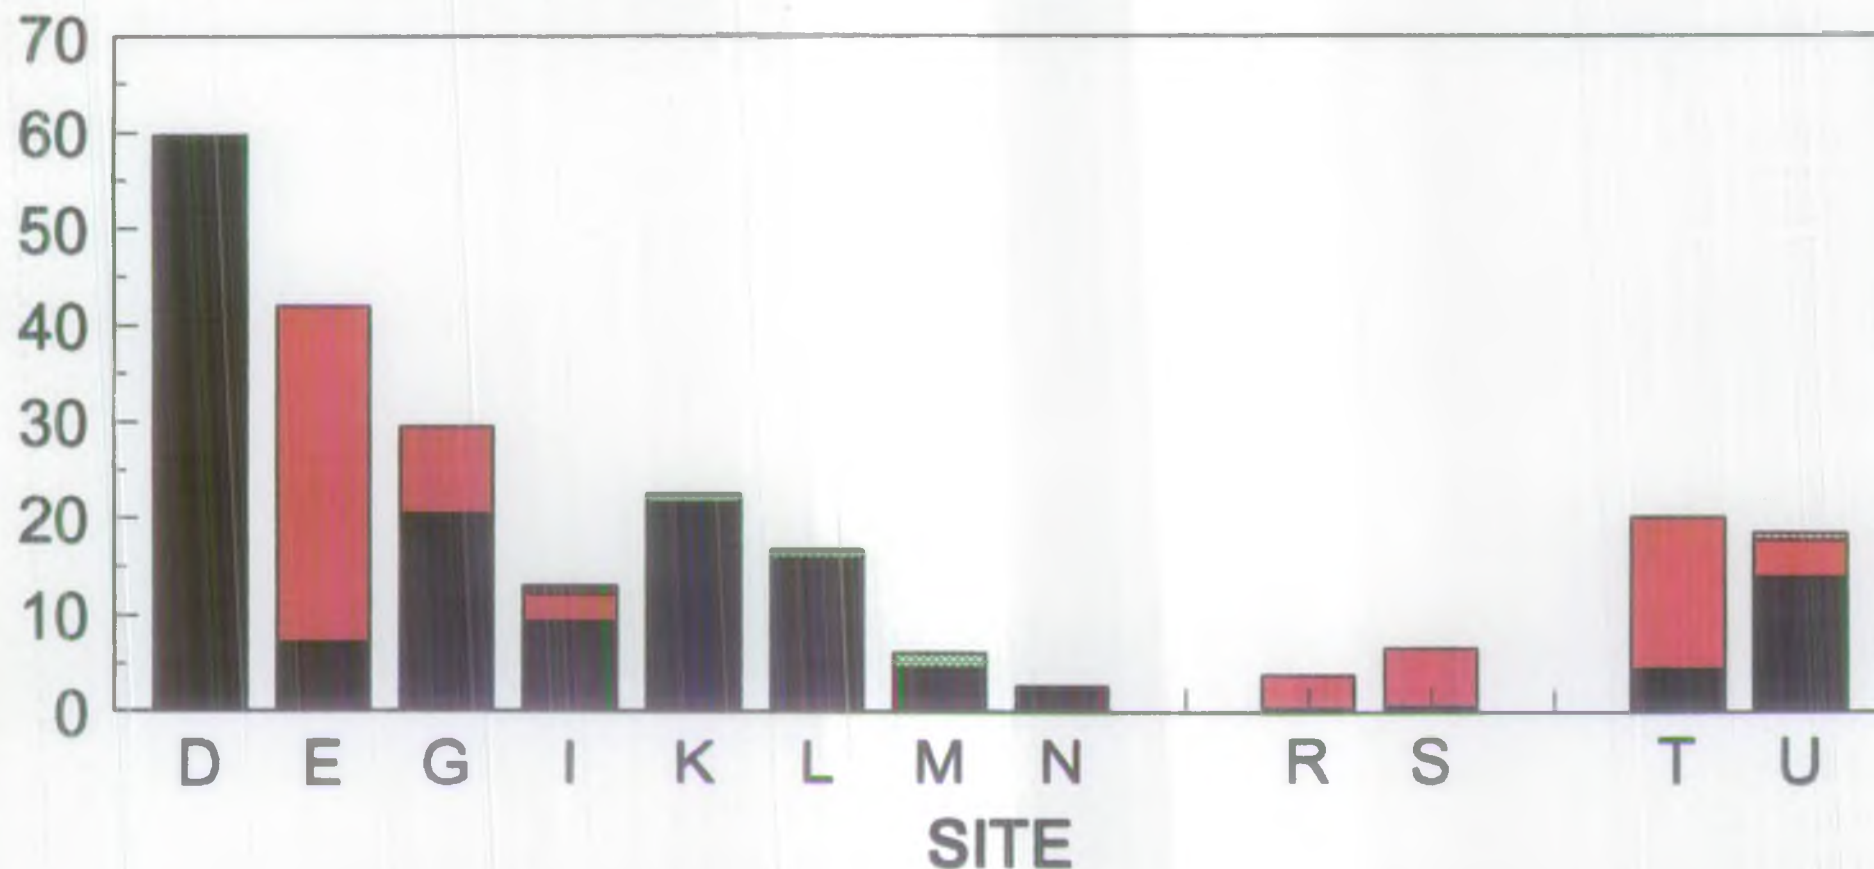
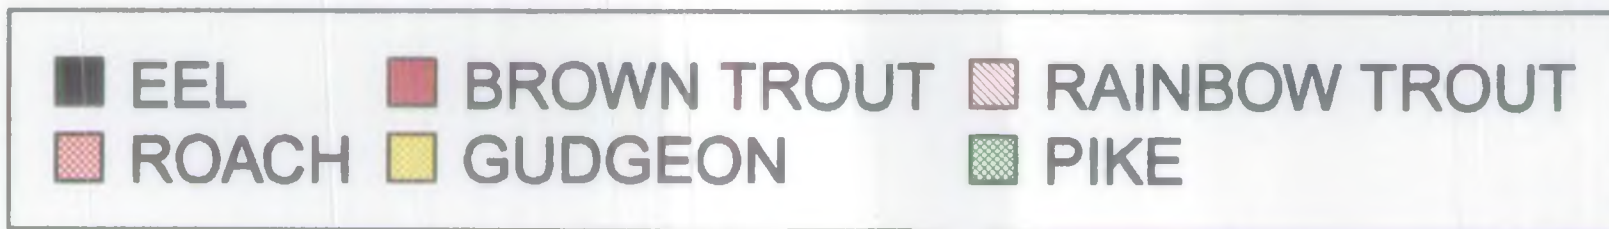
DENSITY OF ALL FISH > 10 cm LENGTH

DENSITY (nos per 100 square metres)

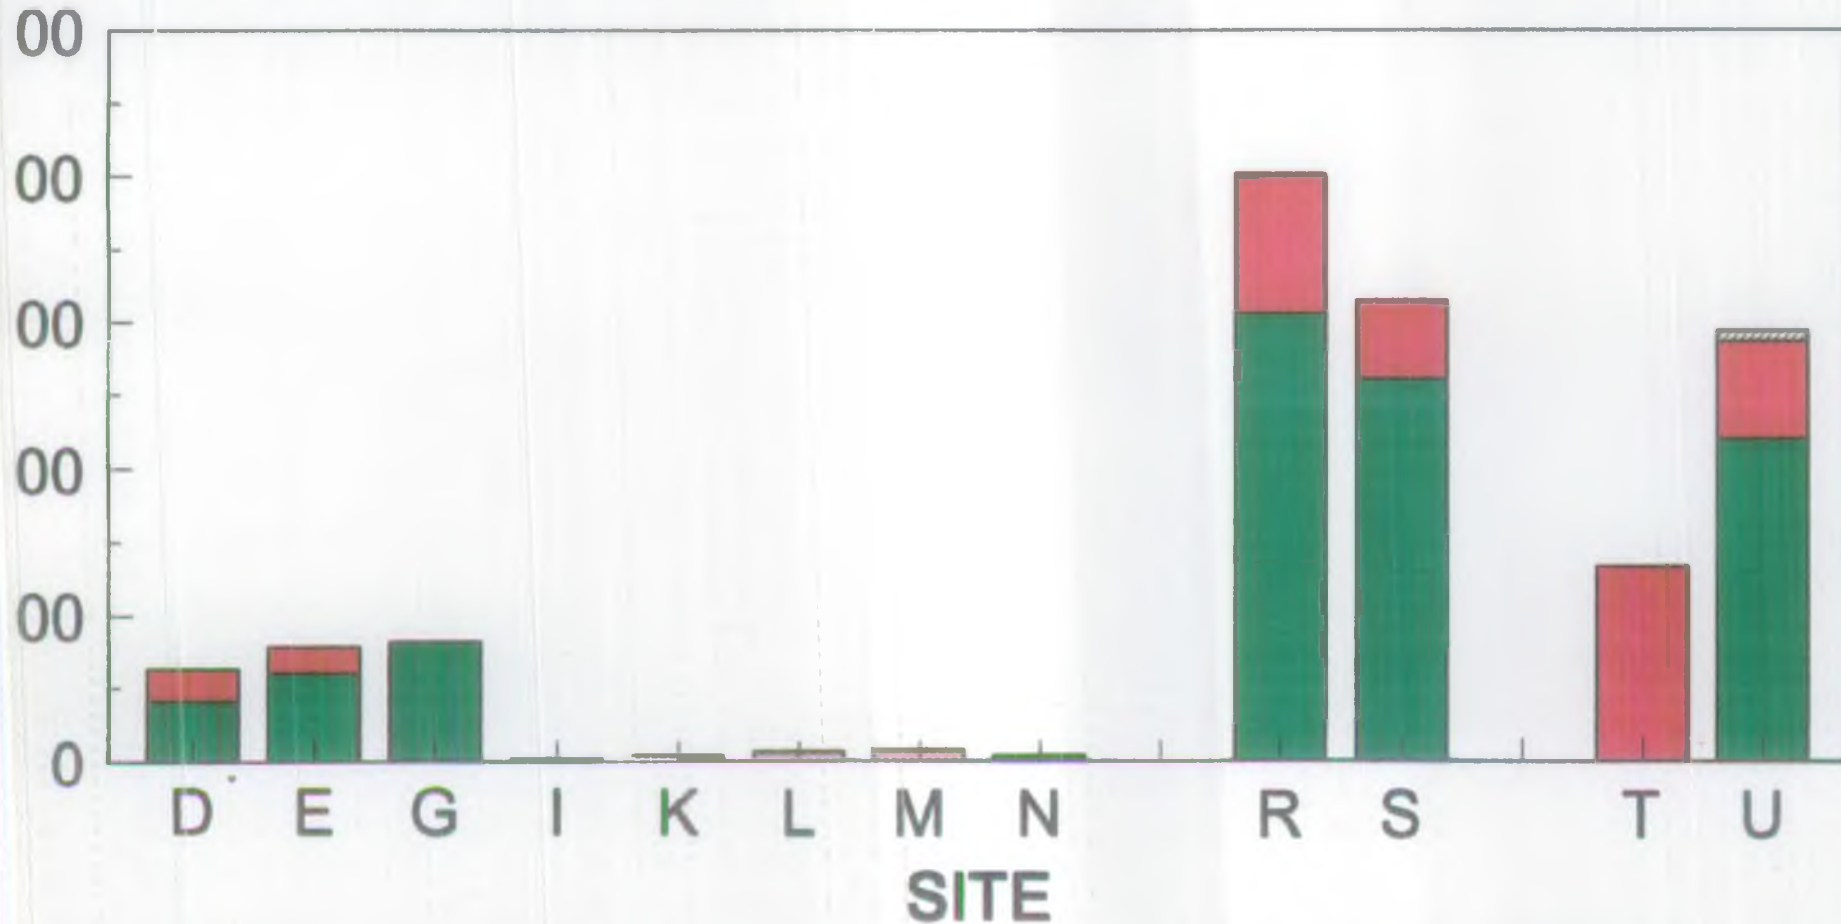
6.2 Figures 3 and 4 show respectively the biomass and population of all fish under 10 centimetres in length caught at each site including those that were counted and weighed in bulk.

BIOMASS OF ALL FISH < 10 cm LENGTH

BIOMASS (gms per 100 square metres)

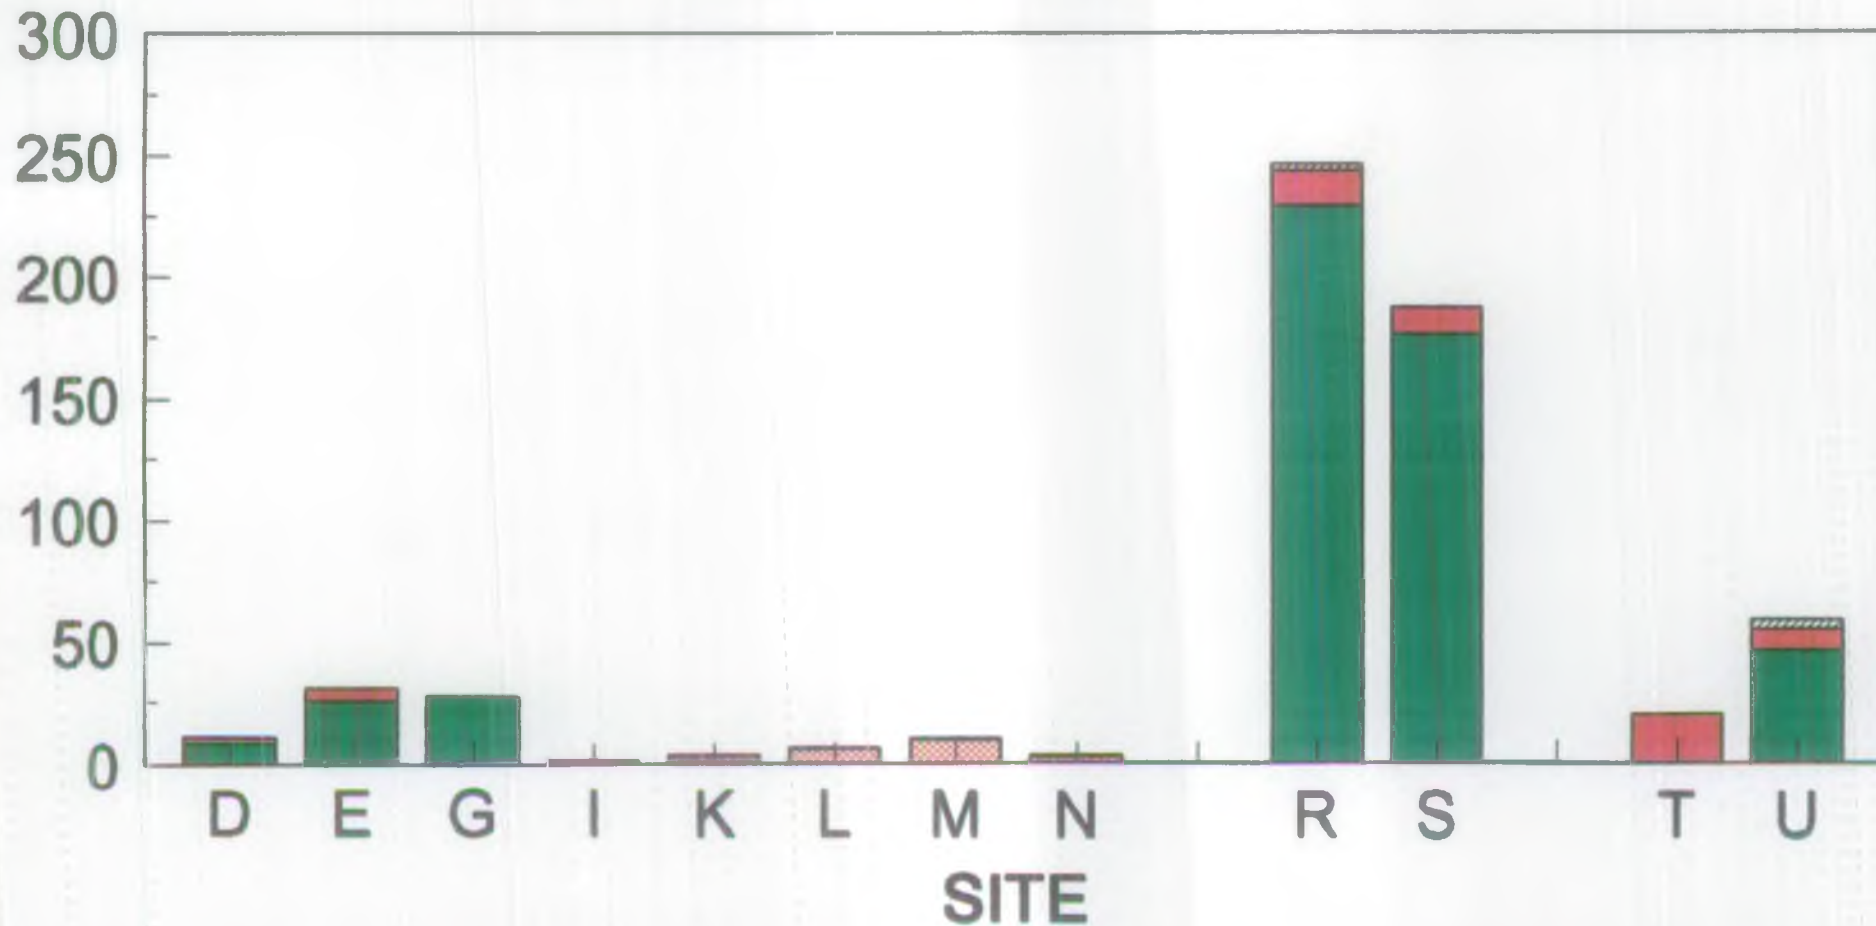
DENSITY OF ALL FISH < 10 cm LENGTH

DENSITY (nos per 100 square metres)
