FLOOD PROTECTION AT FELIXSTOWE

*National Rivers Authority
Anglian Region*

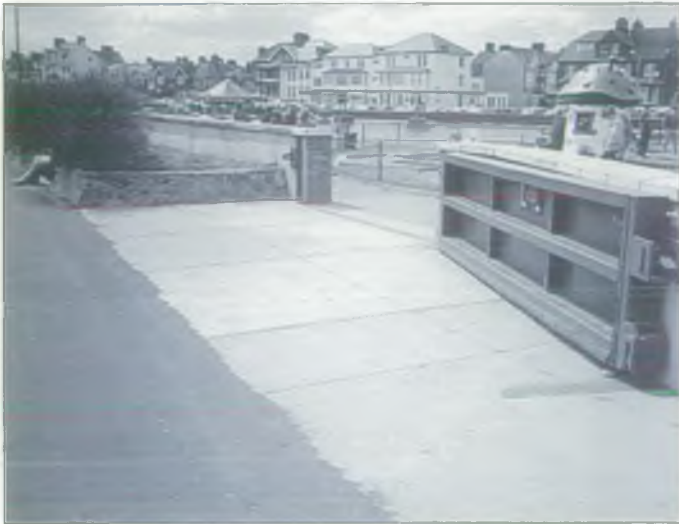
Town Wall, Felixstowe.

This wall, known as the Town Wall, was built in 1983. The sheet piles were clad in concrete for durability and faced with brick on the landward side between what was the Herman de Stern Hospital and the northern end of the wall near the Town Hall to make it visually acceptable. Thirty openings allow public access in the summer season to the promenade and beach, these are closed when necessary by hinged steel gates.

At the northern end, the wall connects to high ground in the vicinity of the war memorial, while at the southern end it adjoins the Manor House Wall.

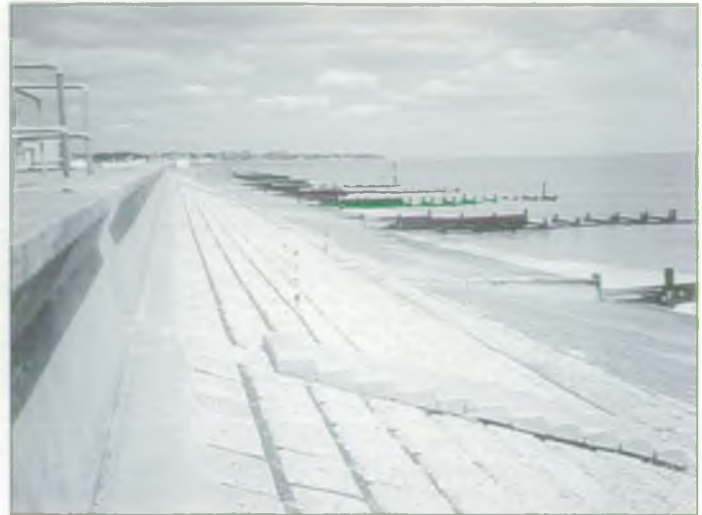
Manor Wall, Felixstowe

Imported shingle was compacted to provide a base for the new wall. Erosion of the shingle foundation is prevented by steel sheet toe piles. These in the first instance were driven into position at the front of the apron to provide a half tide working cofferdam during the construction and later cut to apron level. These piles provided the base for a 2 metre (approx 6 ft) wide concrete apron which was topped with a sloping concrete block revetment and reinforced concrete wave wall supported on driven steel piles.

Timber groynes were constructed along this frontage to help contain the shingle beach (which normally moves from north to south). The formation of a high beach strengthens the defence, reduces wave action and consequent erosion.

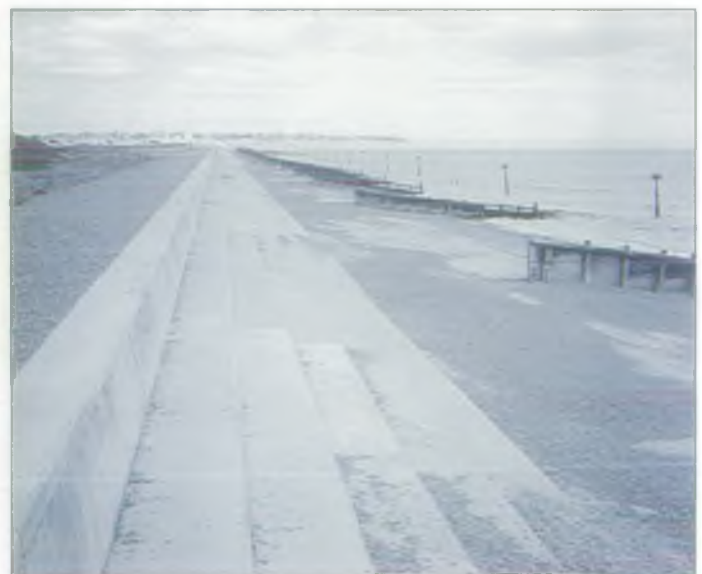
Landguard Sea Wall.

The final link to the town's sea defences was secured with the construction of a new sea wall at Landguard in 1985. The original defence was a mass concrete wall which probably dated back to before the last war and had been subsequently strengthened over intervening years. This wall was severely damaged by high tides in January 1985. Although not exceptional, they ripped out the wall's steel sheet toe piling, lifted large lumps of concrete and scoured a deep cavity under the sea wall.

By April work had started on a new 550 metre (600 yd) sea wall with a reinforced concrete wave wall and stepped apron. This was completed by the end of the year together with the construction of seven new groynes and modifications to eleven others.
