AN INVESTIGATION OF SEWAGE ON THE BEACH  
AT PORTHCOTHAN

R. GRANTHAM  
TIDAL WATERS OFFICER  
N.R.A.  
SOUTH WEST REGION  
MANLEY HOUSE  
KESTREL WAY  
EXETER, EX2 7LQ

OCTOBER 1989

TWU/89/008

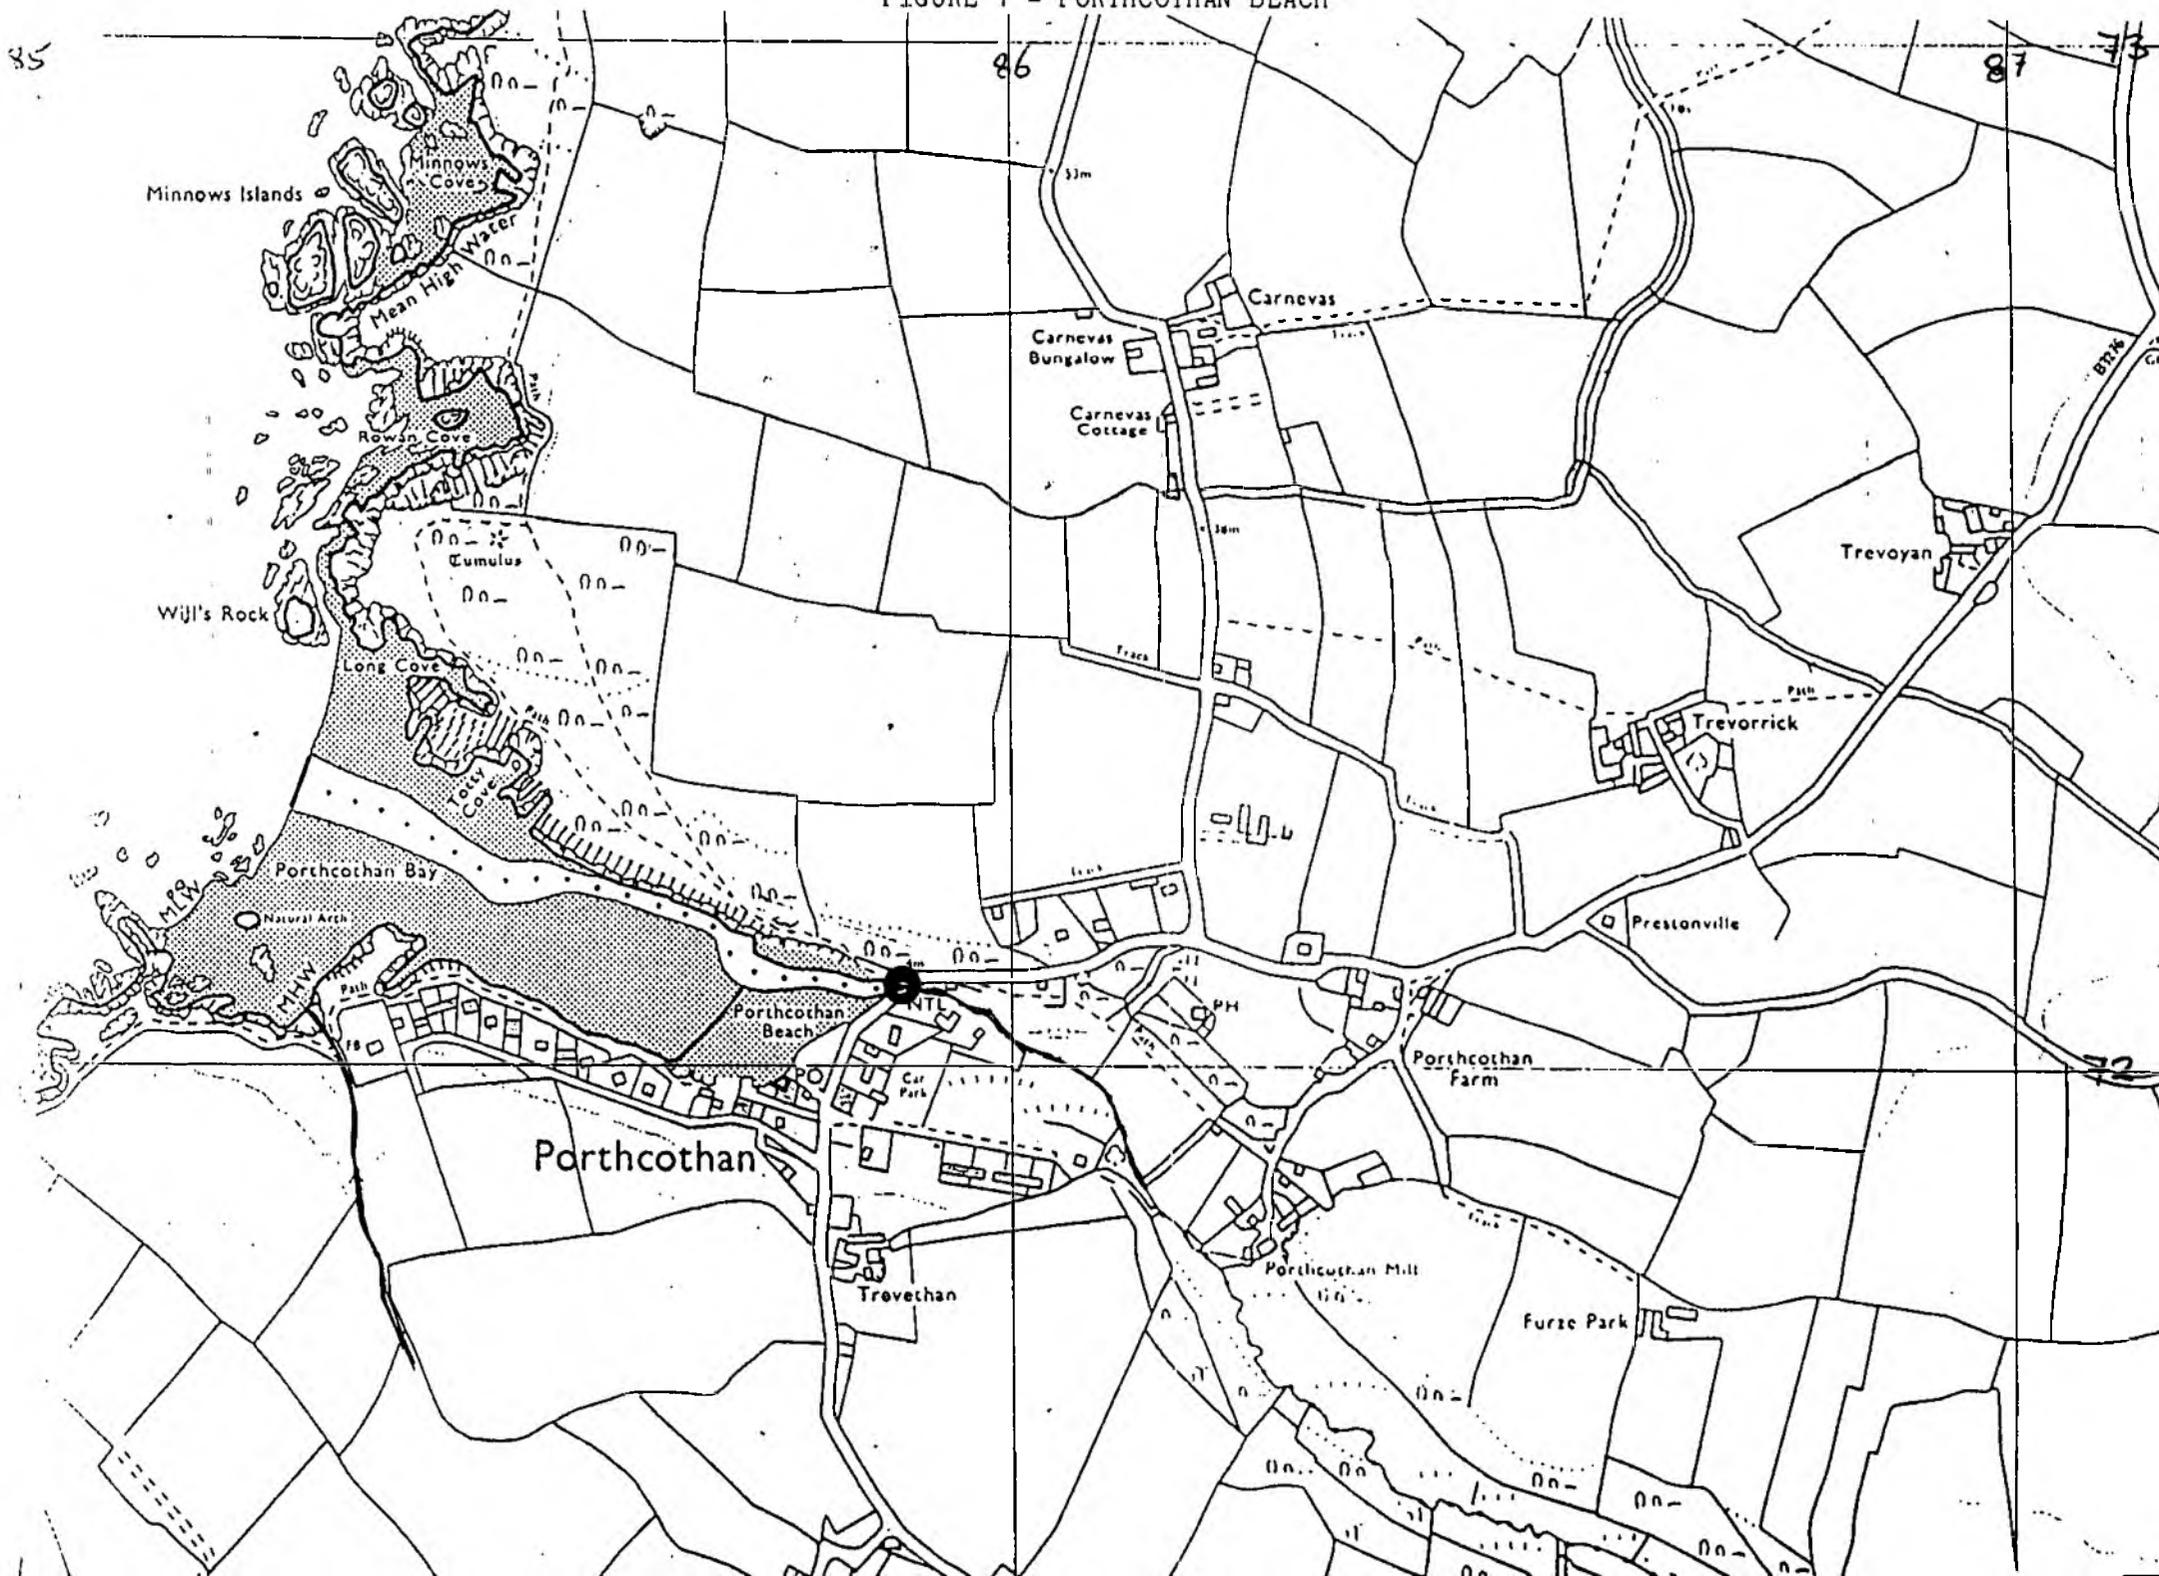
FIGURE 1 - PORTHCOOTHAN BEACH

At Porthcothan there is a deeply indented beach (see Figure 1) that faces the Atlantic in a WNW direction with a small stream (Porthcothan Stream) that runs across the beach (1).

No pipes or discharges were seen during an examination of the cliff base on the south side of the beach but a small stream was observed to enter the beach at SW85307200. An inspection of the beach revealed a few sanitary towels or plastics that appeared to be associated with seaweed and debris that had been washed ashore. A large semi-permanent pool exists where the Porthcothan Stream enters the beach. Reed debris and a few non-biodegradable sanitary towel plastics were present but there was no evidence of faecal contamination.

A sample was collected at the road bridge, Site S (SW85837210), in the village to enable an assessment of the bacteriological quality of the Porthcothan Stream.
