## Environmental Protection Report

# AN ASSESSMENT OF WATER QUALITY IN THE RIVER YARTY CATCHMENT

June 1992

FWI/92/006

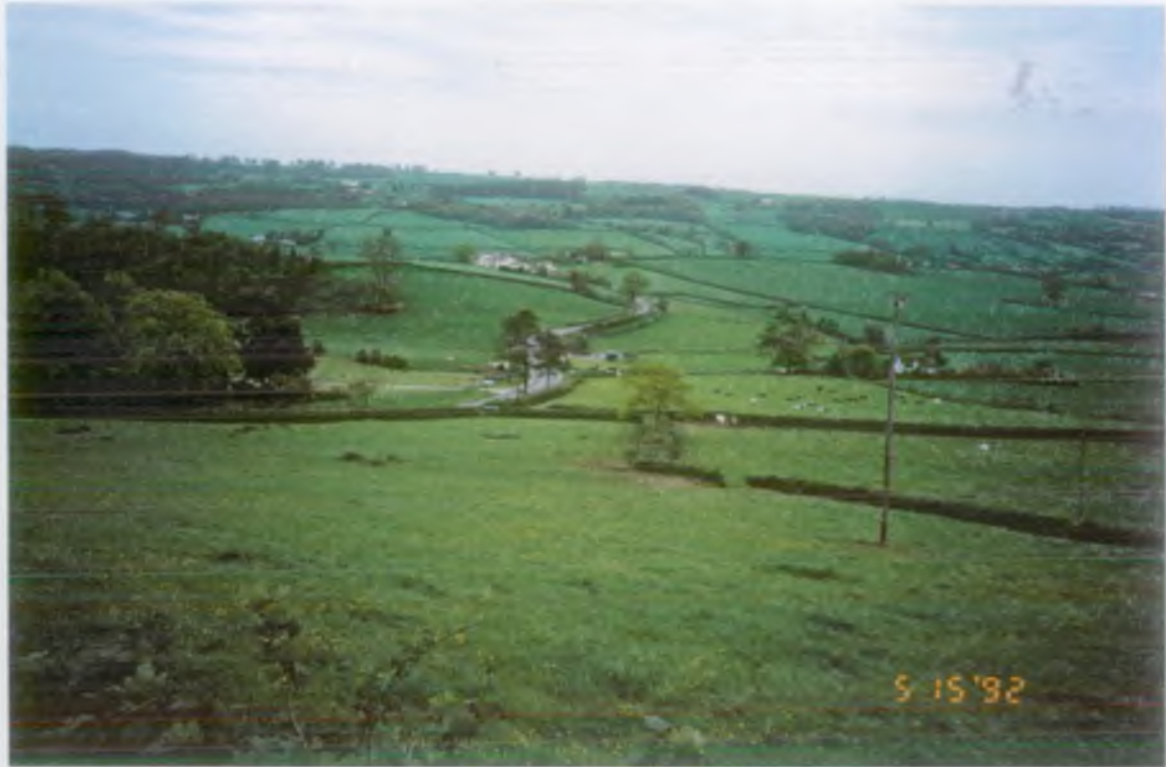
Typical land use in the upper Yarty catchment

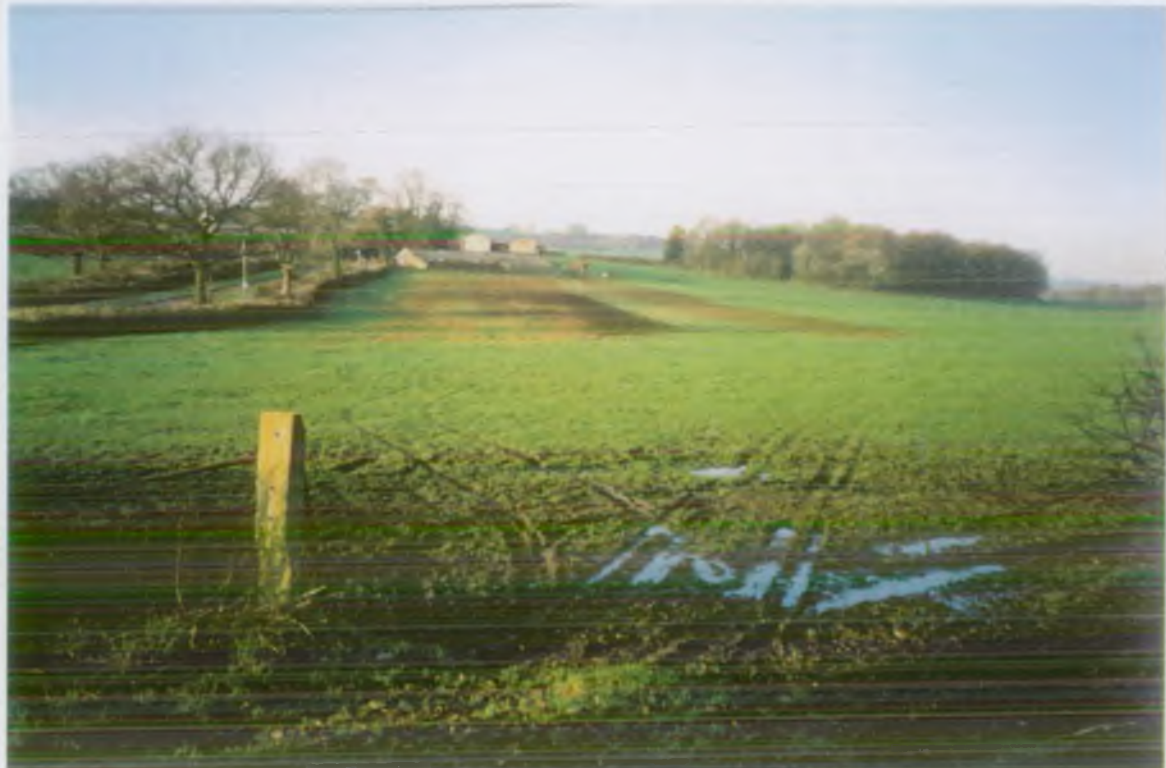
Slurry spreading in the River Yarty catchment

Run off of slurry from farmyards and storage lagoons was the main source of organic pollution from farms. Run off of slurry from fields was also found because slurry had been spread too close to the watercourse and had been applied too thickly. Pollution by silage liquor and dairy washing were identified at a few farms but none were considered a major source of pollution.

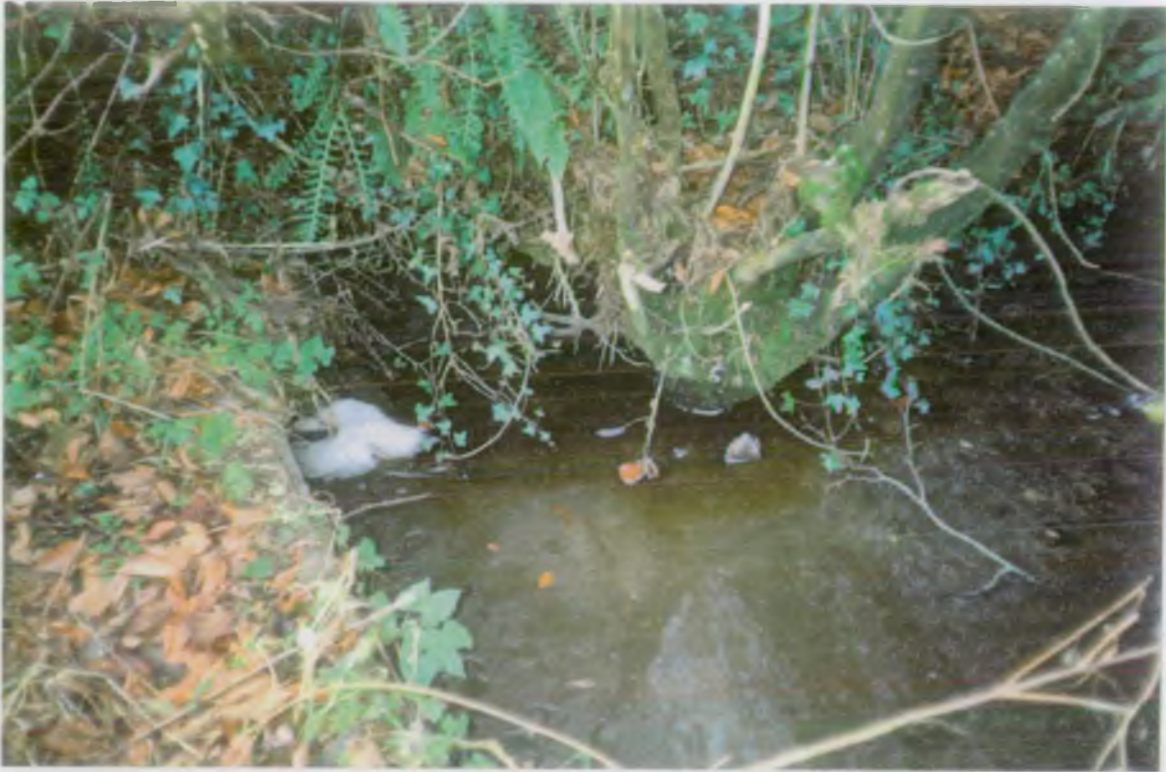
Farm drainage entering the Whitestaunton Stream

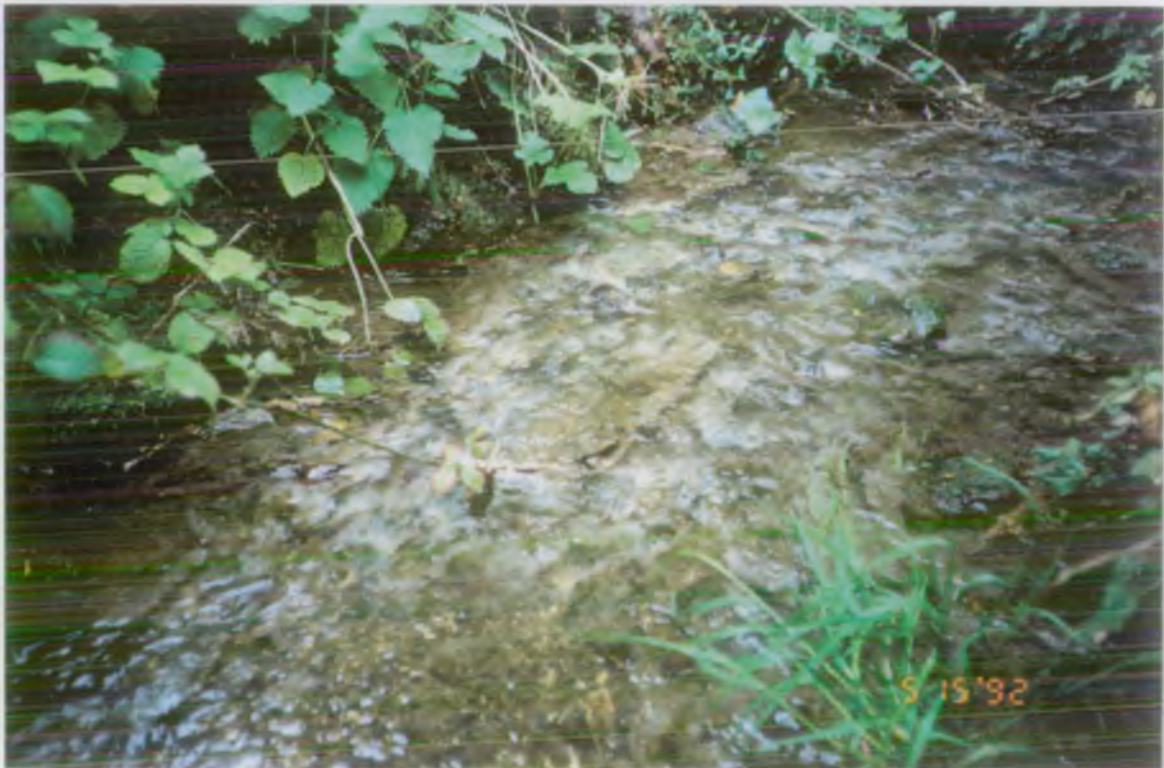
Sphaerotilus natans (Sewage fungus) growth downstream  
of septic tank discharges at Whitestaunton

Pollution from septic tanks was widespread in the upper River Yarty catchment (7 sources). This was particularly severe in the Whitestaunton Stream, where a number of septic tanks from Whitestaunton village and probably Northay village discharge to the stream with minimal treatment (see Figure 8). There is no sewerage system or treatment works in this area at present. A toxic impact was suspected from one septic tank in the Blindmoor Stream (see Figure 7).
