National Rivers Authority

REPORT ON ALTERNATIVE METHODS

OF RIVER BANK PROTECTION

NORFOLK DISTRICT SEPT 1992.

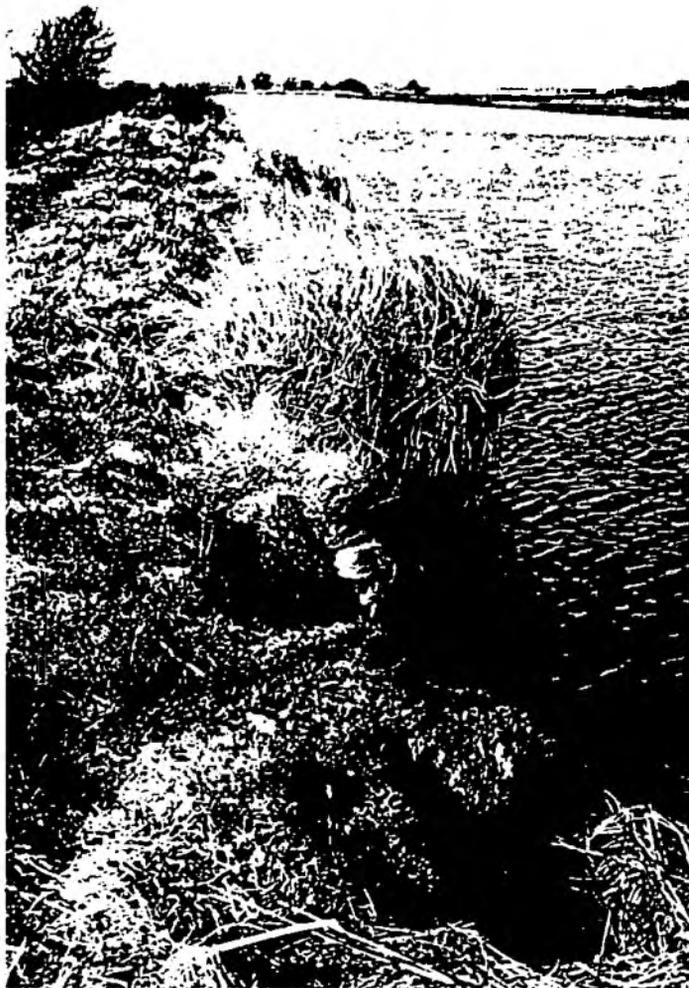
0.2

RIVER BANK EROSION THREATENING STABILITY OF FLOOD DEFENCE

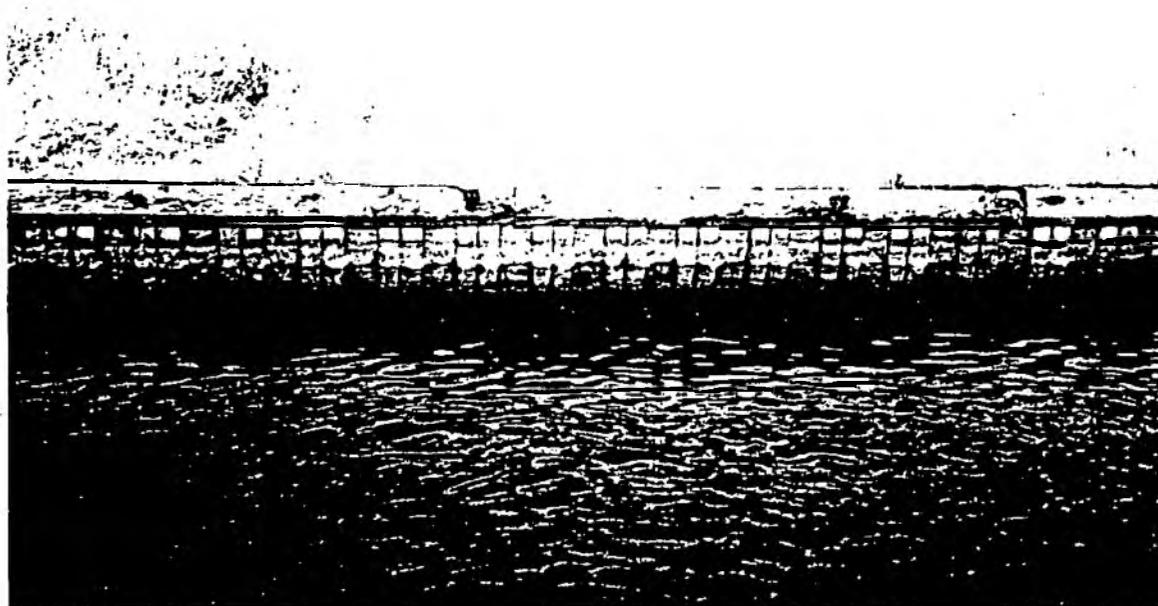
2.1
LIGHTWEIGHT PILING

TYPE LIGHTWEIGHT STEEL SHEET OR TIMBER PILING	DATA SHEET 2
LOCATION VARIOUS LOCATIONS ON BROADLAND RIVERS	
METHOD Piles usually driven from floating plant at toe of embankment with top of piles between 300-800mm above mean water level. Piles are anchored using tie rods and anchor blocks and backfilled using imported or dredged material.	
COST £200-£ 500/m run depending on location.	
COMMENTS This type of piling affords a satisfactory engineering solution especially in areas where boats are moored. The piling by its very nature gives an arid canalised appearance to the waterway.	
PHOTOGRAPHS 2.1 DATE INSTALLED Mid '50's to date.

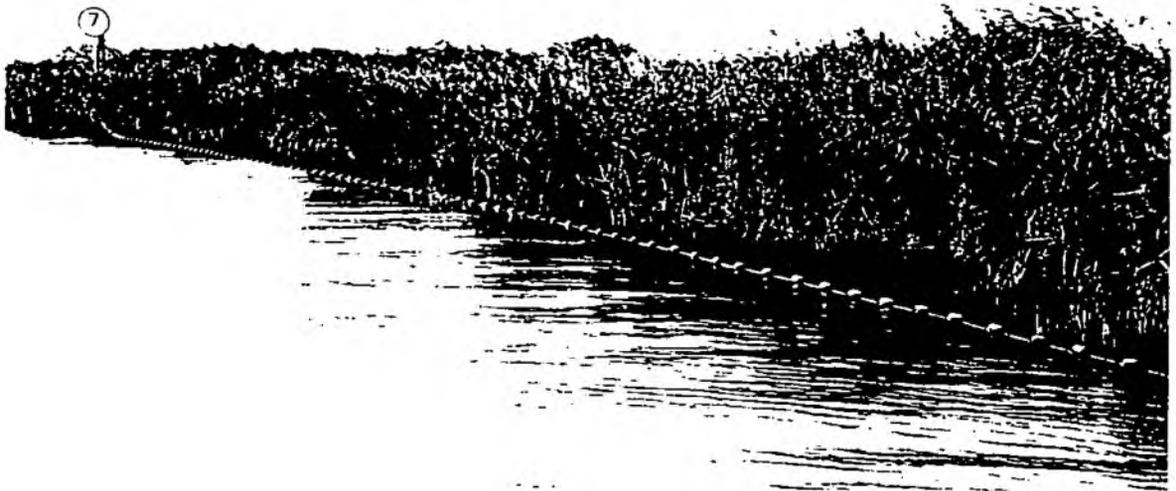
5.1
REED GROWTH THROUGH ASPHALT MATTING LAID ON GRADED BANK

<p>TYPE ASPHALT MATTING LAID TO GRADED BANK</p>	<p>DATA SHEET 5</p>
<p>LOCATION RIVER THURNE - R.B. adjacent to Thurne Mouth.</p>	
<p>METHOD A scour hole approx 60m long was filled using both imported and dredged material. The slope was graded to the bed of the river at approx 1 in 4. A combination of Enkamat A asphalt mat of 5m A20 + 2m A40 was rolled down the slope, which had been spread with reed rhizomes. A 2m wide strip of Enkamat 7220 was laid above the matting following seeding. The matting was fixed in place using short iron stakes.</p>	
<p>COST Approx. £250/m.</p>	
<p>COMMENTS The asphalt matting was easy to lay but grading the bank underwater from a floating pontoon did prove difficult. The reed and vegetation has grown well above the water line but is not colonising at and below normal water level. Geese also proved to be a problem during the first growing season and wire netting was subsequently placed over the matting above the water line. There has been some loss of asphalt due to wash action and some loss of backfill.</p>

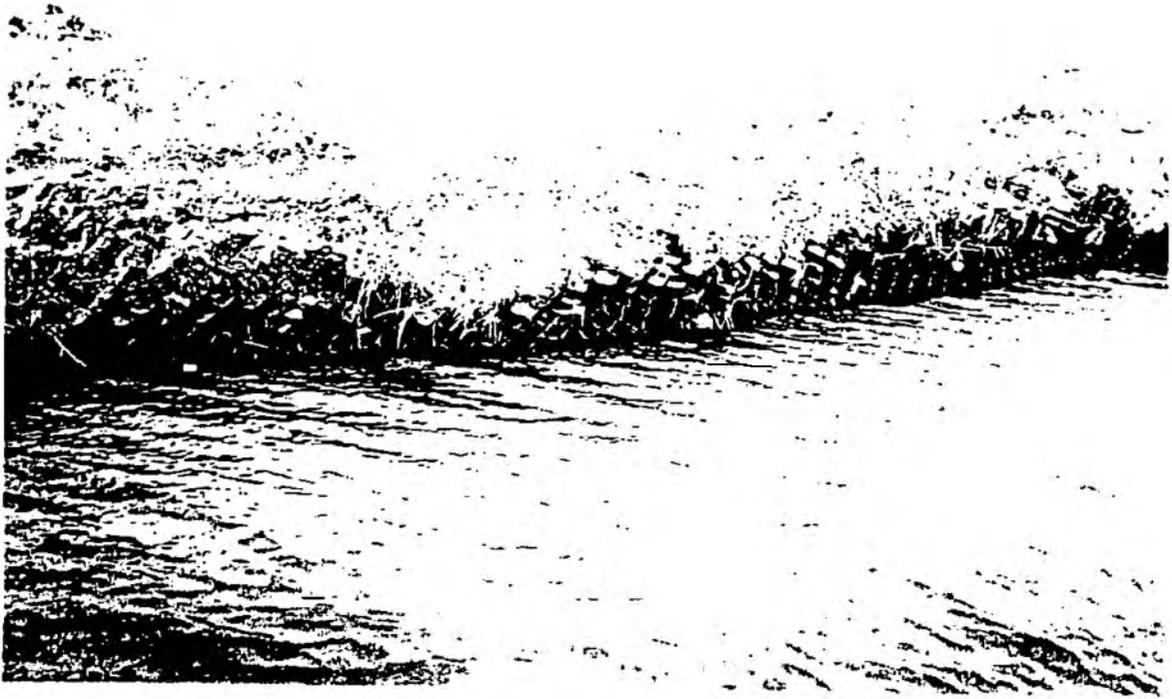
6.1
GEOWEB INSTALLED ON RIVER BANK

TYPE THREE DIMENSIONAL PLASTIC GRID	DATA SHEET 6
LOCATION RIVER BURE - R.B. upstream of Upton Mill	
METHOD The face of the existing embankment was graded to a 1:3 slope using dredged fill where necessary. There was before work commenced some marginal vegetation on the frontage between scour holes and for that reason none was imported. The 8mx2m plastic grids 'Geoweb' were placed by floating crane after weighting the toe with concrete and placing a filter fabric on the slope. They were then fixed in place using anchors and stakes and the whole length was covered with material excavated from the river.	
COST Approx. £400/m.	
COMMENTS This system has not been successful. From the start difficulties were encountered devising a system to weight the toe of the grid down. It also proved difficult laying the grids to ensure they covered the whole face of the embankment. The backfill placed in the cells has not stayed in place, due to the action of the wash, and in places the welds holding the material together have broken. The main disadvantages were the material's rigidity and difficulty in anchoring on to the face of the embankment. This system has now been replaced by low level piling.

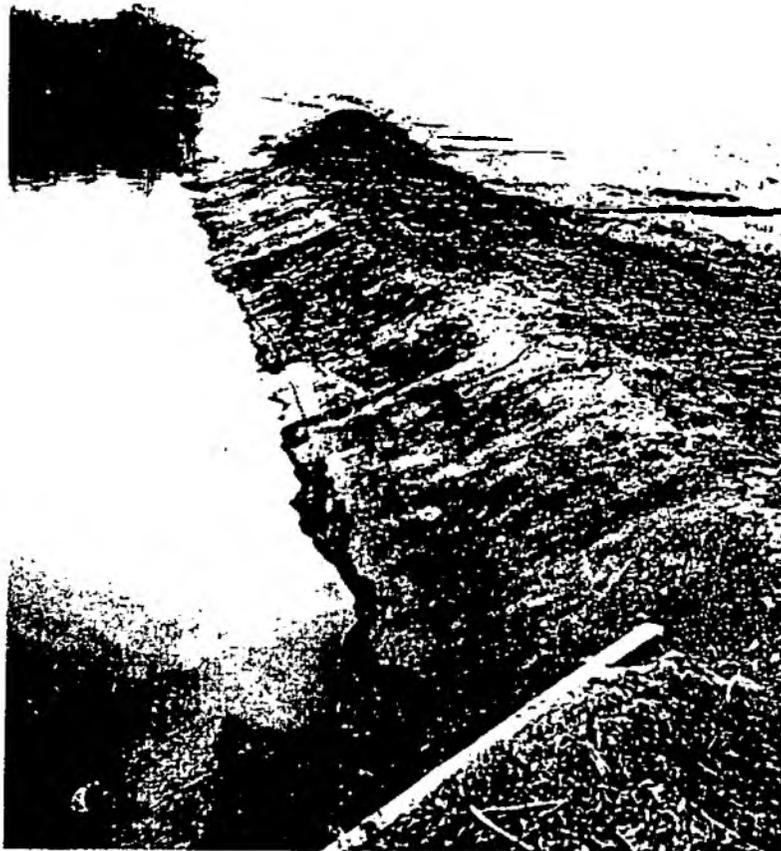
8.1
ASPHALT MATTING FOLLOWING INSTALLATION

TYPE ASPHALT MATTING FACE PROTECTION	DATA SHEET 8
LOCATION RIVER ANT L.B. - Chapelfield Marsh.	
METHOD The peat embankment on this frontage is constructed on a layer of clay giving a ledge just below water level. The face of the eroded embankment was graded to a 1:3 slope and sedge roots placed on the face of the bank at the water line. The asphalt mats (similar to Enkamat A used in 3) were laid along the bank in a 2.4m wide strip and pegged down.	
COST Approx. £200/m.	
COMMENTS This system proved easy to lay using land based plant. The sedge grew quickly, completely covering the lower section of the matting in two years.	
PHOTOGRAPHS 8.1, 8.2	DATE INSTALLED February, 1987

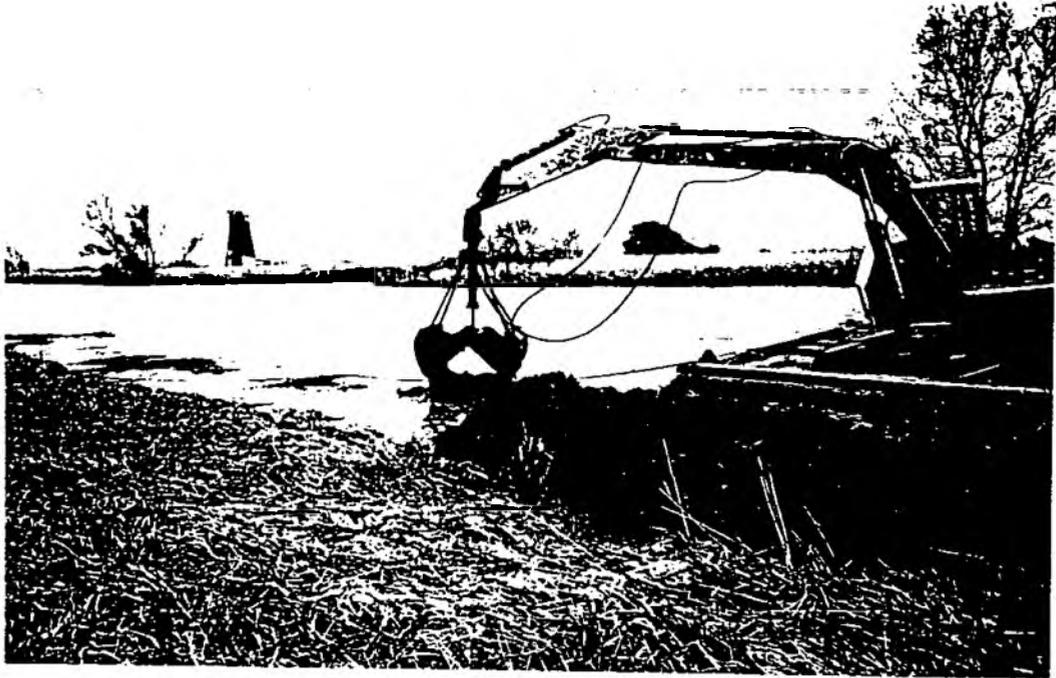
10.1
MATTRESS BEING BACKFILLED

TYPE FASCINE MATTRESS FACE PROTECTION	DATA SHEET 10
LOCATION RIVER THURNE - L B downstream of Lion Dyke.	
METHOD The front face of the eroded bank was filled with dredged material and overlain with a fascine mattress manufactured from a geotextile and willow. This was then filled with dredged material.	
COST Approx. £150-£250/m run	
COMMENTS The reed growth has not as yet migrated into the mattress. Some of the fill is being worked out and may need replacing in future years. If used on a larger scale it would be beneficial to weight the toe with whole stones.	
PHOTOGRAPHS 10.1, 10.2	DATE INSTALLED March 1990

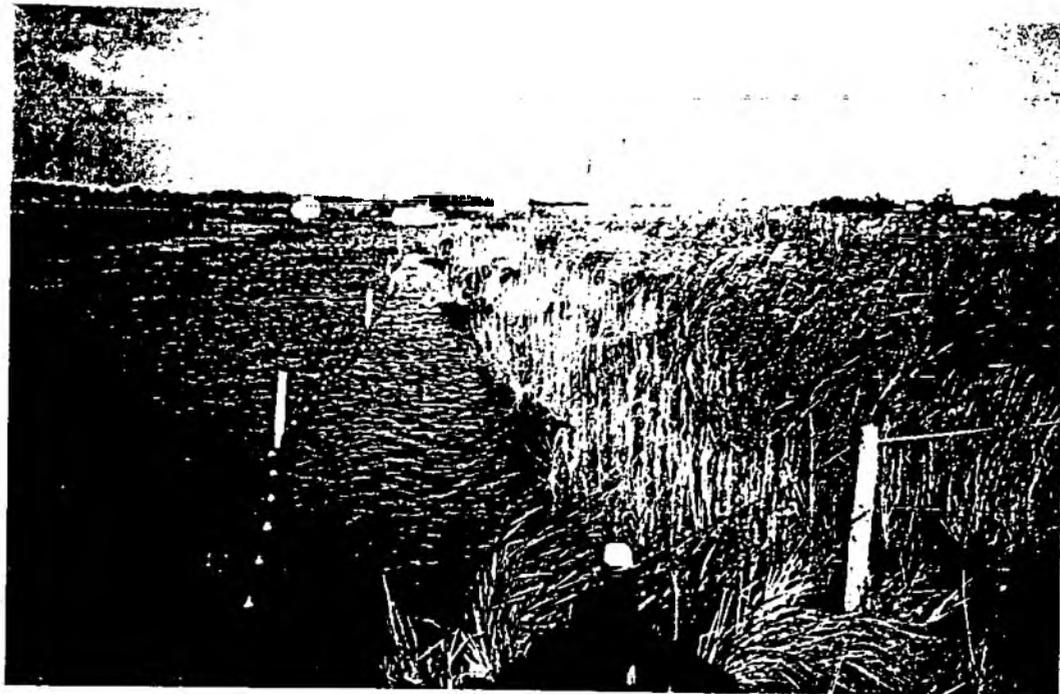
10.2
THE SITE AFTER 1 YEAR

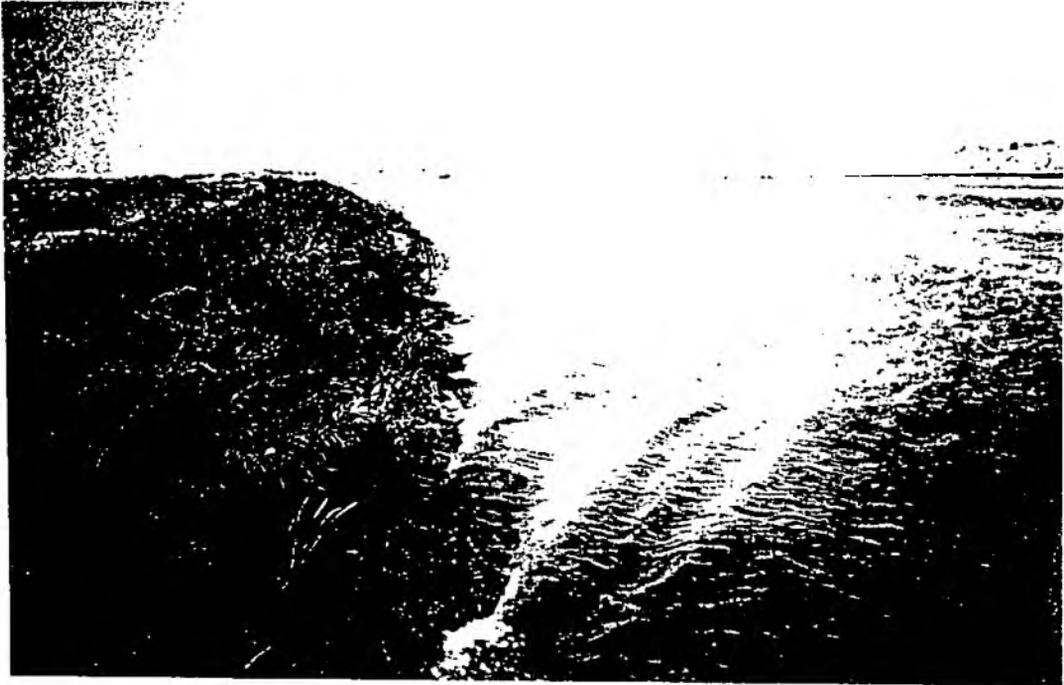
11.1
OPEN CELL CONCRETE BLOCKS (R. BURE)

METHOD The front face of the embankment is filled and graded to approx 1:3 or 1:4. The blocks were laid in mat form on Bure Loop and singly on Nth Breydon - on a Filter fabric.

COMMENTS The 2 locations are at the downstream end of the river systems subject to wave action, and salt water. No reeds were planted under the blocks. They have greened over with grass and other vegetation. A small scale trial in underway which has successfully grown reeds through the geotextile and the cells in the blocks.
