**DEVON AREA  
INTERNAL REPORT**

**INVESTIGATION INTO  
POTENTIAL STORM SEWAGE  
DISCHARGE MOVEMENTS  
DURING SPRING AND NEAP TIDES  
FROM SHARKHAM POINT STORM  
OVERFLOW.**

**NOVEMBER 1999  
DEV/EP/15/99  
(CATCHMENT 06A)**

**Author: S. HUNTER  
ENVIRONMENT PROTECTION  
INVESTIGATIONS OFFICER**

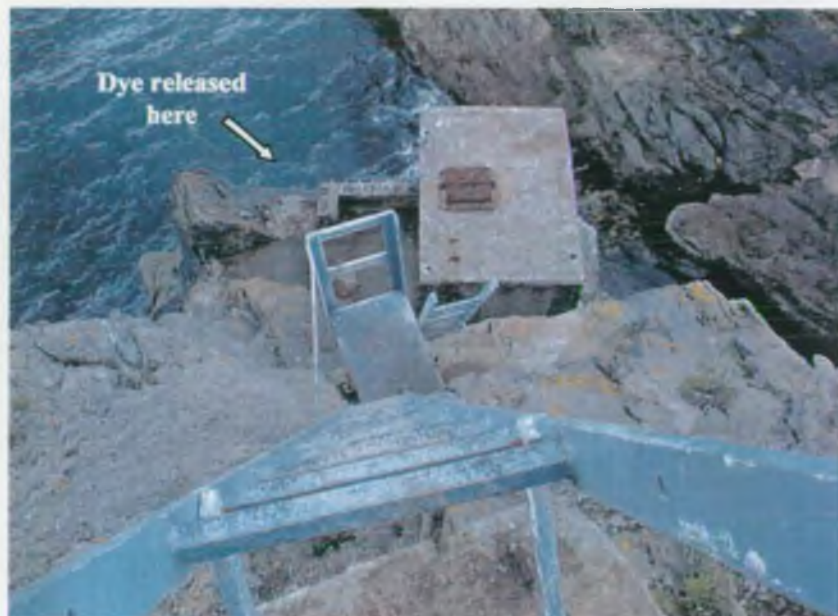
**Plate 1**

Sharkham Point is situated on the southern side of Torbay in South Devon (figure 2). The outfall chamber is located on a rocky outcrop at the base of the cliff. The storm overflow consists of a square opening in the side of the chamber with horizontal bar screens approximately 100mm apart. Access is via ladders permanently secured to the cliff face (see figure 3, plates 1 and 2).

**Sharkham Point, looking down on outfall chamber**

The chamber housing has suffered from pounding by the waves and should be checked for structural integrity.

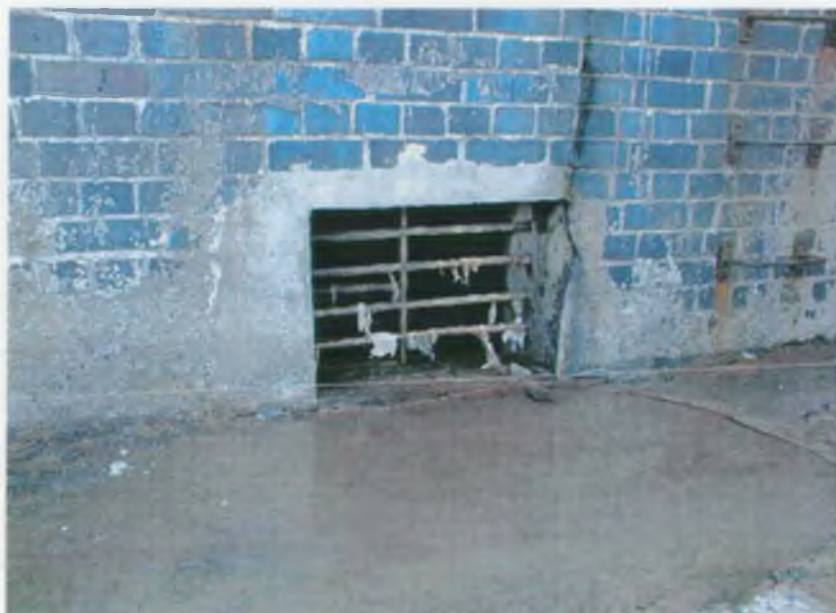
**Plate 2**

During both survey's it was evident the chamber had spilled recently, sewage related debris was on the horizontal bars. See figure 3, plate 2.

**Storm discharge overflow in outfall chamber**

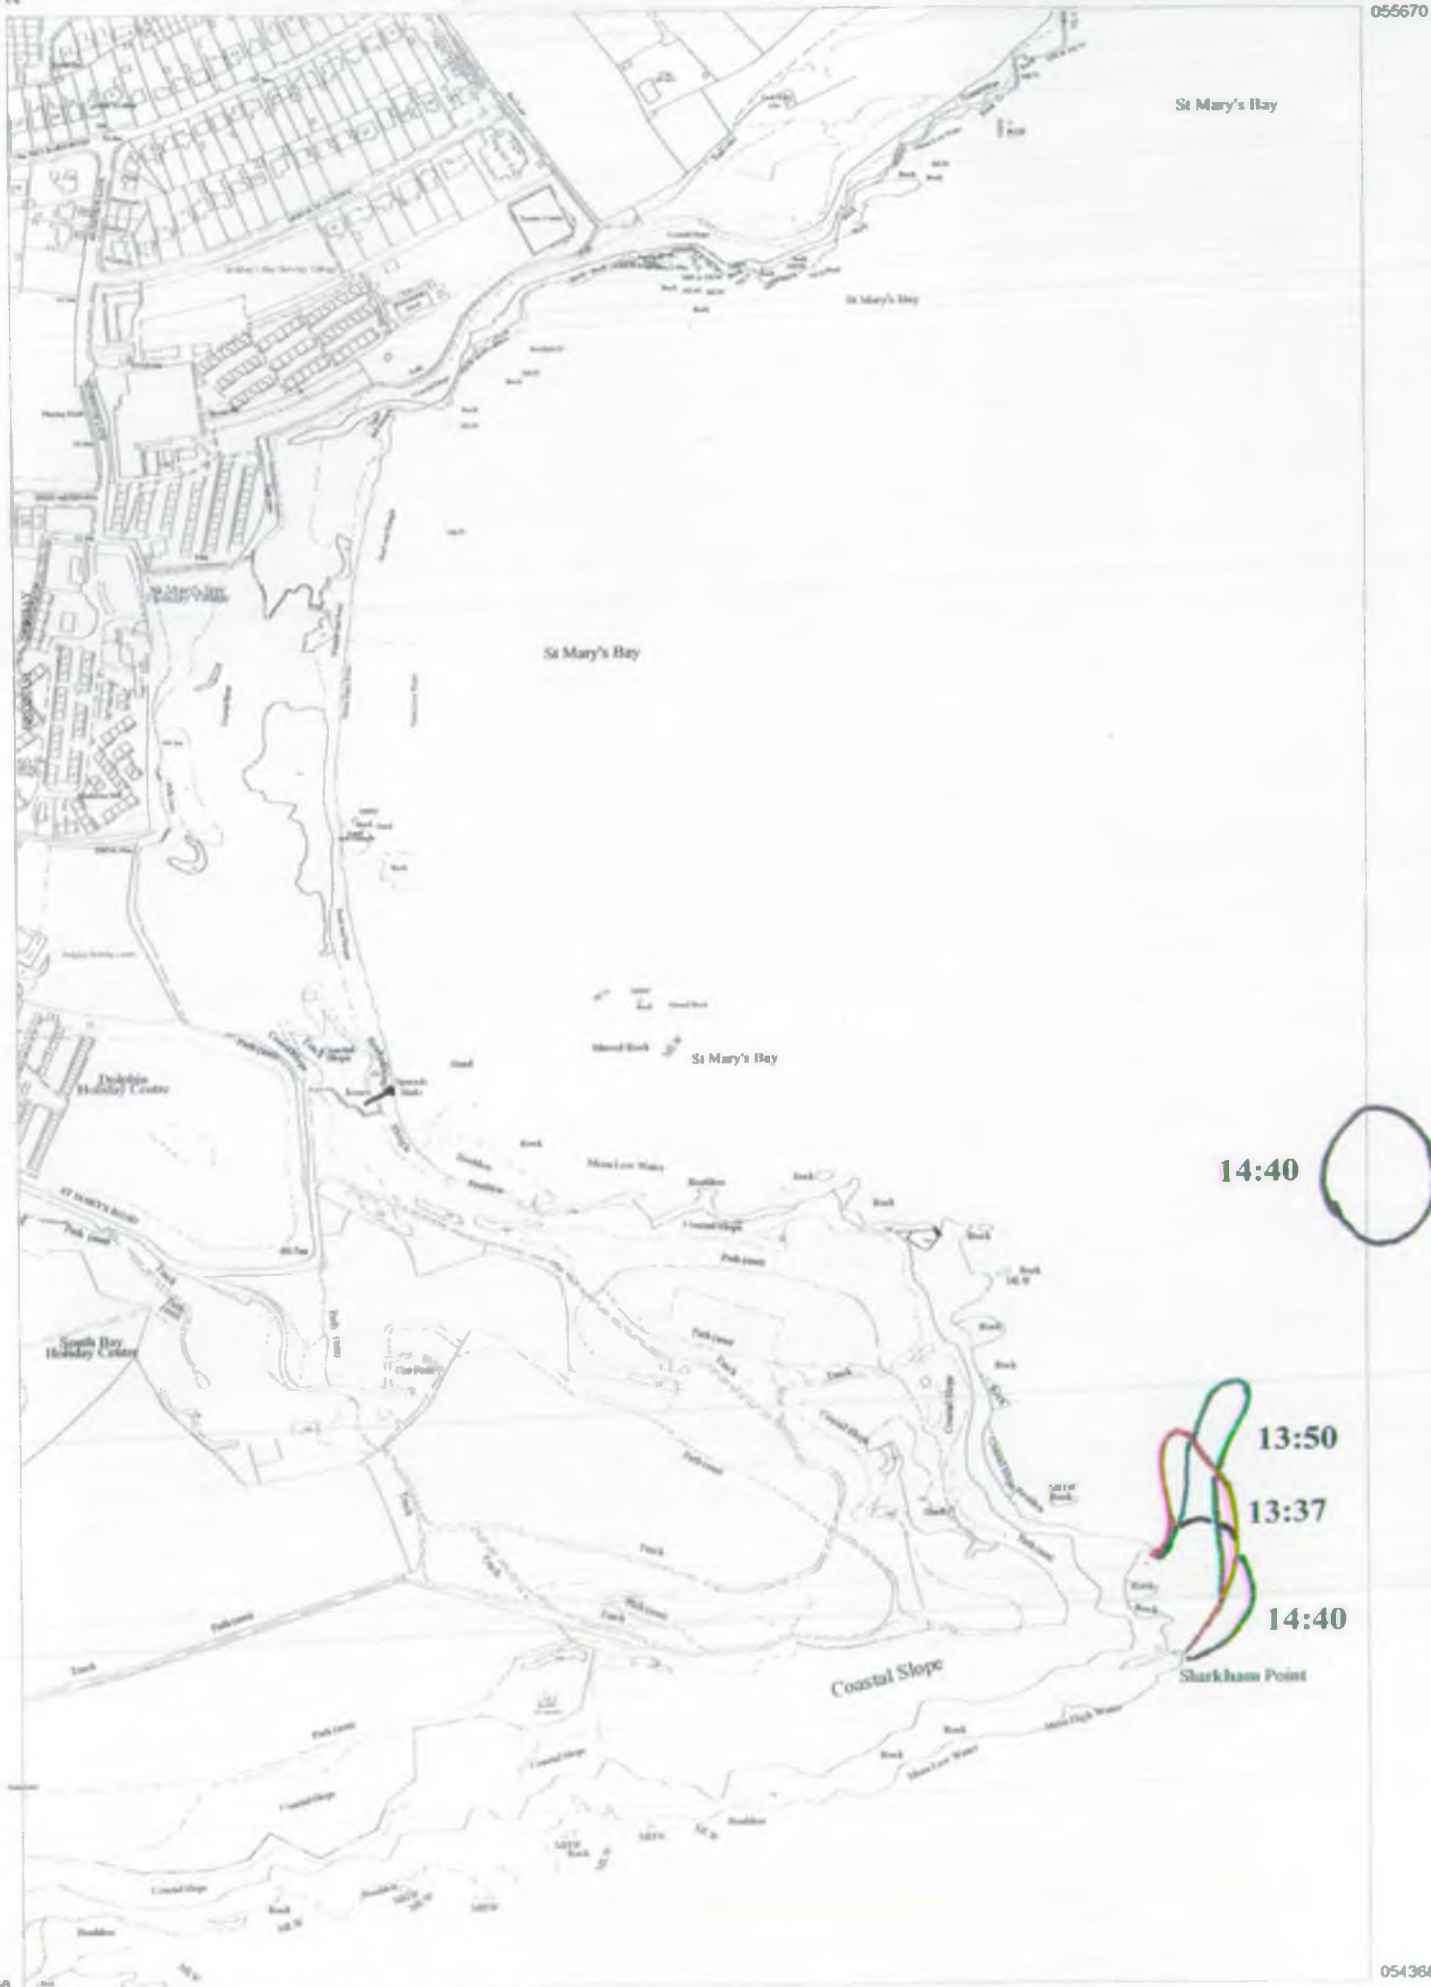
Figure 7

Plates 25, 26 and 27 show release one moving towards St Mary's Bay. Release 2 was made at 13:06 figure 7 shows a diagrammatic representation of the plumes movements. Plate 28 shows release one in the bottom left of the picture and release 2 is visible moving around the headland. Plate 29 shows release one inside St Mary's Bay, plates 30 and 31 are of release one.

Plates 32 and 33 show release two, that initially followed release one but then the leading portion of the plume broke away and moved out to sea, figure 7. This is most clearly visible in plate 35 taken at 14:32, also see figure 3.

2<sup>nd</sup> Dye Release Sharkham Point  
Neap Tide Survey 25<sup>th</sup> May 1999

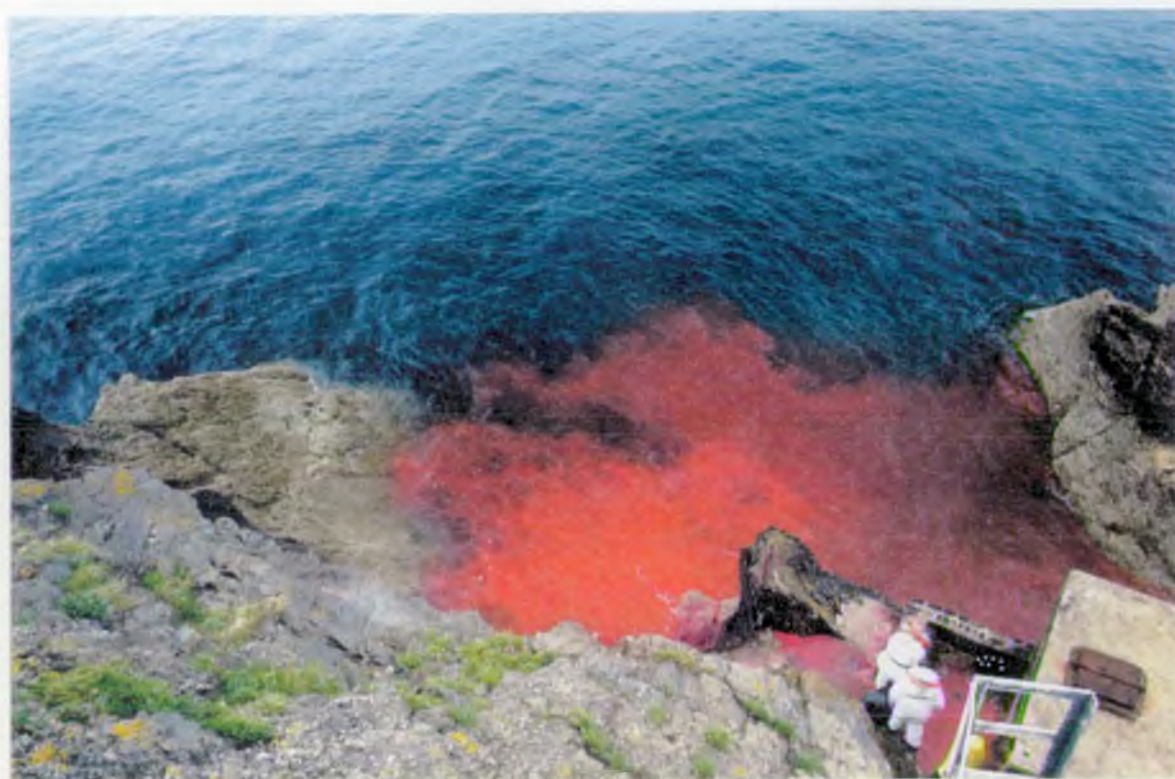
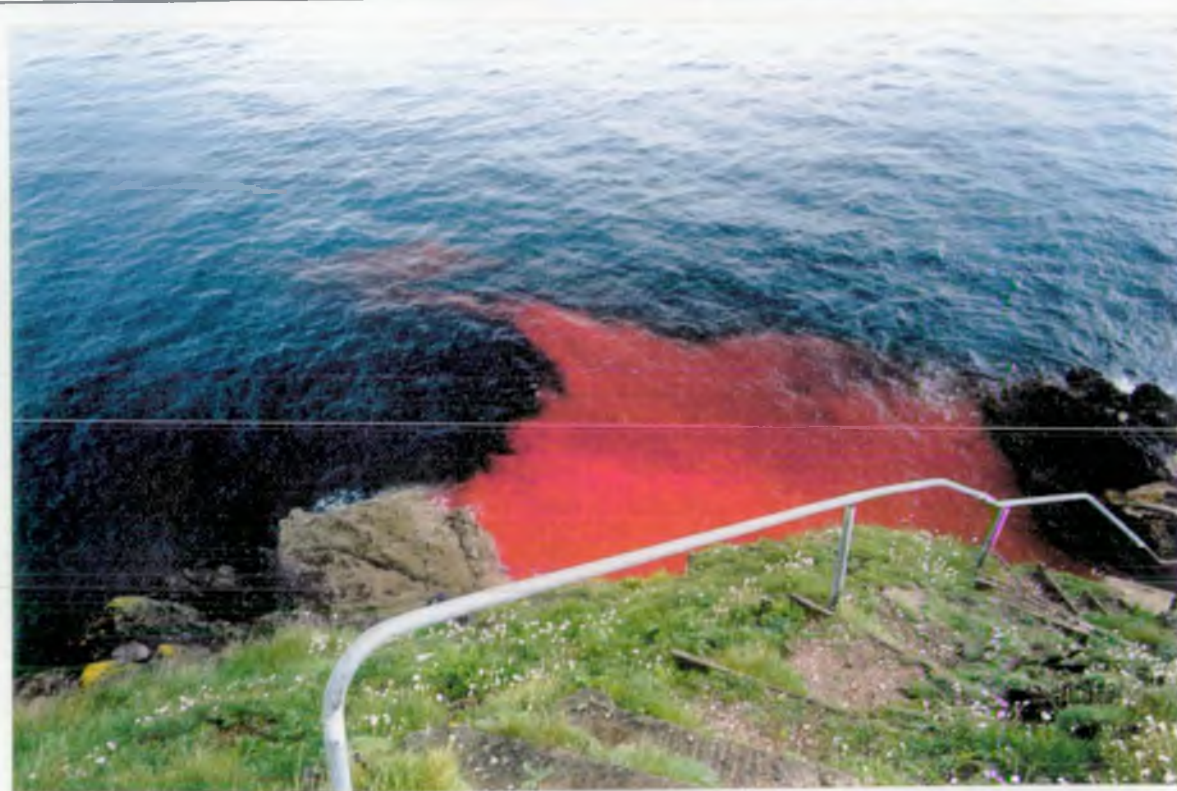
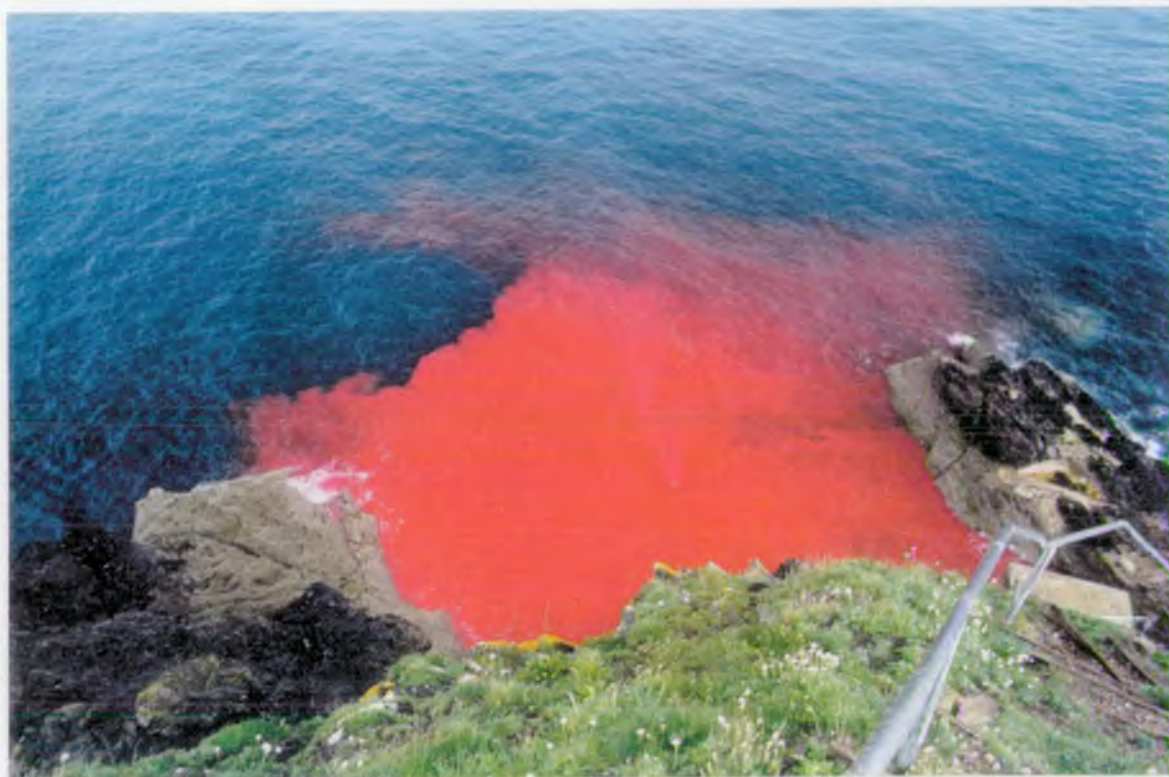
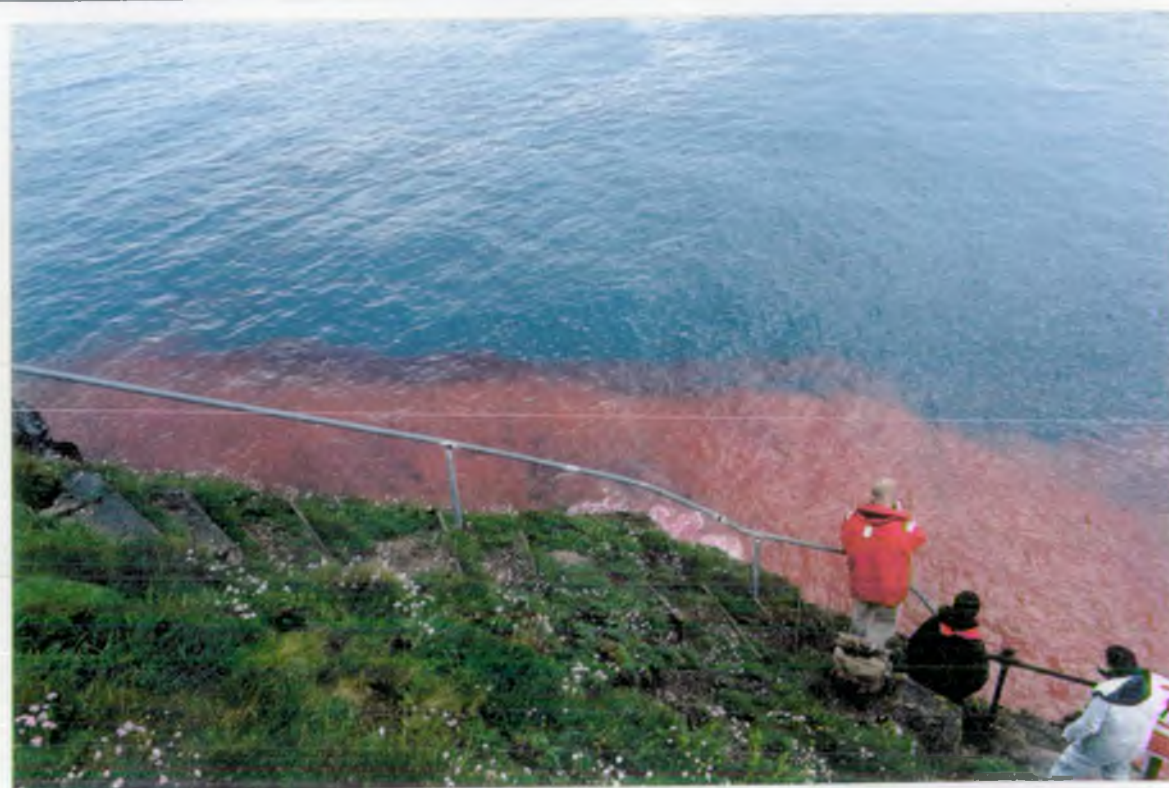
The spring tide survey took place on the 14<sup>th</sup> May. High tide in Dartmouth was 4.90m at 18:13 British summer time. The first dye release was made at 14:57. Plates 3 to 7 show the first release. These plates show the dye pooling against the surrounding rocks and remaining in the locality of the release. Figures 4 and 5 show the movements of the dye drawn on to maps. As the dye remained close to the shoreline the two dye patches merged. Plate 9,12,13, 14 and 15 show the easterly portion of release 2 moving out to sea and dissipating. Due to the lack of movement of the plume only two releases were made. Table 1 shows details of tide, wind speed and direction.

As shown in plates 3 to 17 at no point did either dye release indicate a potential threat from storm sewage discharges to impact upon water quality at St. Mary's Bay Bathing Beach.

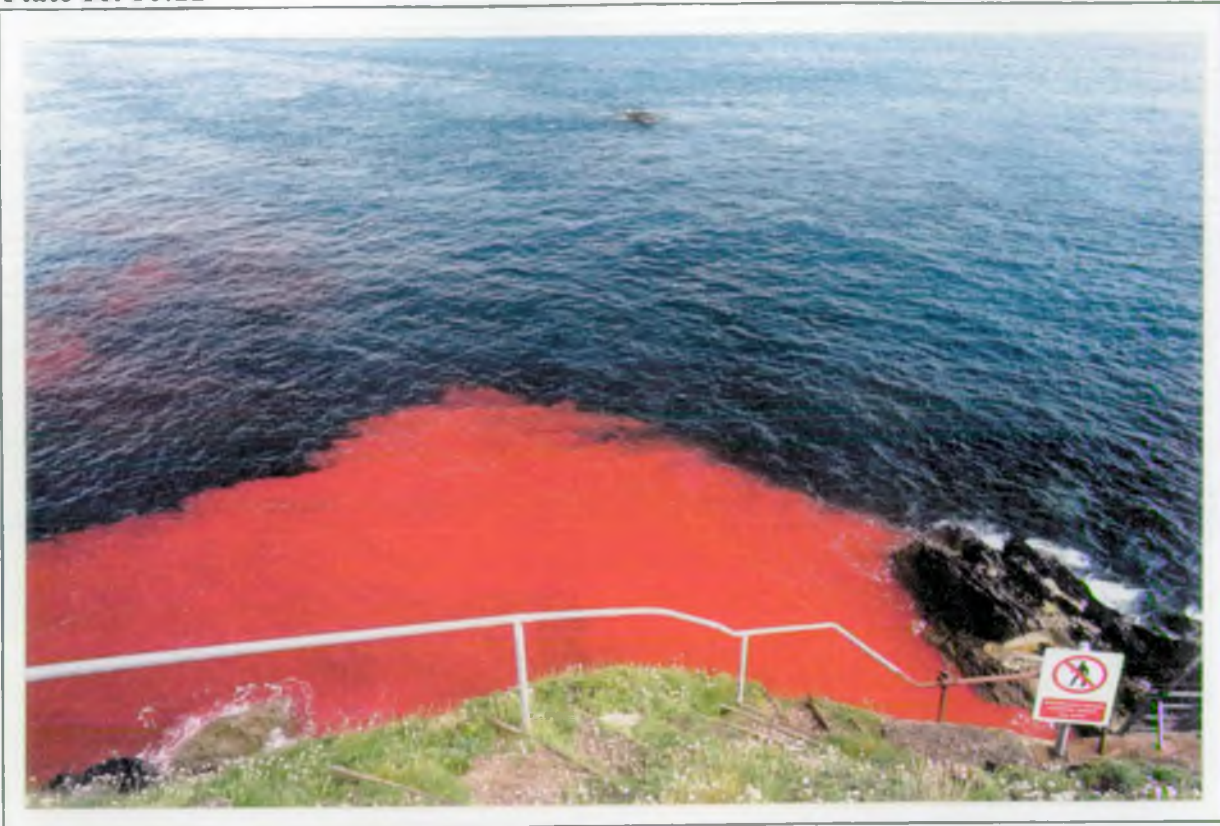
As seen during the second dye release of the neap survey, the plume initially followed the direction of the previous plume then turned out to sea. This turn offshore was seen during the spring tide survey too, see plate 12.

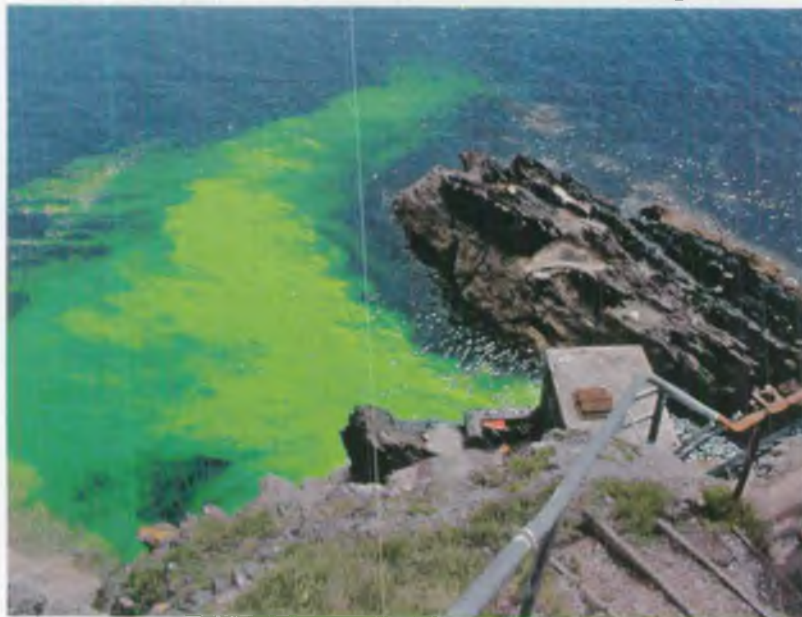
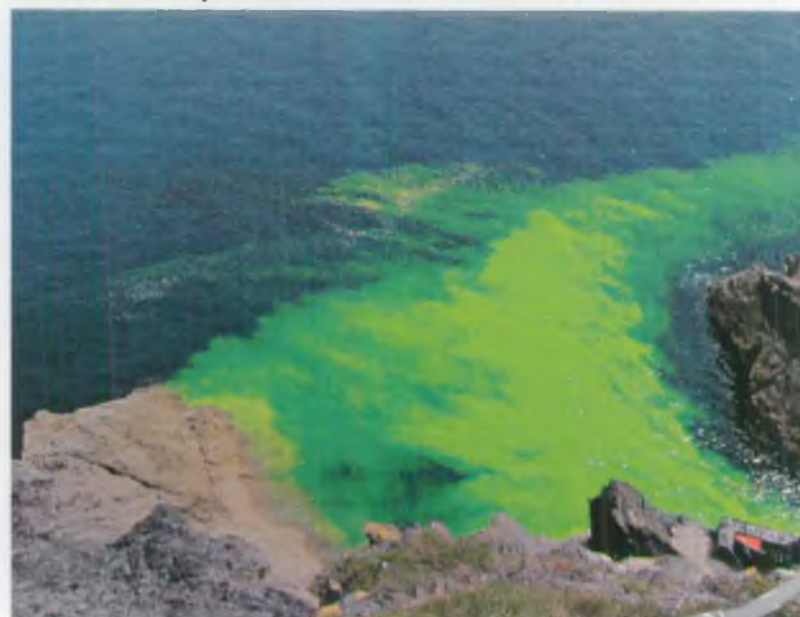
The first release of dye was at 12:16, high tide was 3.99 metres at 15:55 British Summer Time at Dartmouth. The plume was seen to move rapidly in a westerly direction (Appendix 1 plates 18, 19 & 20 and figure 6). When the dye was released some foam was formed (visible in plates 18 & 19, on the left of the plume) this was taken in an easterly direction very quickly by the wind, see plate 21.

**12:19:24 25/05/99 1st Dye Release, 2 litres of fluorescein @ 12:16**

**12:19:47 1st Dye Release**

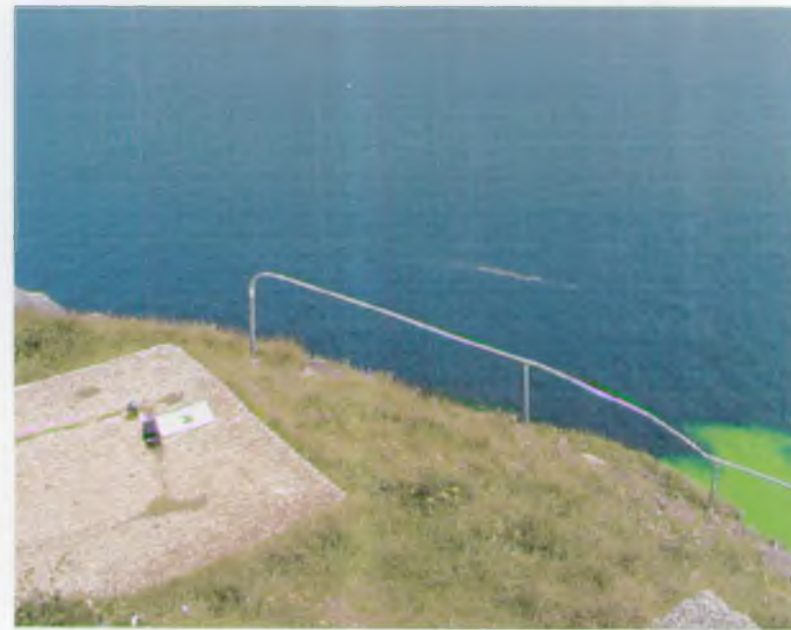
**12:30 1st Dye Release**

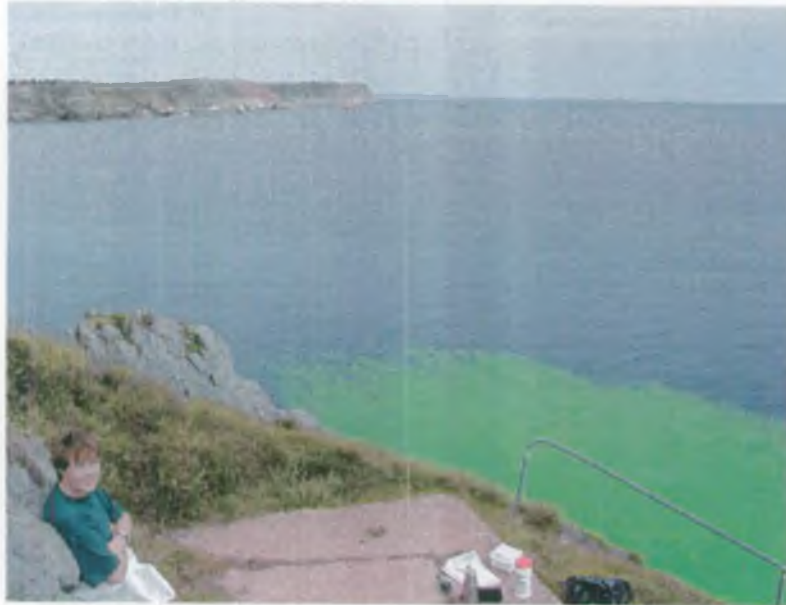
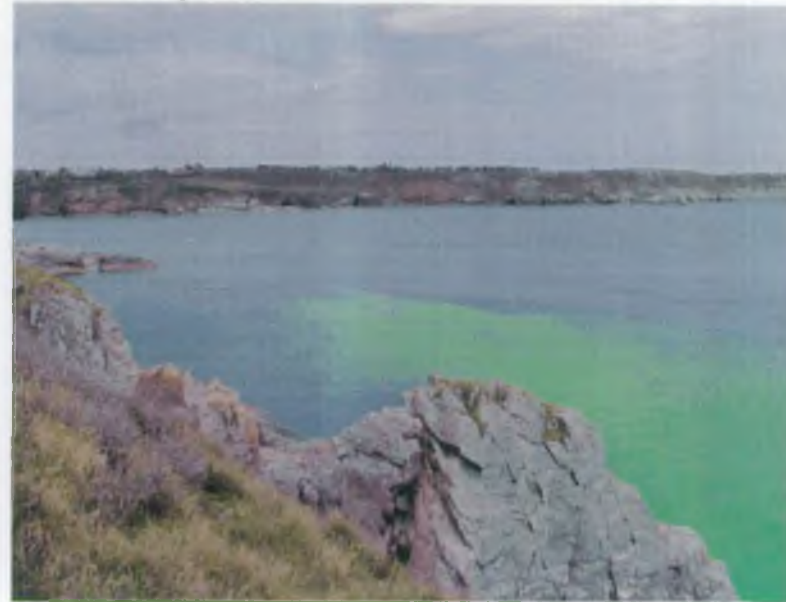
The tide turned at approximately 12:45. At this time the plume was seen to stop moving to the west and began moving swiftly in an easterly direction, plates 22 and 23 show this.

12:52 1st Dye Release  
Plate  
22

13:11:06 1st Dye Release  
Plate  
23

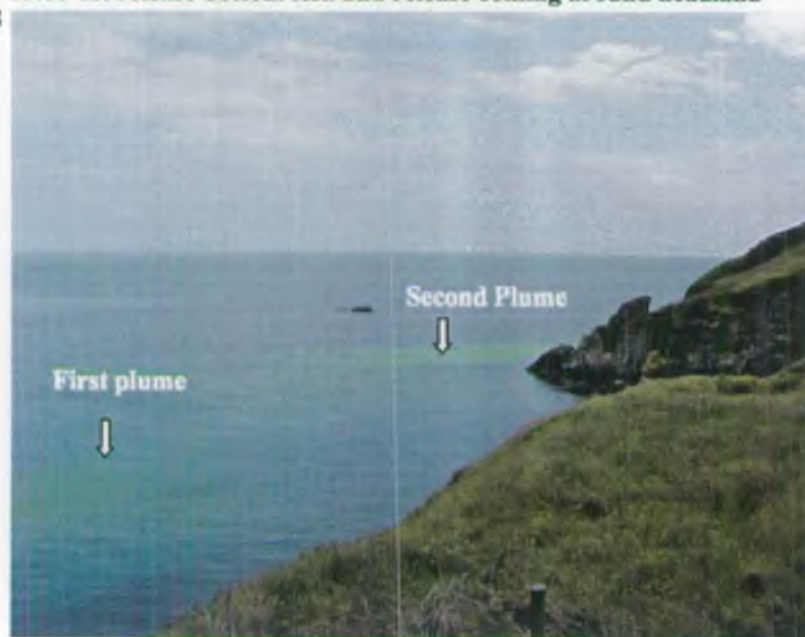
13:33 1st release bottom left. 2nd release coming around headland

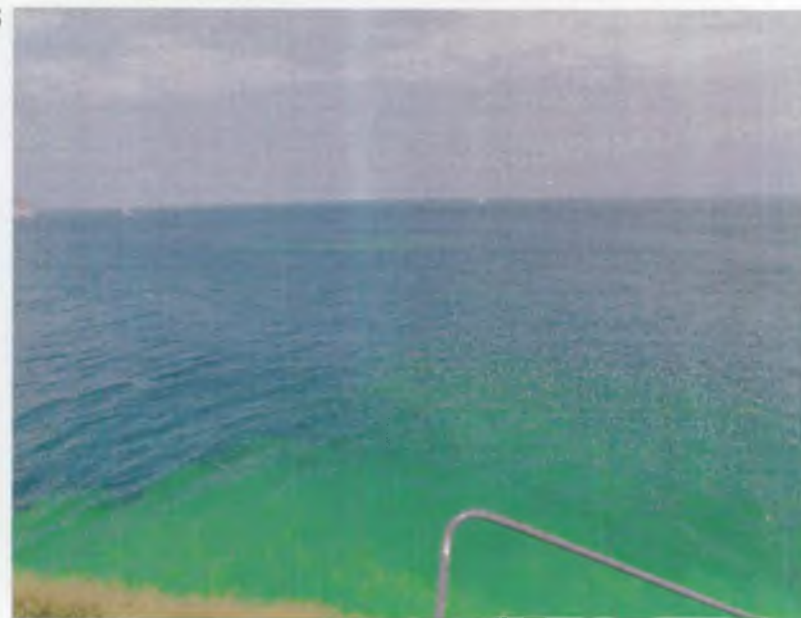
14:32 2nd Dye Rrelease  
Plate 35

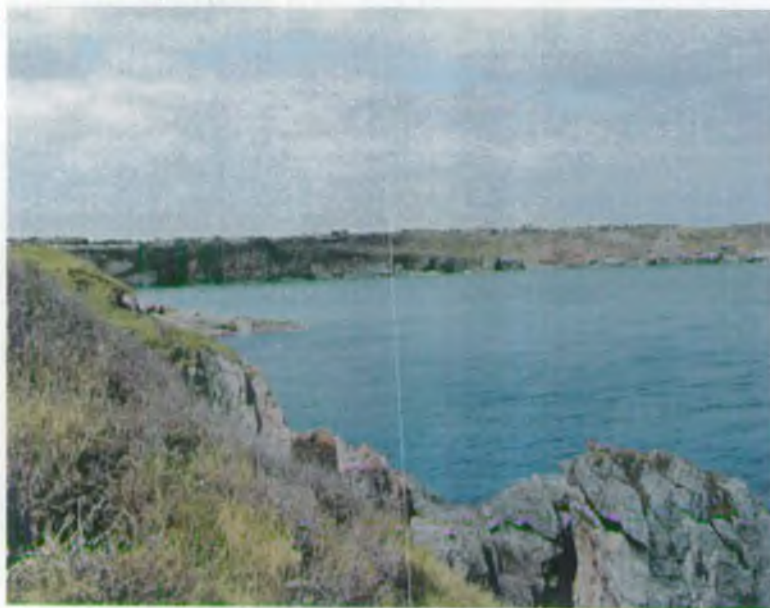
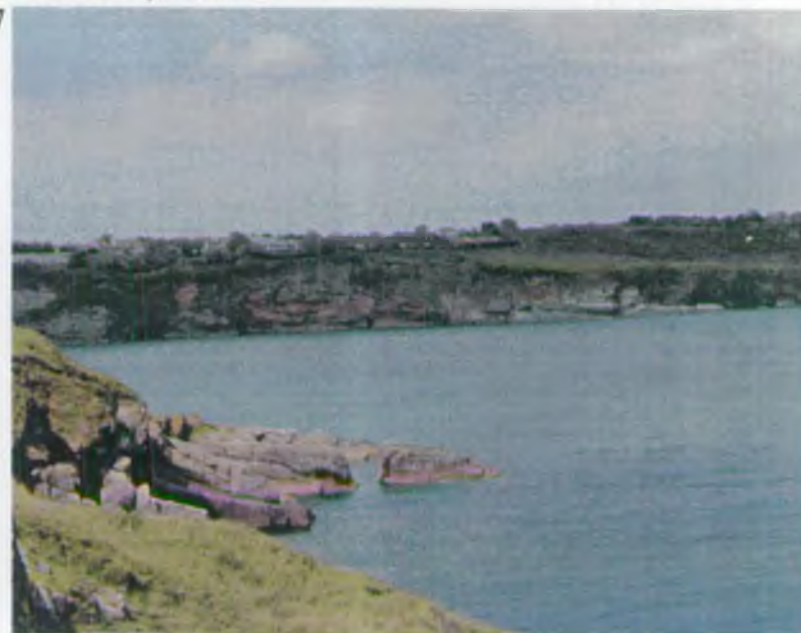
Plates 36 and 37 are of release one but unfortunately the dye is not visible, please refer to figure 6, which is a diagrammatic representation of the dye plume movements visible to the naked eye but too dilute to show up on the photographs. Table 2 shows details of tide, wind speed and direction.

The results from the neap tide survey were very different to those of the spring tide survey. It is evident that the dye patch moved into the vicinity of St. Mary's Bay. It was not actually seen to move onto the beach itself, but the possibility of this can not be ruled out as the dye patch dispersed to a degree where it was not possible to see it at that point (as can be seen in plates 36 and 37).

14:32 1st Dye Release  
Plate 36

14:40 1st Dye Release  
Plate 37
