**DEVON AREA
INTERNAL REPORT**

**ENVIRONMENT
AGENCY**

**BIOLOGICAL INVESTIGATION
INTO THE IMPACT OF THE STORM
OVERFLOW AT MIDDLE
MARWOOD SEWAGE TREATMENT
WORKS.**

**AUGUST 1999
DEV/EP/12/99
(CATCHMENT 30A)**

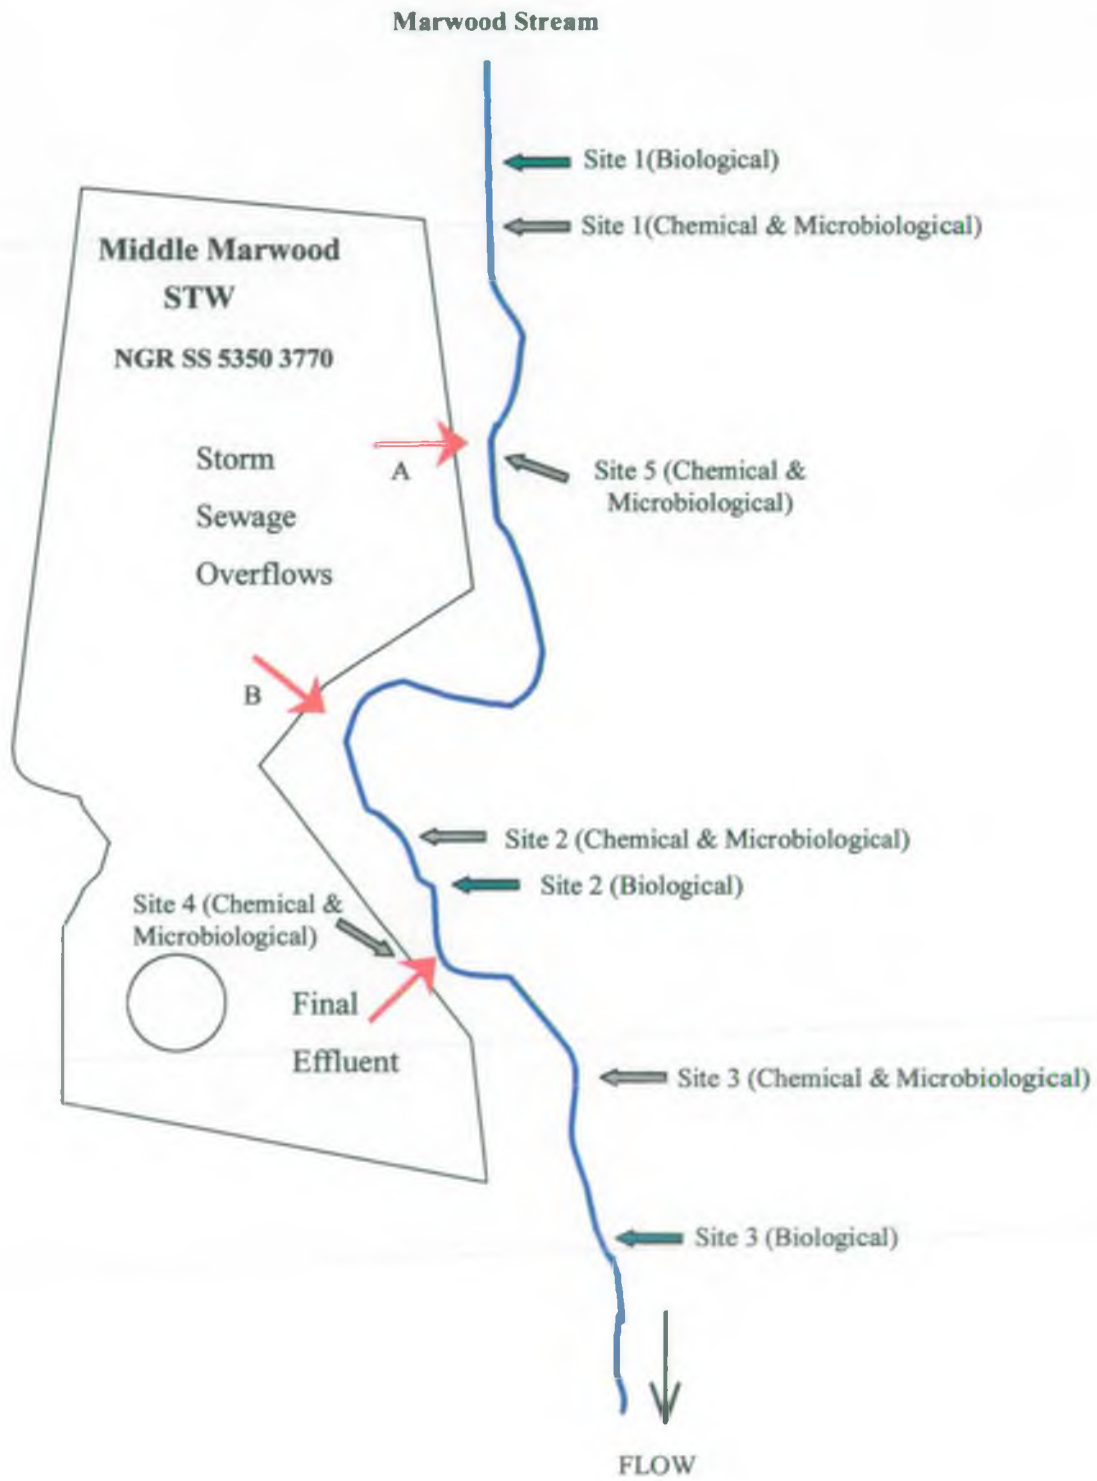
Figure 1.

On 5th November 1998 Alex Grant and myself undertook a site visit to Middle Marwood Sewage Treatment Works. Three sites were selected for biological sampling; site 1 upstream, site 2 down stream of the two storm discharges and up stream of the final effluent and site 3 down stream of the final effluent and storms, figure 1. The location of each site is detailed in Table 1.

Five sites were selected for microbiological and chemical sampling. Site 1 up stream of the sewage treatment works, site 2 between the storm and final effluent and site 3 down stream of the final effluent. Site 5 was storm overflow 'A' and site 4 the final effluent. See figure 1.

Middle Marwood Sewage Treatment Works Showing Biological and Chemical Sample Positions

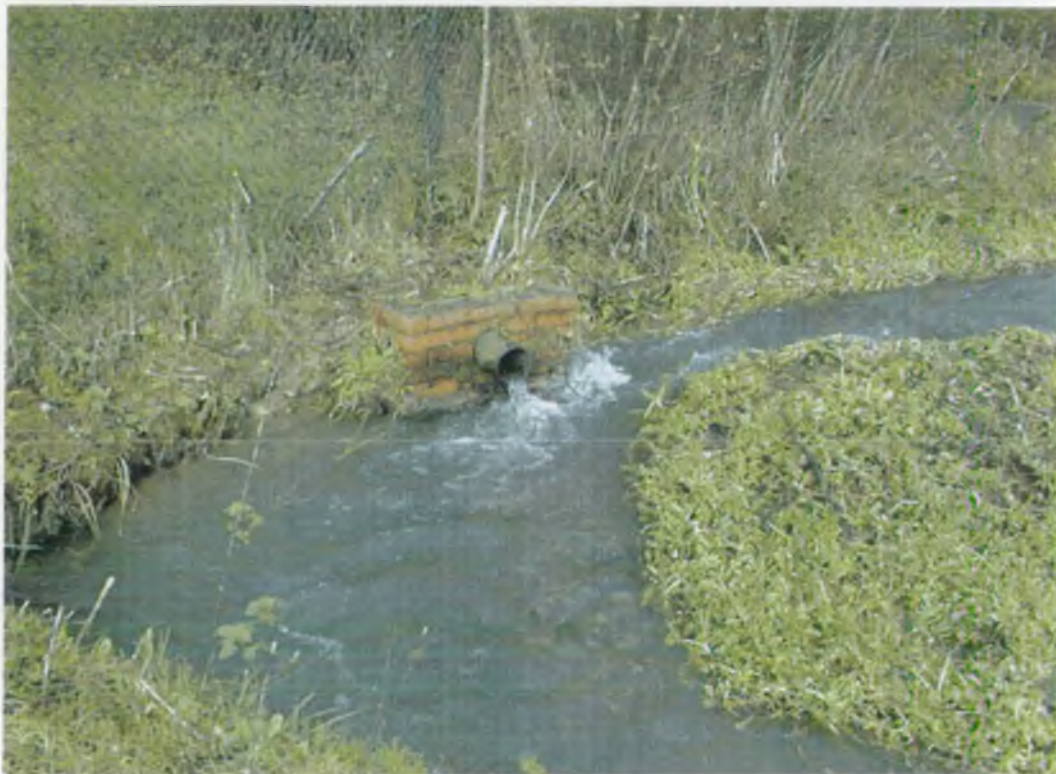
Plate 2

Final Effluent Discharge Situated Downstream From Storm Discharge.

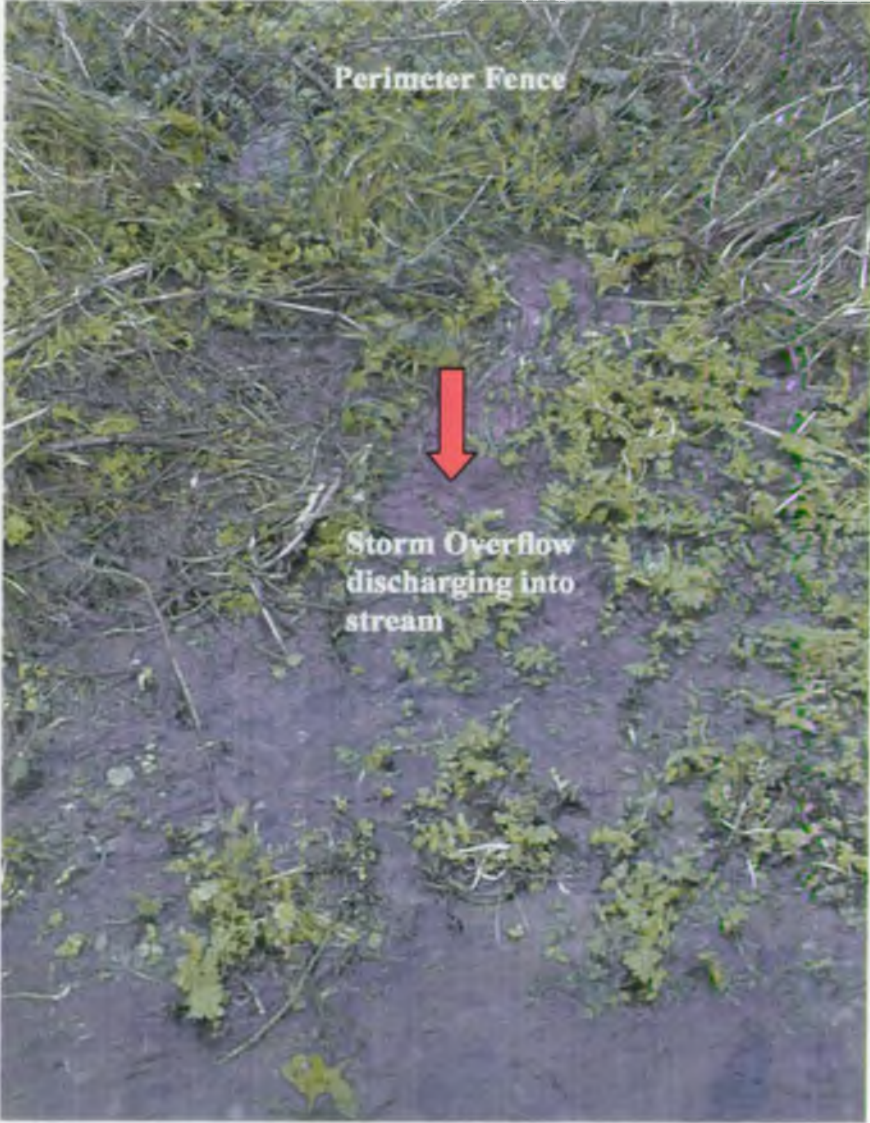
Plate 3

A storm overflows function is therefore to discharge storm water during periods of wet weather when the works receives 6 DWF or the storm tanks are overflowing. Storm overflows also discharge during periods of mechanical or electrical failure within the works. This storm overflow is allegedly discharging during all weather conditions (reported by

EPO), during the two surveys these allegations were corroborated. The evidence indicates that the volume of effluent currently received by the works leads to hydraulic overloading.

Showing Storm Overflow Discharging under fence into stream

Although no significant detrimental impact could be shown from this investigation. Consideration should be given to whether monitoring of the storm overflows should be undertaken to support the continuation of the current embargo.
