ENHANCING The River Otter

ENVIRONMENT AGENCY

Otterton weir is the first and most difficult obstacle in the catchment for fish to negotiate. Surveys showed a 'pool and overspill' pass - a series of stepped pools which fish jump up, attracted by the fast flowing water overspilling the front of the next pool - would be appropriate for the weir.

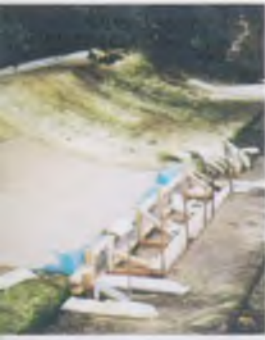
Pools were then created by sections of concrete, each with a smooth lip, which allow an overflow of water during the majority of the year.

The pool and overspill fish pass is a proven design, which will not block readily with trash and debris.

◀ *The concrete pool and overspill pass under construction*

The foundations to the fish pass were excavated adjacent to the old wall and a concrete base laid down.

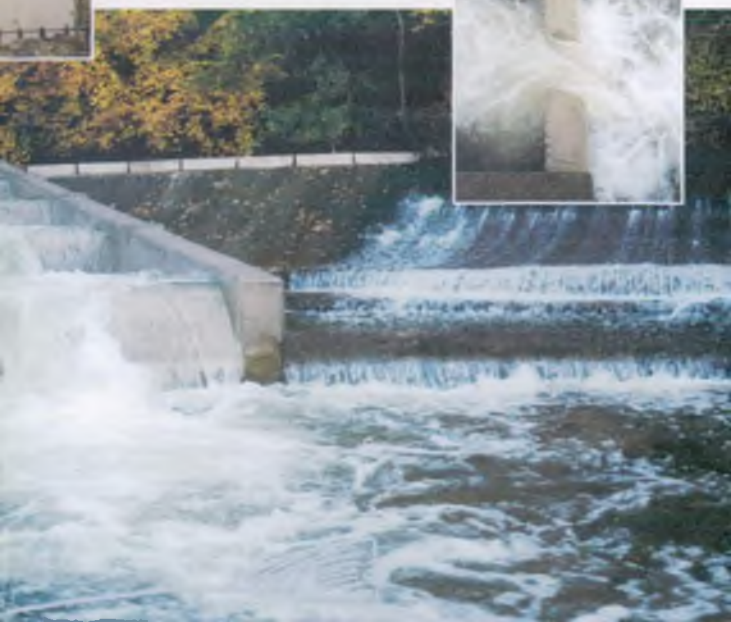
▼ *The completed fish pass*

The weir was initially repaired to maintain stability during construction of the fish pass. Work on the pass began in August 1999 and was completed in December 1999. Sea trout were even spotted attempting to use the fish pass during the last few weeks of construction.
