**RIVER DEBEN (Suffolk)
POLLUTION PREVENTION PROJECT
2001/2**

ENVIRONMENT AGENCY

SUMMARY

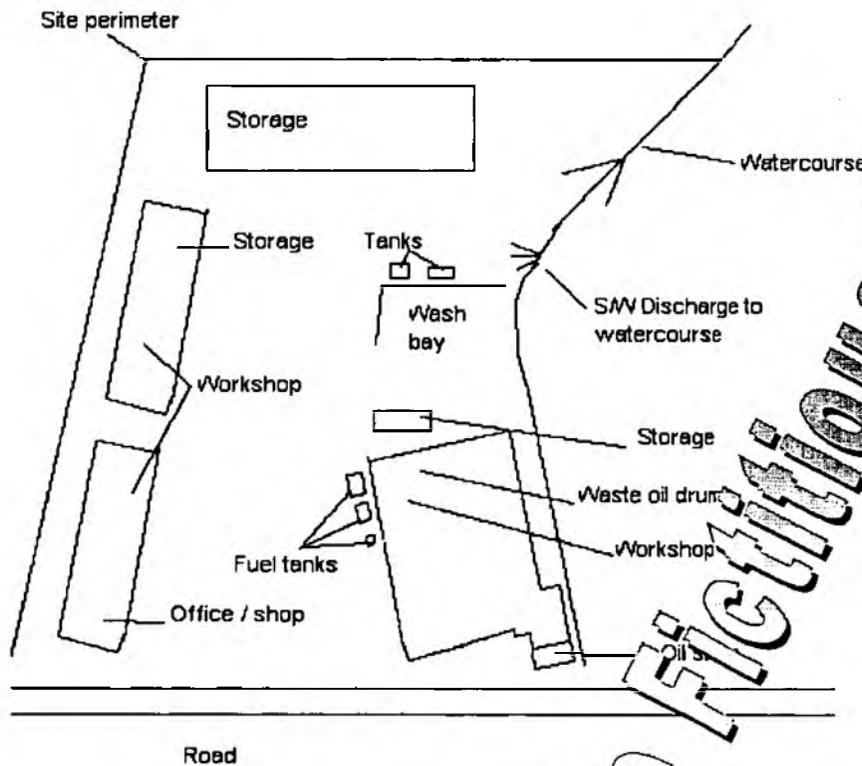
Industry Example Fictitious Data

Name	Mr Engineer
Site Address	Best Works in Ambridge
Contact Name & Address if different	
Telephone number	01234 567890
NGR	AB 123 456
Nature of Business	Agricultural Engineers
Other Sites / Land	Meadow with Barn in Borchester.
Owner / Tenant / Company	Owner
Borehole supplies	No
Water Abstraction	NO
Raw Materials	Lubricating oils 55 X 20 litre drums 4 X 45 gallon drums Paints Creosotes ~ 10 X 25 litre drums Red diesel 1200 gallon tank DERV 1250 gallon tank Paraffin 80 gallon tank
Product	Well maintained equipment
Waste	Waste oil kept in 45 gallon drums
Drainage	Buildings on main sewer Separate collection system for vehicle wash bay.
Contingency Plans	No
Awareness / Attitude	Awareness fair to good Attitude good
Business Ethics	Meadows are organically kept
Surrounding Geology	Very heavy

Service, hire and sell machinery and parts. Engineer / fabricate parts to order.

Site has wash bay, goes to two sealed tanks of 1.2 sq metres 2.5 metres deep have these pumped out.

Waste oils stored in 3 X 45 gallon drums in workshop, solid floor no drains. Bunded.

Fuel and paraffin tanks bunded, close to surface water drain.

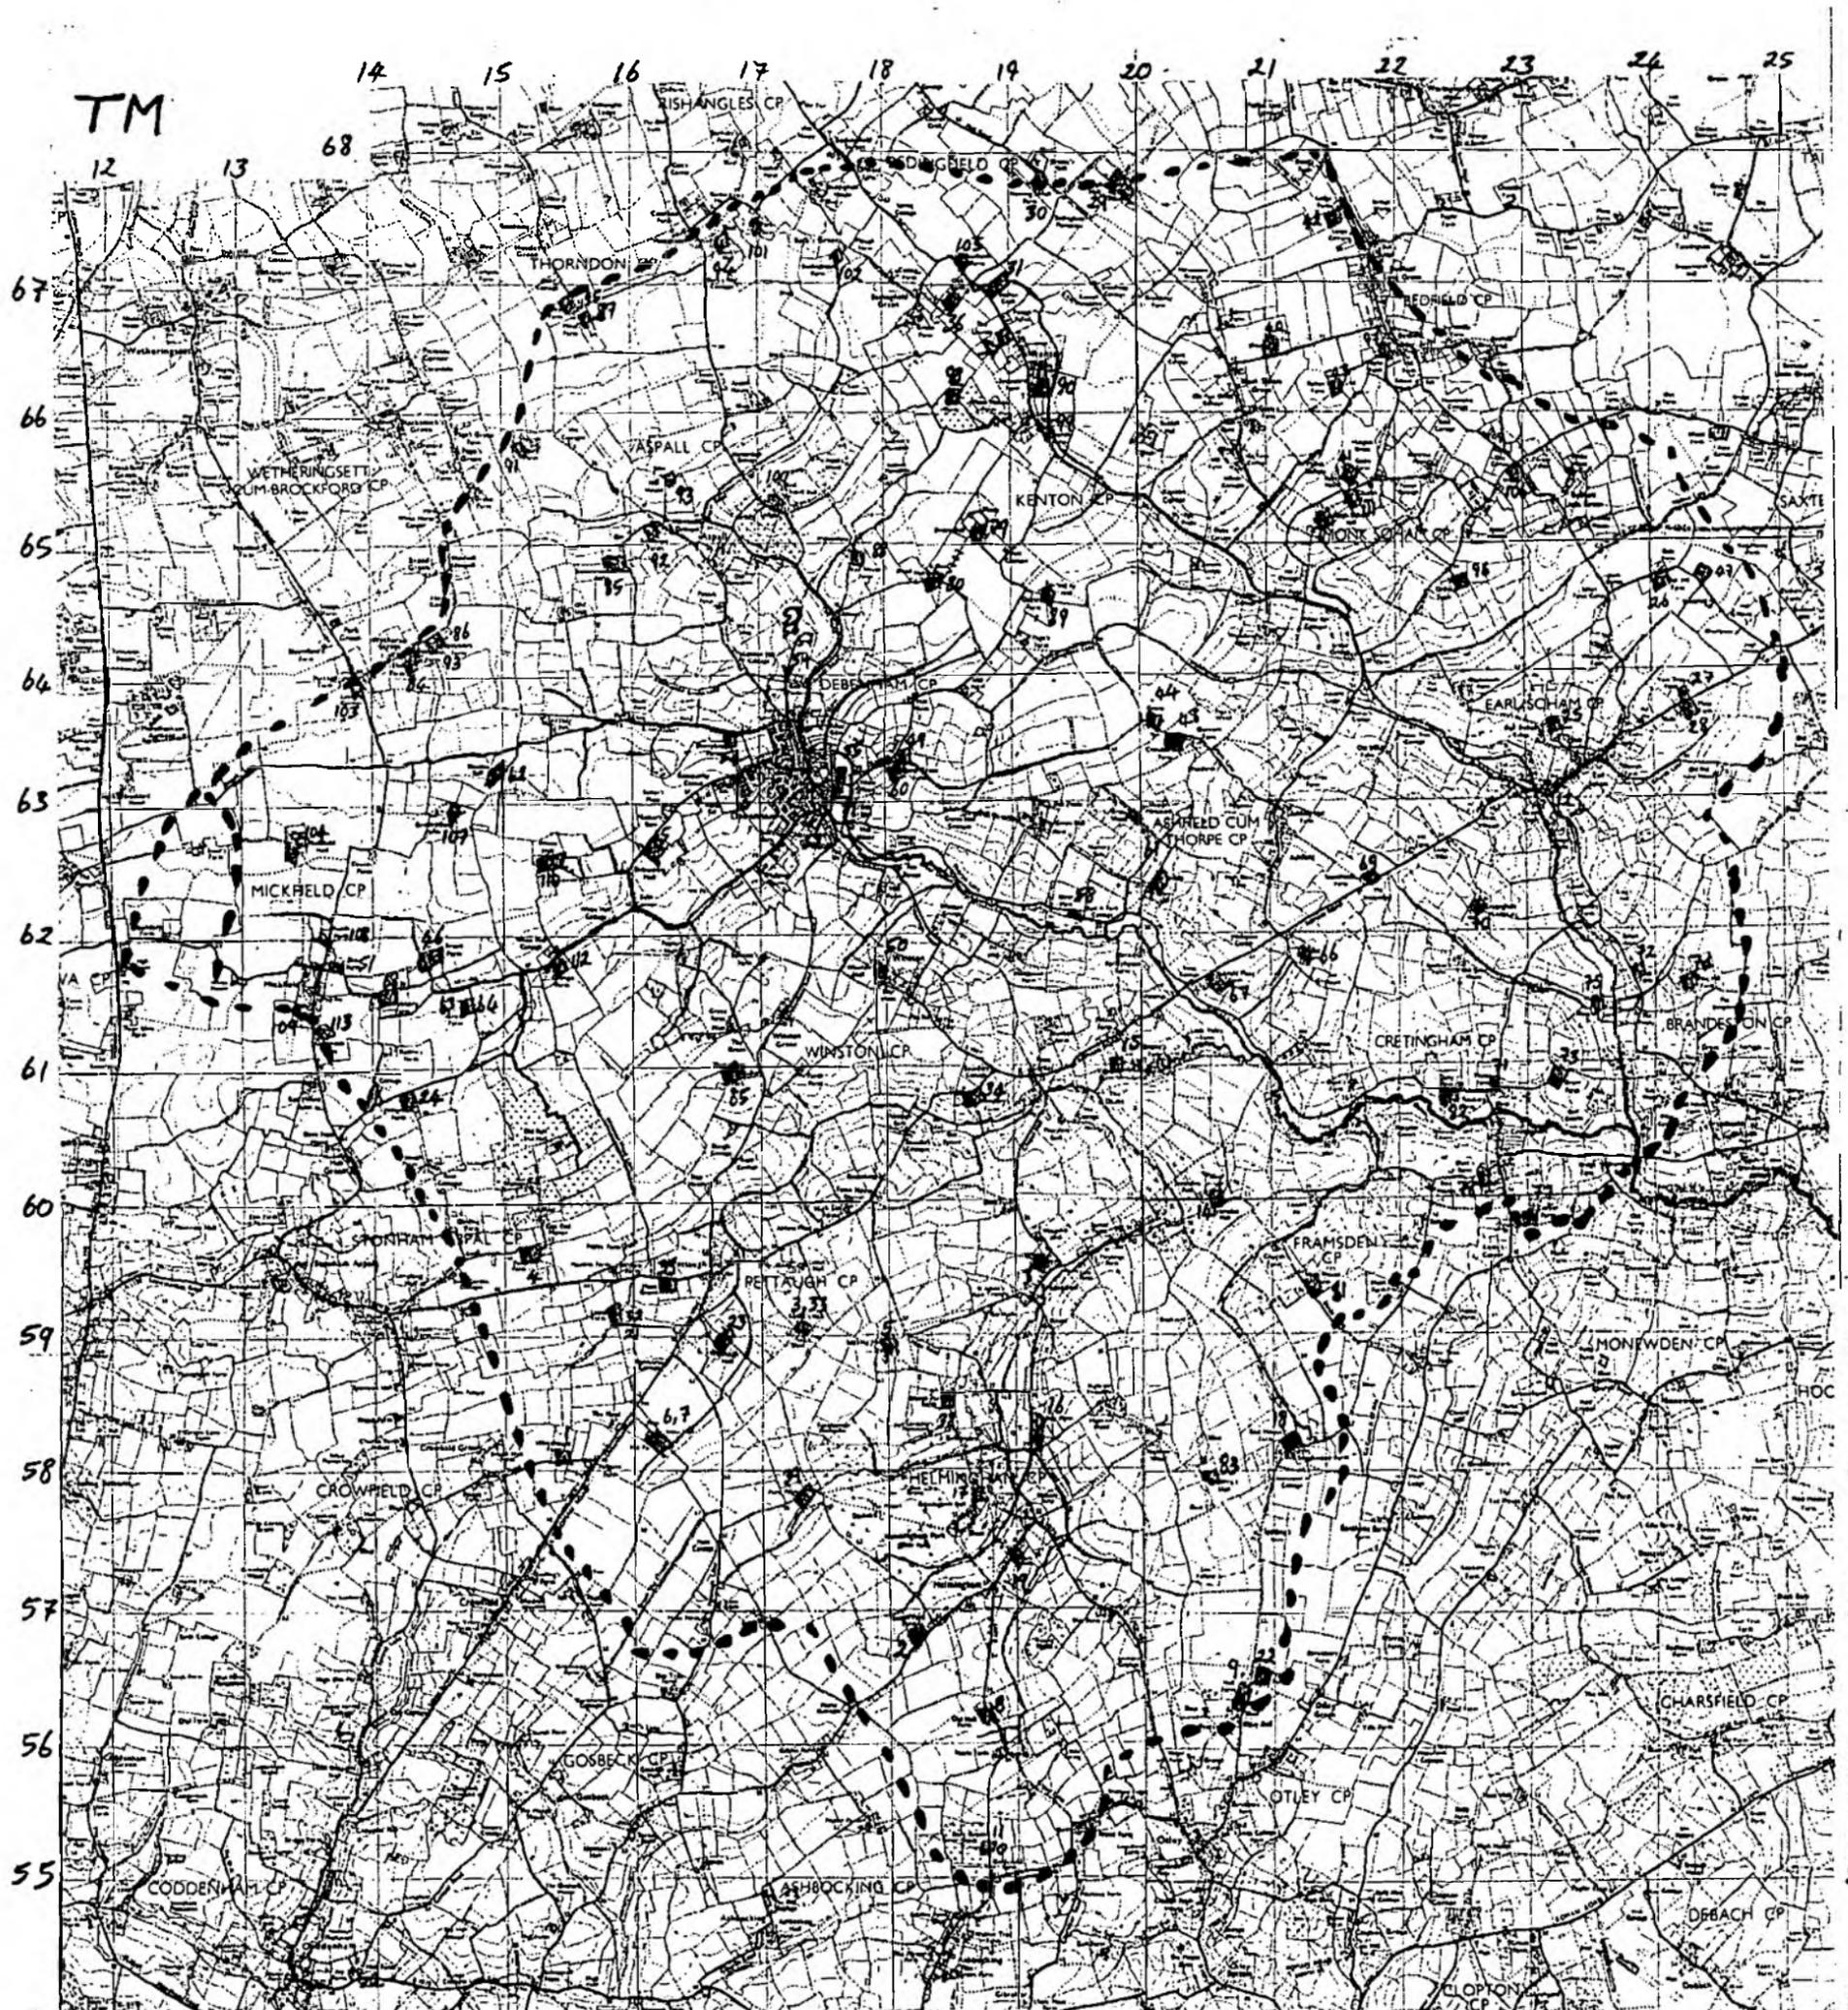
DEBEN MAP Sites located with Project Identity Numbers

This map is also available as 'Debenmap.bmp' from the cd or from Ipswich G:\Env_Protection\Deben. As such it must be opened with Microsoft Photo Editor (available to EA users in 2003). In the editor single click on the zoom icon (a magnifying glass). Position the cursor in the area you wish to enlarge and single click until the required magnification is achieved.

To view the data for a particular site its number within the Project must be found from the map. This can be done from one of the paper copies in the appendix 2 of this report, from the cd or from Ipswich G:\Env_Protection\Deben.

In the case of the electronic version of the map 'Debenmap.bmp' this must be opened with Microsoft Photo Editor (available to EA users in 2003). Open the file from the cd or G drive using the 'open with' option on the right click drop down menu. Single click on the zoom icon (a magnifying glass). Position the cursor in the area you wish to enlarge and single click until the required magnification is achieved. Read the number/s from the map for the site/s of interest. You may move around the map at the magnification chosen or reduce the magnification by holding the shift key down whilst clicking.

For example on 'Debenmap' at Dog Corner, Bedfield you will find a site numbered 106. In 'Data' you will find the file 106, this contains the data collected by the contractor and includes a sketch of the site. File L106 is the first letter sent to the owner of the site and file L106r is a reminder letter. In 'Check list' 106 can be found on the Sheet1 and Retailindustry sheets.

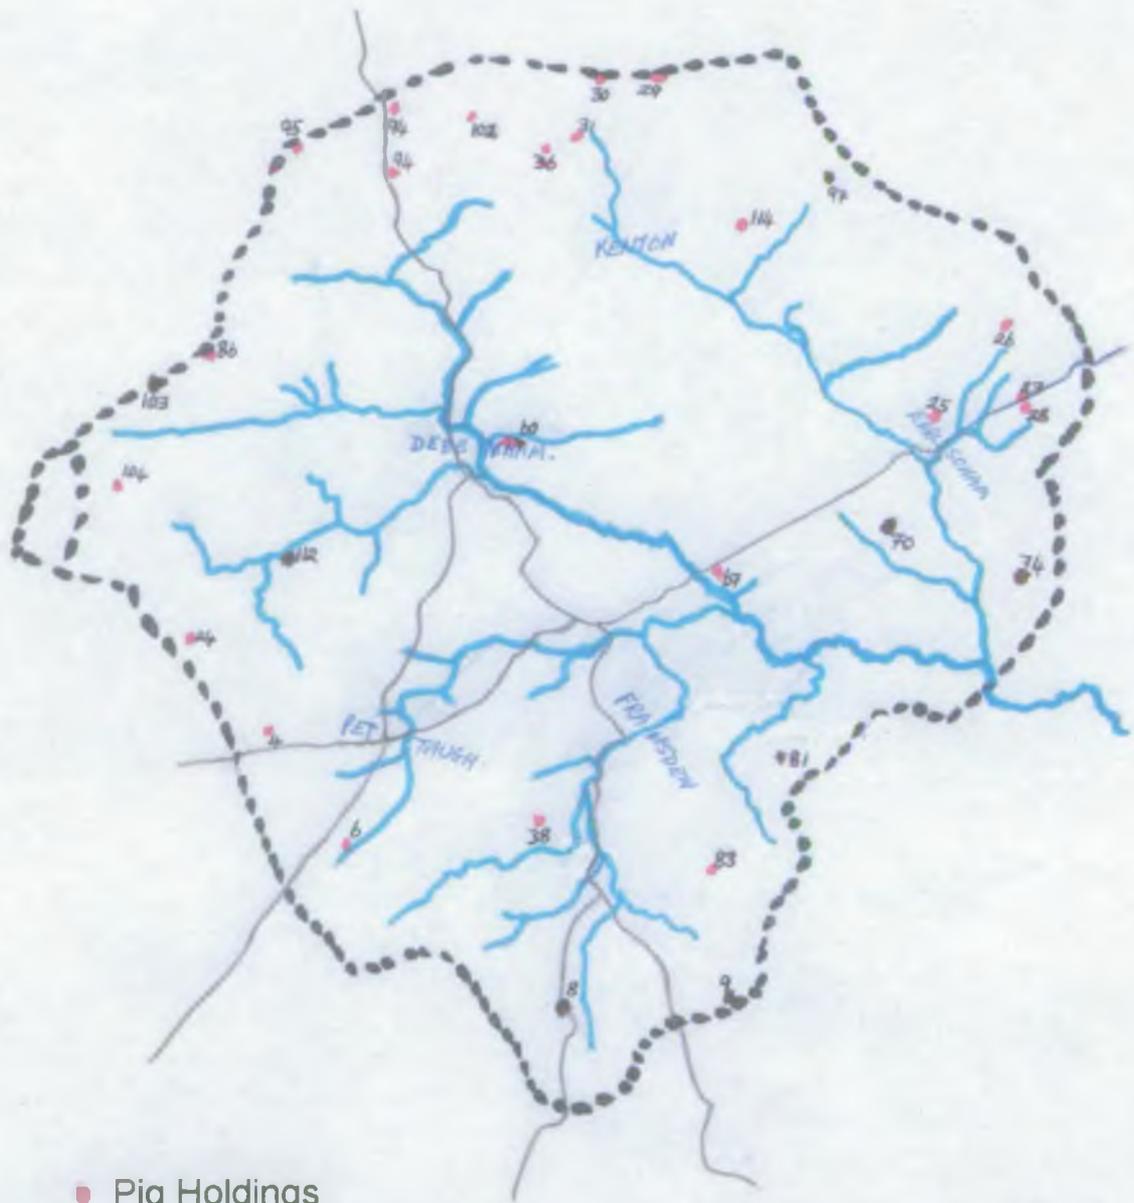
River Deben Project Skeleton Map

Pig and Cattle Holdings

- Pig Holdings
- Cattle Holdings

The skeleton maps may be used to identify the sites with the specific stock type above a particular point on the river. Again the sites number should be noted.
