**RIVER CAMEL EC DANGEROUS
SUBSTANCE DIRECTIVE FAILURE -
1993**

**May 1995
INV/95/002
Author: Peter Long
Investigations Technician**

**AN ASSESSMENT OF RIVER WATER QUALITY IN THE ST. LAWRENCE STREAM SUB-CATCHMENT
FOLLOWING AN EC DANGEROUS SUBSTANCE FAILURE IN THE RIVER CAMEL IN 1993.**

INV/95/002

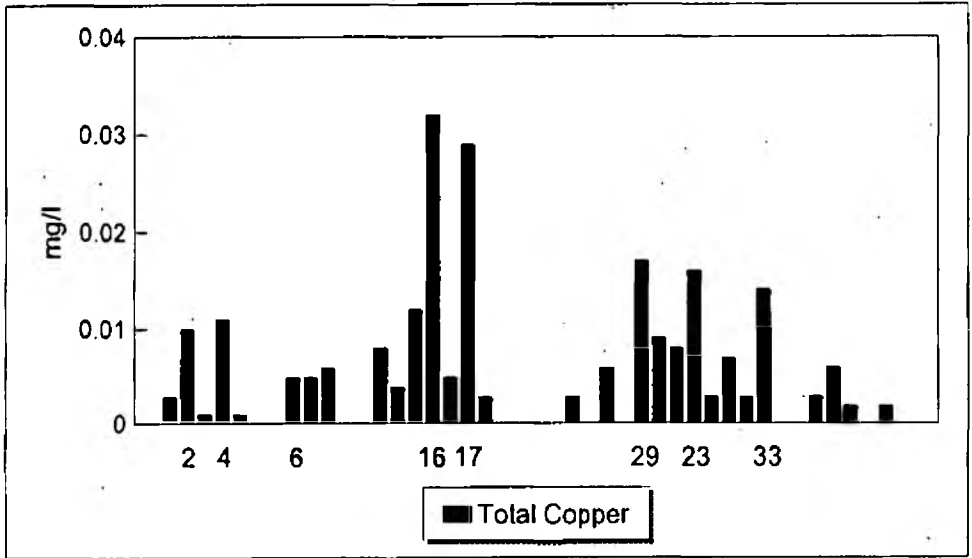
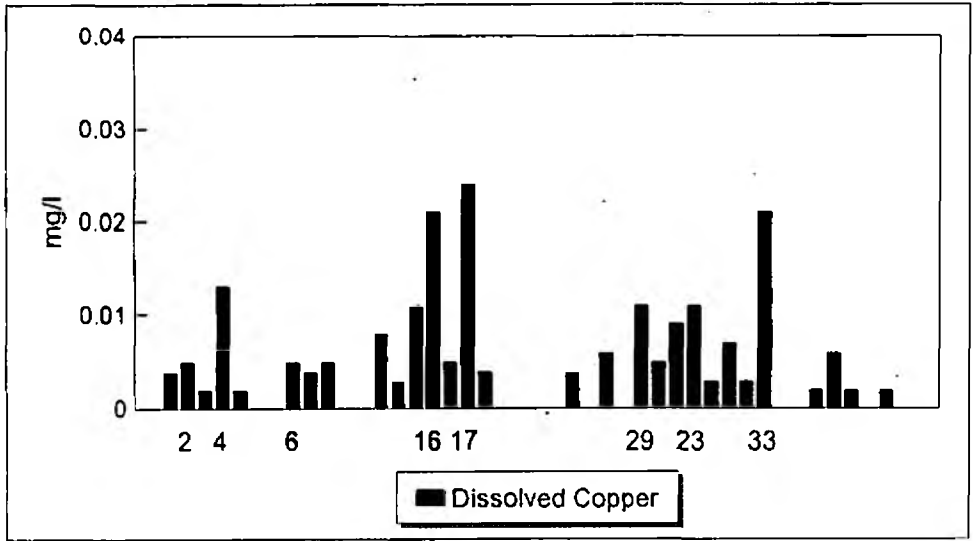
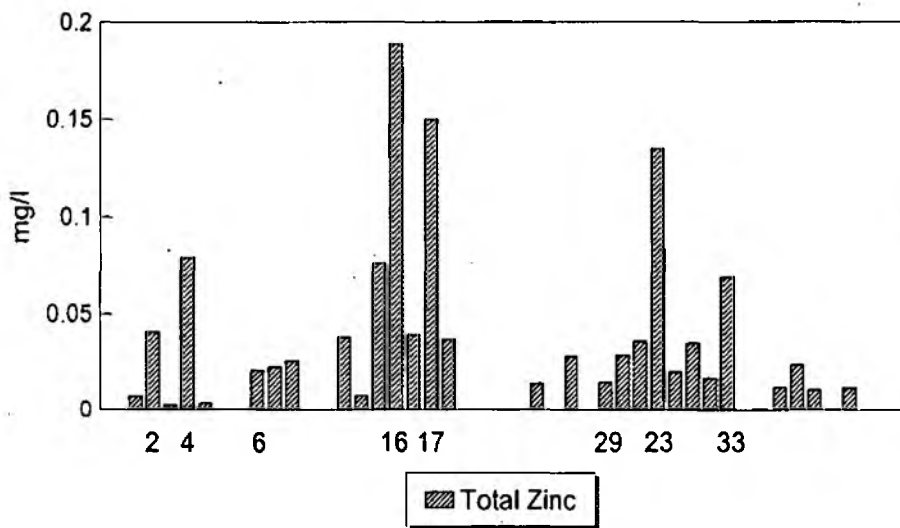
Figure 4. Results of First Phase Chemical Survey

The water chemistry data are illustrated in Figures 4 and 5.

The chemical survey confirmed that reasonably high concentrations of Copper and Zinc were present in the water discharging from both of these areas and, in addition, confirmed that both Bodmin (Scarlet's Well) STW and Bodmin (Nanstallon) STW were also notable sources.
