DEVON AREA INTERNAL REPORT

**AN INVESTIGATION INTO ELEVATED BOD
LEVELS AT BROCKEN BRIDGE (R30H001)
ON THE BARNSTAPLE YEO**

**DECEMBER 1995
DEV/E/20/95**

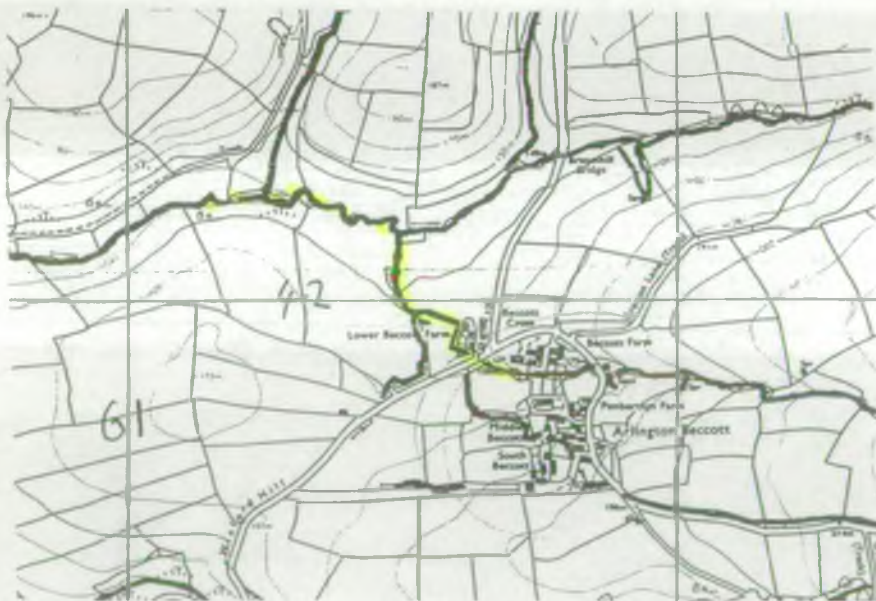
SITE: Beccott Farm area.

Farm Tributary covered with 100% sewage fungus, sewage fungus downstream of this tributary increased to approximately 20 % cover.

On following up, the tributary smelt of farm effluent. Upstream of Lower Beccott Farm, colony sizes increased substantially. No sewage fungus located upstream.

Area of Beccott Farm. Several farms inter-twined. Water Quality Officer for area informed immediately in order to inspect and sample area as necessary.

By the cover and colony size of the sewage fungus present, this is probably a chronic problem exacerbated by rainfall events. The Beccott Farm area has the potential to cause chemical impact at the routine water quality monitoring site downstream at Brockham Bridge.

The Water Quality Officer has been notified in order that the discharge may be controlled.

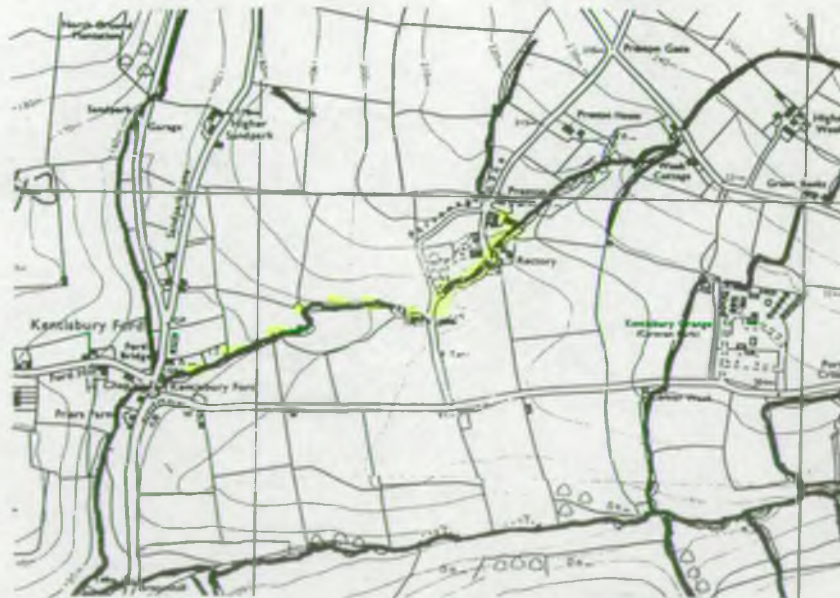
SITE: Preston Farm, 'Rectory' area.

Small stream at side of track covered with 100 % sewage fungus. Causing sewage fungus to approximate 5 - 10 % cover downstream at Kentisbury Ford. Upstream of the farm area there was no sewage fungus present.

The stream runs through Preston Farm and the old Rectory' property. This area was particularly deep with farm waste. Further investigation was not thought appropriate as two work-men downstream of this area has described the farmer to be slightly difficult to deal with.

This farm will probably cause localised impact during wet weather and could contribute to impact downstream at Brockham Bridge under the same conditions.

The Water Quality Officer has been notified .
