OUSE WASHES

BARRIER BANKS IMPROVEMENTS

*National Rivers Authority
Anglian Region*

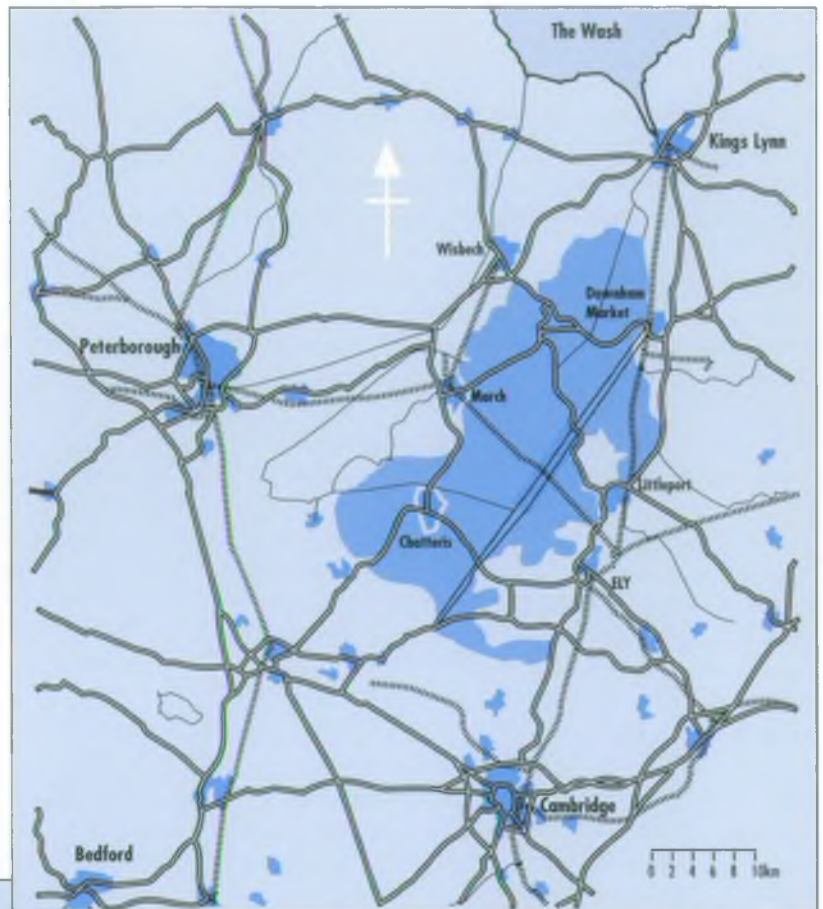
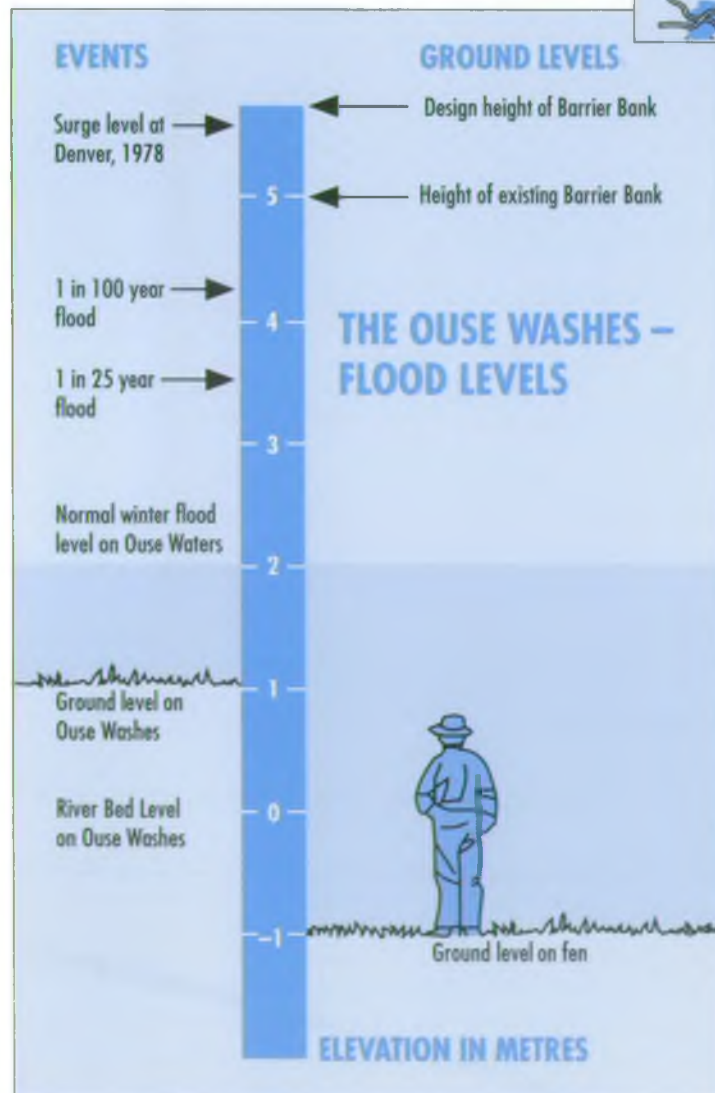
AREAS LIABLE TO FLOOD FOLLOWING A BREACH

Area of fens liable to flood following a breach of the Barrier Banks

If the Barrier Banks were allowed to totally deteriorate the flooding would be even more extensive than shown. The fens would then flood up to Peterborough and Ely.

Failure of the South Level Barrier Bank would affect 230 residential properties with flooding up to a depth of 1.8m causing damage valued at £4.2 million. Up to 11,000ha of high grade land would be flooded with crop damage totalling £12 million. When damage to buildings, machinery, commercial properties, road vehicles, road and rail infrastructure and repair to the bank itself are taken into consideration the total potential damage is estimated at some £23 million.

Failure of the Middle level Barrier Bank would inundate a significantly greater area with damage estimated at some £42 million.

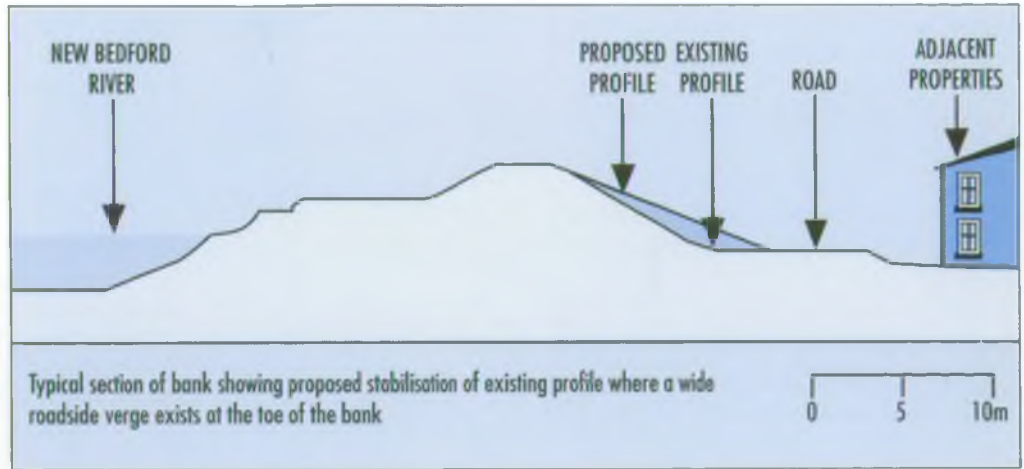
MIDDLE LEVEL BARRIER BANK

The favoured option was for engineering works to raise the Middle Level Barrier Bank throughout its length using imported fill and to stabilise by reforming the bank with a 3m wide bank top width. A haul road is being provided along the bank toe for access and for use by construction traffic. This road will also permit future access for inspection and maintenance. Willow and osier planting, where practical, will be carried out to minimise bank erosion.

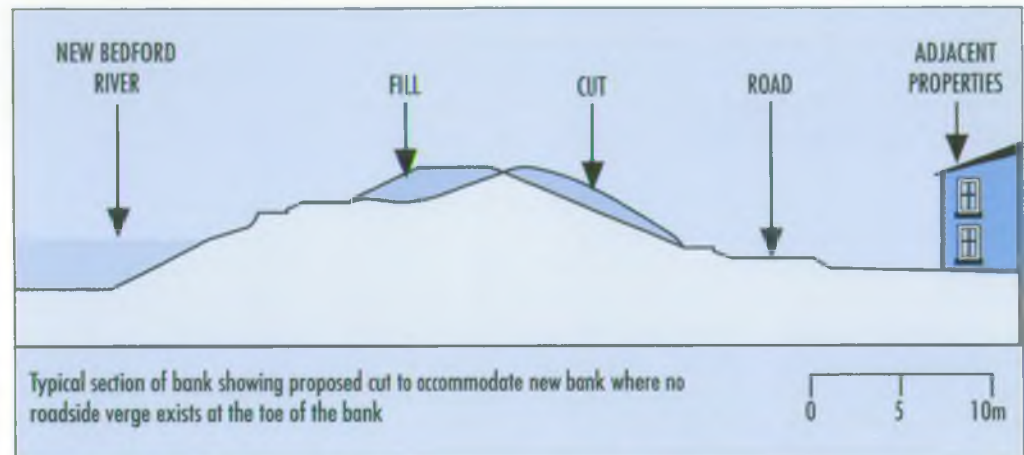
SOUTH LEVEL BARRIER BANK

Studies showed little actual raising of the South Level Barrier Bank was required except just south of Denver and south of Mepal.

The main work is to strengthen the bank either on the back face if there is no road or properties in the way or by moving the bank top towards the river where there are obstructions on the Fen side. On some isolated stretches additional reprofiling work will occur on the riverside face of the bank.
