DEVON AREA
INTERNAL REPORT

INVESTIGATION OF THE
WATER QUALITY IN THE
BUCKLAND STREAM UP
AND DOWNSTREAM OF
EAST / WEST BUCKLAND

April 2000
DEV/EP/05/00
(CATCHMENT 08A)

Author: P. ROSE
ENVIRONMENT PROTECTION
INVESTIGATIONS OFFICER

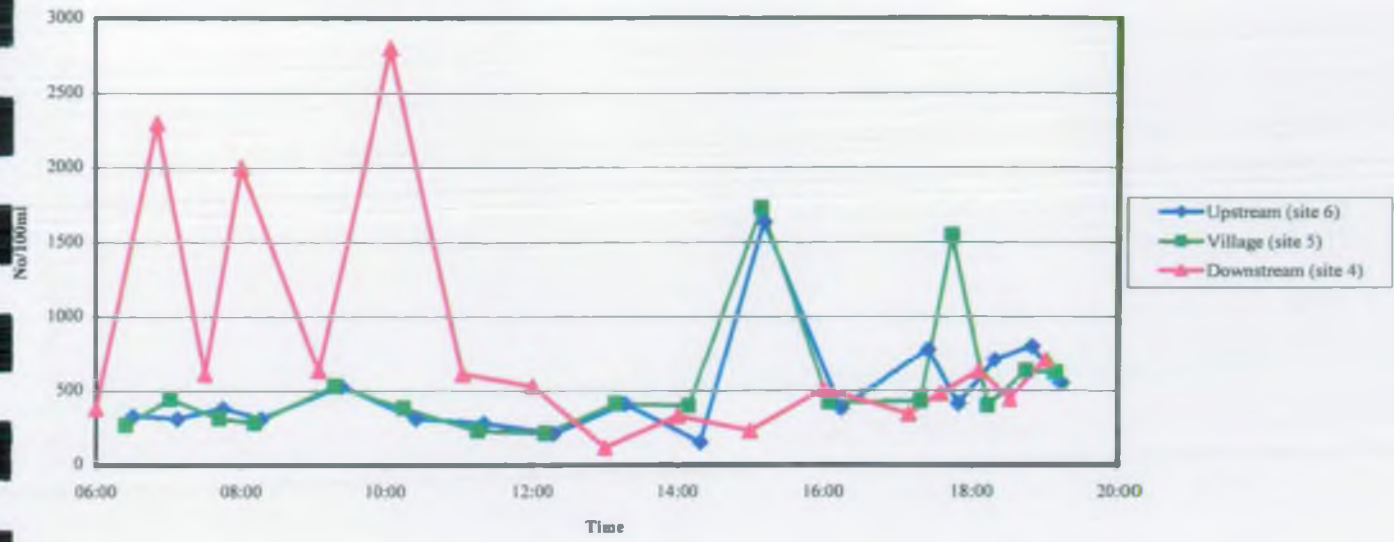
Faecal Coliforms No/100ml 03 November 1998

Figure 6. Charts comparing the same bacteria groups for each sample site: 03 November 1998

There are no EQS's that are applicable to inland rivers with regard to bacteriological counts other than sites designated under the Surface Waters Abstraction Directive used for public water supply. However, the geometric means (a simple statistical calculation used to give a broad overview of bacterial numbers) calculated for each site for the two surveys showed higher levels of total / faecal coliforms and faecal streptococci downstream of the village compared to upstream (see Table 5 for geometric means). Results are presented in Tables 2 and 4 and Figures 6 - 9 graphically show the spatial and temporal trends in the counts throughout the survey periods.
