**Audit of Recreational
Access for Disabled
People
1997/98**

ENVIRONMENT AGENCY

INTRODUCTION AND METHODOLOGY

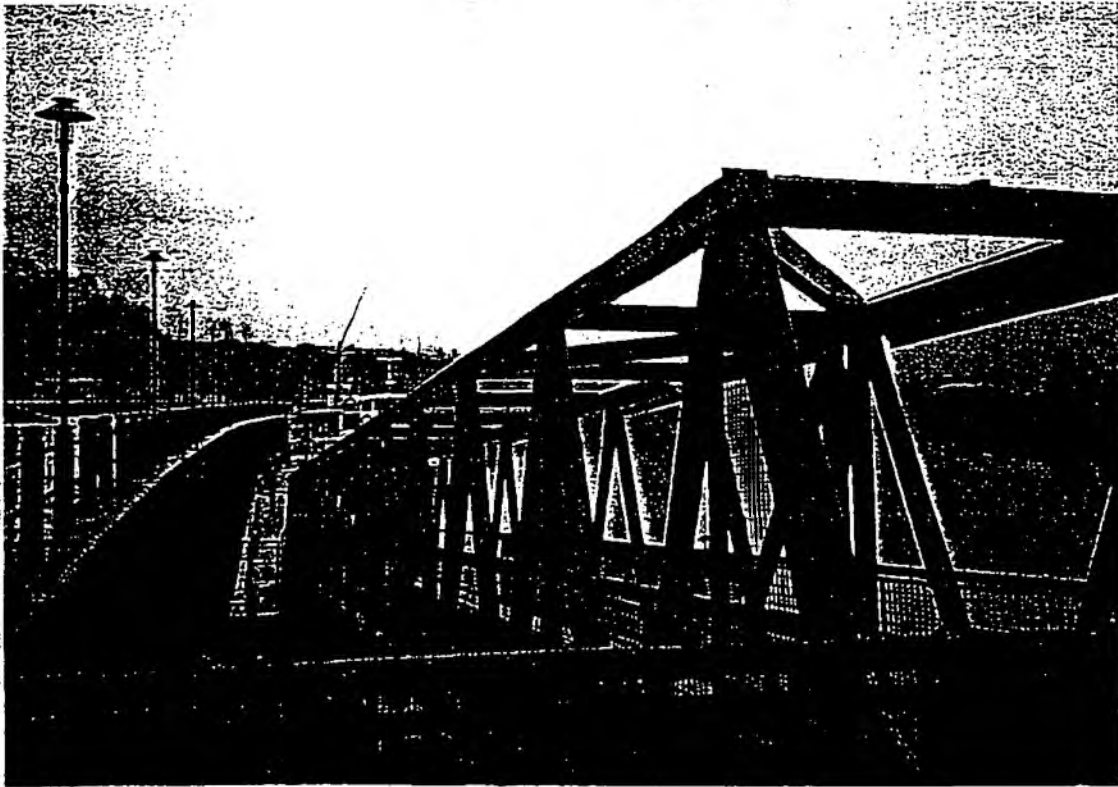
Photograph 5 - Newcastle Quayside Visitors Pontoon

3.3.3 One of the most recent improvements is a visitors pontoon at Newcastle Quayside (Photograph 5) where the large tidal reach previously deterred local boats and visiting yachts from mooring.

3.3.4 This pontoon has a hydraulic 30 metre ramp, down from the fixed walkway on the quayside, which accommodates the rise and fall of the water. On the day and time of the site visit the tide was out and the slope of the ramp was found to be 1:20. This slope will be less when the water level rises with the tide causing the pontoon to rise and the bottom end of the ramp to rise with it.

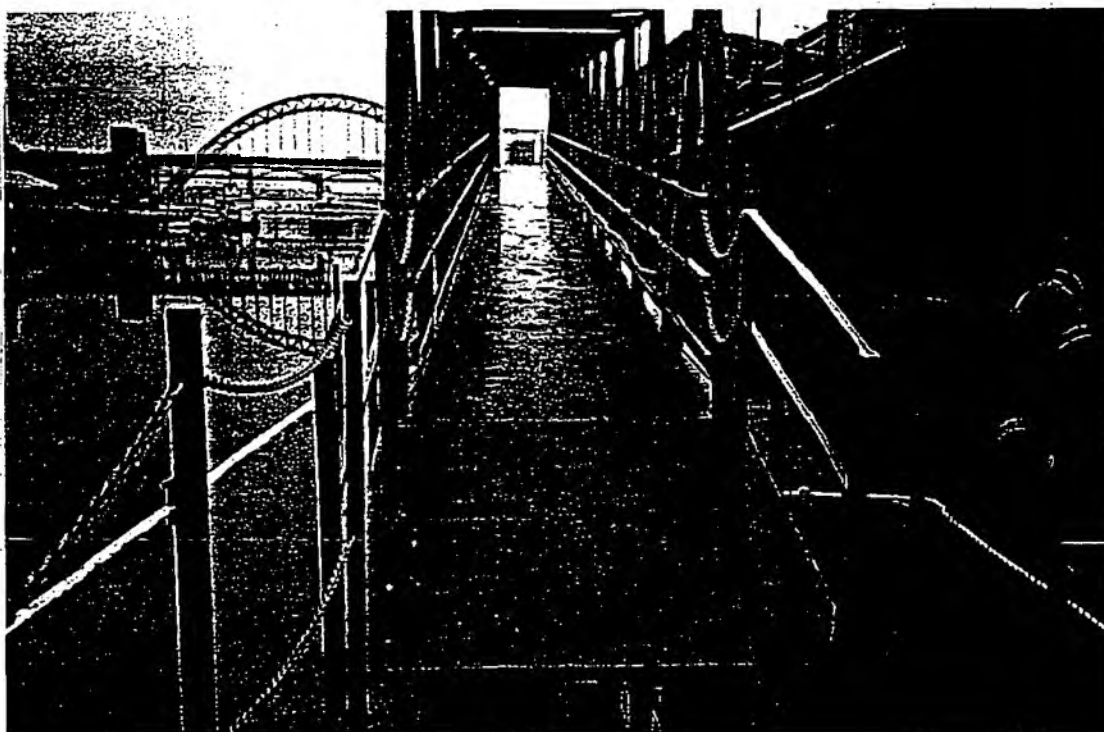
Photograph 6 - Newcastle Quayside Visitors Pontoon Ramp

3.3.5 At the bottom of the ramp, there is a 2.0 metre metal flap which provides the link to the pontoon. (Photograph 6) When the tide is out, the slope of this flap is 1:7. This is likely to be the steepest the slope will ever be. When the tide rises, the pontoon and the bottom end of the ramp are designed to rise producing less of a slope between them. Therefore the slope of metal flap will decrease. At high tide, the ramp and the metal flap will be practically flush.

3.3.6 The ramp is caged and 1.44 metres wide. Access to the ramp is gained via a 3 metre level walkway which is 1.62 metres wide. There is plenty of room for a wheelchair user to manoeuvre the 90° turn between them. The minimum space required is a space of 1.2 metres by 1.2 metres.

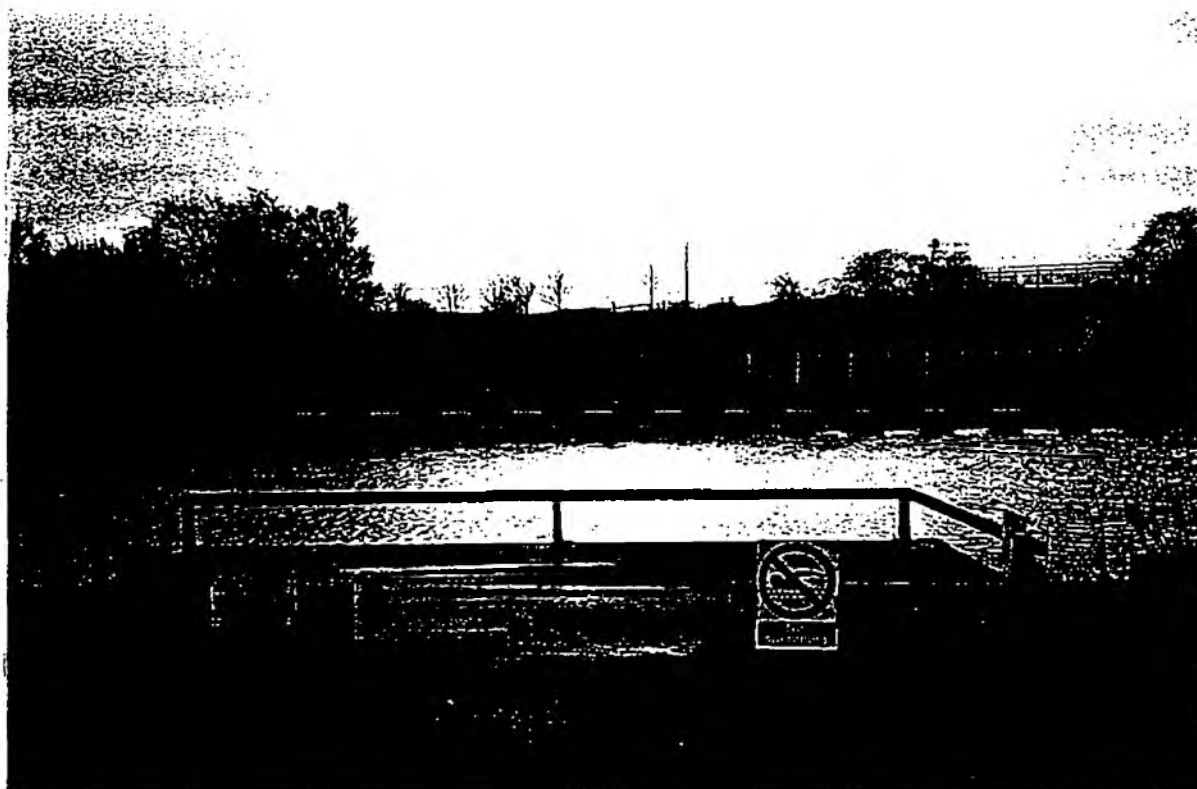
Photograph 11 - Fishing platform

- 4.1.6.3 The rail around the edge is 0.47 metres high. This is above the guideline specification of safety edging of 0.15 metres high.
- 4.1.6.4 There are no arm or rod rests provided. Ideally there should be a mixture of these. Where provided these should be inclined at 30°. Arm rests should be 0.8-0.85 metres high for seated anglers and 1.05-1.17 metres high for standing anglers.

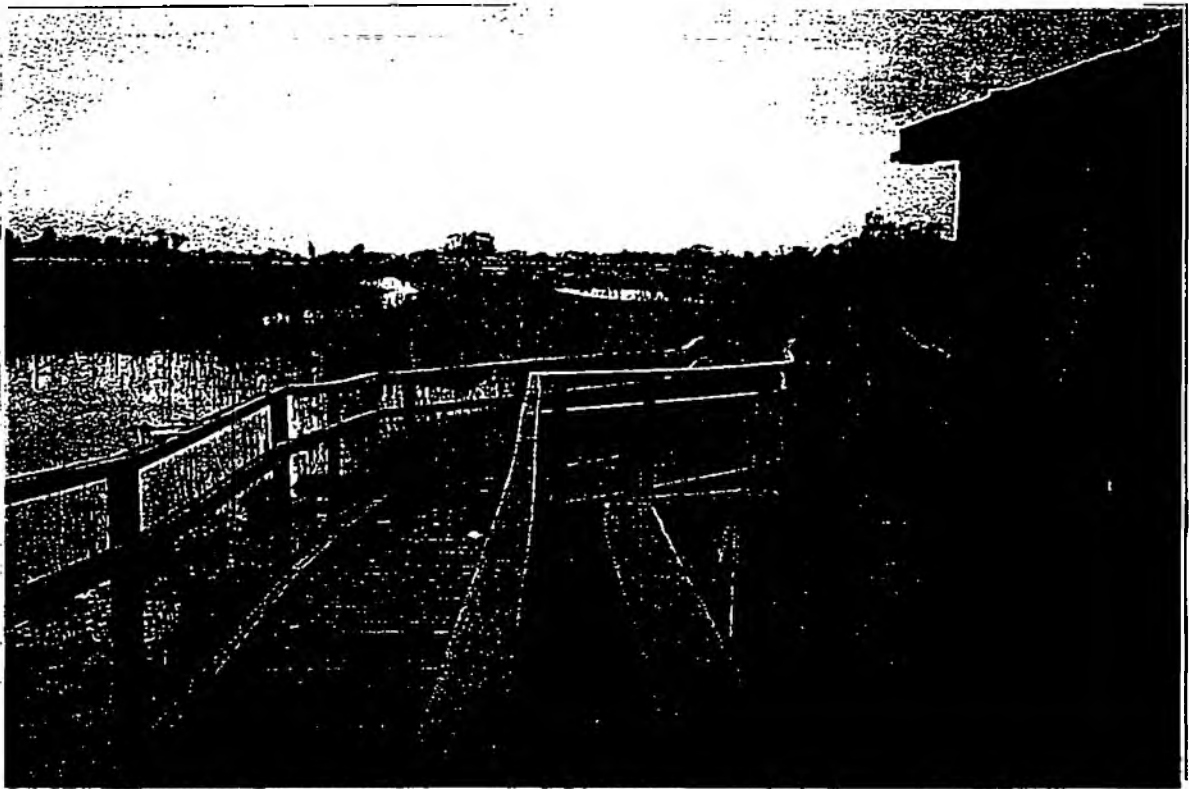
Photograph 13 - Wheldrake Ings

- 4.3.3 The length of path from the car park to the furthest birdhide "Swantail Hide" was paced and estimated to be 1620metres.
- 4.3.4 The car park, was largely puddled on the day of the site visit following the recent seasonal flooding of the site. Entrance to the site is gained by going over a wooden decked bridge and via either a kissing gate or a conventional five-bar gate. The five bar gate is 3.75metres wide and 1.10 metres high with the fastener at 1.00 metres.

- 4.3.5 The dimensions of the kissing gate include gate width of 0.94 metres with a manoeuvring space inside of 1.25 metres in length.
- 4.3.6 There are three substantial types of surfacing found at the site: wooden decking, mud/grass, and hardcore.

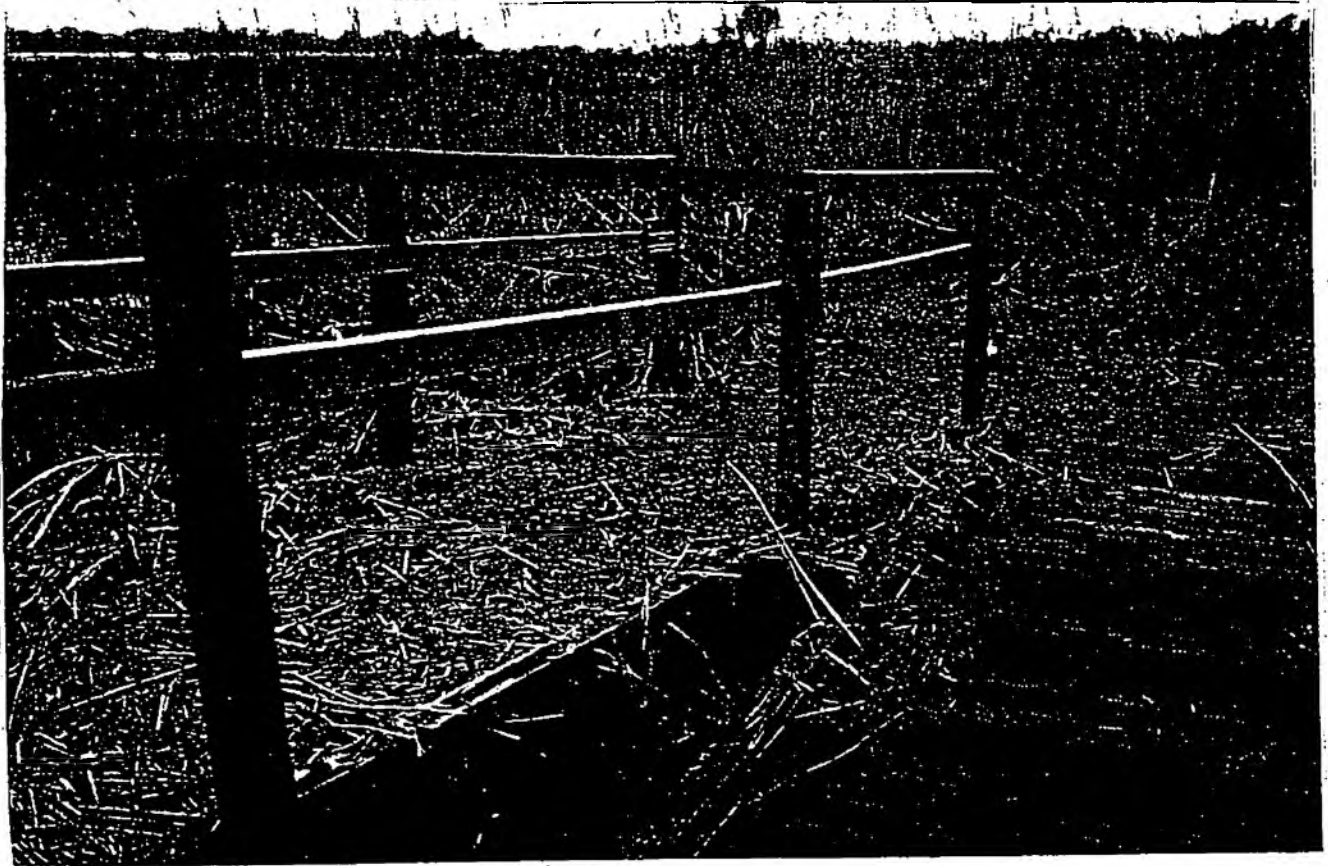
Photograph 14 - Flood Debris on the boardwalk

- 4.3.9 The width of the bridge and mud/grass track are of sufficient width to allow necessary vehicular access. The mud track itself is 5 metres wide. The boardwalk is 1.15 metres wide for the most part with a 5 centimetres toeboard on both sides. Ideally the boardwalk would be 1.2 metres wide with a toeboard of 75 millimetres.

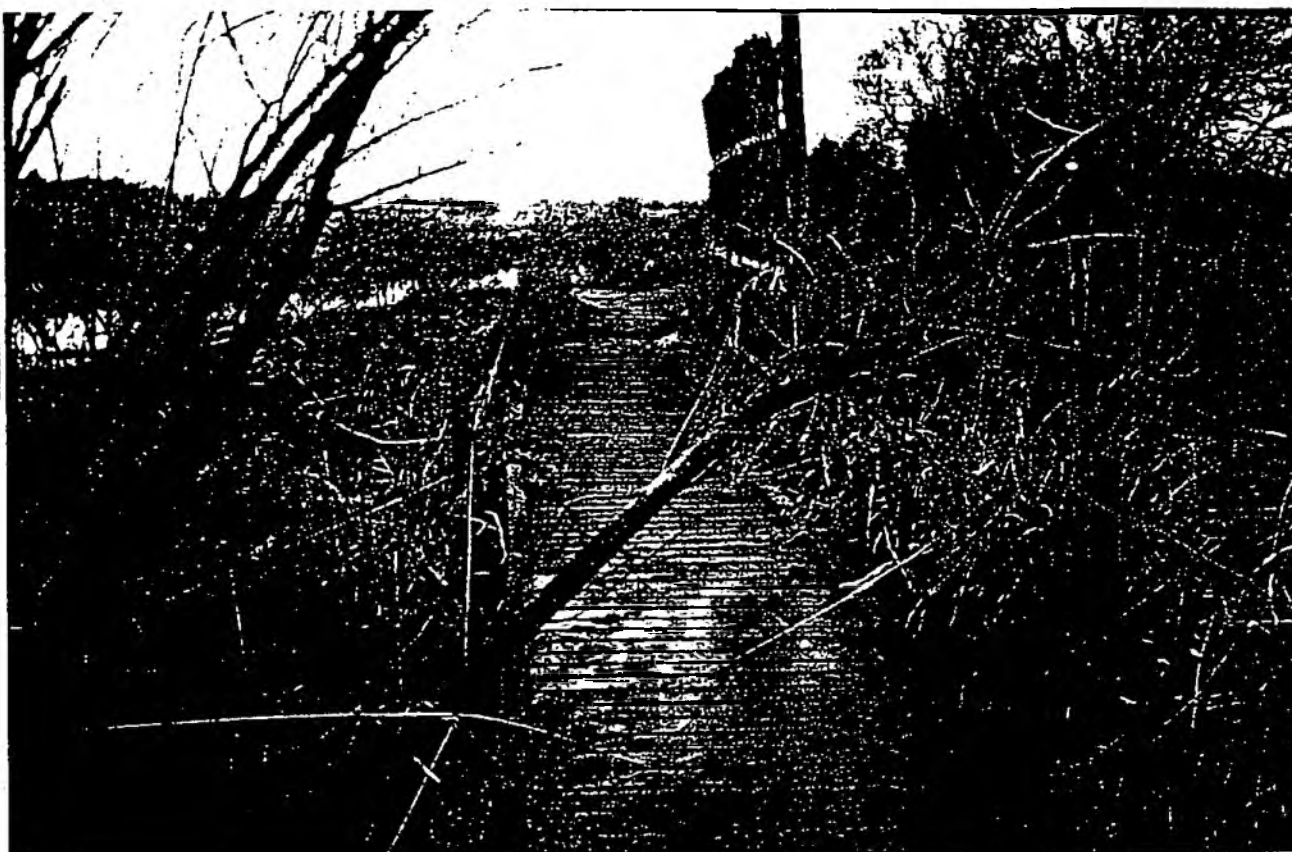
Photograph 15 - Fallen tree

- 4.3.11 On the day of the visit, the path was blocked by a number of barriers. This is likely to be largely due to the seasonal flooding which had only recently subsided. These barriers included young fallen trees (Photograph 15). There were also wooden battens lying on the boardwalk - these may have fallen from the rush screening, some of which had collapsed.
- 4.3.12 The boardwalk was found to be "pushed up" in two places (Photograph 16). It is assumed that this had occurred as a result of the flooding. In the worst instance the height difference between the "pushed up" boardwalk was found to be 10 centimetres.

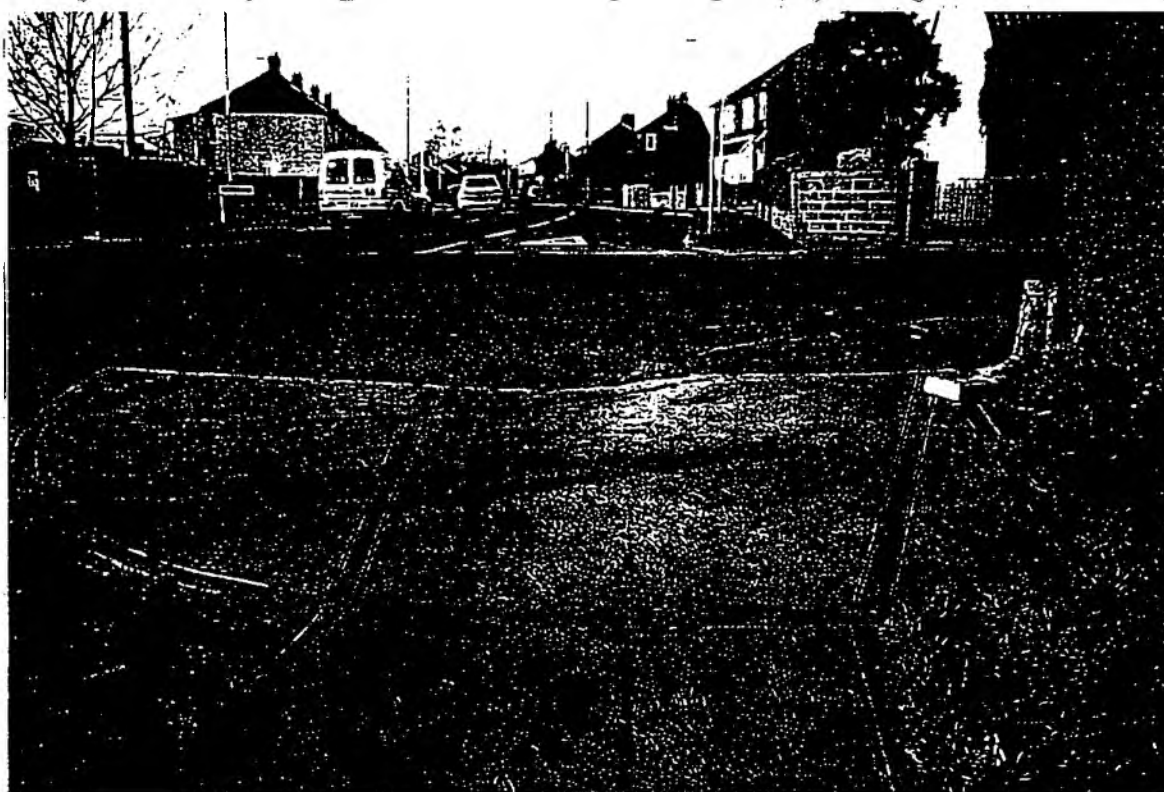
Photograph 18 - Pavement Ramp

- 4.4.3 The recreational aspect of the site focuses upon a surfaced route running along the south bank of the river. The route is accessed via a short ramp of 3.35 metres in length (Photograph 18) and 4.70 metres wide which creates a level between the pavement and the level of the site. This ramp creates a slope of 1:20 with a cross slope of 1:25. The route is surfaced with concrete with the exception of a short gravelled section which measures 15.60 metres in length. The gravel pieces surfacing this section vary in size with some larger than 10mm. Ideally there should be little or no loose material on the surface. Even very small loose particles can make a surface very slippery for people with poor balance and mobility. Loose particles should not exceed 5 millimetres in size.

- i. The gravel surface could be resurfaced.
- ii. The concrete plugs could be replaced.
- iii. The mid -handrail on the footbridge could be altered so that it is at a level of 0.75 metres.
- iv. Resting places could be provided. Ideally these should be at 200 metre or less intervals with a mixture of seating designs.
- v. Replace pavement ramp with one with a cross-slope not exceeding 1:50.

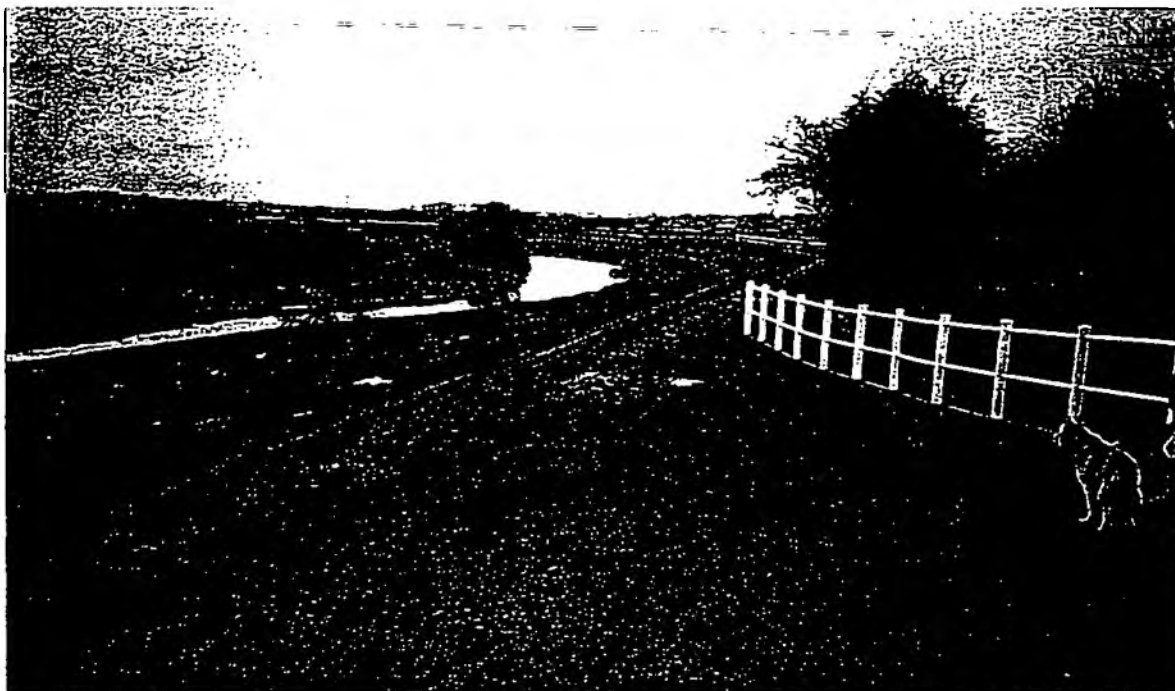
Photograph 24 - Trans-Pennine Trail

- 5.3.3 The trail section looked at is constructed upon Agency owned land and runs from the entrance gates (Photograph 24) to the point at which it joins Denaby Ings Nature Reserve. These gates have special hinges to ensure they always swing closed. The gate opening mechanisms were found to be slightly stiff on the day of the site visit which may make it difficult for older people or those with a muscular disability. There are two gates, one of approximately 1.4 metres wide and one which is 4 metres wide to allow vehicular access for operational purposes. The smaller of the two gates have a handloop on the top bar to allow horse riders to open them without dismounting.

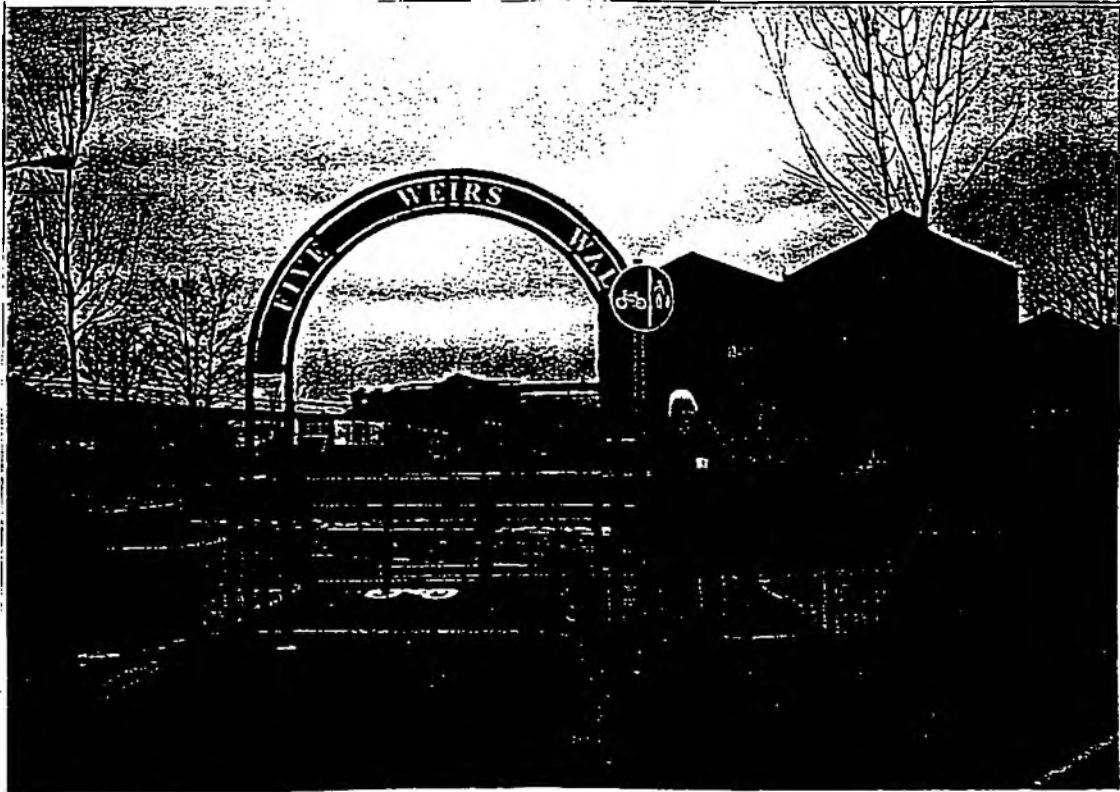
Photograph 25 - Five Weirs Walk

- 5.4.2 The section which was reviewed runs from Weedon Road to Carbrook and is approximately 420 metres in length and in excess of 2 metres wide. Access is via a 1.14 metre wide gate. There is also a double gate adjacent to the first which it is assumed allows access for maintenance vehicles.
- 5.4.3 The route is surfaced with two-coloured tarmac, the cycleway being distinguished from the route for other users. On the day of the audit there was some tree debris on the path. This may impede passage for some. This was assumed to be general seasonal debris. (Photograph 27) Drainage holes are built into the route to prevent standing water on the route. Whilst the path is slightly sloped to allow water to run off to these drainage holes the cross slope does not exceed 1:50. The section is virtually flat with no slopes exceeding 1:20.

- 5.4.4 There are no width restrictions or barriers blocking the path and the walking tunnel is clear. There are no formal passing places although the route is wide enough to allow passing anyway. There are four benches on the section, 1 at either end and 2 approximately 45 metres from the Carbrook end. (Photograph 26) The benches are of the "park bench" style with back rests. These are 1.85 metres wide with a seat height of 0.45 metres. There is no restriction on heel space and there is a clear space around both benches.
