**Environmental
Appraisal of
Derwentwater Low
Water Levels**

Volume 1 :
Hydrological &
Geological Study

January 1999

Job number 55390

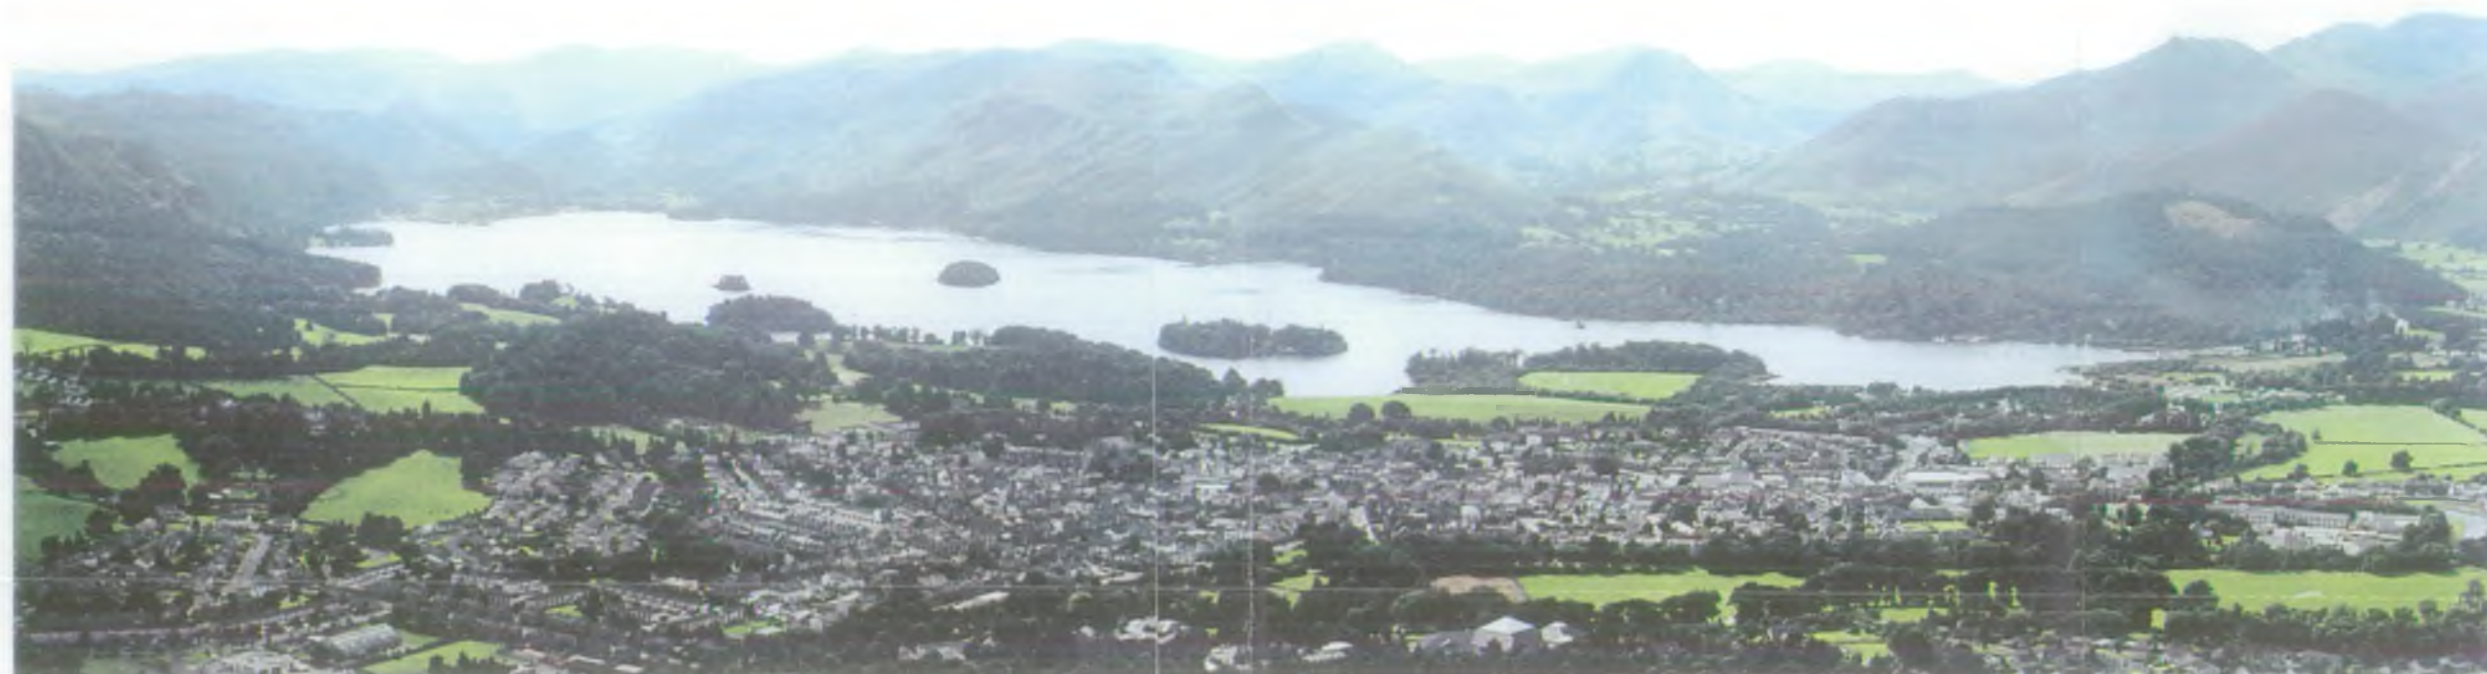
Figure 1

Derwentwater is the third largest lake in the Lake District in Cumbria. It is situated south-west of Keswick and is in the Lake District National Park. As shown in Figure 1, Derwentwater is aligned north-south and is approximately 4.5km in length and 1.25km in width. It is centred on National Grid Reference NY260210. In normal conditions, Derwentwater has a surface area of approximately 6.7km². The catchment area of the lake is approximately 85km².

The River Greta enters into the River Derwent 400m downstream of the lake. The River Greta catchment area to its confluence with the River Derwent is approximately 150km², shown on Figure 1, and takes in tributaries from the Blencathra, Matterdale Common and Helvellyn range, together with St Johns Beck from Thirlmere. The River Derwent then flows over the gauging station at Portinscale.

Eight raingauges, as shown on Figure 1, were identified as being useful for the determination of rainfall within the Derwentwater catchment. Data for these raingauges was obtained from the Environment Agency and the Meteorological Office.

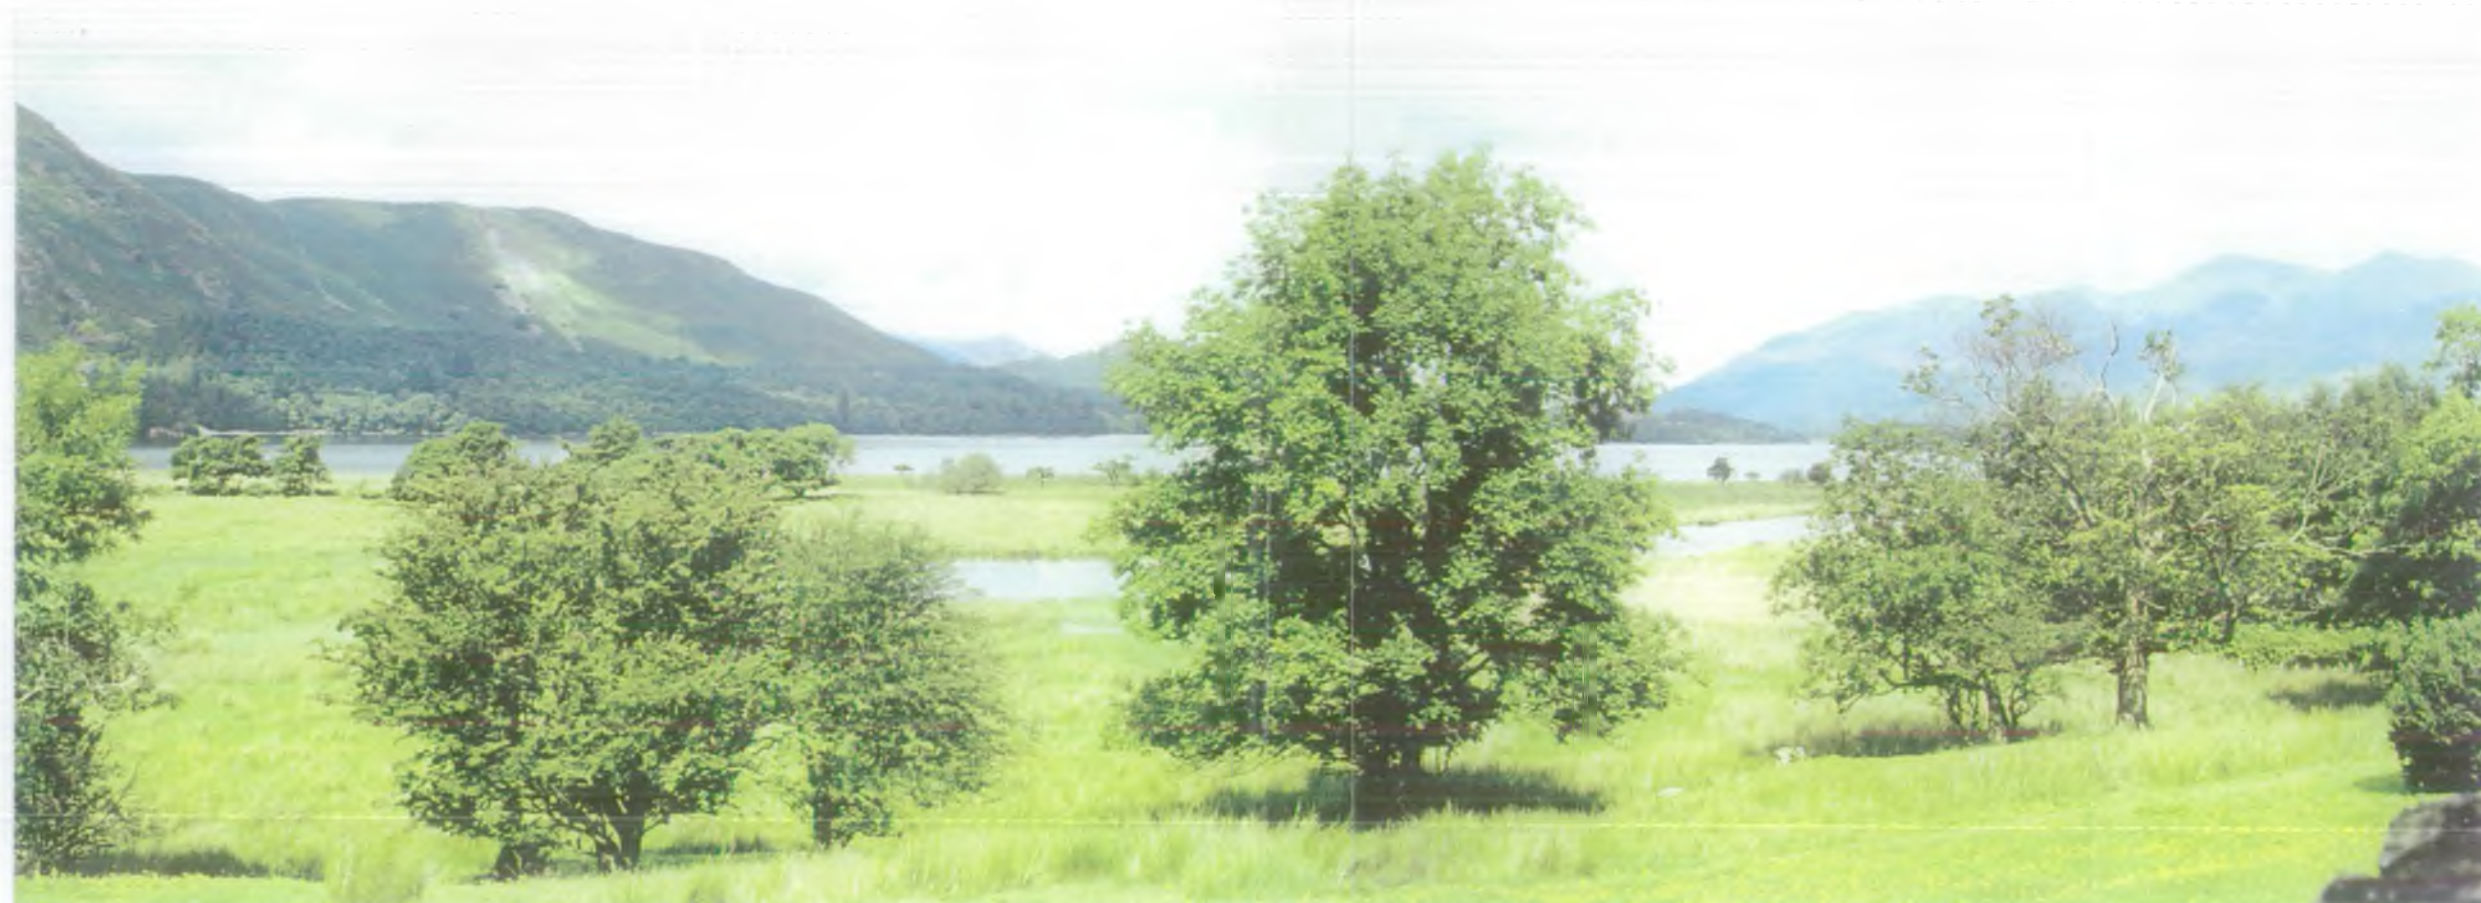
Figure 3

PHOTOGRAPH No.2 - View over marsh area to southern end of Derwent Water around the inlet

The topography to the south-west falls steeply from Cat Bells at 451mOD to a general shoreline level of 75mOD. To the south-east the topography is again steep, falling from Castlerigg Fell and Bleaberry Fell to the shoreline (Figure 2). To the north and south there are significant 'wash lands' where the River Derwent enters and leaves the lake (Figure 3).
