IMPACT ASSESSMENT OF ACIDIC AND METALLIFEROUS POLLUTION IN THE FOWLEY STREAM

March 1992

FWI/92/003

TECHNICAL REPORT No FWI/92/003

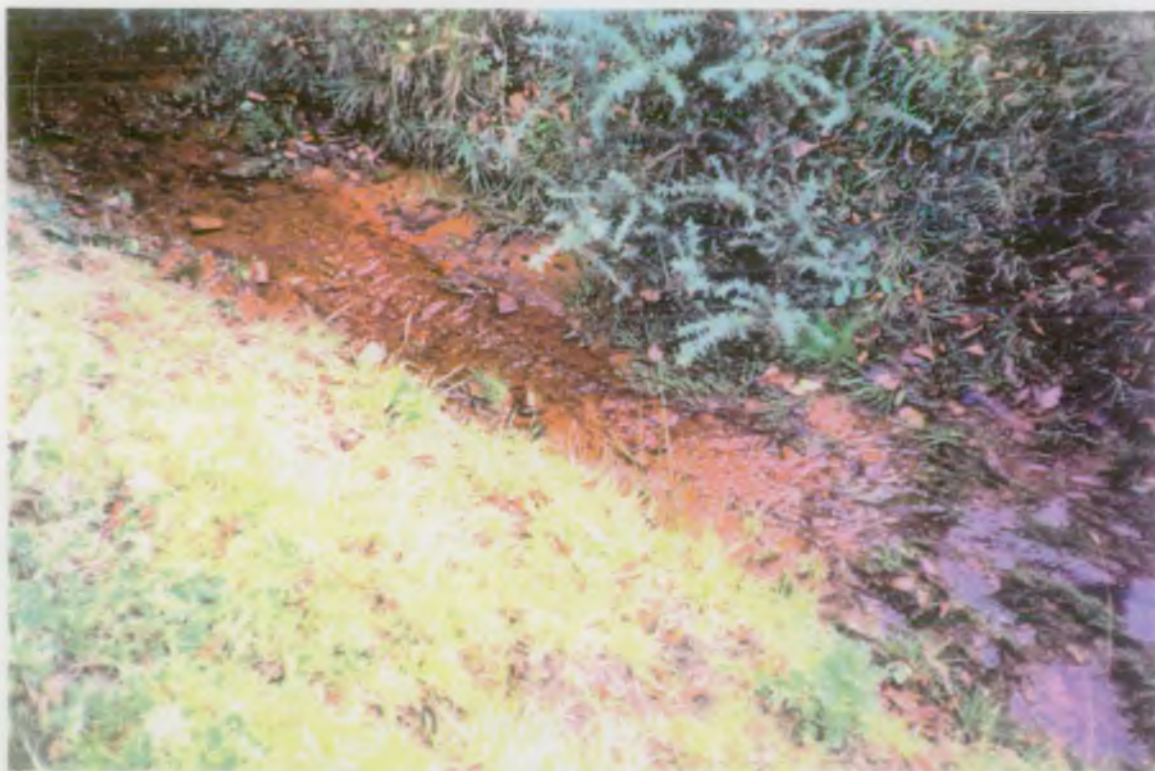
Iron ochre deposits in the land drainage ditch.

Land drainage improvements in the Fowley Stream catchment has allowed the bacterial oxygenation of pyrites in the soil. Contaminated water gains access to the stream via the ditch and land drains entering the ditch. Water quality is particularly poor during the first flush at the break of a drought. A similar process occurs in the Brightley Stream catchment.

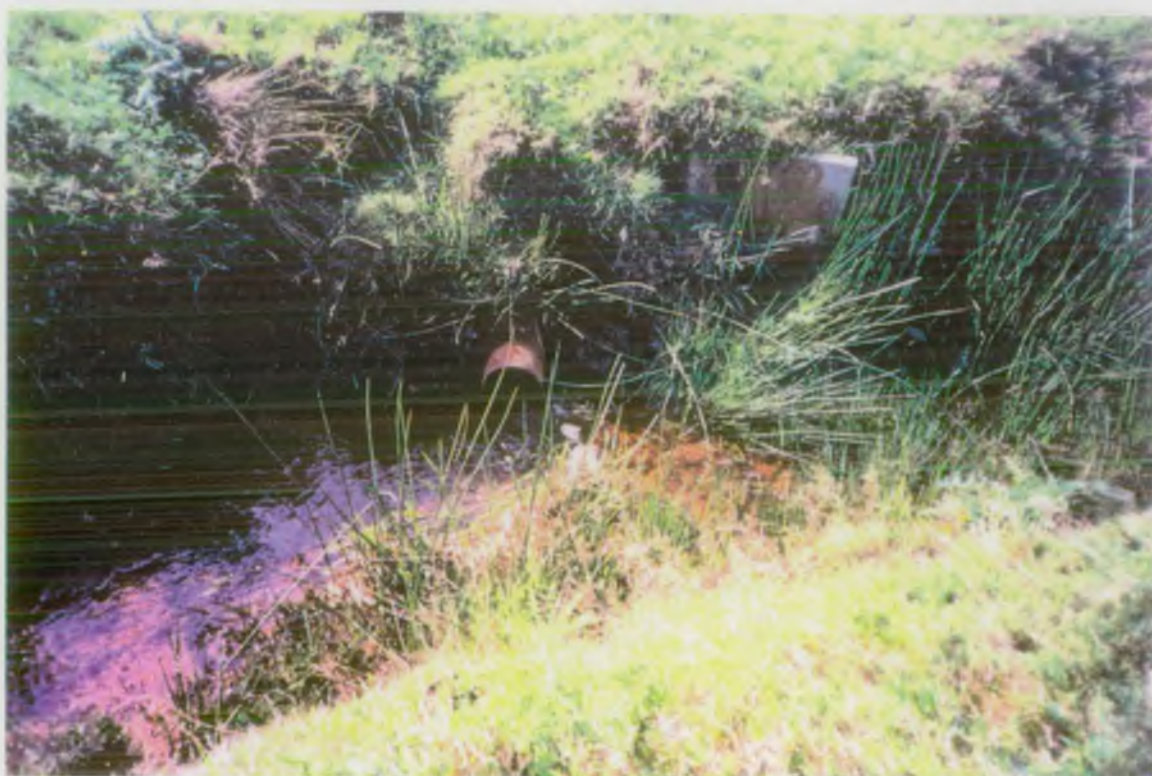
Land drain entering the land drainage ditch.

1. Block/break the land drains and fill in the land drainage ditch.

- This would impede the flow of contaminated water to the Fowley Stream.
