# A NATURAL ASSETS REGISTER FOR THE SANKEY CATCHMENT

# VOLUME 2 DRAFT

Sankey NOW River Valley Initiative Conservation Assets Register

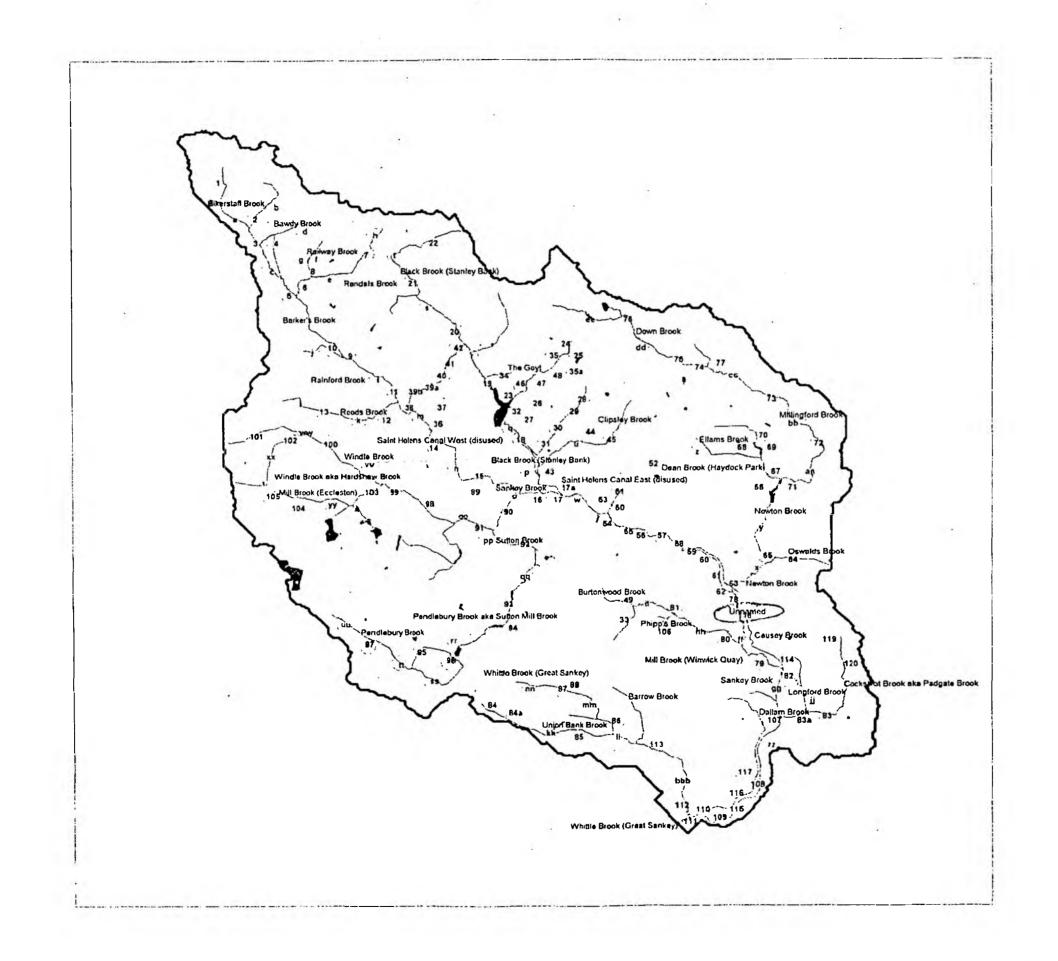
Figure 2:/ River Habitat Survey Location Plan

- Numbered circles RHS Sections
- Lettered circles Inter-reach Sections
  - -- Sankey Catchment Boundary

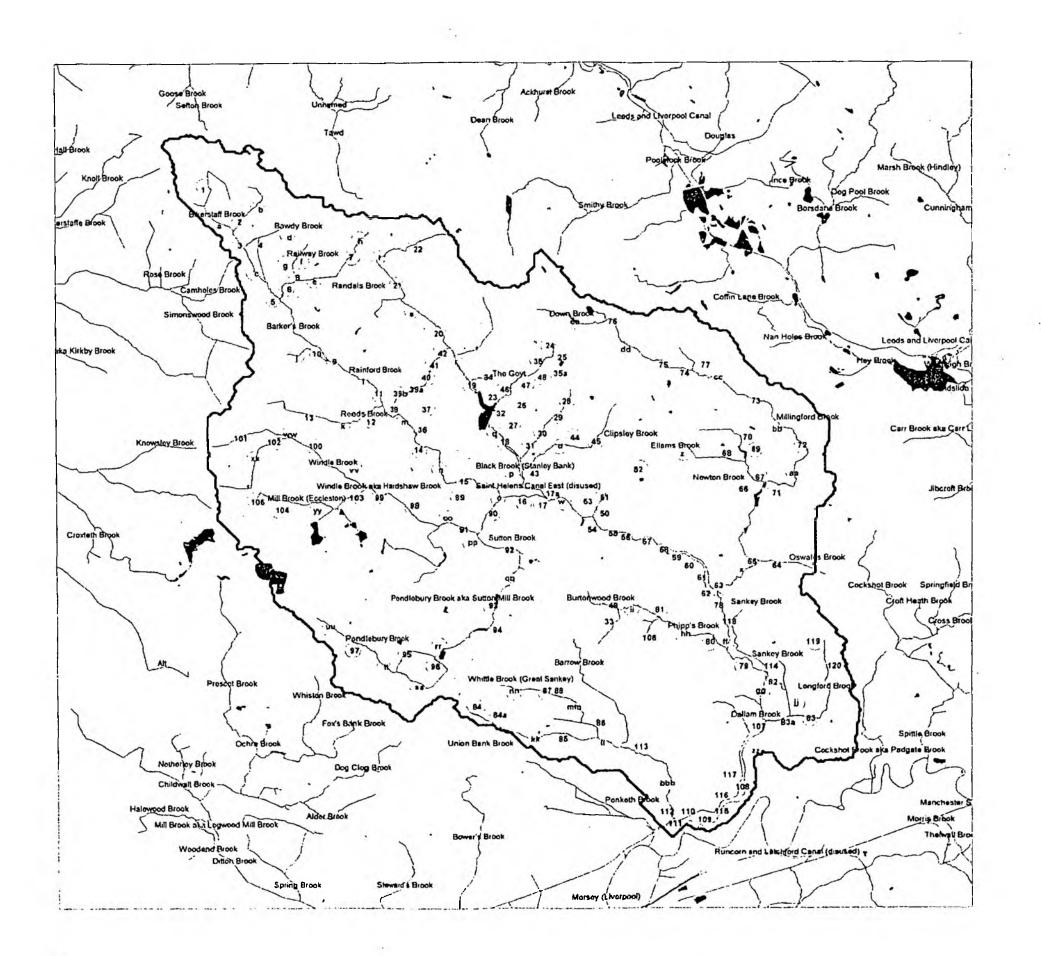
Figure 2.2
The Sankey Calchment - Context

- Numbered circles RHS Sections
- Lettered circles Inter-reach Sections

Sankey Catchment Boundary

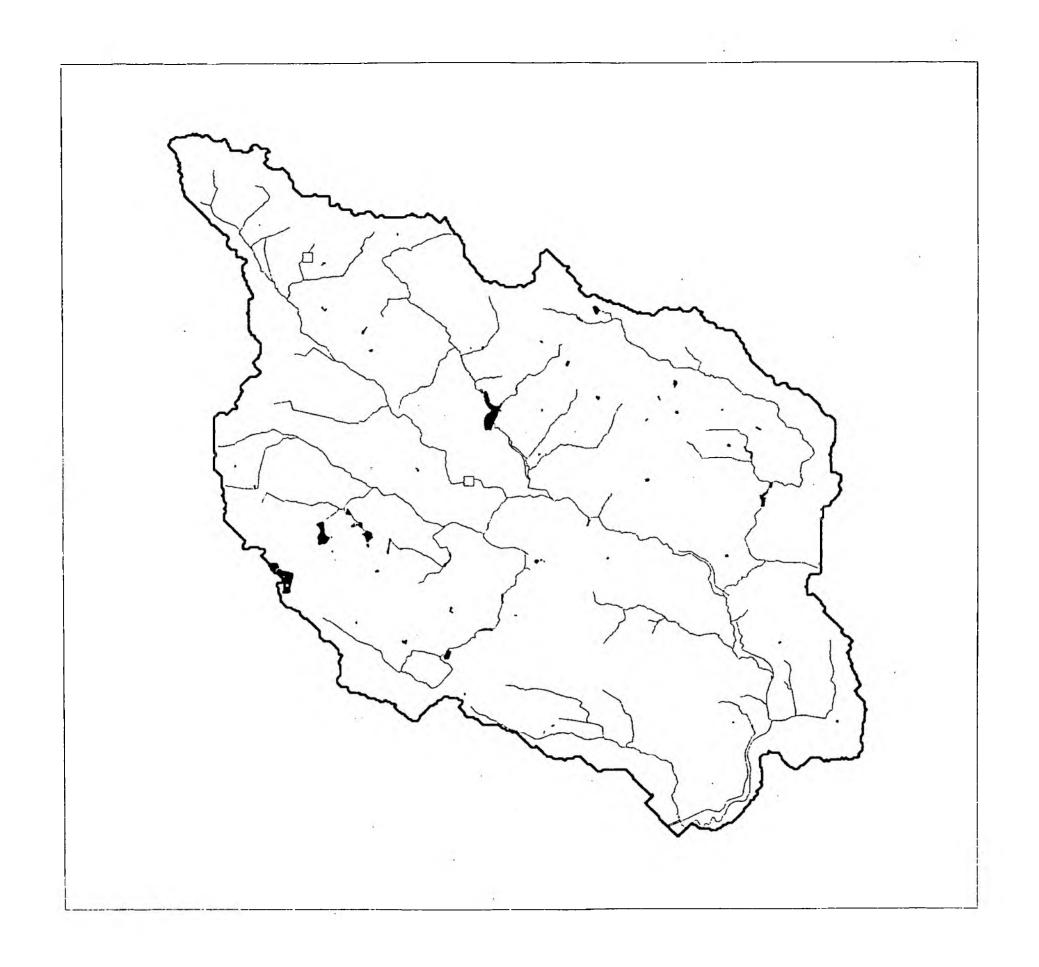
Figure 5.4

## GIANT HOGWEED HISTORIC PRESENCE

☐Historic Presence (2)

- 1) 1997 RHS records were noted during survey of September/October 1997. Precise positions available for RHS sample sections.
- 2) Historic records are derived from Environment Agency River Corridor Surveys, St Helens, Nature Conservation Audit (1996) and other sources.
- 3) Refer to text of report for details.

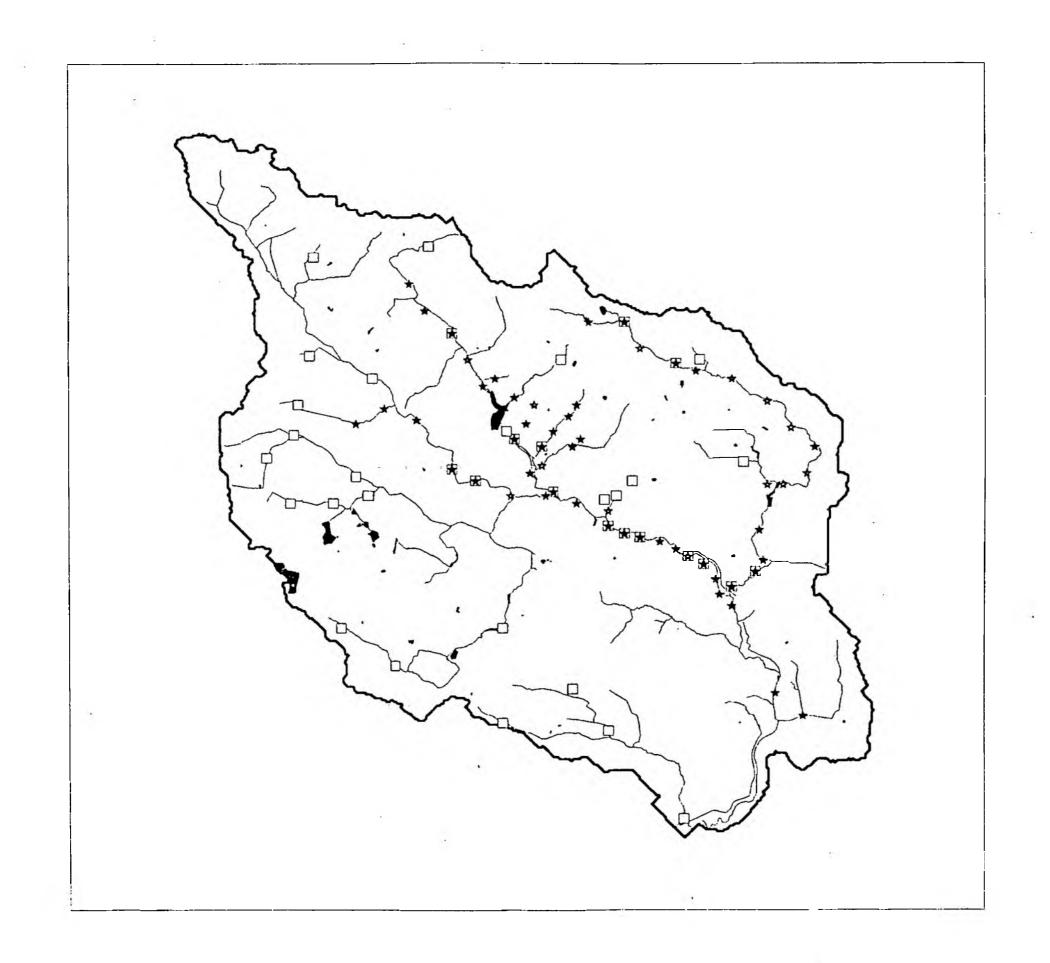
Figure 5.5

## HIMALAYAN BALSAM . PRESENT RECORDS

- ★Present (43) ★Extensive Presence (14)
- HISTORICRECORDS
- ☐Historic Presence (41)
- 1) 1997 RHS records were noted during survey of September/October 1997. Precise positions available for RHS sample sections
- Historic records are derived from
   Environment Agency River Corridor
   Surveys, St Helens, Nature Conservation Audit (1996) and other sources.
- 3) Refer to text of report for details.

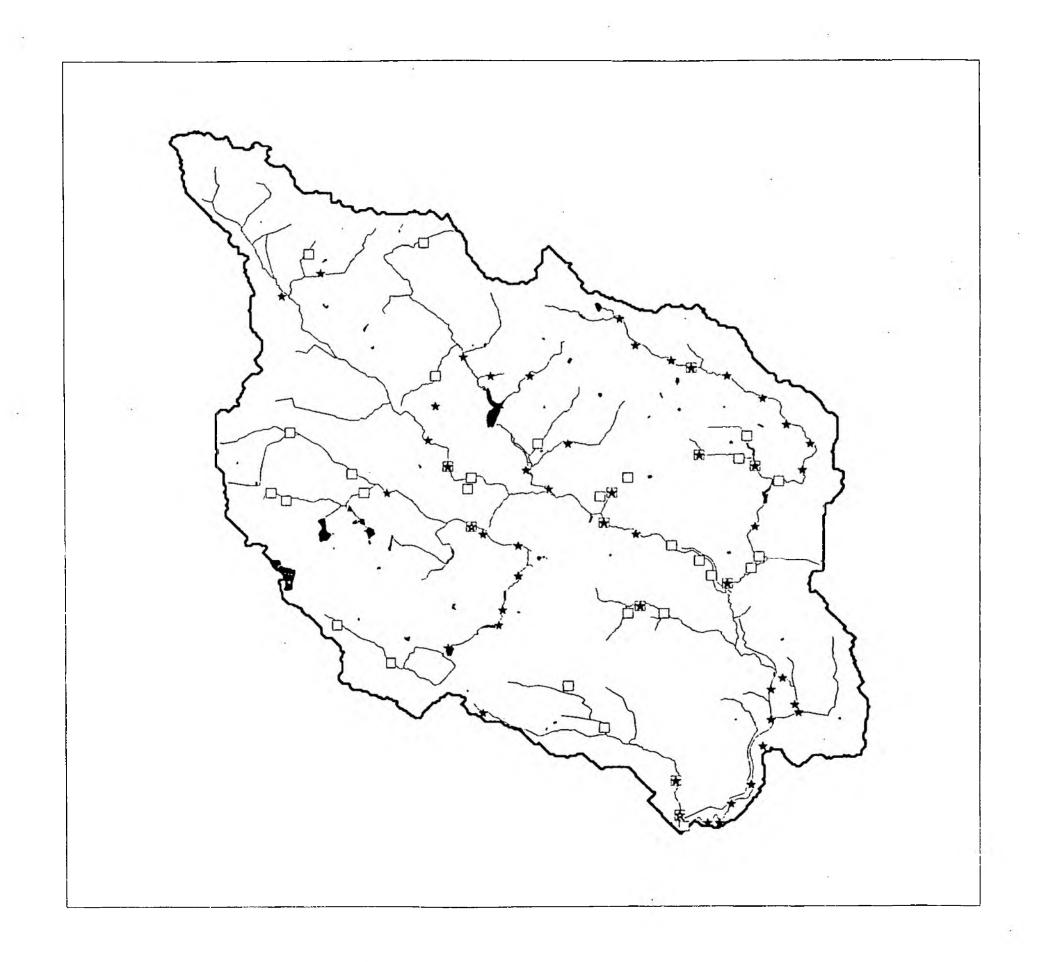
Figure 5.6

## JAPANESE KNOTWEED PRESENT RECORDS

- ★Present (49) ★Extensive Presence (2)

☐Historic Presence (40)

- 1) 1997 RHS records were noted during survey of September/October 1997. Precise positions available for RHS sample sections.
- Historic records are derived from
   Environment Agency River Corridor
   Surveys, St Helens, Nature Conservation Audit (1996) and other sources.
- 3) Refer to text of report for details.

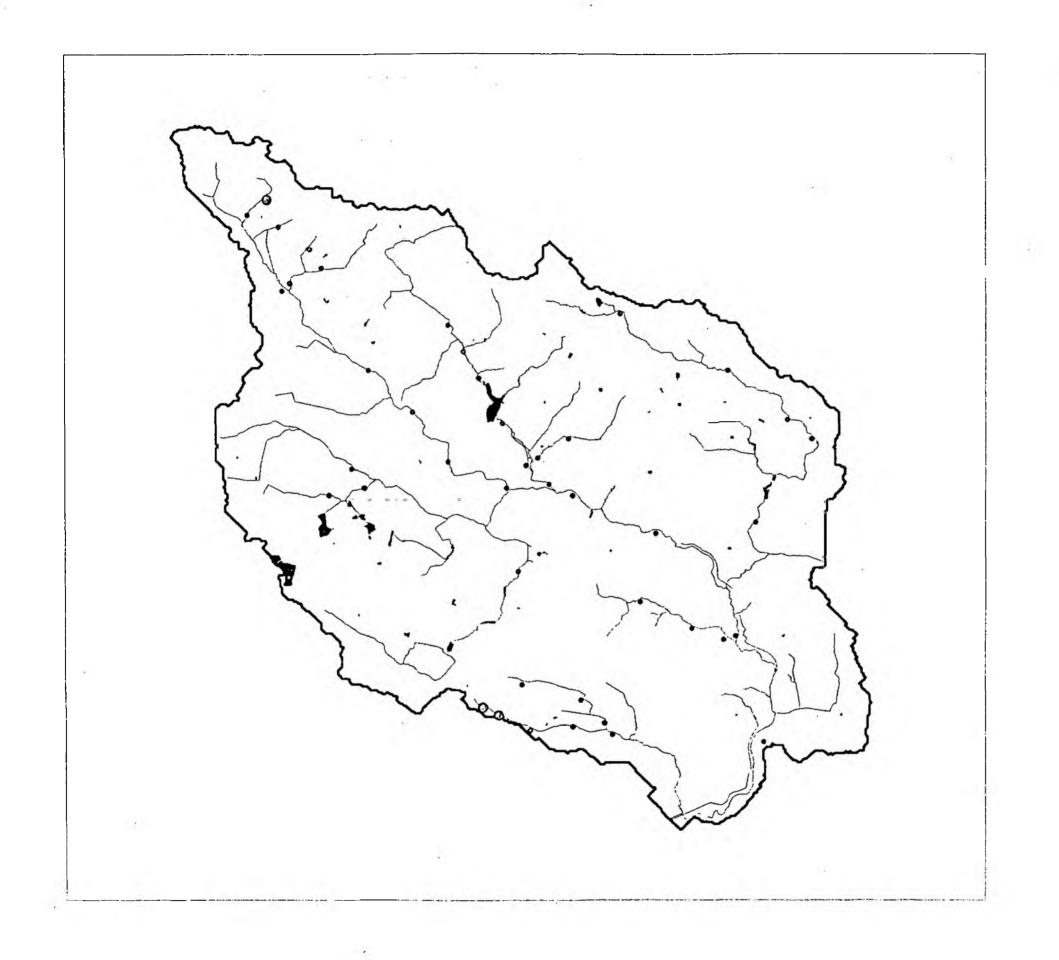
Figure 7.2

## DISTRIBUTION AND EXTENT OF RIFFLES

• Riffles Present (41)
• Riffles Extensive (3)

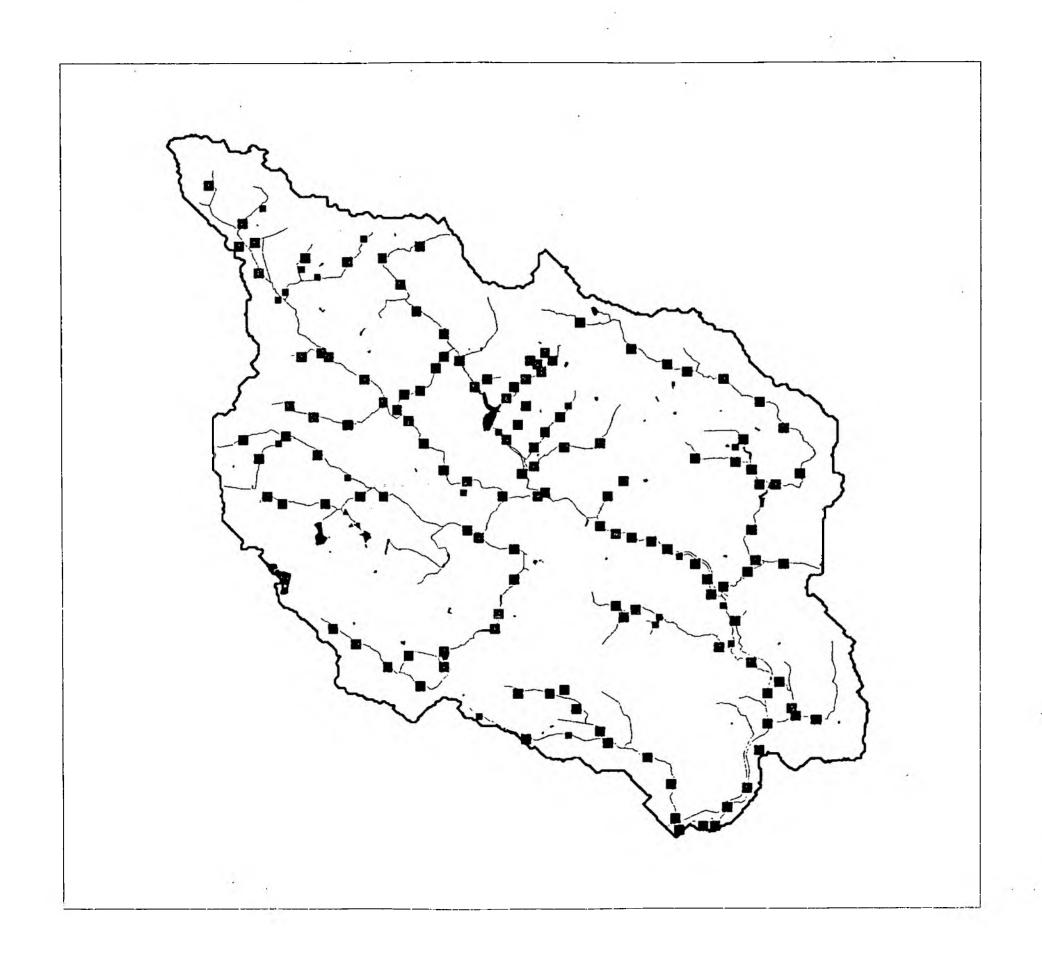
Figure 7.3

#### DISTRIBUTION AND EXTENT OF GLIDES

■Glides Present (19) ■Glides Extensive (136)

1) Includes Inter-reach sections

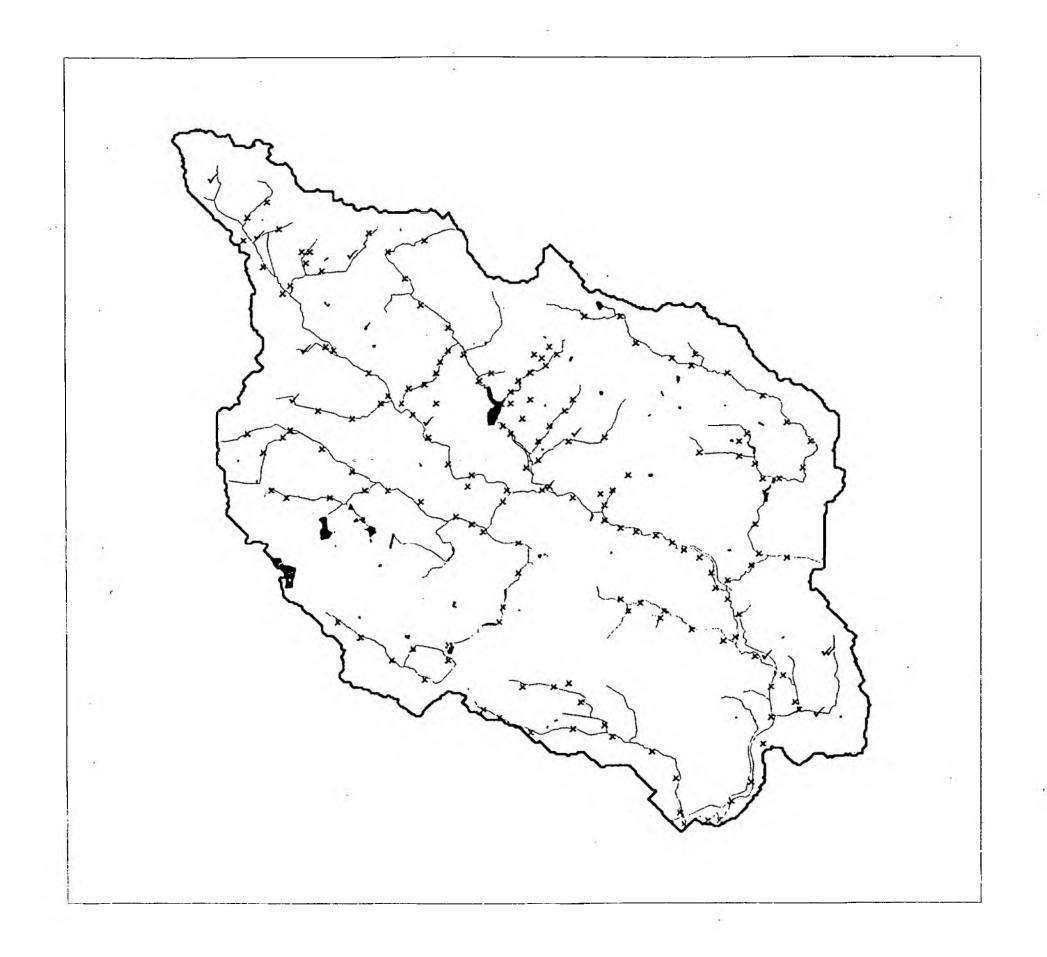
Figure 7-4
Distribution of Choked Channels

#### DISTRIBUTION OF CHOKED CHANNELS

Absent (165)

Present (12)

1) Includes Inter-reach sections

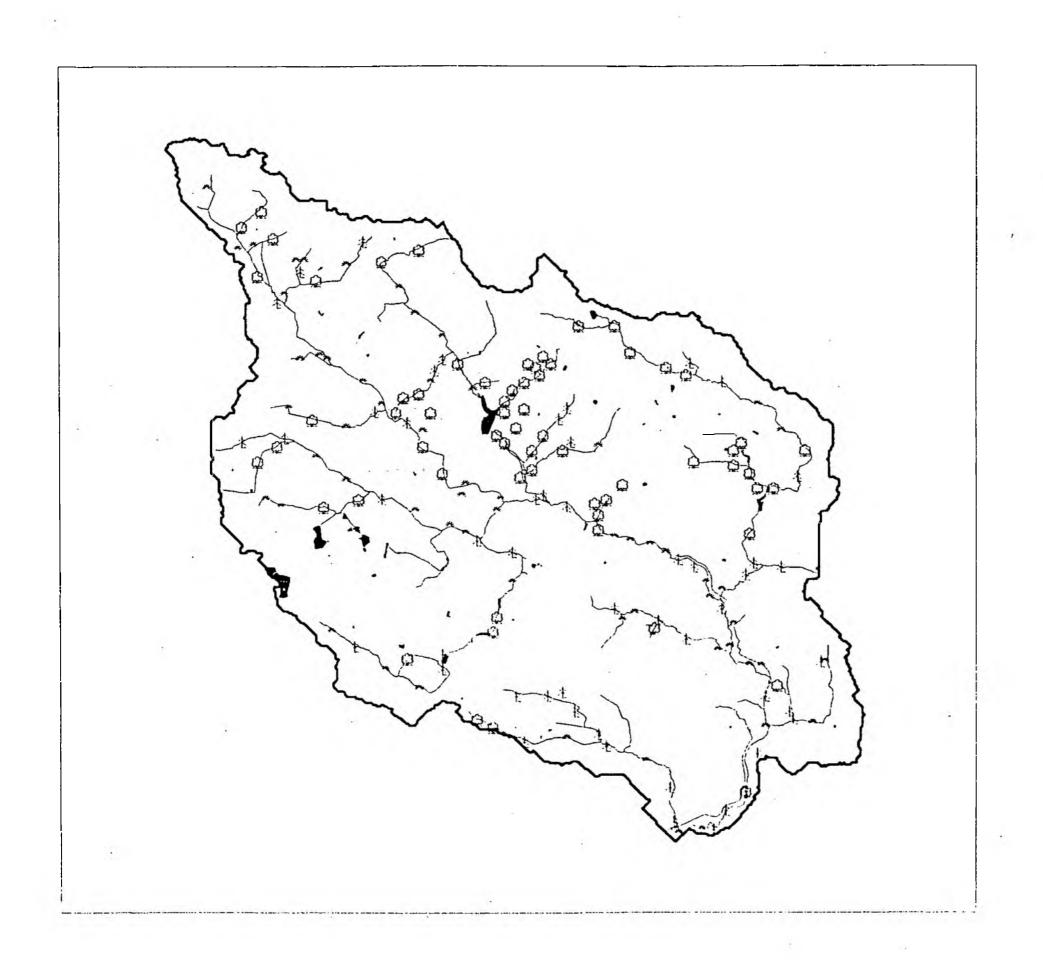
Figure 7.5
Bankside Tree Distribution

#### BANKSIDE TREE DISTRIBUTION

1 7 to 10 Continuous/Semi-continuous (65)

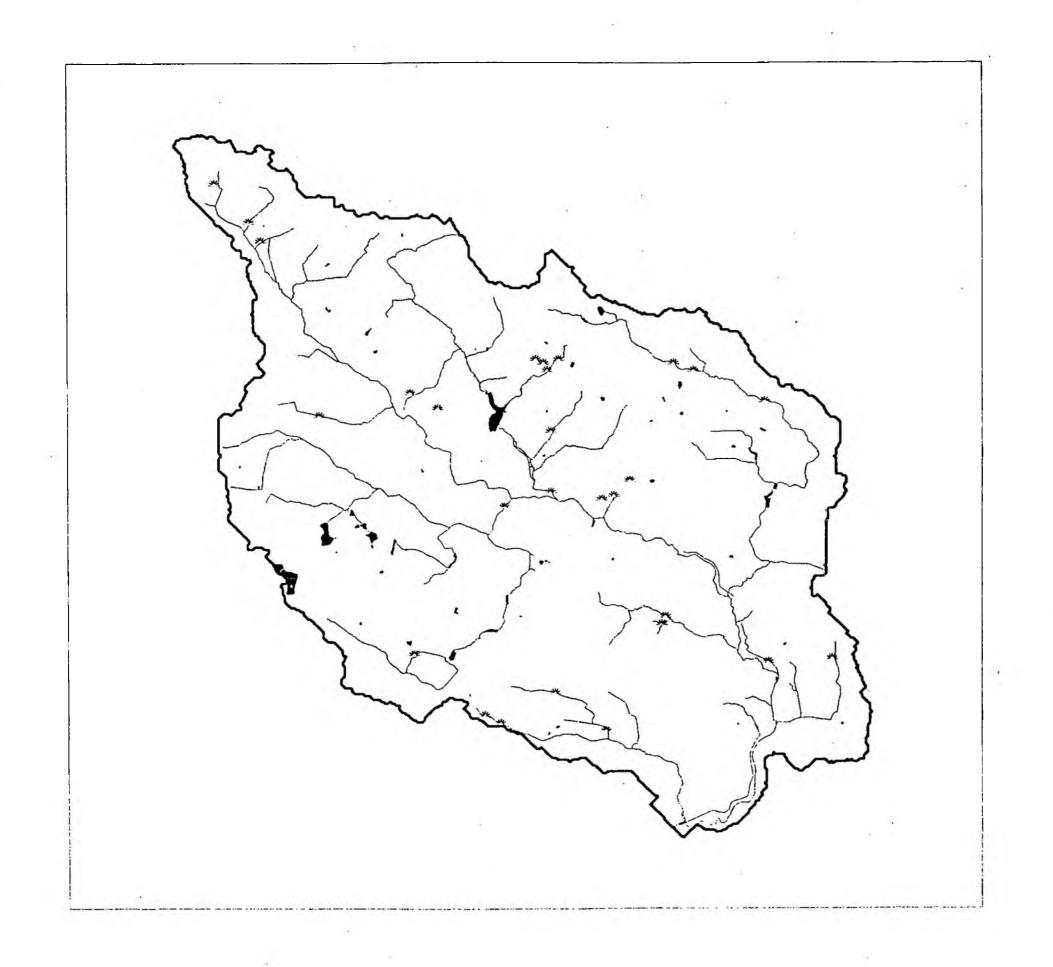
Figure 7-7
Bank Face Vegetation Diversity

## BANK FACE VEGETATION DIVERSITY

Sites where >50% spot checks have simple or complex vegetation structure (28)

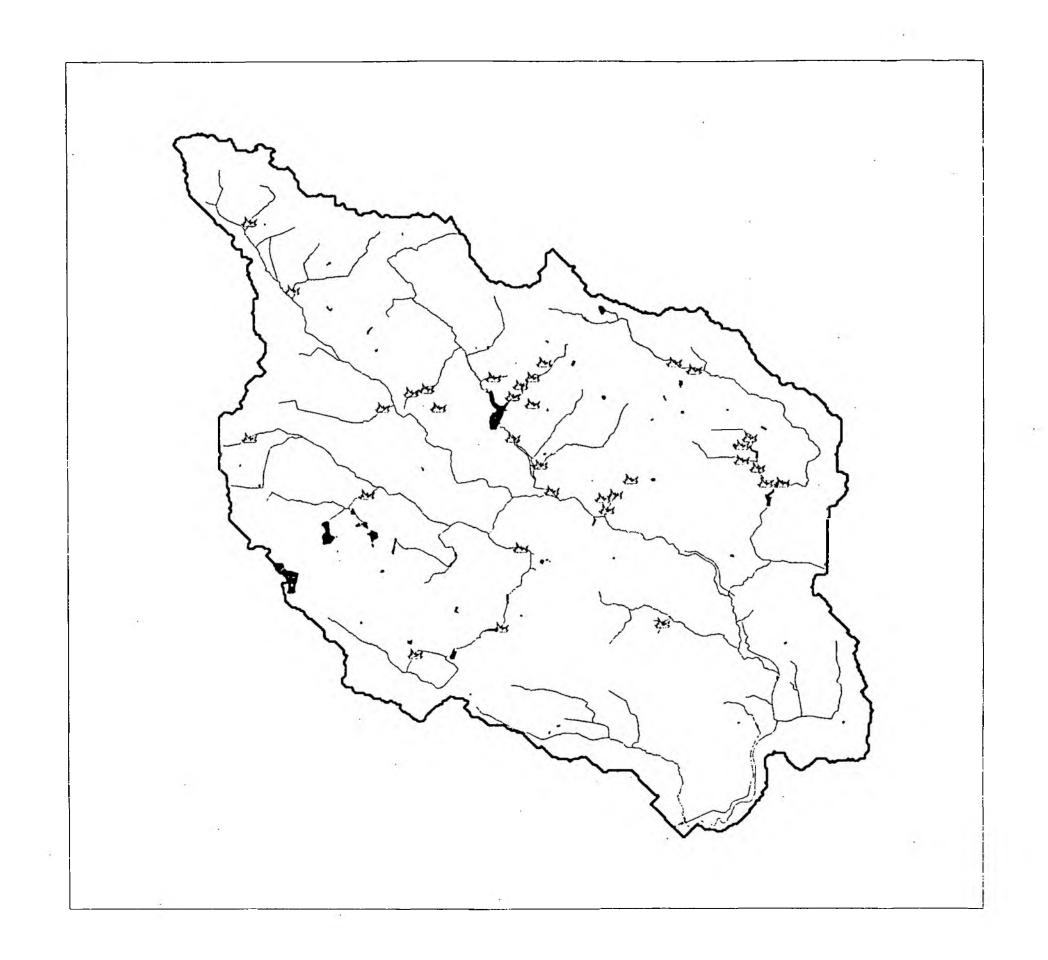
Figure 7-8
Bank Top Vegetation Diversity

BANK TOP VEGETATION DIVERSITY

Sites whree 50% spot checks had simple or complex banktop vegetation (35)

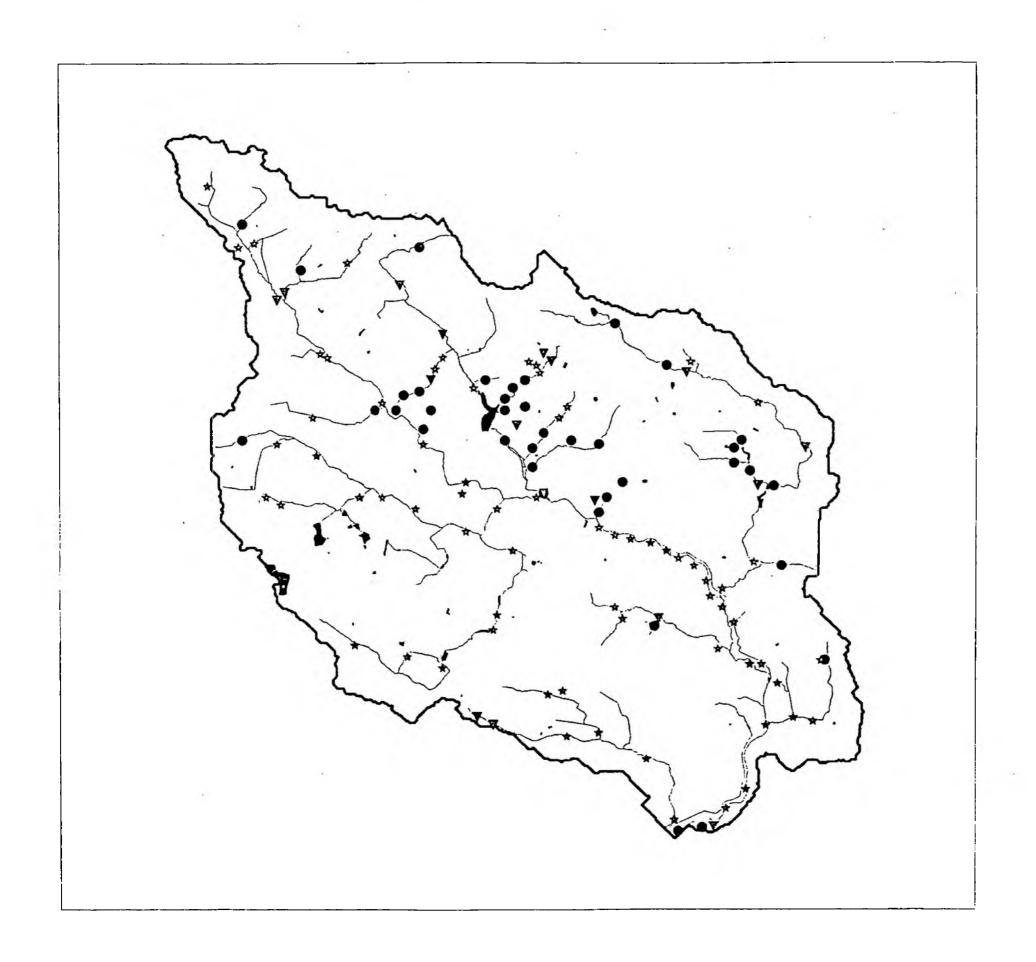
Figure 7.9
Extent of Bank Resectioning

#### EXTENT OF BANK RESECTIONING

◆0 to 1 no resectioning (39) ▼1 to 7 little resectioning (17) ★7 to 20 extensive resectioning (69)

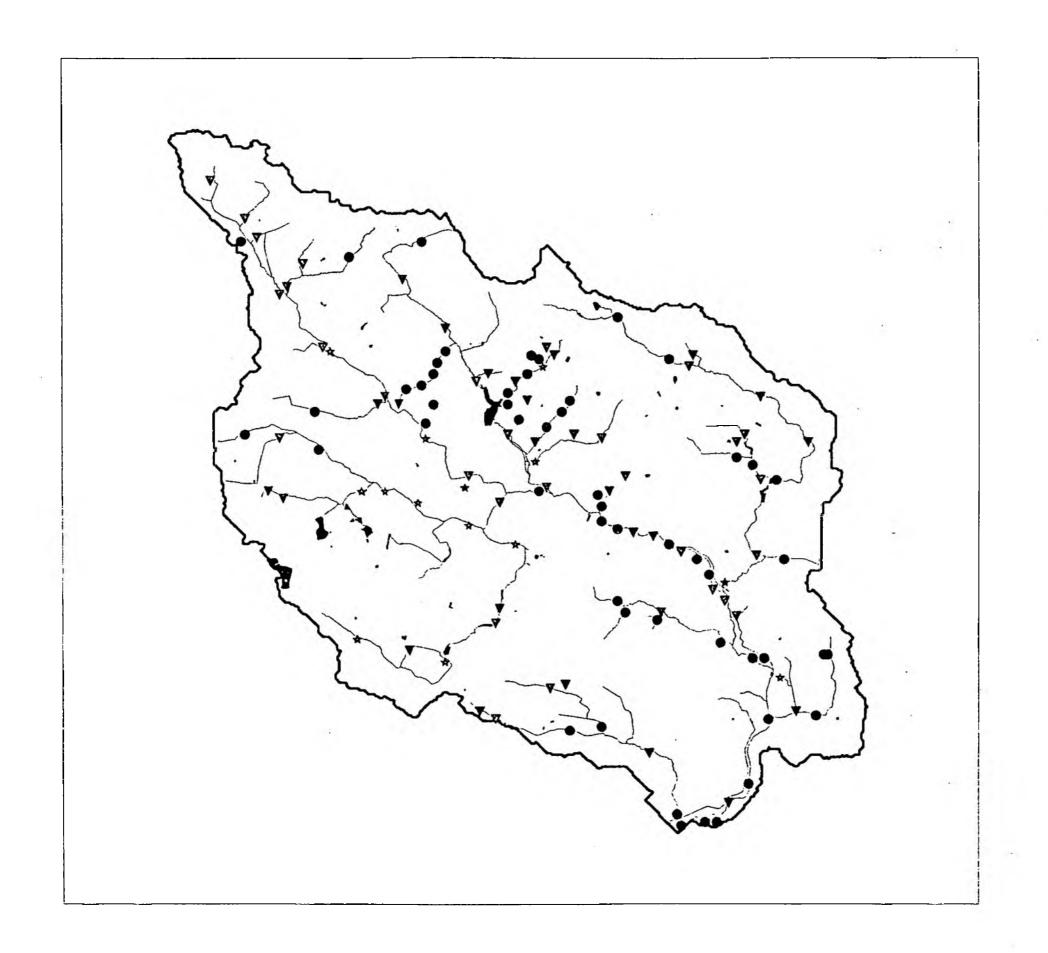
Figure 7-10
Extent of Bank Reinforcement

#### EXTENT OF BANK REINFORCEMENT

●0 to 1 no reinforcement (54) ▼1 to 7 reinforced (56) ★7 to 20 extensive reinforcement (15)

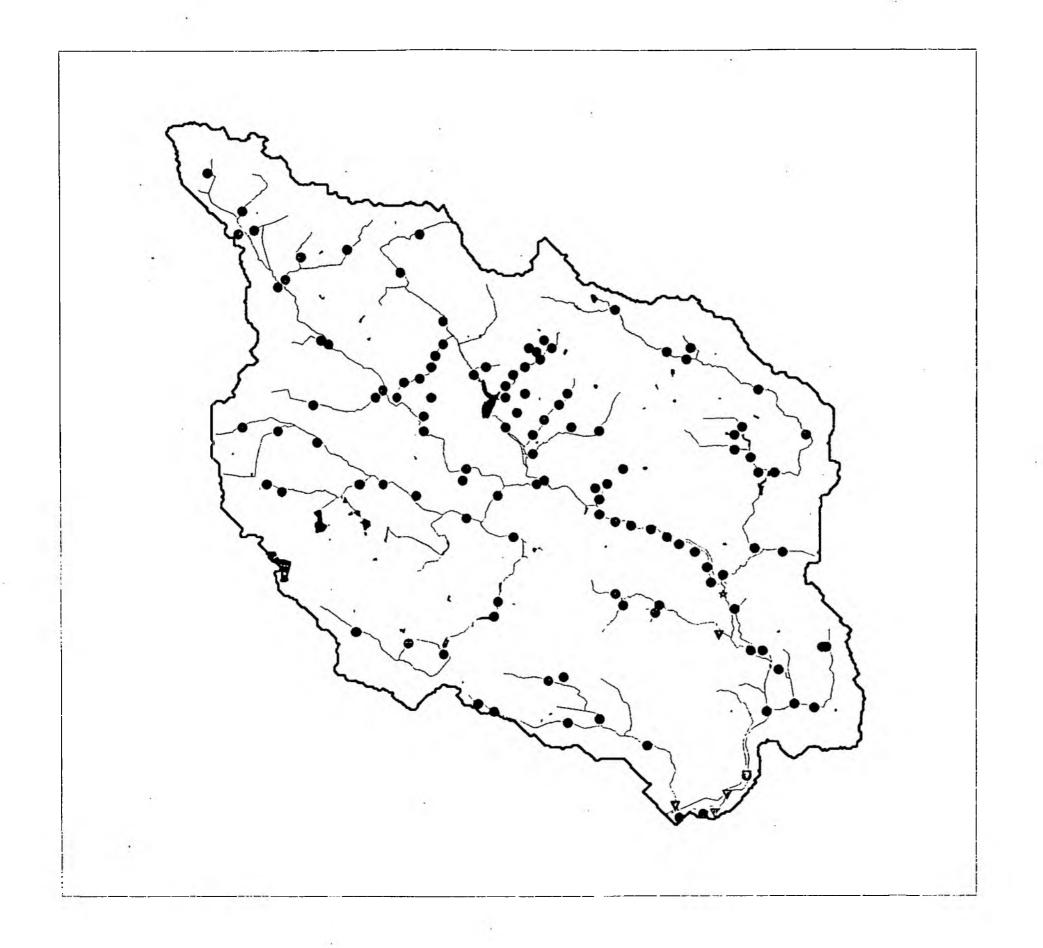
Figure 7.11 Extent of Embankments

#### **EXTENT OF EMBANKMENTS**

●0 to 1 no embankment (119) ▼1 to 7 few embankments (5) ★7 to 20 extensive embankment (1)

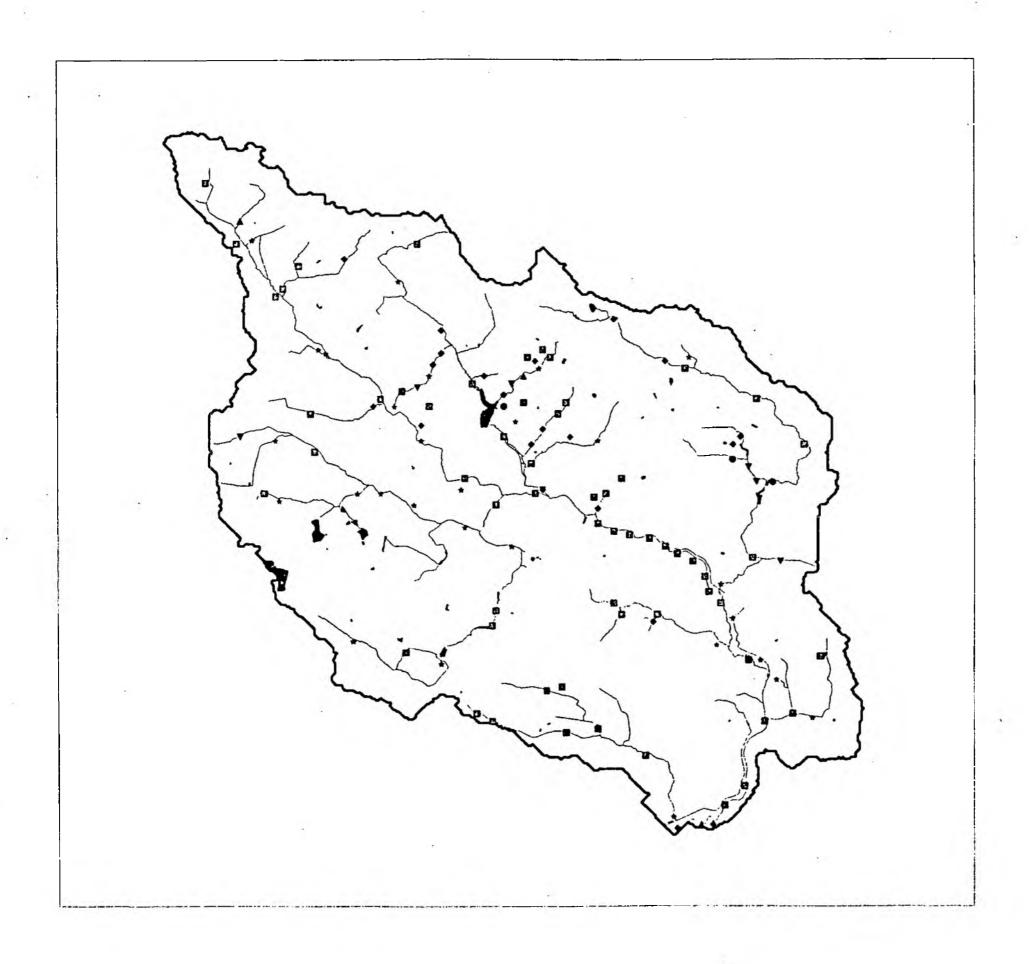
Figure 7.12

# HABITAT MODIFICATION INDEX By Habitat Modification Score

It to 1 - Pristine (4)
 It to 1 - Semi-natural (3)
 ▼ 3 to 2 - Predominently unmodified (8)
 ● 9 to 21 - Obviously modified (21)
 ■21 to 4 - Extensively modified (60)
 ◆45 to 101 - Heavily extensively modified (29)

Habitat Modification Index - by Score

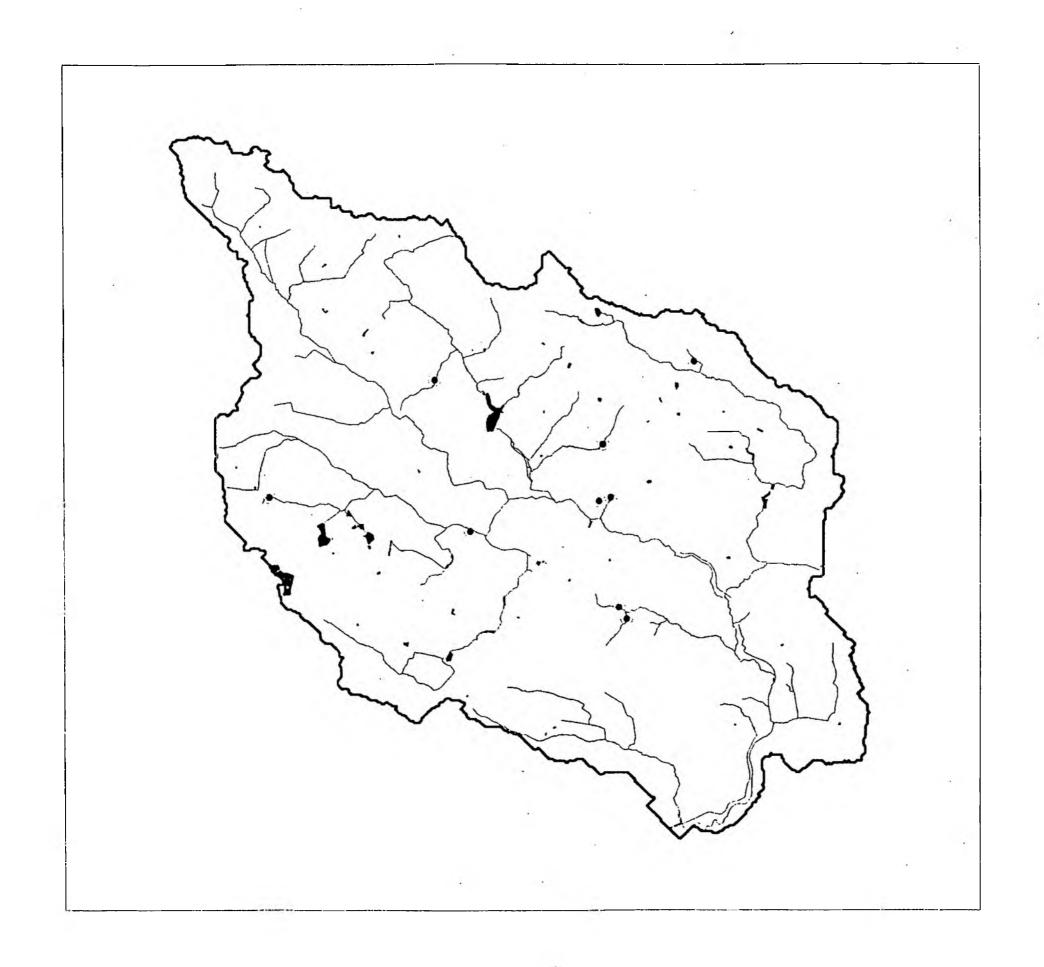
#### **REHABILITATION POTENTIAL**

Prime Sites for Geomorphological Rehabilitiation (9)

Refer to text for details of derivation of rehabilitation potential

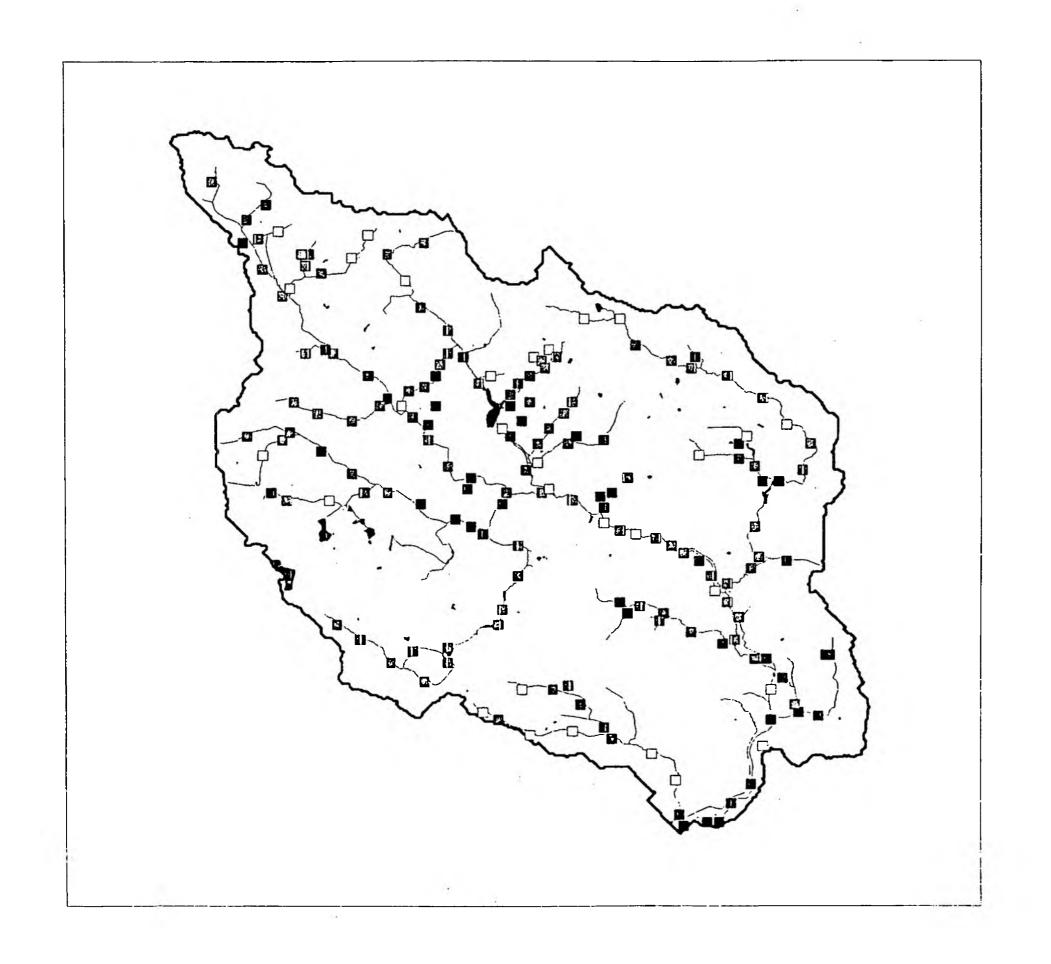
Figure 7.18 Genuplobyical Divents haden

#### GEOMORPHOLOGICAL DIVERSITY

180 (1) 1 (6) 2 (39) 3 (57) 4 (30) 5 (34) 6 (10)

1) GDI is based on data researched survey for sediment sources, sediment sinks, substrate condition and flowtype - refer to text for detail

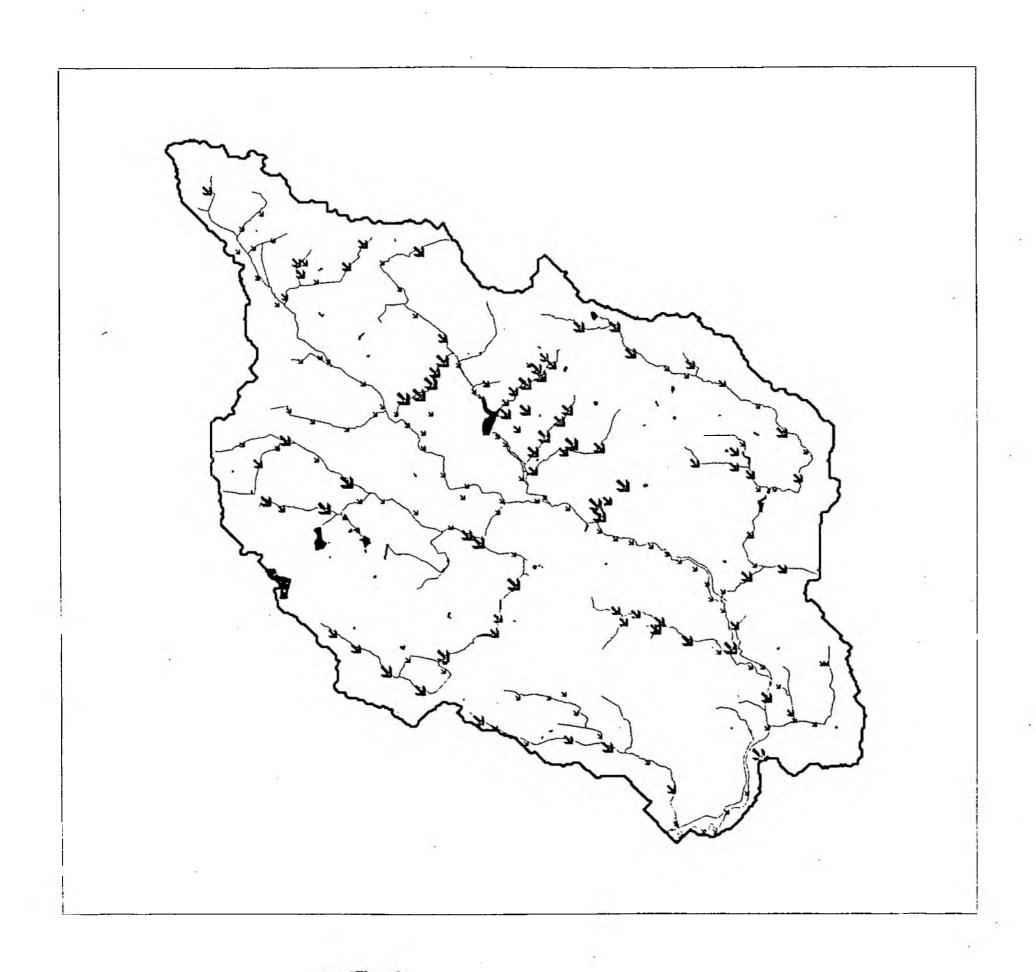
# STREAM POWER INDEX Proxy Index (rounded)

34 0 to 2 (93) 34 2 to 3 (10) 34 3 to 7 (31)

¥ 7 to 21 (24)

21 to 120 (19)

1) Stream Power Proxy is a measure of the the power of a river to entrain, transport and deposit sediment. Refer to text for full details.

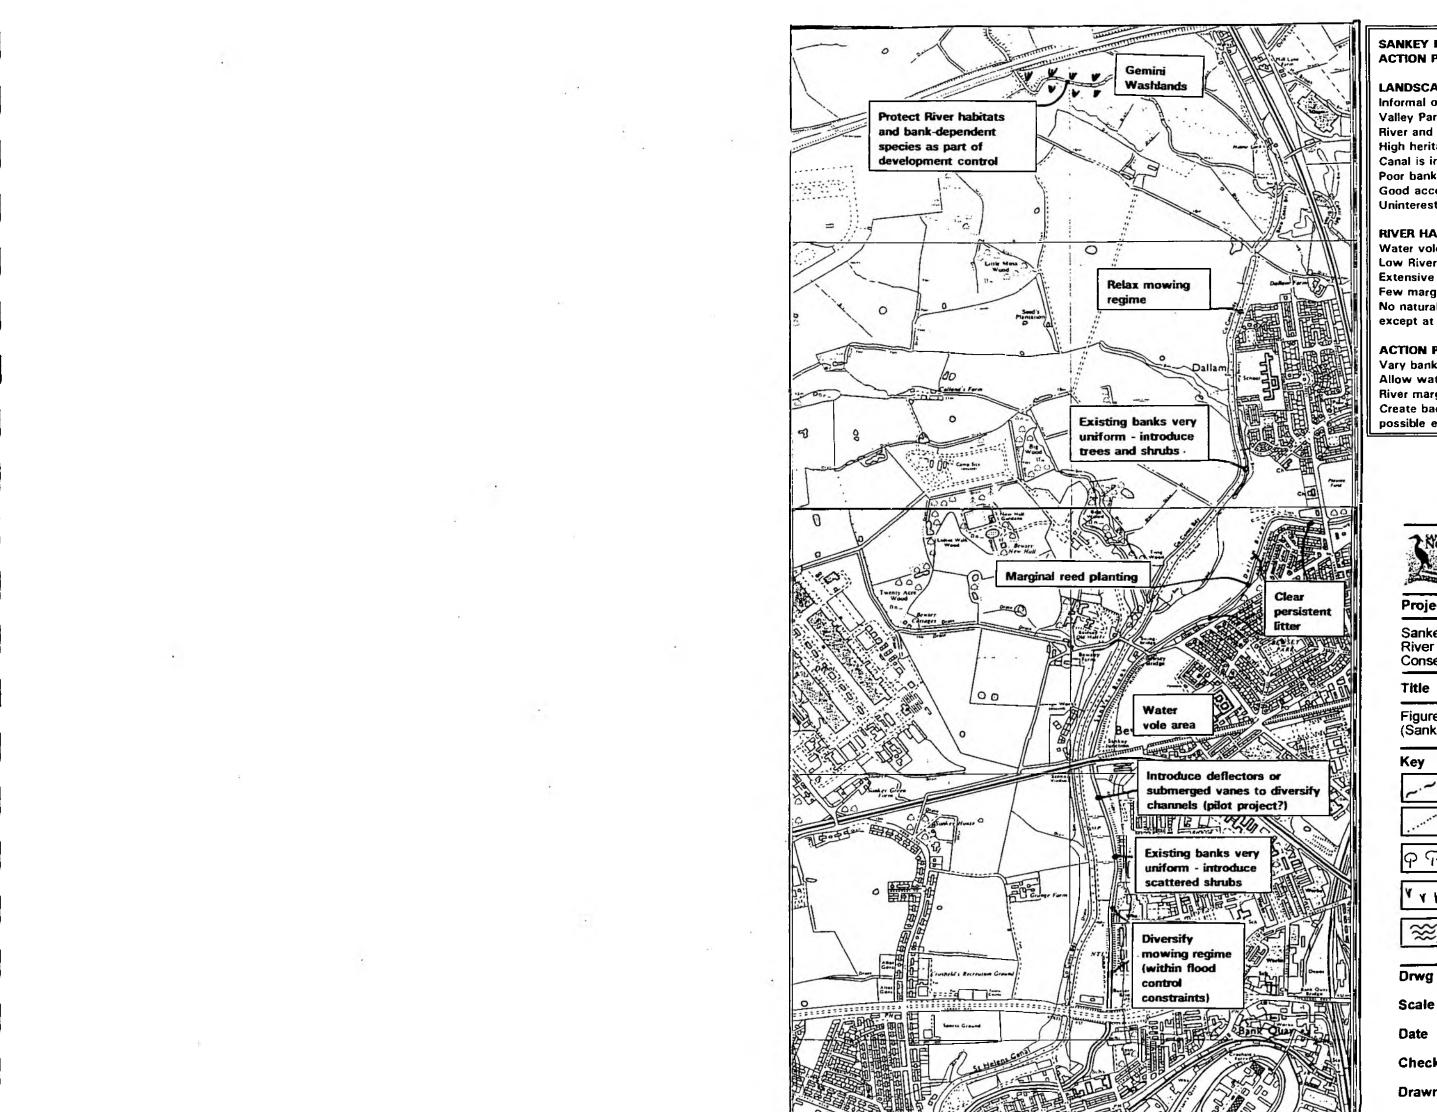
Figure 10.3 Warrington (Sankey Brook) Action Plan

#### SANKEY BROOK (WARRINGTON) **ACTION PLAN**

Informal open space of Sankey Valley Park River and Canal share corridor High heritage value Canal is important for angling Poor banktop tree cover Good access along watercourse Uninteresting bankface vegetation

Water vole stronghold Low River Habitat Quality Extensive resectioning Few marginal or reedbed habitats No natural floodplain features except at Gemini Washlands

Vary bankface mowing regimes Allow water vole expansion River margin reed planting Create backwater channels where possible eg at Gemini washlands?

New access proposed Existing access

New woodlands/trees proposed New/widened buffer strip proposed

New floodplain wetland
