AN ASSESSMENT OF RIVER WATER QUALITY IN THE RIVER KENN.

> November 1991 FWI\91\018

National Rivers Authority South West Region

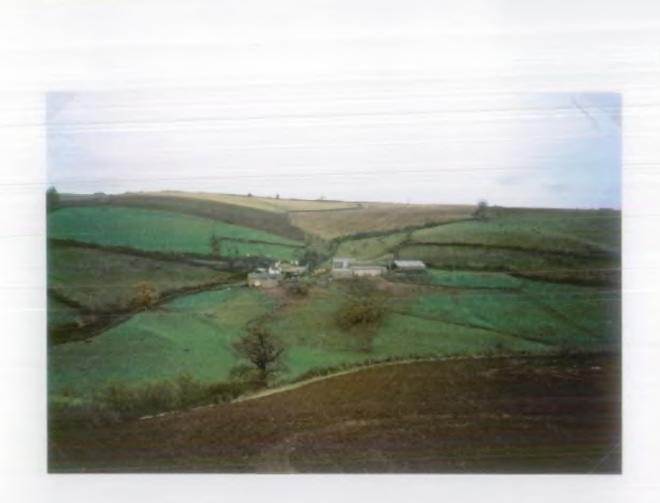
Typical Land-use in the Upper Kenn Catchment 26.11.91.

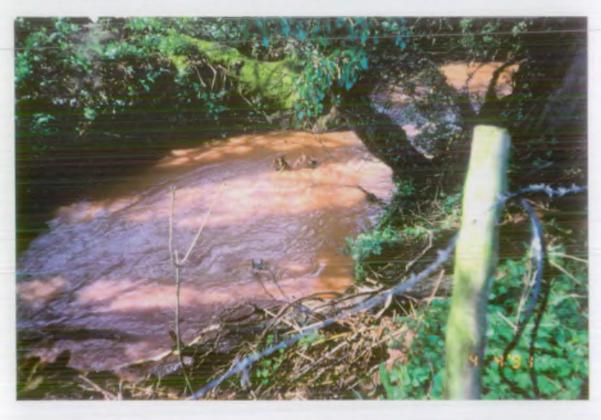
River Kenn at Lower Brenton Farm during the high-flow chemical survey (4.4.91).

Two continuous (pHOX 100DPM) water quality monitors were installed in the catchment; one system was placed at Lower Brenton Farm in the middle reaches (site B), and the other at Lower Horrels in the headwaters (site A) (see Figure 1). Ammonia concentrations were recorded at 15 minute intervals.

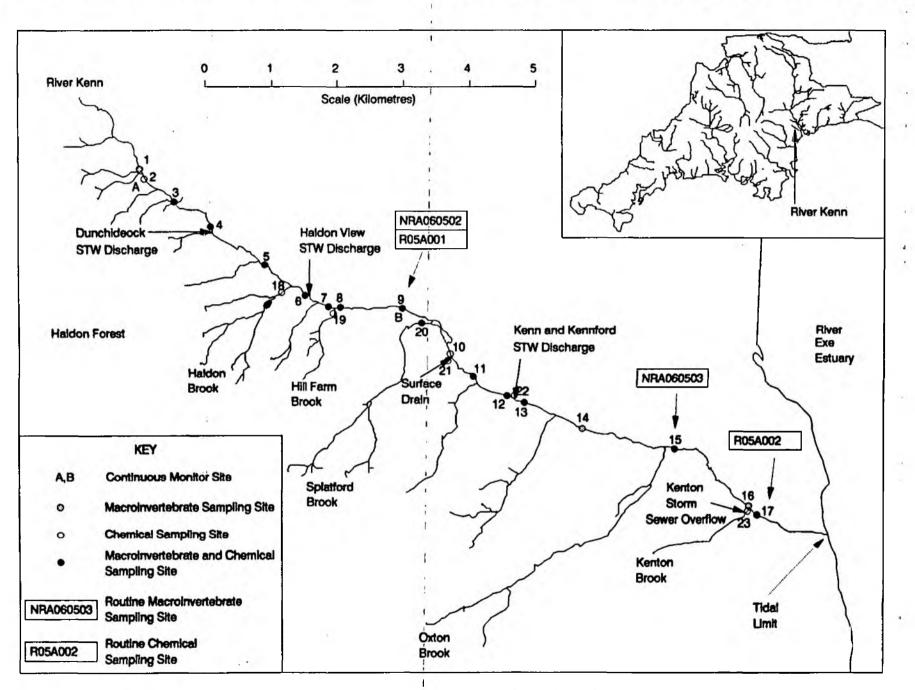
FIGURE 1. MacroInvertebrate & Chemical sampling sites in the River Kenn Catchment.

Aquatic macroinvertebrate samples were taken from 16 sites on the main River Kenn and its principle tributary, Splatford Brook, to locate areas of poor water quality in the Kenn catchment (see Figure 1).

Three sewage treatment works discharge to the River Kenn (see Figure 1); the details of which are given below:

There are 2 routine water quality monitoring sites within the catchment: at the A38 bridge Kennford (NGR SX 9132 8662) and at Powderham Castle (NGR SX 9660 8343) (see Figure 1). The 1990 classification of determinands monitored at each site using the National Water Council (NWC) river classification system are given in Table 2 (see Appendix I for the complete data).

Locations are indicated in Figure 1 and data given in Appendix II.

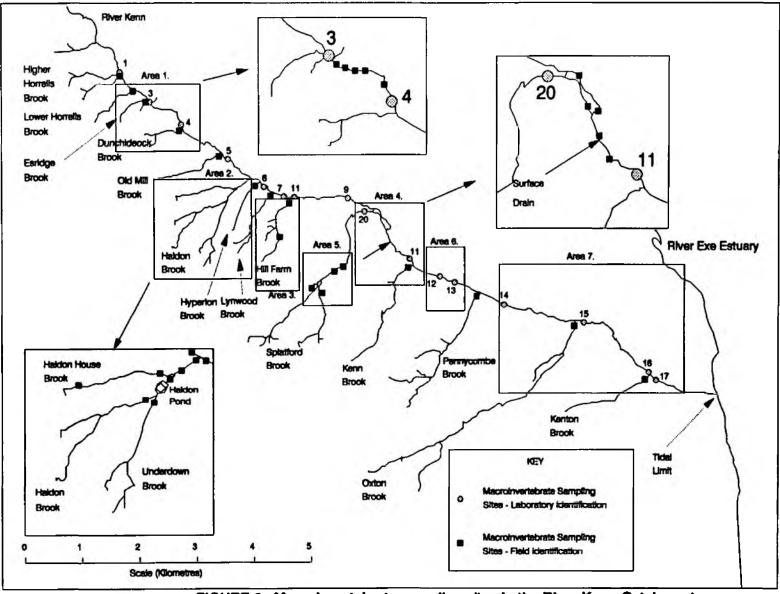
FIGURE 2. Macroinvertebrate sampling sites in the River Kenn Catchment.

Areas of poor water quality identified by the initial survey were further investigated to trace sources of pollution (as indicated in Figure 2).

Aquatic macroinvertebrate samples identified in the field between sites 3 and 4 (see Figure 2) traced the source of poor water quality to a river stretch below Idestone Brook Cross (NGR SX87818836), although the precise source of pollution was not found. An increase in BOD and suspended solids concentrations at site 4 compared to site 3 supported the biological findings.

Analysis of macroinvertebrate samples identified in the field within the Haldon Brook catchment (see Figure 2) indicated organic pollution from the Haldon House Brook. The lack of Ephemeroptera (organic pollution sensitive taxa) downstream of ponds at Haldon Grange traced the problem to the headwaters of the tributary. Farm drainage from Penhill Farm (NGR SX87608660) was the most likely cause of poor water quality.

Macroinvertebrates samples identified in the field between sites 9 and 11 (see Figure 2) traced the absence of Baetidae and Crustacea to downstream of a surface water drain entering the River Kenn at NGR SX91888592. This decline resulted from an unknown pollutant in the surface water drain. However, samples collected from the surface water drain during the high flow event did not contain oils and greases.
