CORRIDOR SURVEY : RIVER BOVEY AND MINOR TRIBUTARIES

RIVER BOVEY & BOVEY MINOR TRIBUTARIES CORRIDOR SURVEY

October-November 1990

A REPORT PREPARED FOR THE NATIONAL RIVERS AUTHORITY

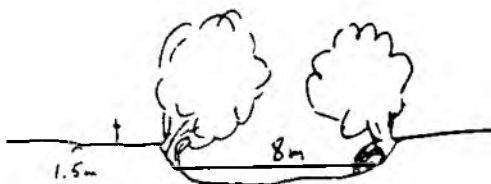
Gently winding section through Bovey Tracey.

Banksides

Upstream there are 1.5-2m earth banks, steep with occasional access points. Tree cover is continuous and includes some excellent very old coppiced ash, oak and sycamore on the south bank, providing possible otter lying-up sites (a spraint was found by the bridge). Below the bridge there is bank reinforcement opposite the mill and on the lower bend. Elsewhere banks are gently sloping 0.5-1m with mixed age alder and willow coppice. Banktop vegetation consists of Indian balsam, hemlock water-dropwort and annuals, along with pockets of bramble and bracken.

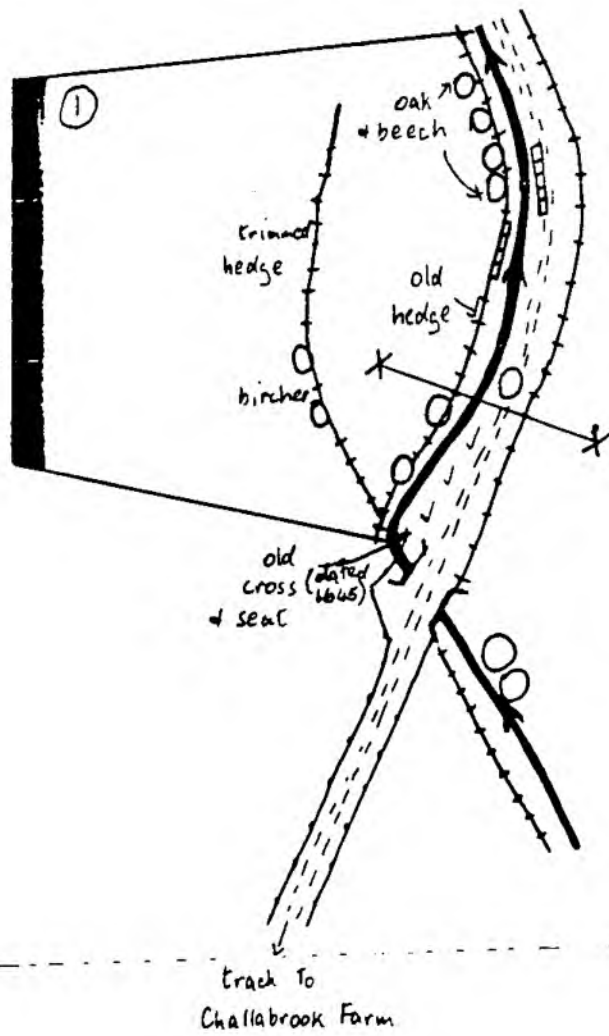
BOVEY POTTERY LEAT Chainage 0.7-1.0 Grid ref: SX 8117 7758-
8095 7753

The leat flows between gardens and is densely overgrown with brambles. Where the channel emerges beside Ashburton Road there are abundant ferns and brambles overhanging the channel. The leat goes under the road and then flows south. The seclusion and dense growth are of value to wildlife.
