WATER QUALITY INVESTIGATIONS AT NANCEKUKU, CORNWALL

WQP/92/002

TECHNICAL REPORT NO. WQP/92/002

APPENDIX 1. SAMPLING LOCATIONS AT NANCEKUKUKE

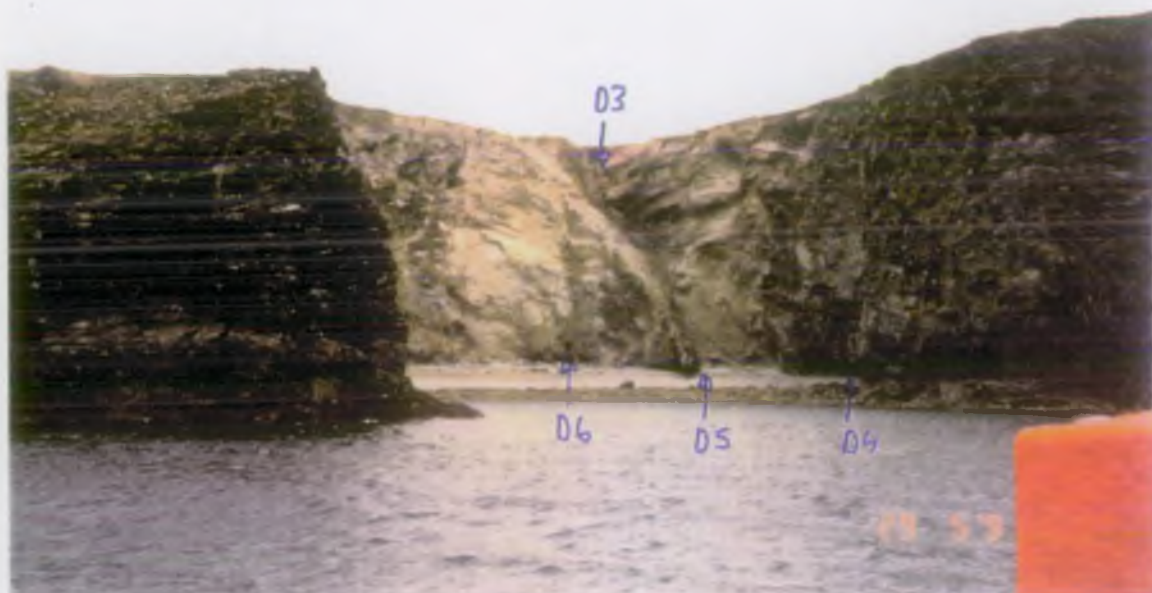
View of sampling locations D3, D4, D5 and D6 from the sea.

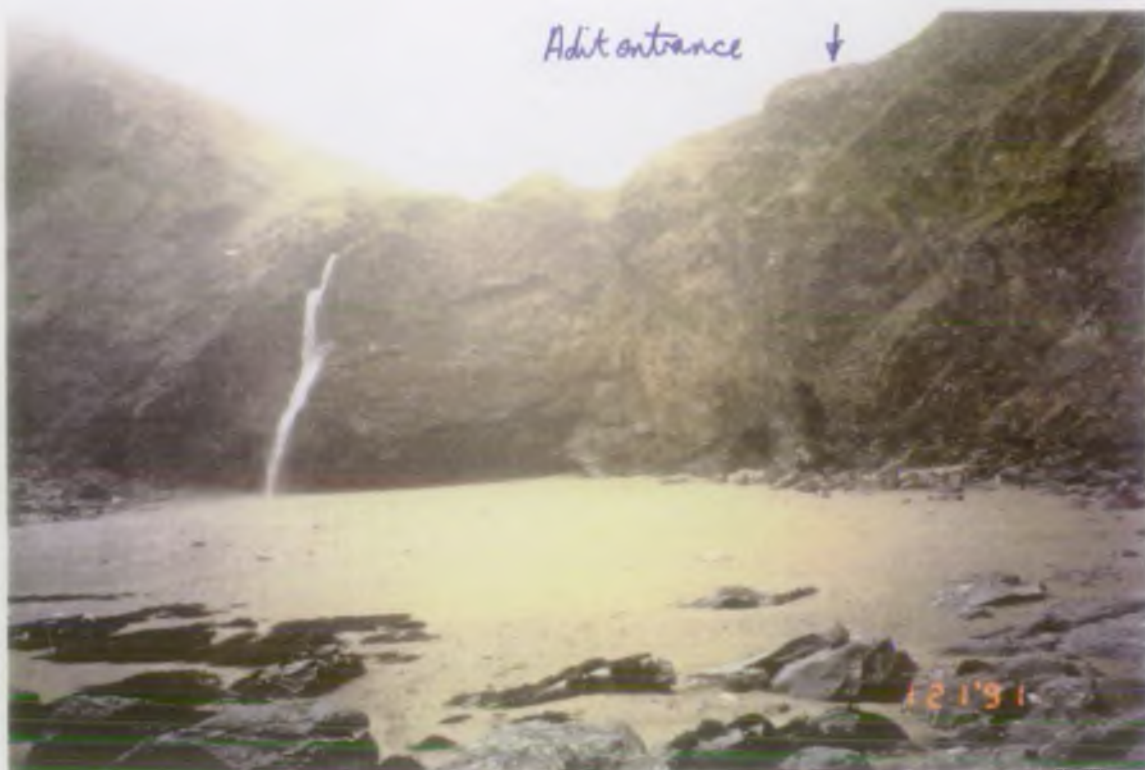
View of location of two adits, D7 and D8, and Sally's Bottom Stream overflowing the cliffs at Sally's Bottom.

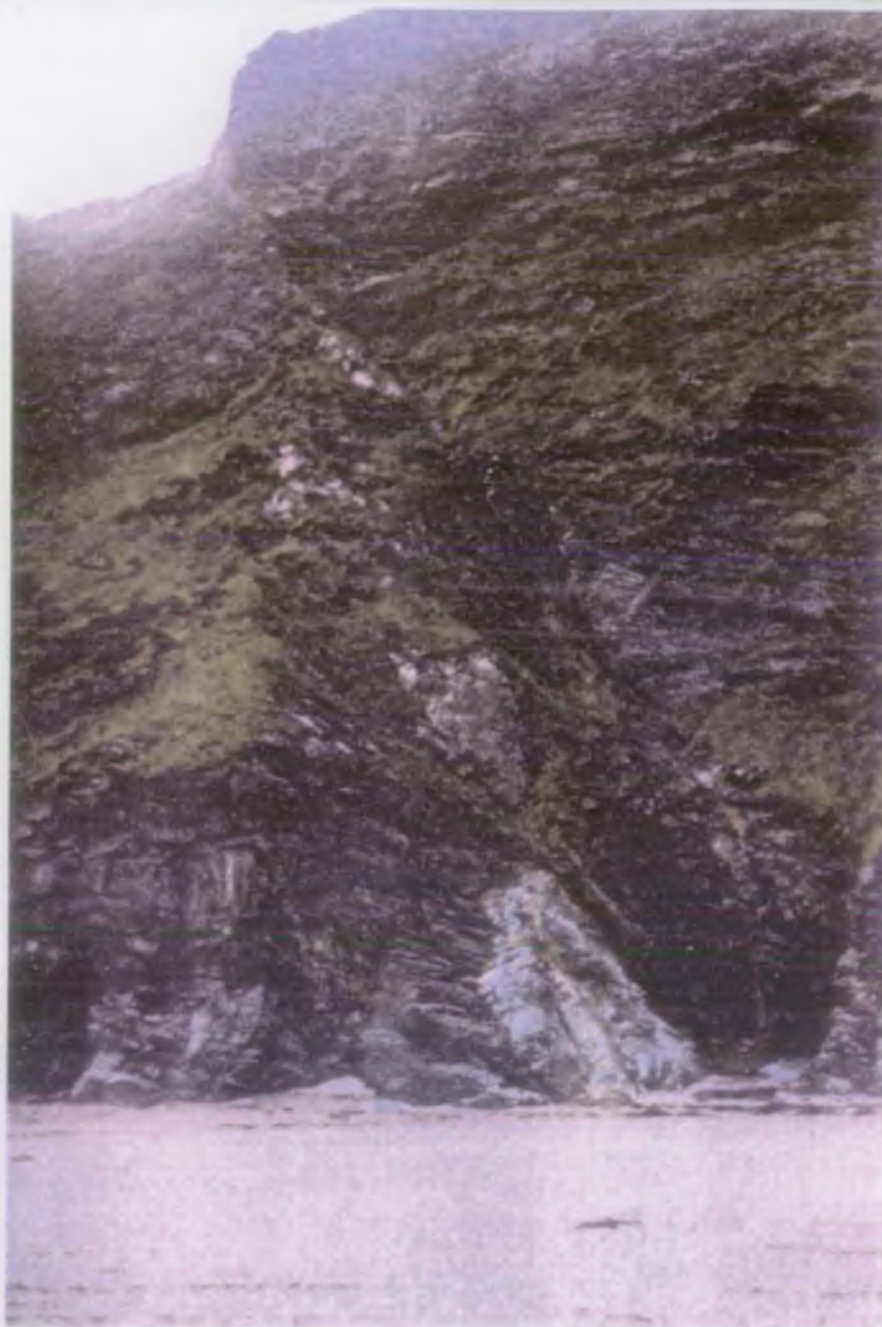
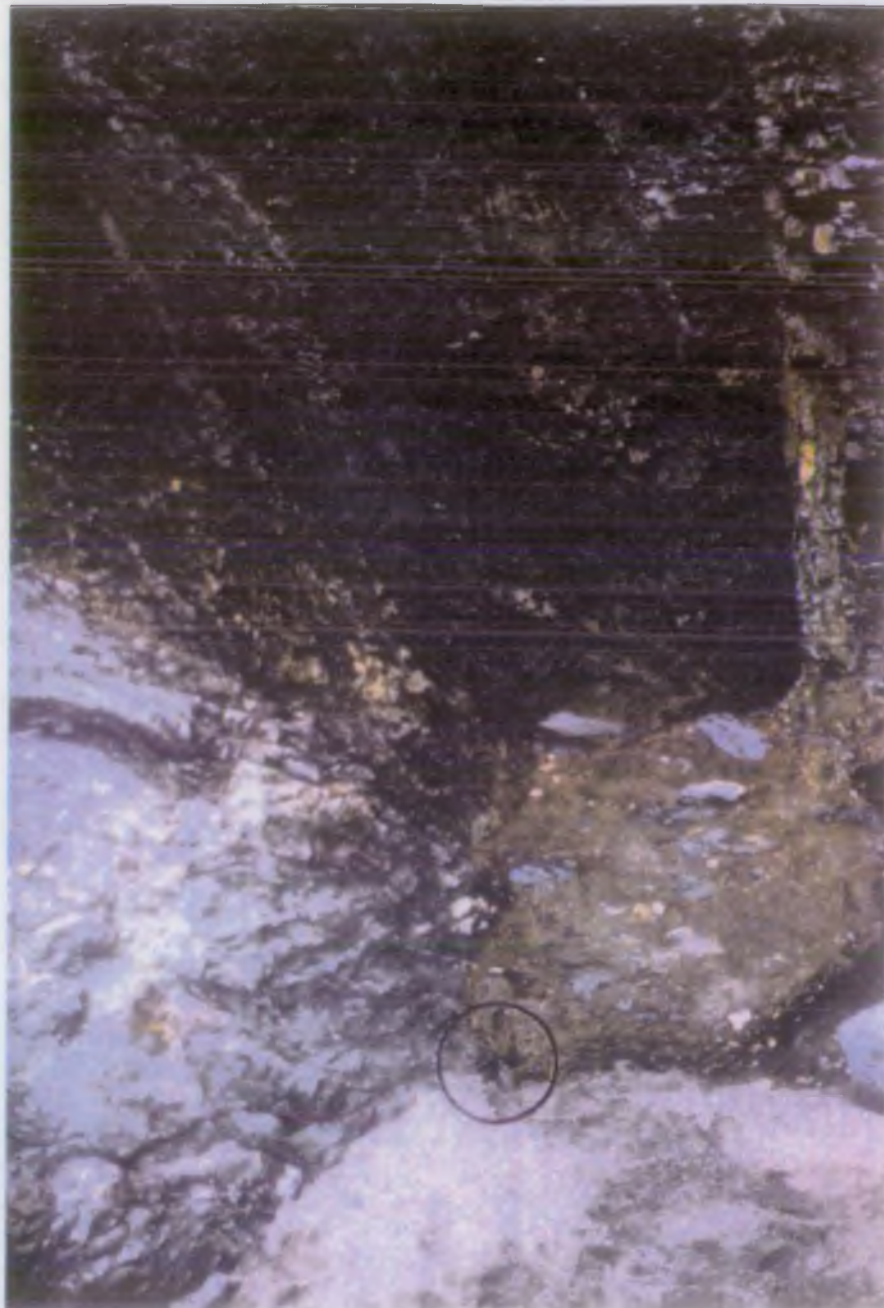
P1: Sample Point D1.

General view of D1 showing major cross-course exposed in cliff.
Sample point lower right, at top of sand.

Samples collected lower centre (sample point ringed).

Nature of Sampling Point: Water dripping from major quartz filled
cross-course several metres wide (trending 140 deg.m, dipping
60 deg. West). Apparent high Fe content cementing beach sand.

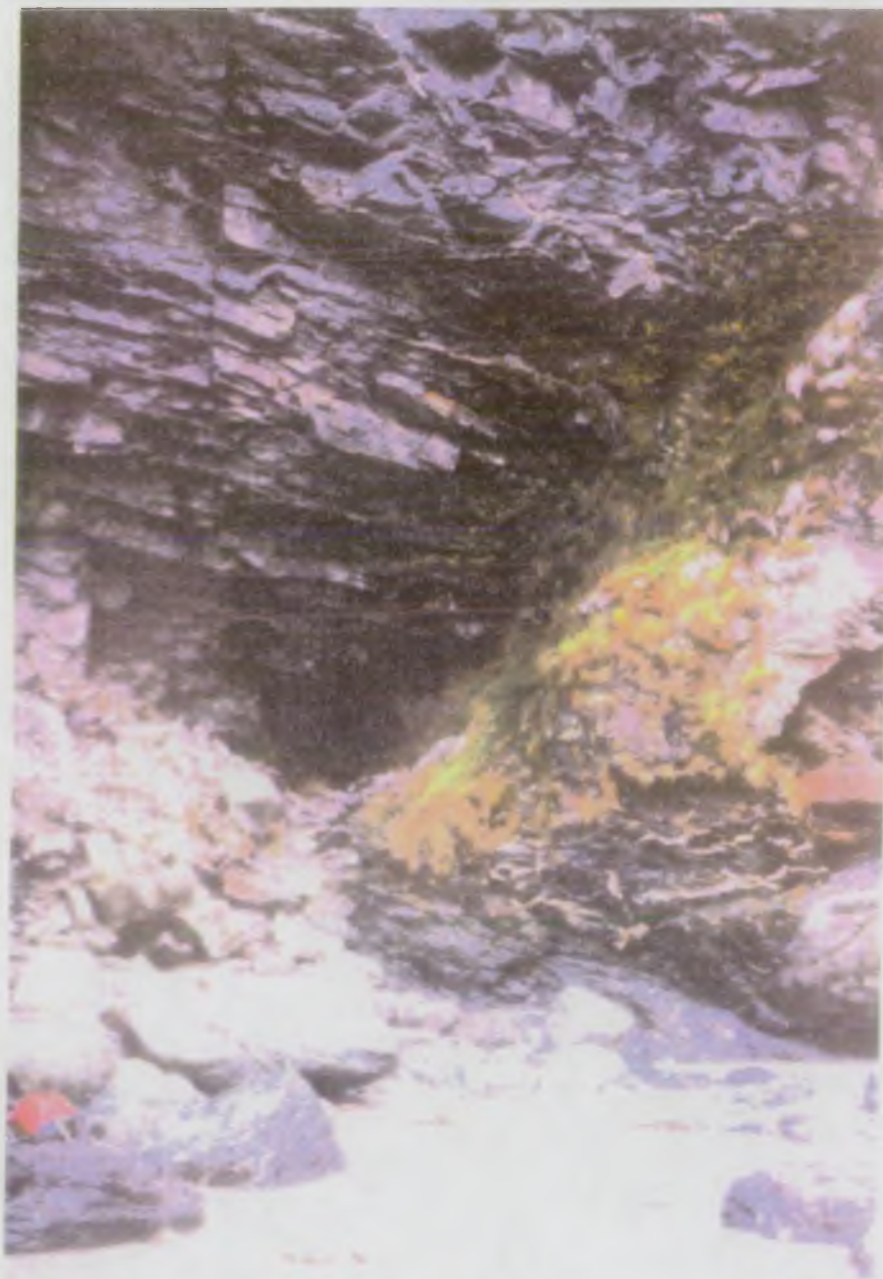
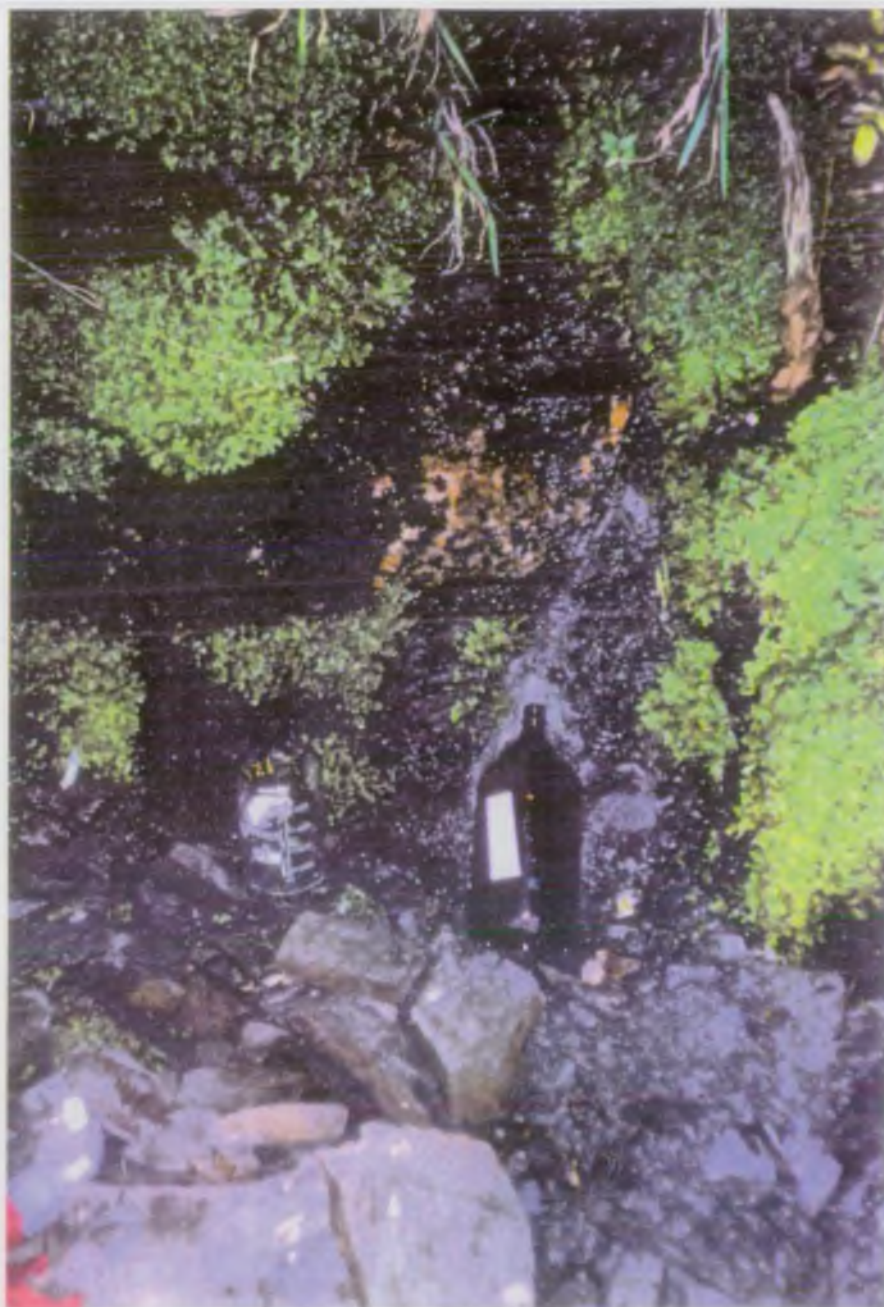
P3: Sample Point D2.

- (a) 21.5 nanograms/litre of op'TDE (a breakdown product of the pesticide DDT) were found in the sample collected from D2, which is from a seepage from the rock face in Gooden Heane Cove.

The origin of the trace amounts of this substance is not known. It is possible that illegal tipping outside the boundary of the former CDE site is a source of this material. It is not suspected that the pesticide residues result from the uses of the site at Nancekuke. The extremely low flows (0.7 litres/minute) from this rock seepage will have minimal impact on the surrounding marine environment.

Samples taken from shallow cave, centre.

Nature of Sampling Point: Sample from shallow cave formed by two faults (085 deg.m dipping 80 deg. south and 045 deg.m dipping 60 deg. north). Generally wet with large number of drips and trickles, sample taken from largest, on joint running 070 deg.m dipping 70 deg. north, with some evidence of mineralisation. (NB: Redruth Sewer Tunnel lies about 150m away in this direction, and the geological section indicates similar features)

No detailed investigation of the trace amount of op' TDE found in the groundwater seepage at sampling location D2 should take place until its presence is confirmed in the sample collected from the next survey.

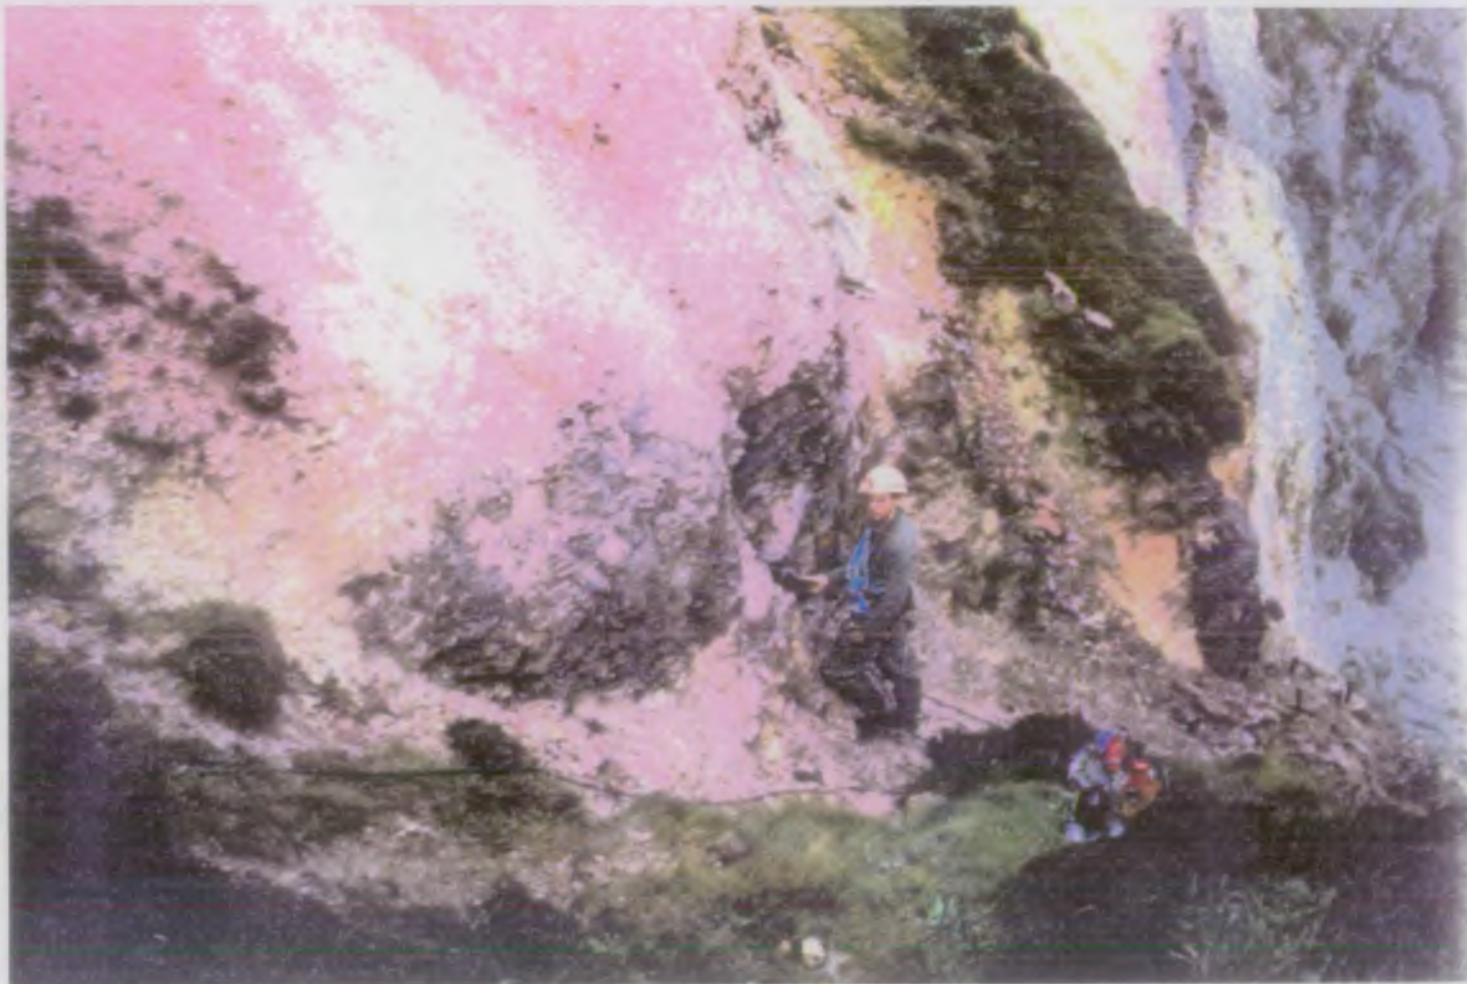
P5: Sampling D3, 10 metres below top of gully.

Nature of Sampling Point: Water issuing from band of harder shale outcropping in gully formed by heavily altered soft shale associated with two parallel cross-courses (trending about 150 deg.m dipping 60 deg. west). In total probably 3 - 4 l/min issues from various fissures but the sample was taken from the largest flow point, about 10m down the gully, an open joint trending due south and dipping 70 deg. east.

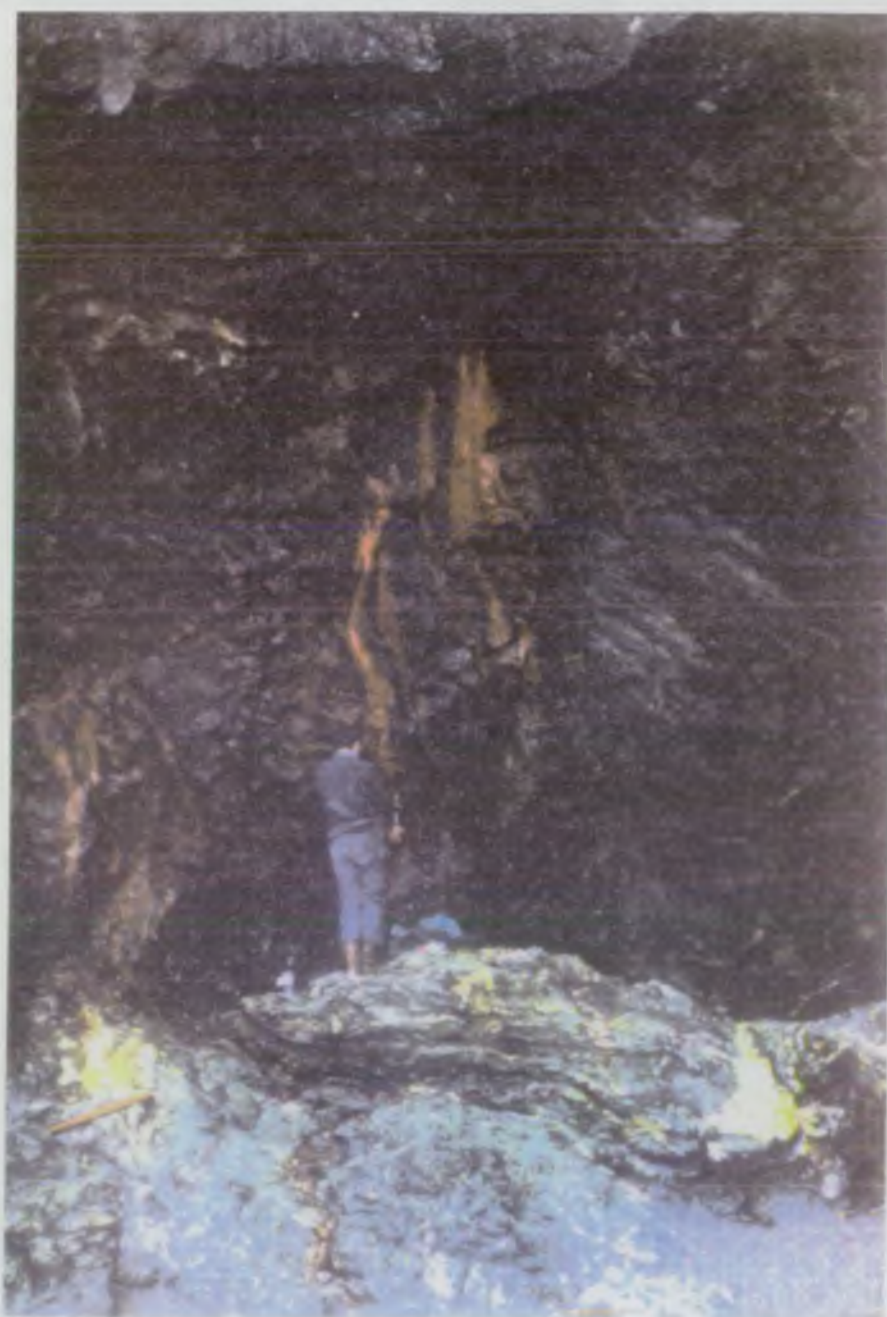
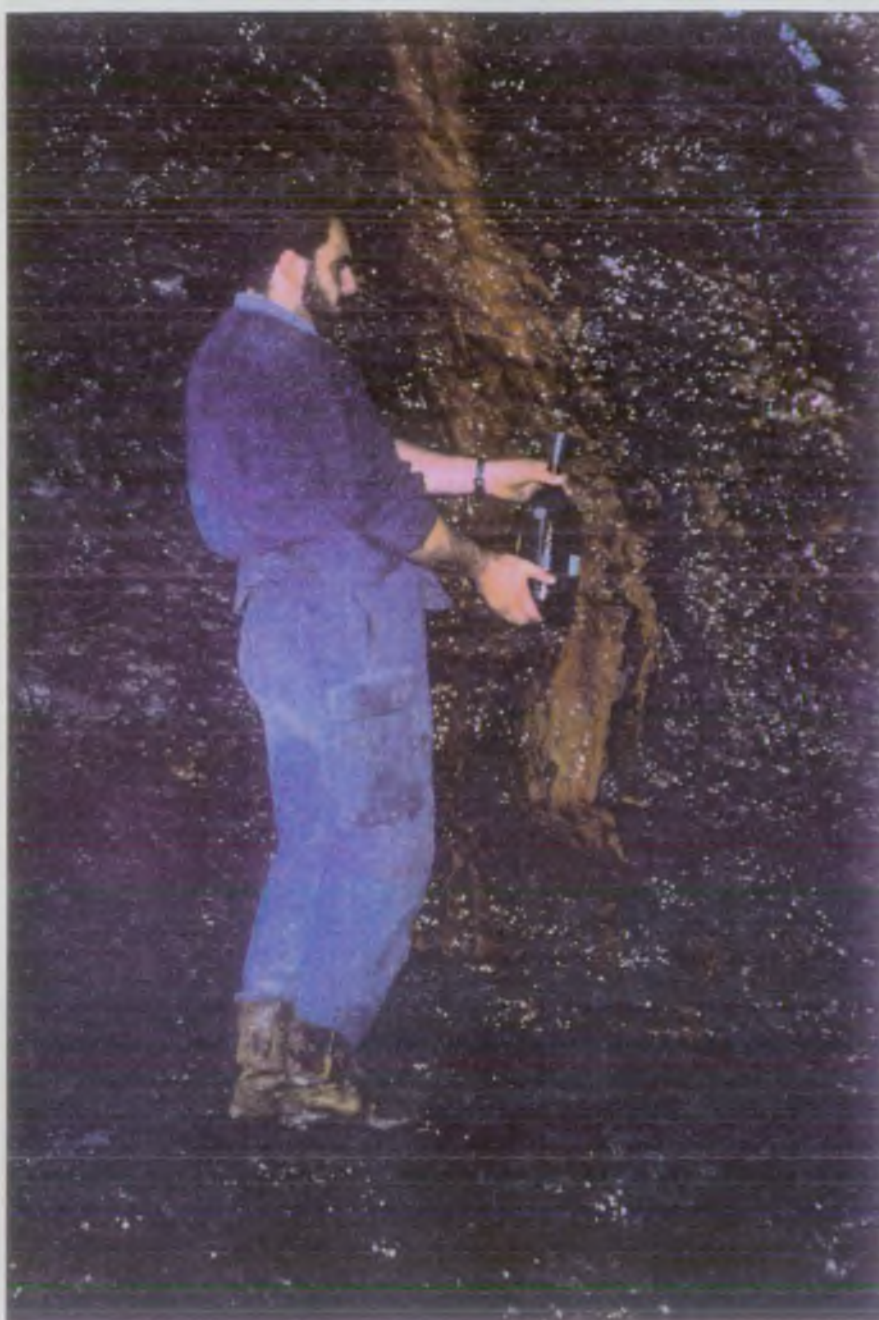
P8: Detail D4.

Nature of Sampling Point: Water dripping from vertical fault trending due south, outcropping in cliff at west end of beach. Evidence of mineralisation and considerable Fe staining.

P7: Sampling D4. West end of Gullyn Cove beach.

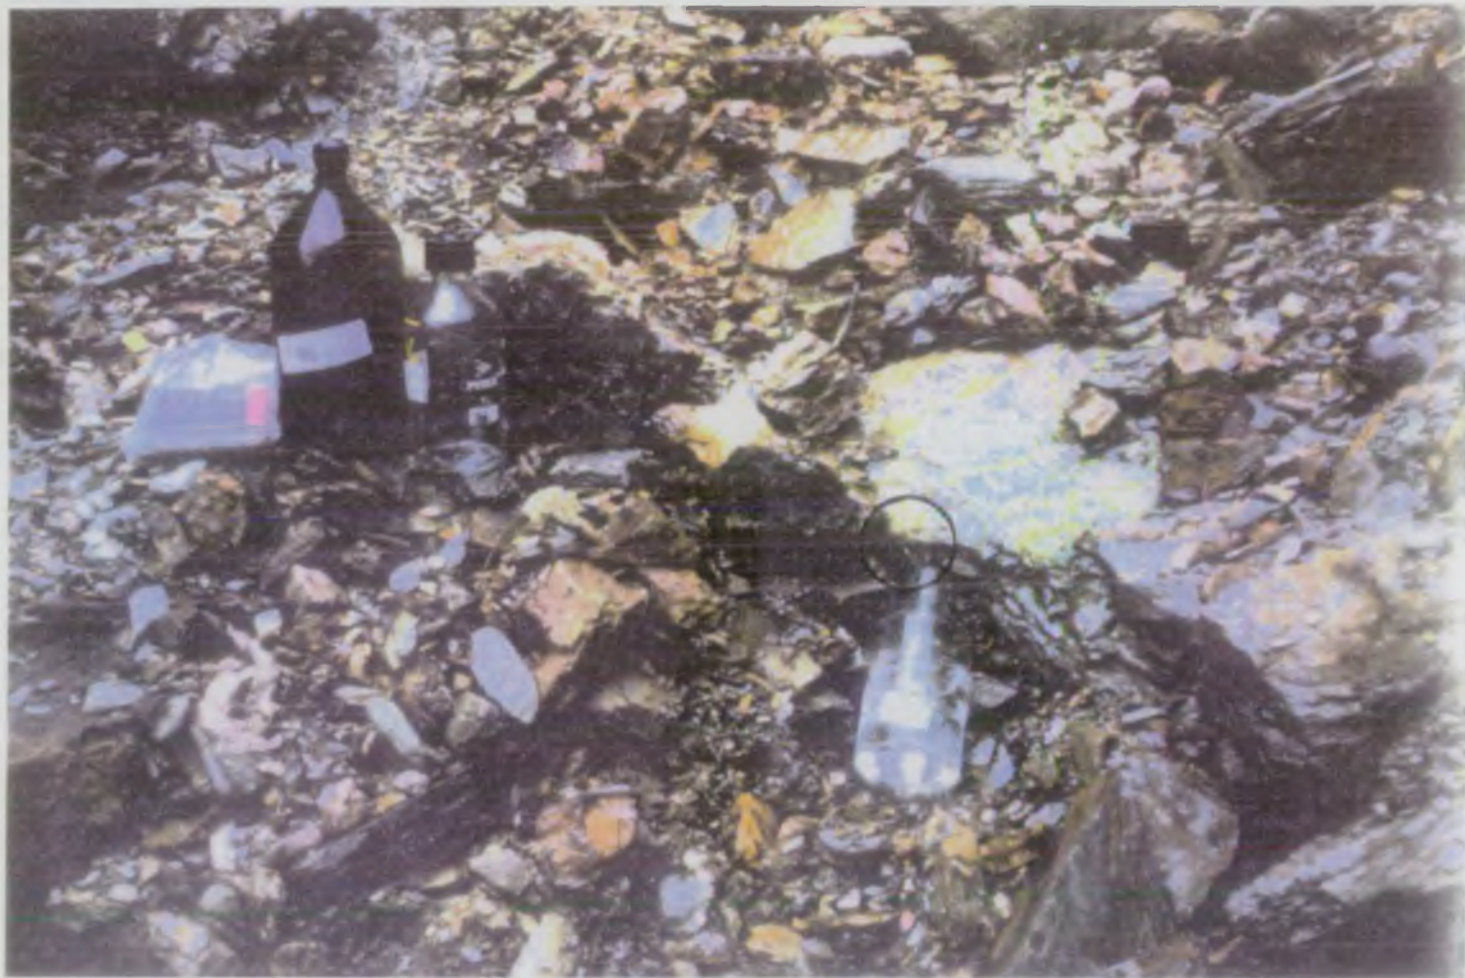
P9: Sample Point D5, near bottom of gully.

Sample point lower centre, ringed. Approximate position of D11 also shown.

Nature of Sampling point: Flow at base of same gully as D3 and D11, sampled at convenient point about 5m above beach. Flow much dispersed amongst rocks so difficult to estimate.

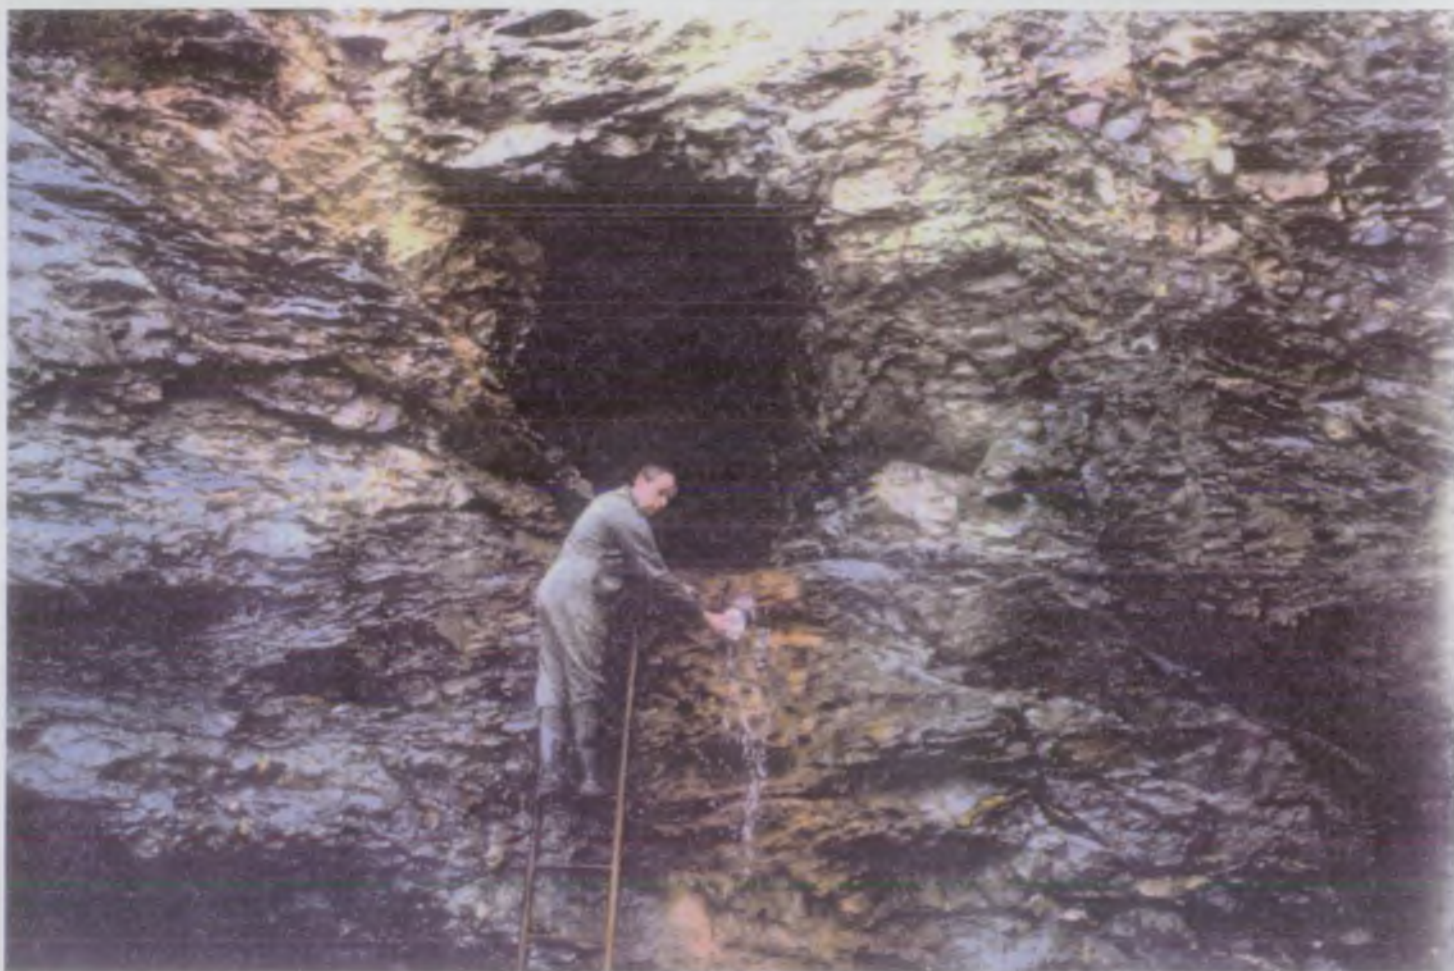
P11: Sampling D6, adit at Gullyn Cove.

Nature of Sampling Point: Flow from adit driven on mineralised fault, trending 130 deg.m dipping 45 deg. west.

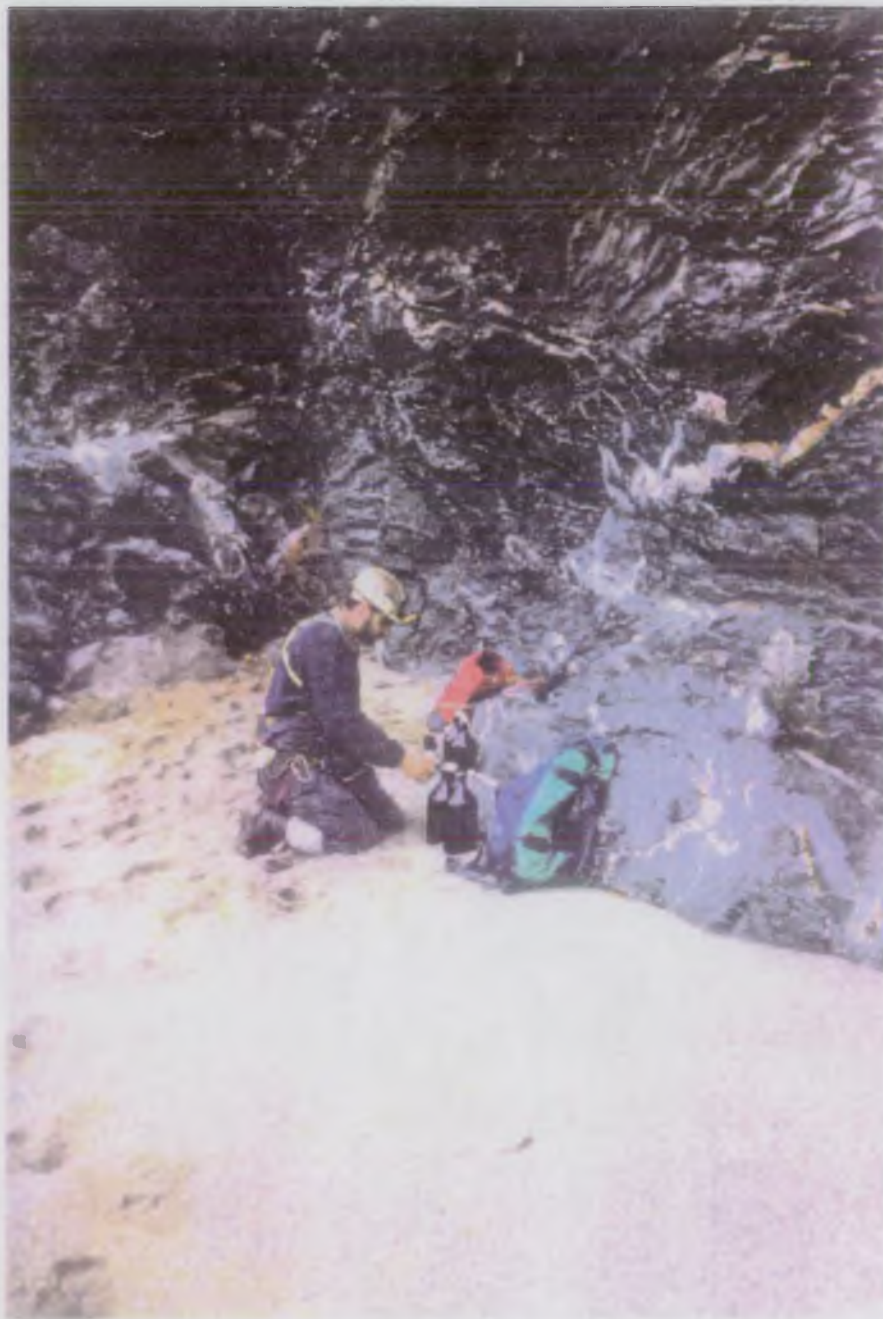
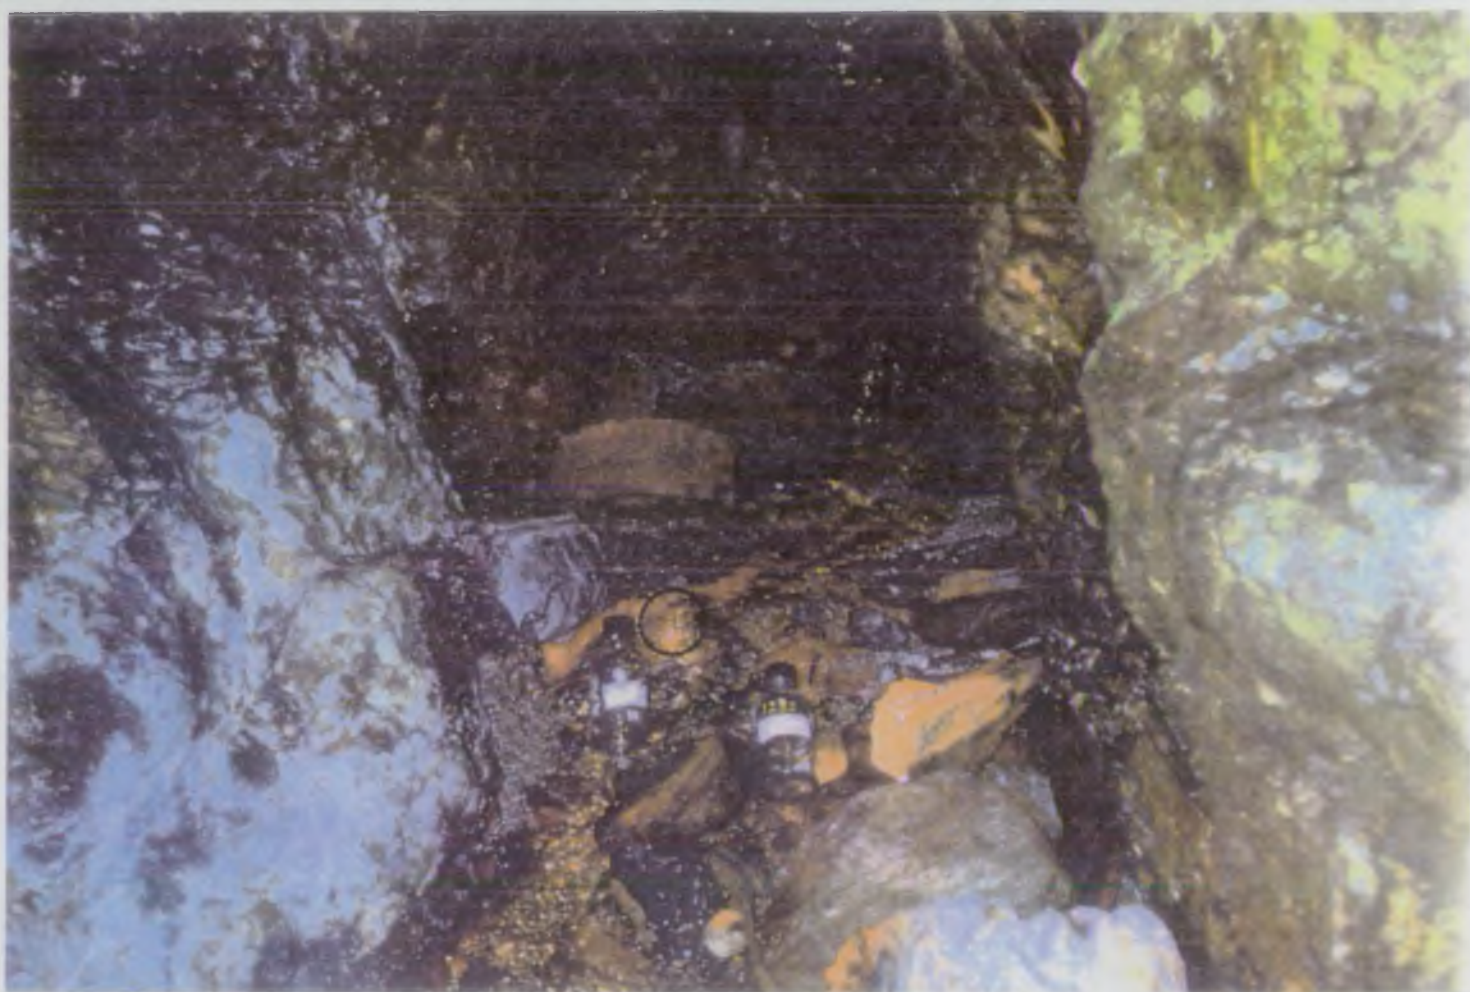
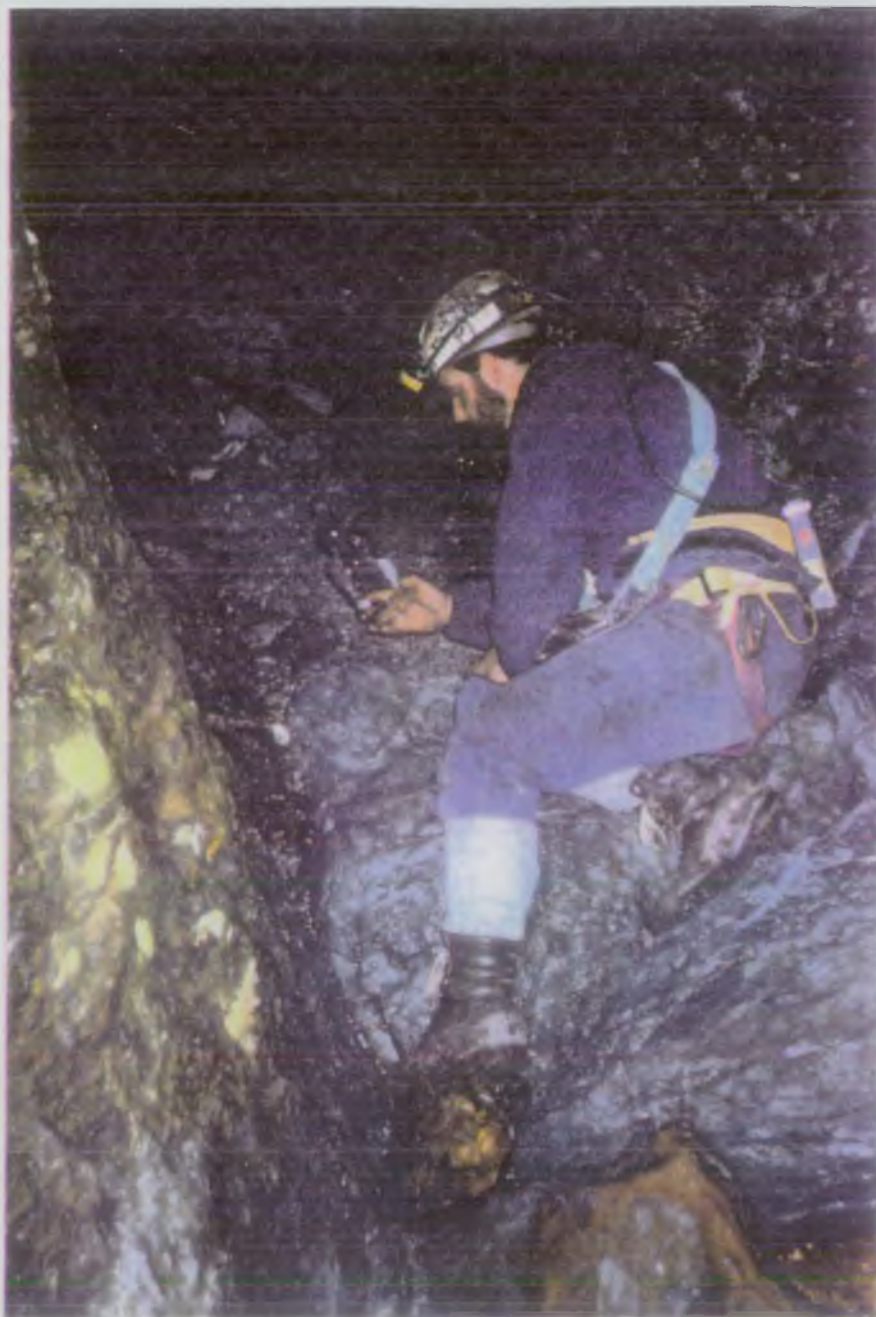
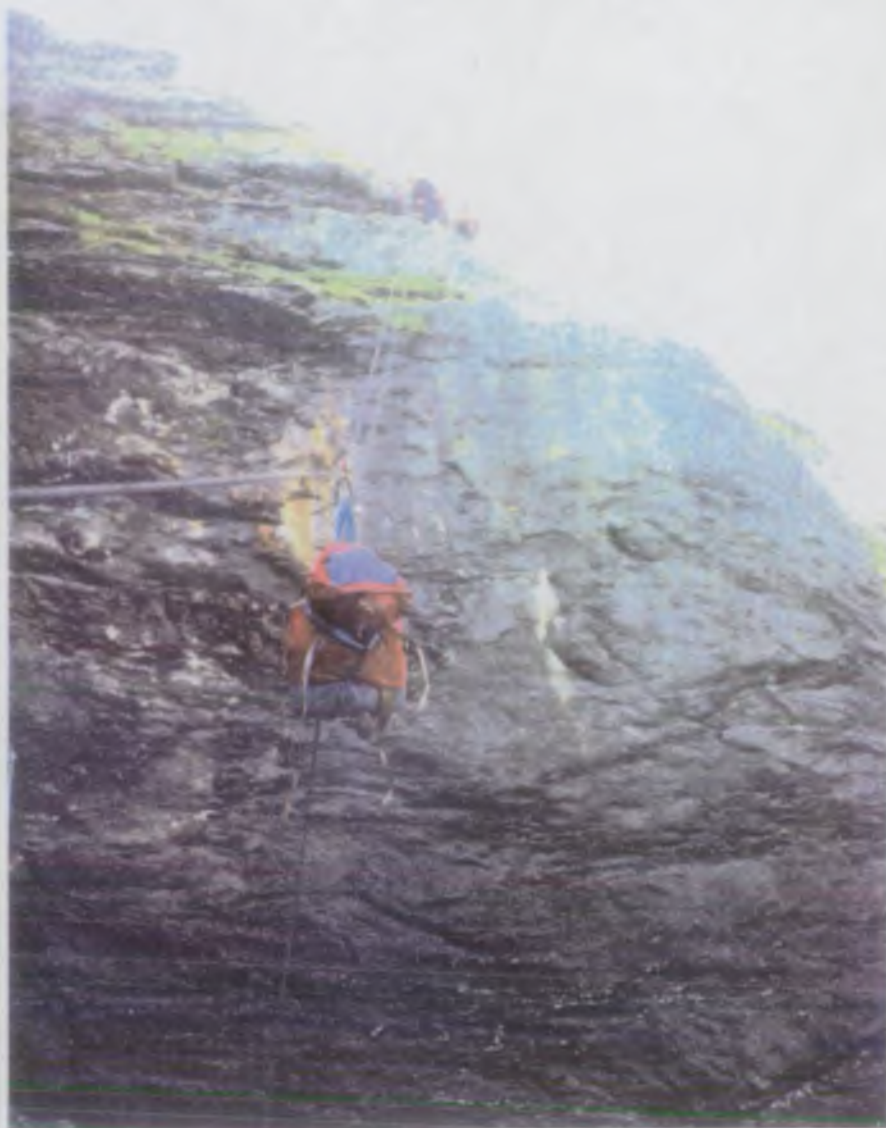
P12: Sample Points D7 & D8.

Entrance to Sally's Bottom adit top left.

Nature of Sampling point: Flow from eastward (main) branch of Sally's Bottom adit.

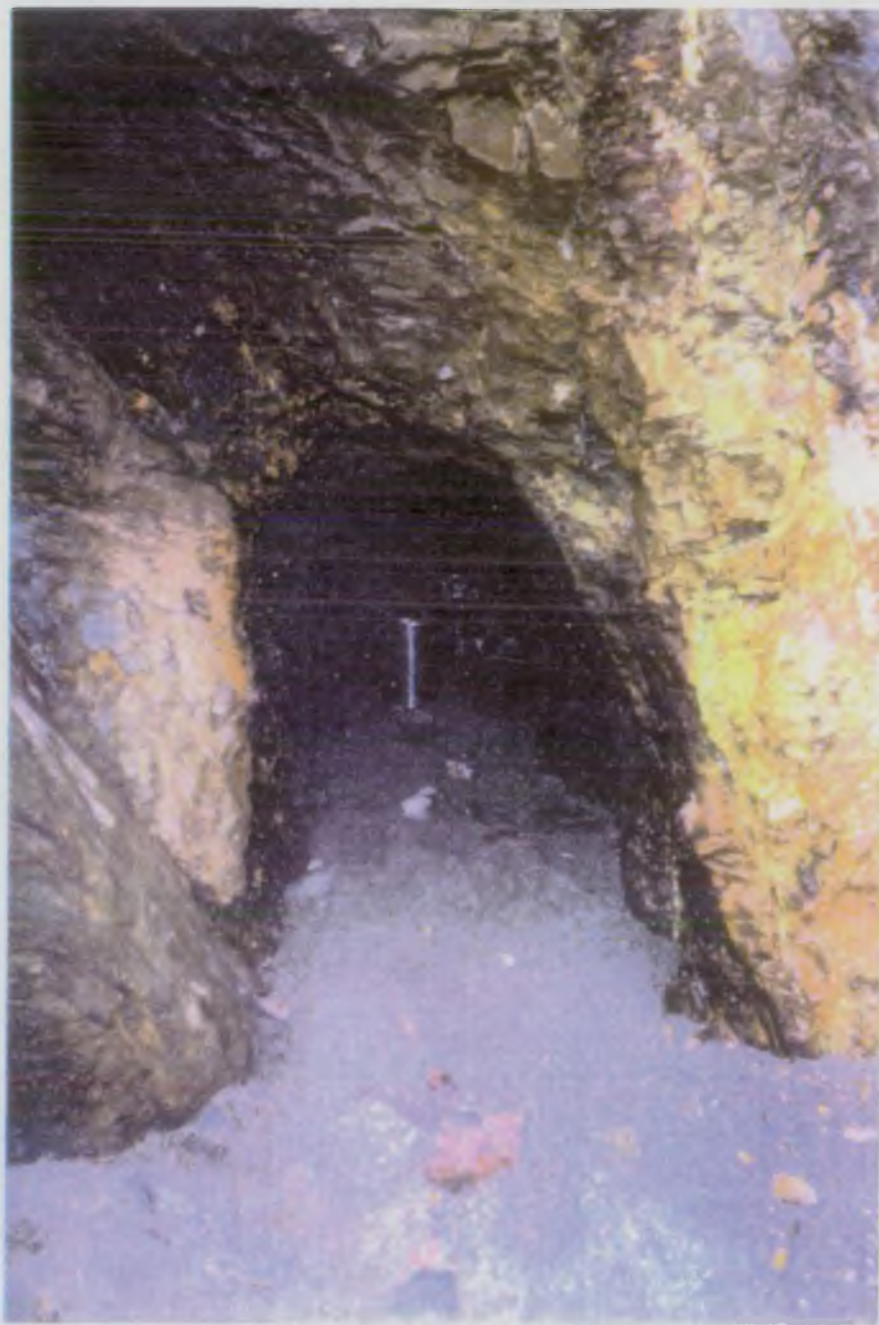
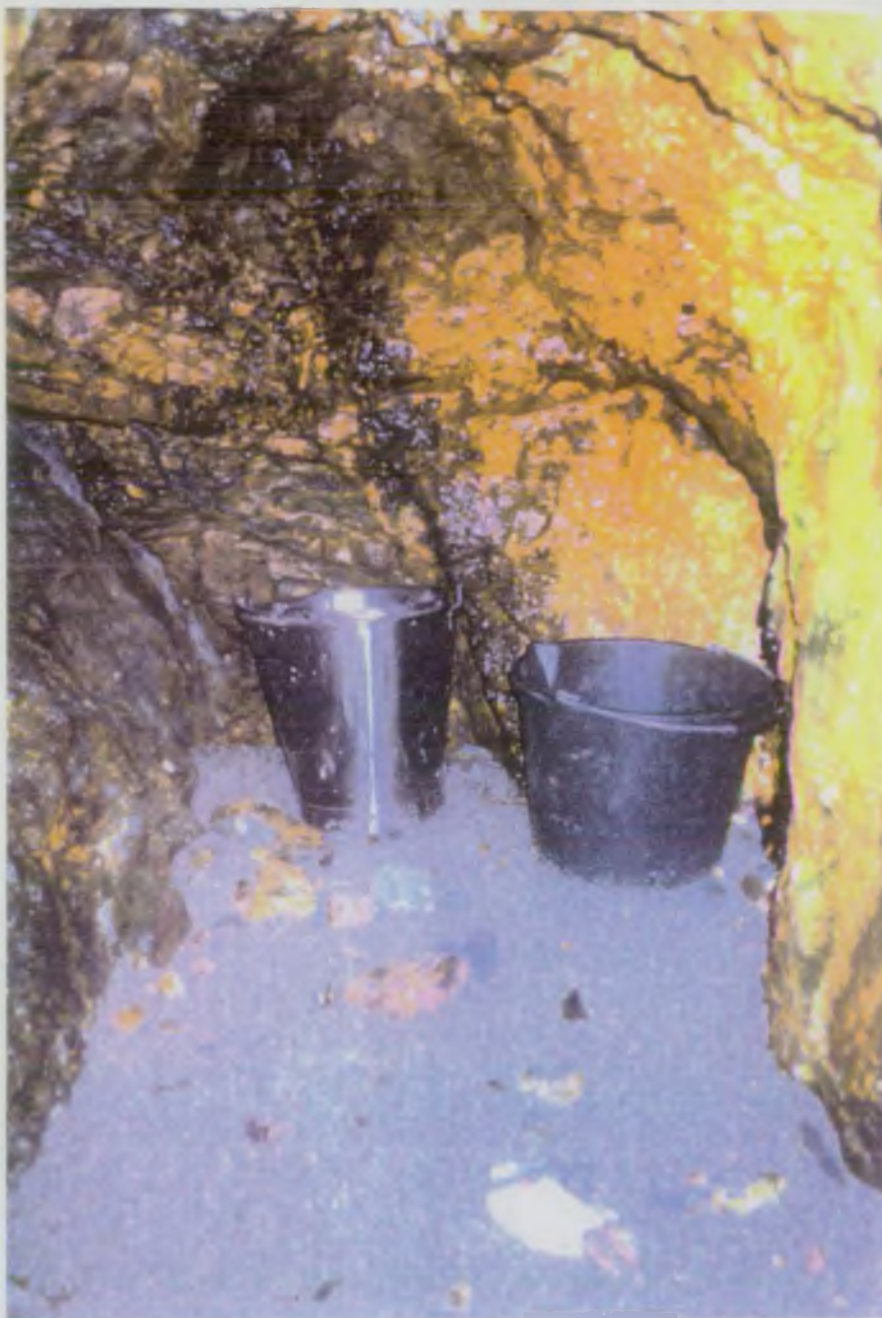
P18: Detail D10.

P17: Sample Point D10, old trial workings on cross-course at back of beach. Collecting drips in buckets over 24 hour period.

Nature of Sampling Point: Water collected from drips in shallow trial adit at back of beach on junction between major cross-course (trending 160 deg.m dipping 80 deg. west) and mineralised fault (trending 180 deg.m dipping 55 deg. west). The cross-course of blocky quartz is about 2m wide with a 0.4m band of clay infill and probably represents an impermeable lateral barrier, whilst still allowing longitudinal water movement. The water collected comes from the east of this cross-course, and is associated with the mineralised fault, which exhibits rich visible traces of Cu, As, Zn and Pb minerals.
