WATER QUALITY INVESTIGATIONS AT NANCEKUKU, CORNWALL

WQP/92/002

TECHNICAL REPORT NO. WQP/92/002

APPENDIX 1. SAMPLING LOCATIONS AT NANCEKUKUKE

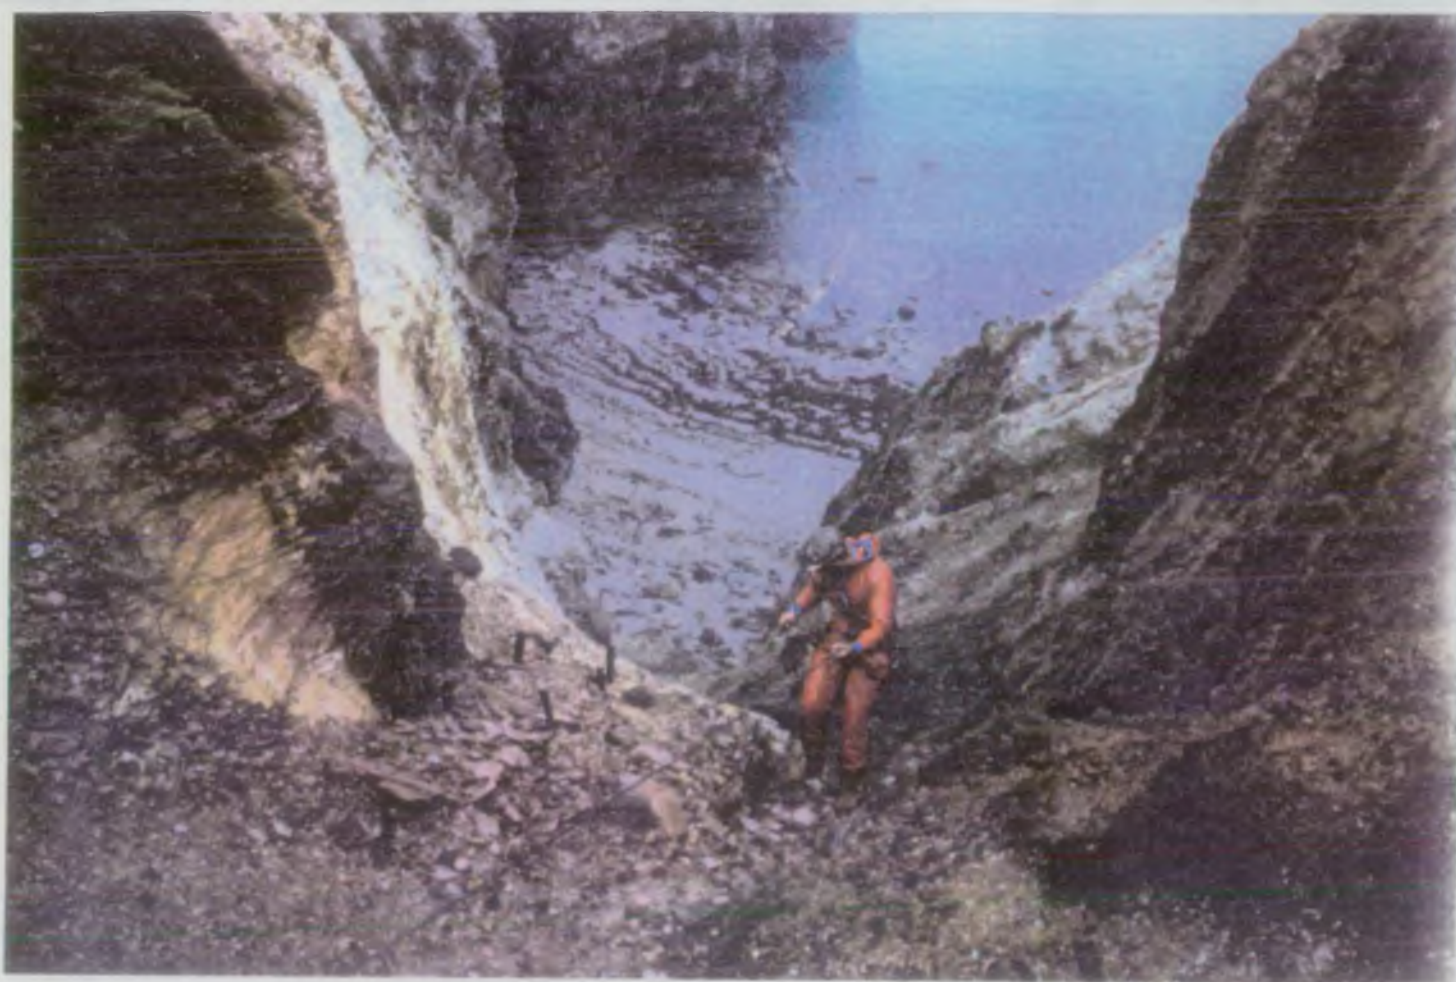
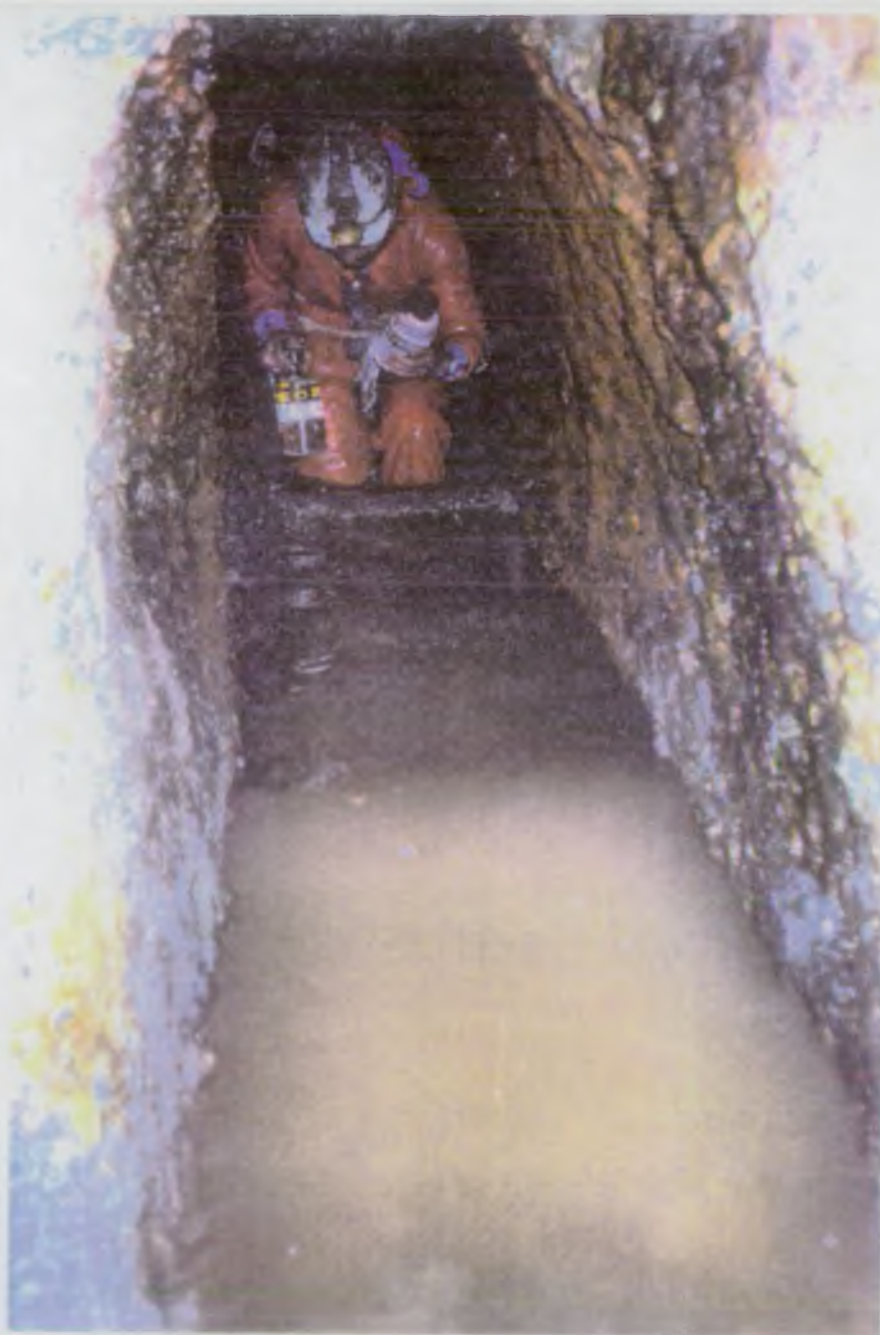
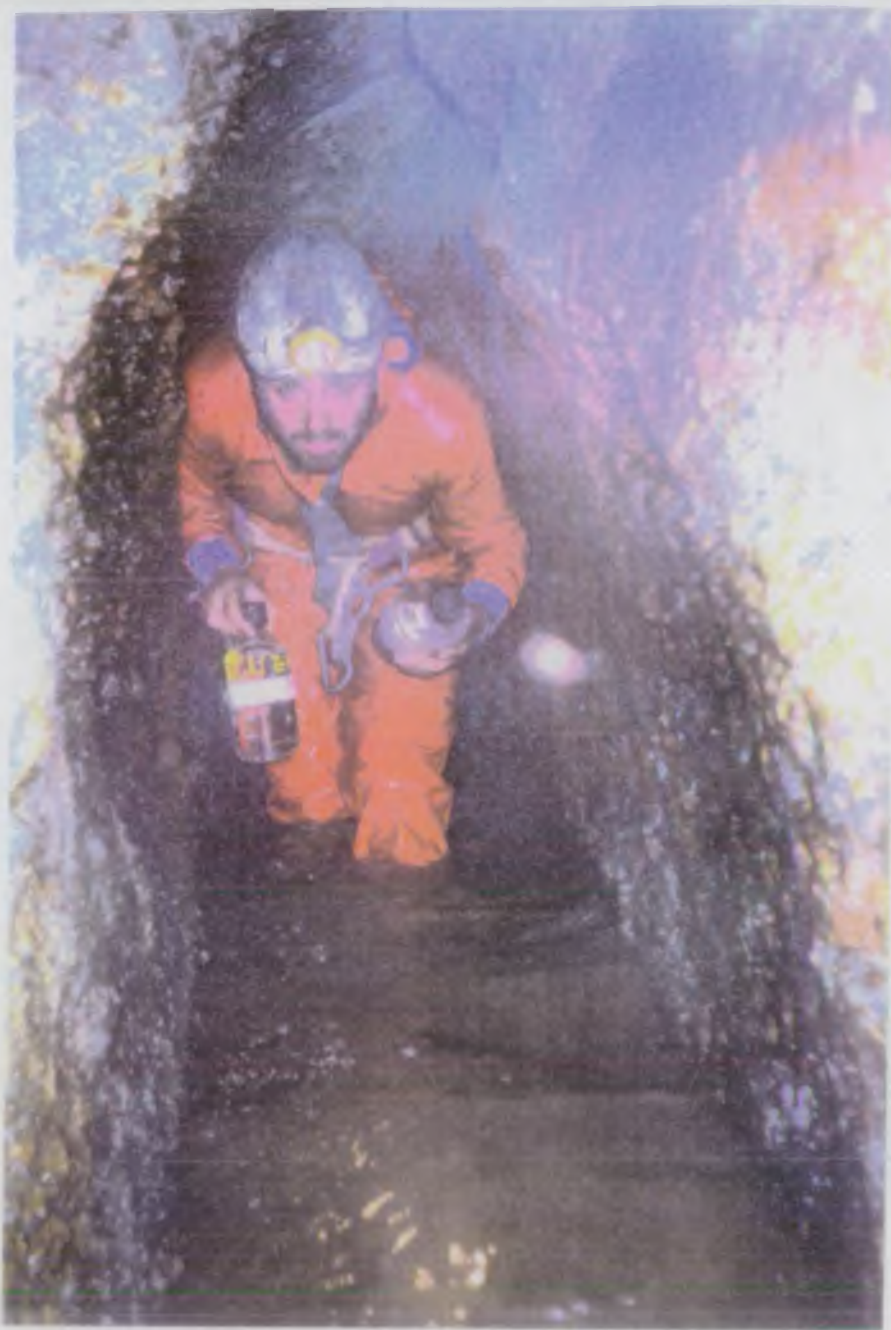
P19: Access to D11, abseiling down gully.

P20: Entrance to D11 adit in side of gully. See photo P9 for approximate position of D11 in relation to D5.

Nature of Sampling Point: Water dripping from roof at end of trial adit (about 10m long) into large pool. Adit driven on mineralised joint trending due south dipping 70 deg. east about 40m down same gully as D3 and D5.

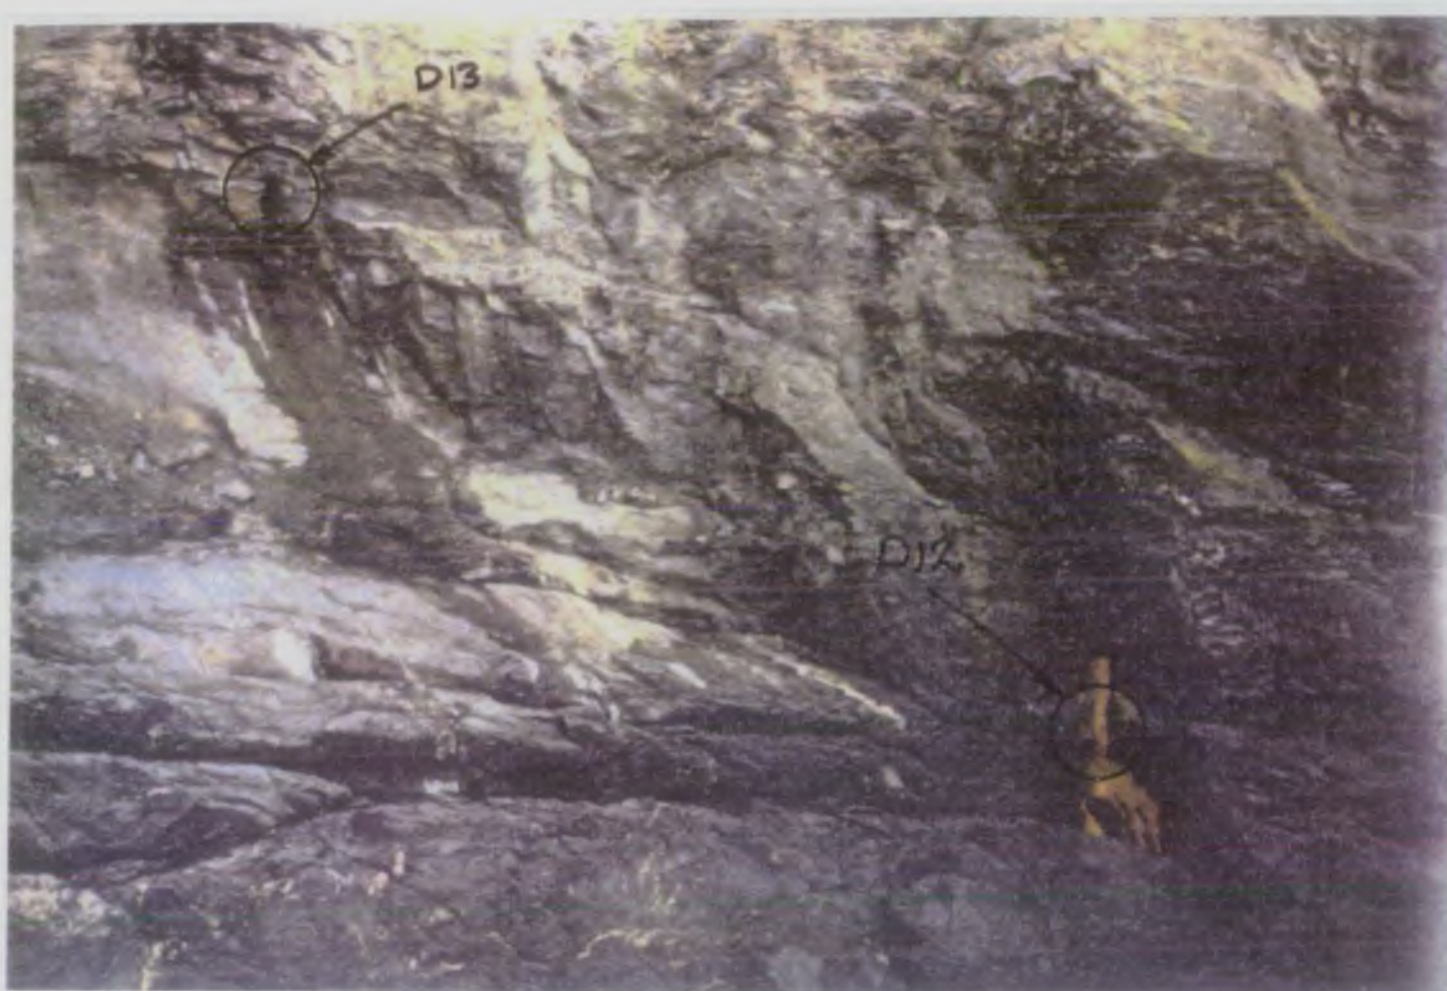
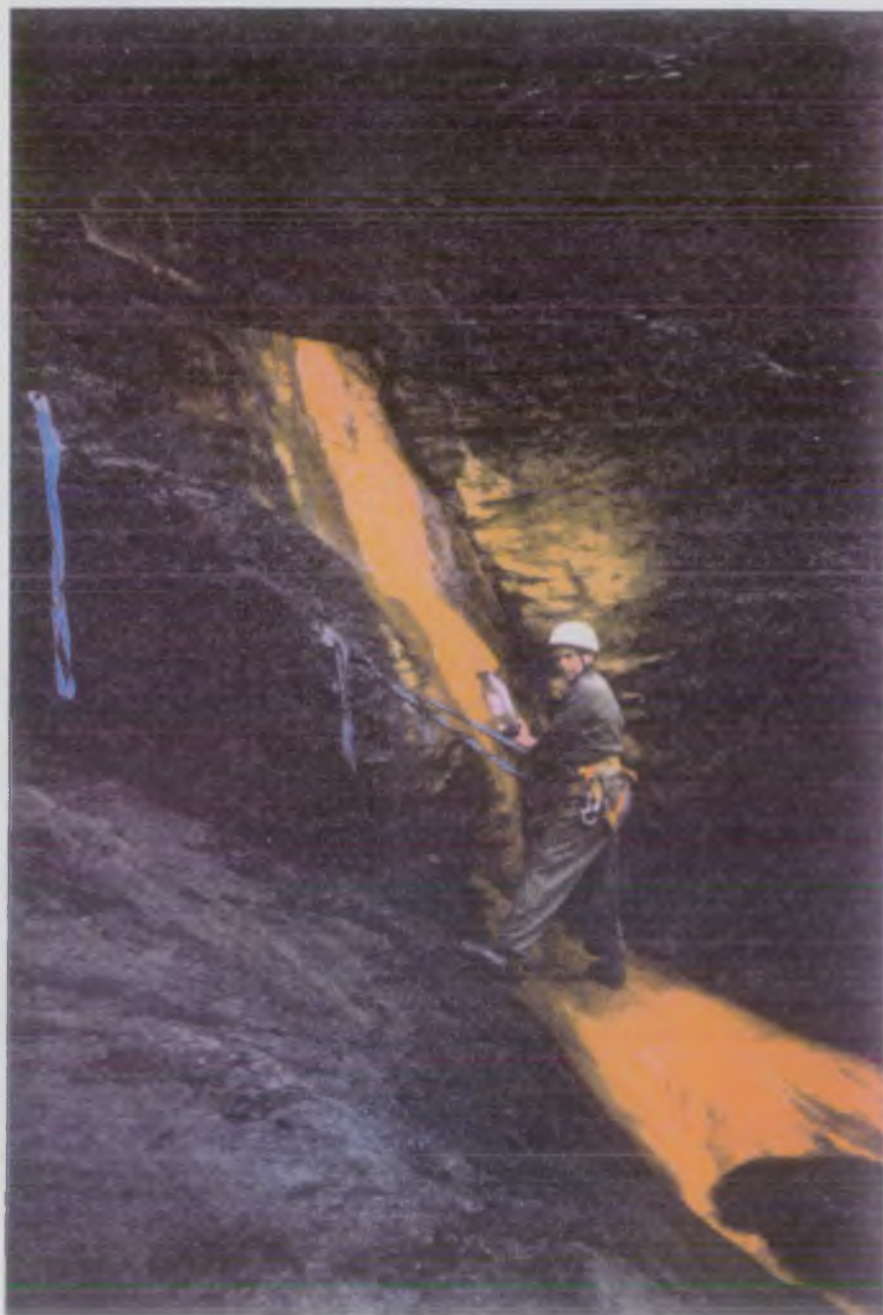
P23: Showing relative positions of D12 and D13, ringed.
D12 is main adit, lower right, and D13 is older higher adit, upper left.

P24: Sampling from D12.

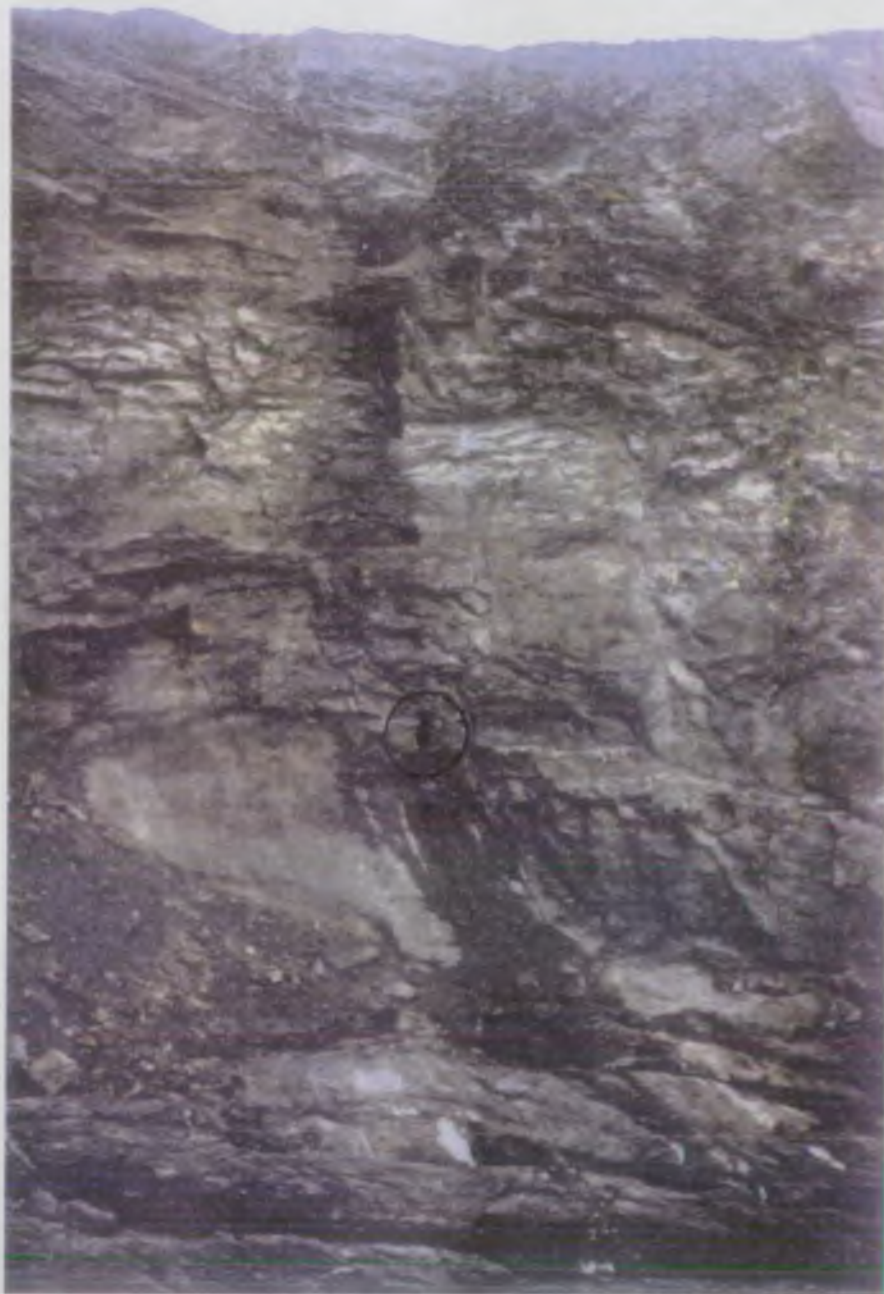
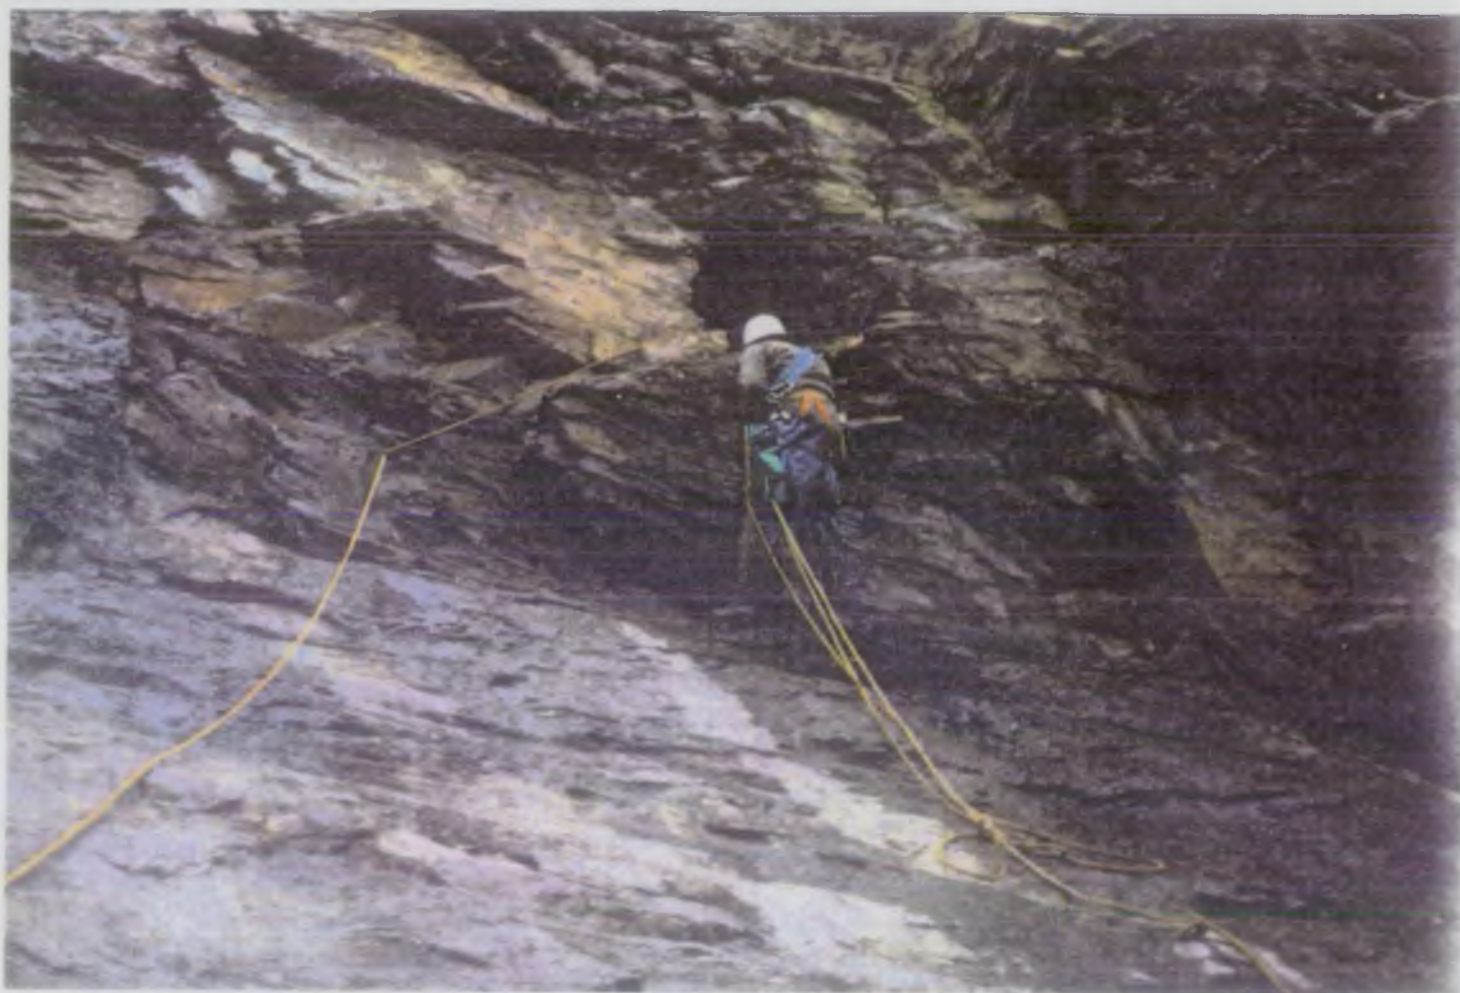
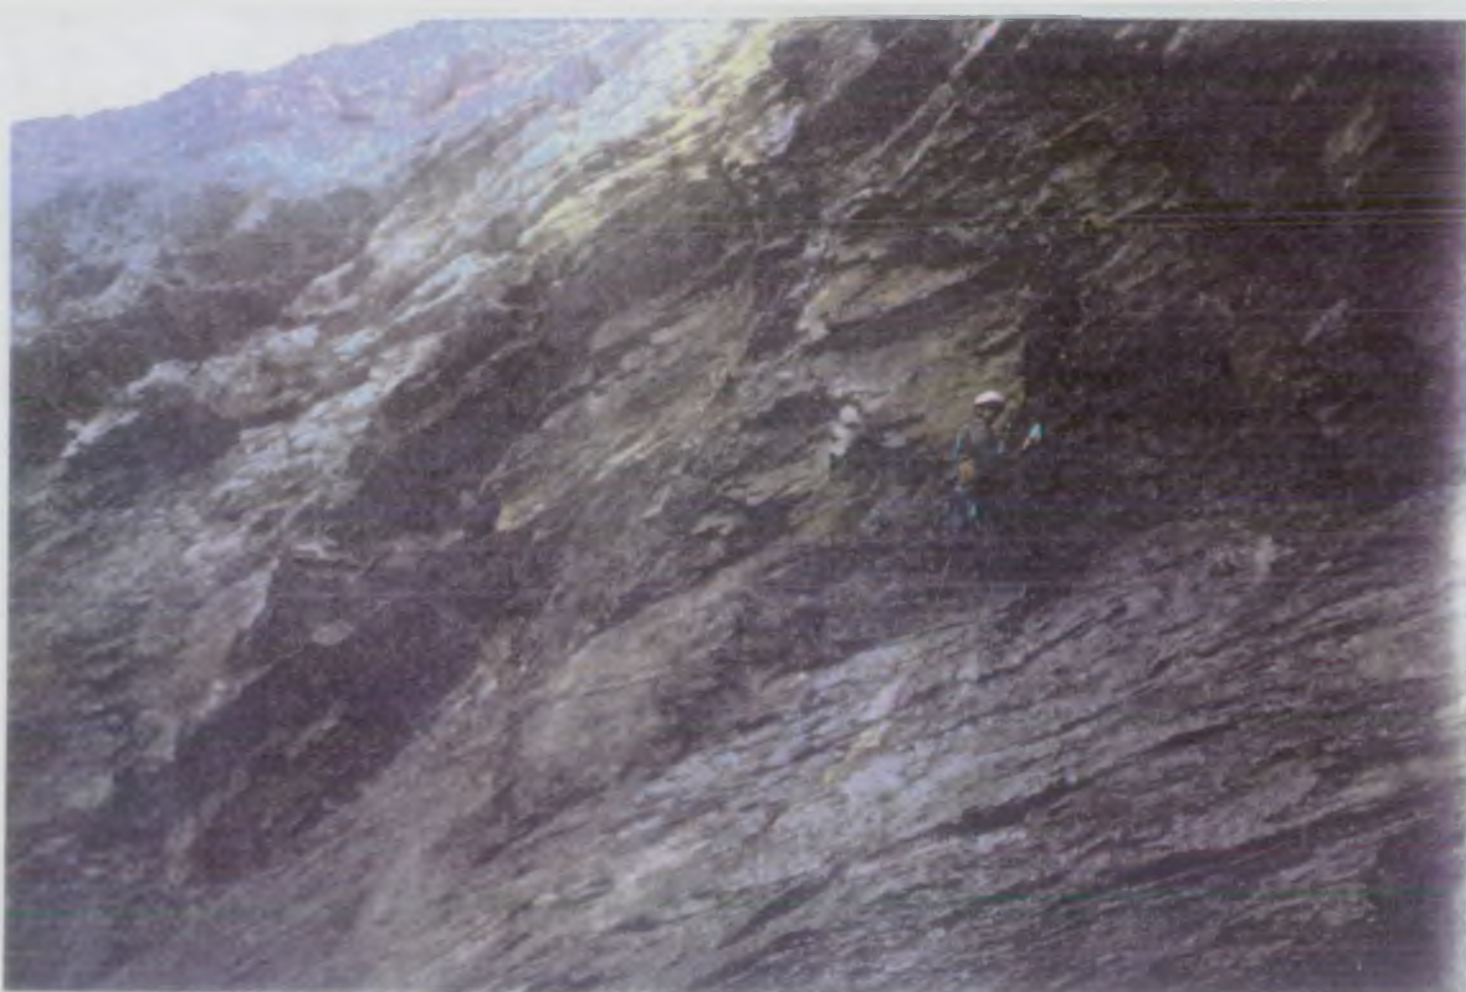
P25: General position of D13 (ringed) in relation to other workings.

P26: Access to D13 adit.

Nature of Sampling Point: Slight flow issuing from old Wheal Sterran adit about 25m above MHWS and about 10m east of D12. Much of this flow appears to come down shaft (exposed in cliff) from higher level.

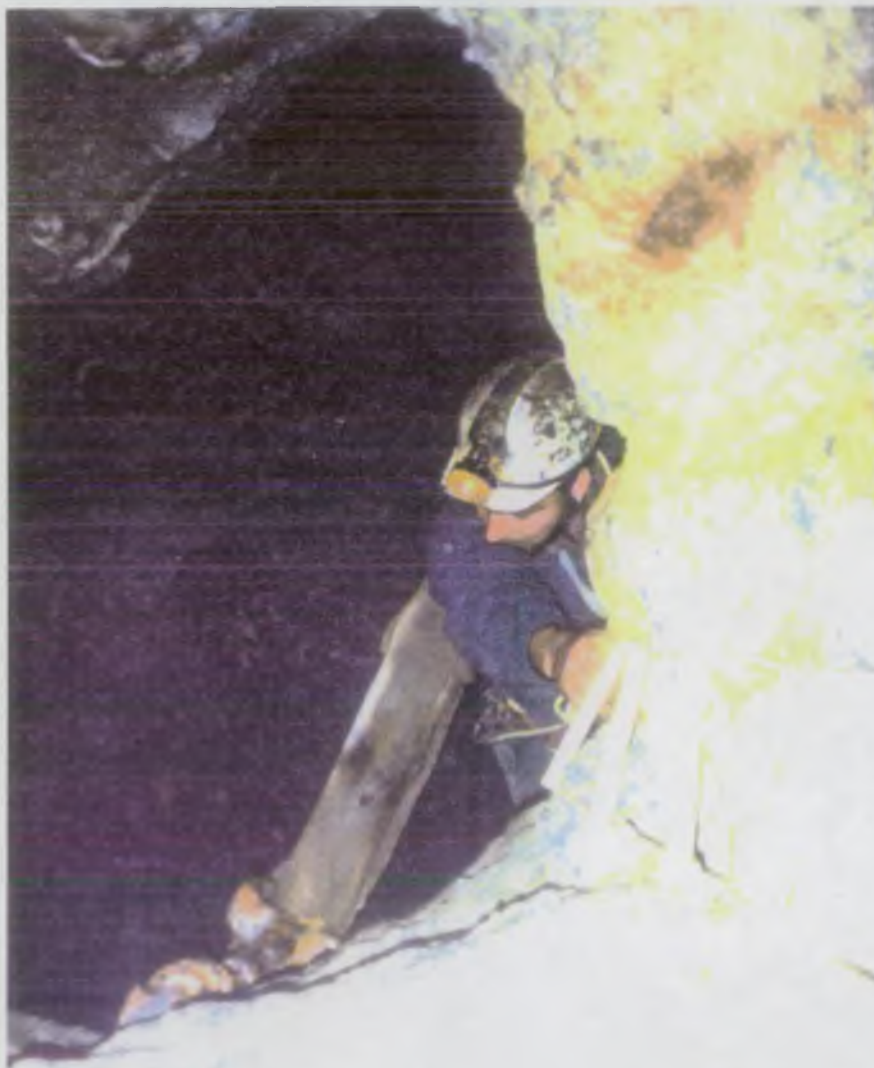
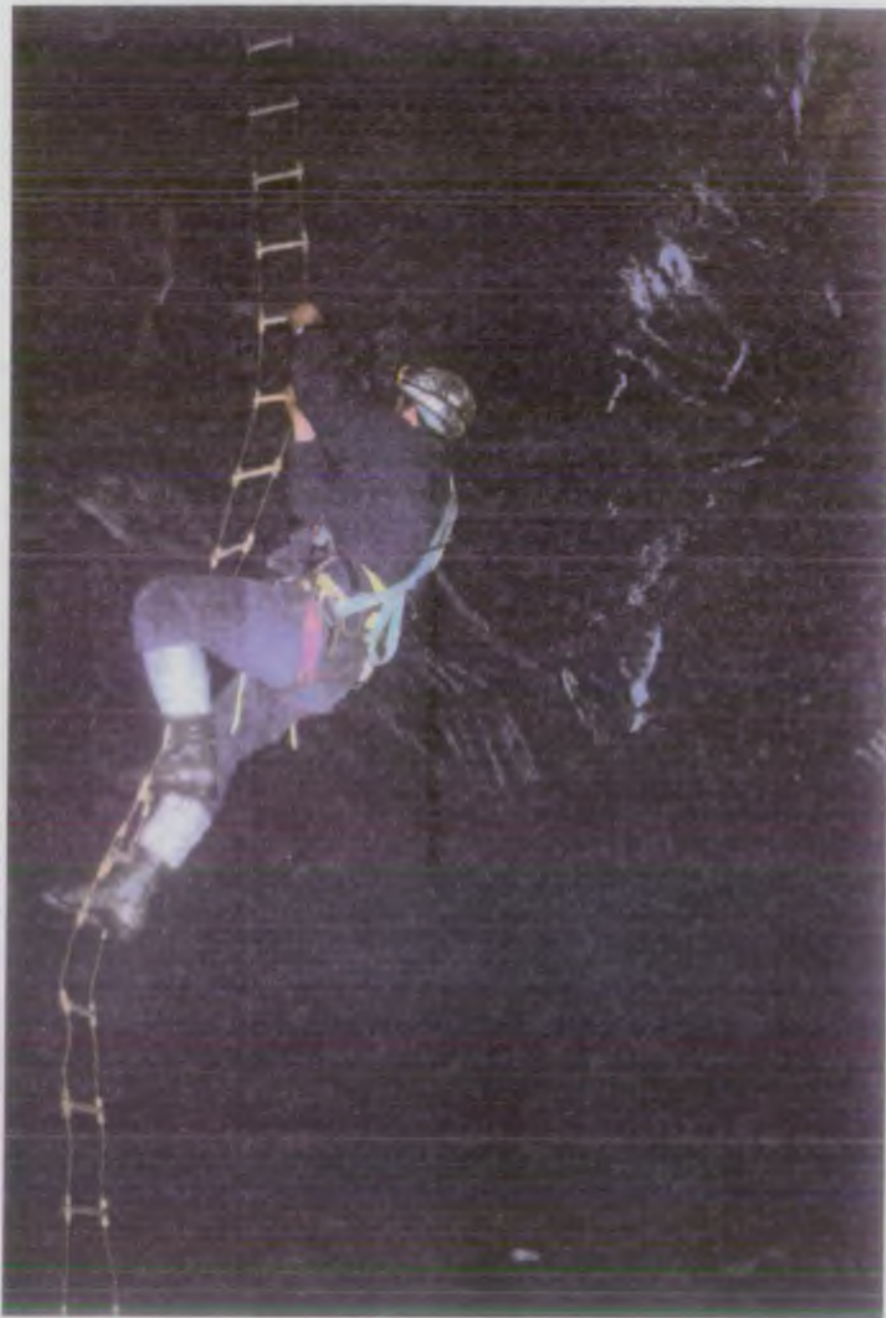
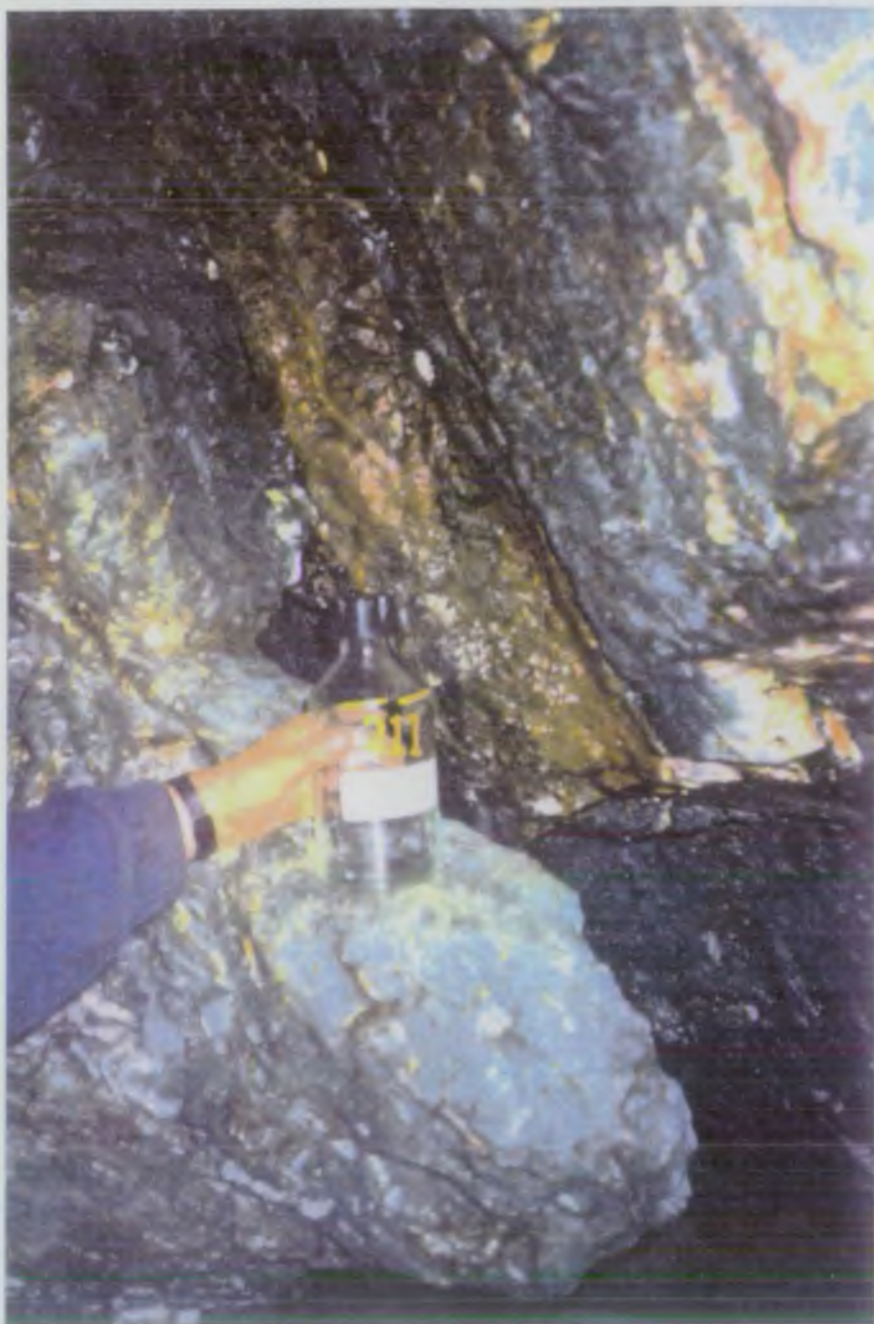
P28 & 29: Access to D14 sea cave from old workings.
P30: Detail of D14, adit at back of sea cave, showing insignificant flow.

Nature of Sampling point: Wheal West adit is driven about 100m east on a Cu lode and starts at the back of a sea cave about 3m above MHWS. A small trickle was visible from its entrance but it was not possible to obtain any sample (it is known to flow in very wet conditions). Access was from old workings in the roof of the sea cave about 15m above the beach.

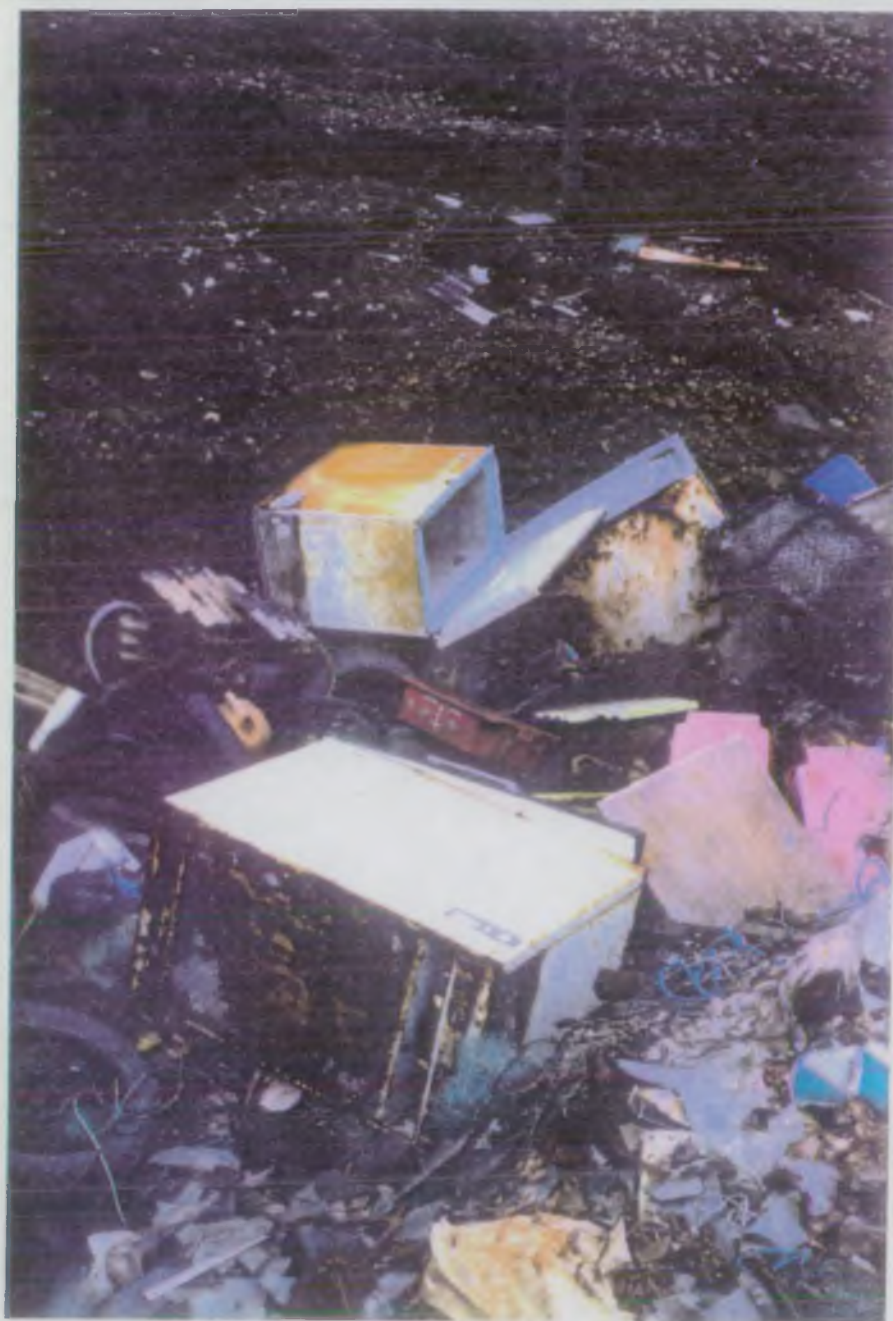
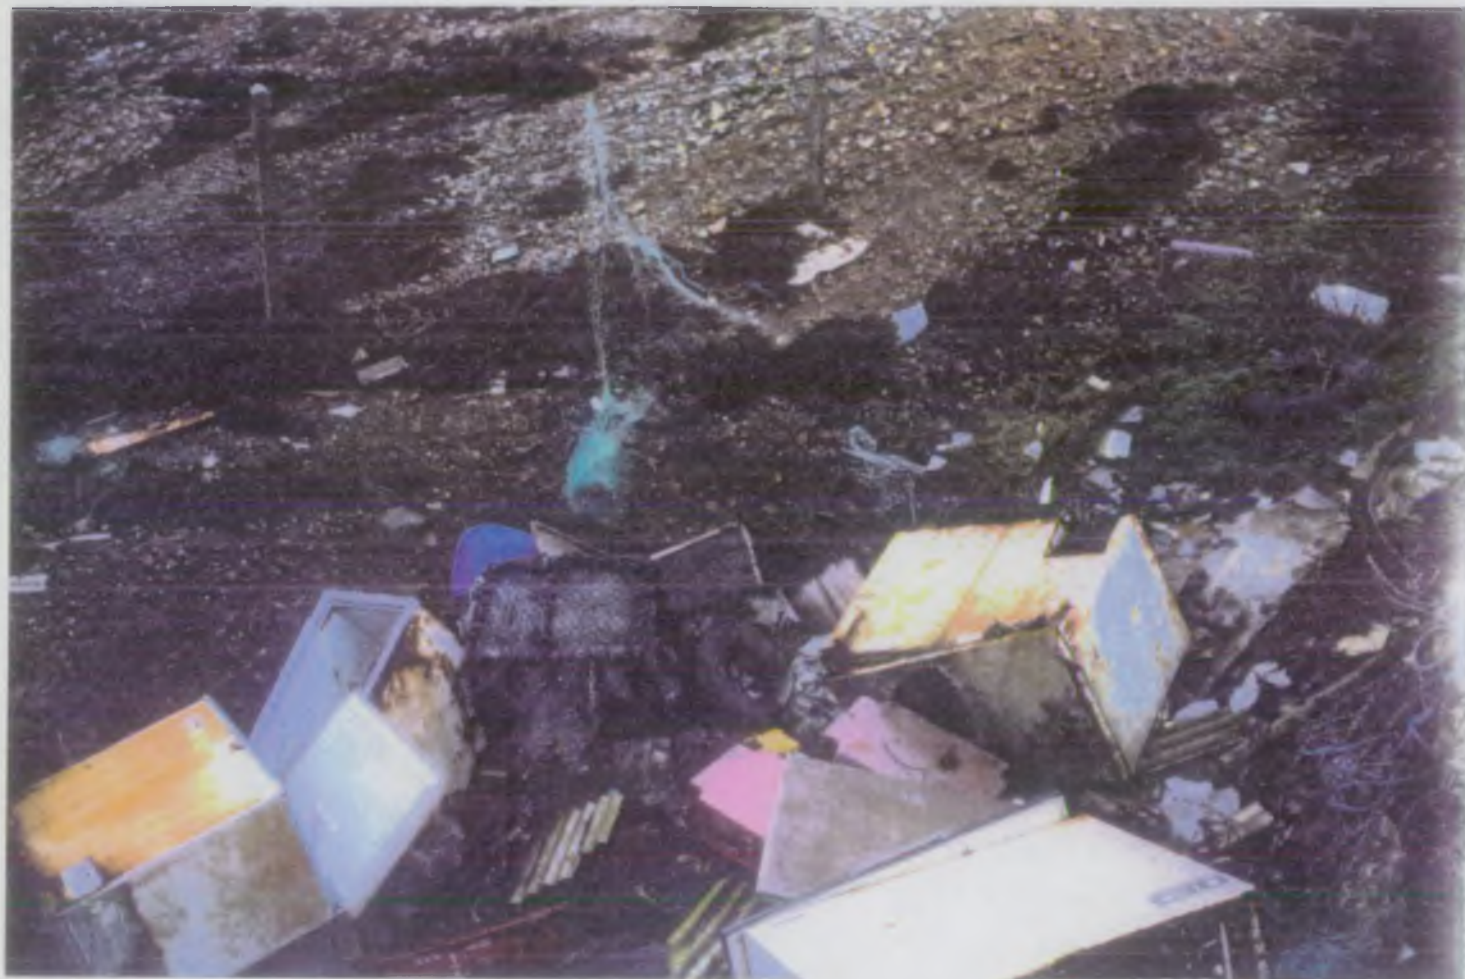
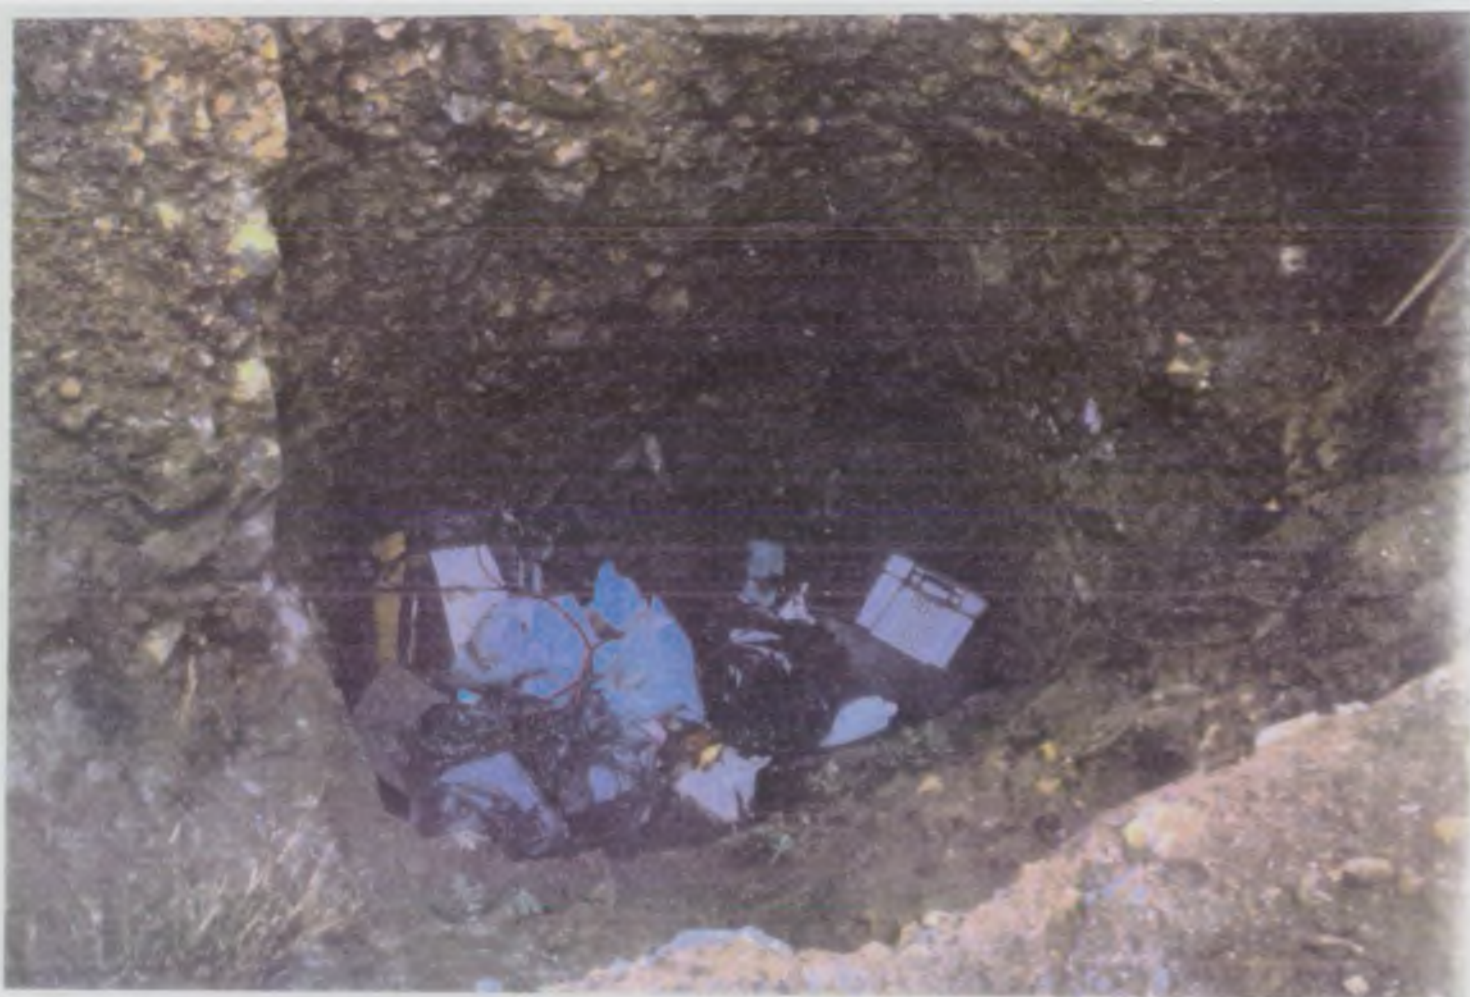
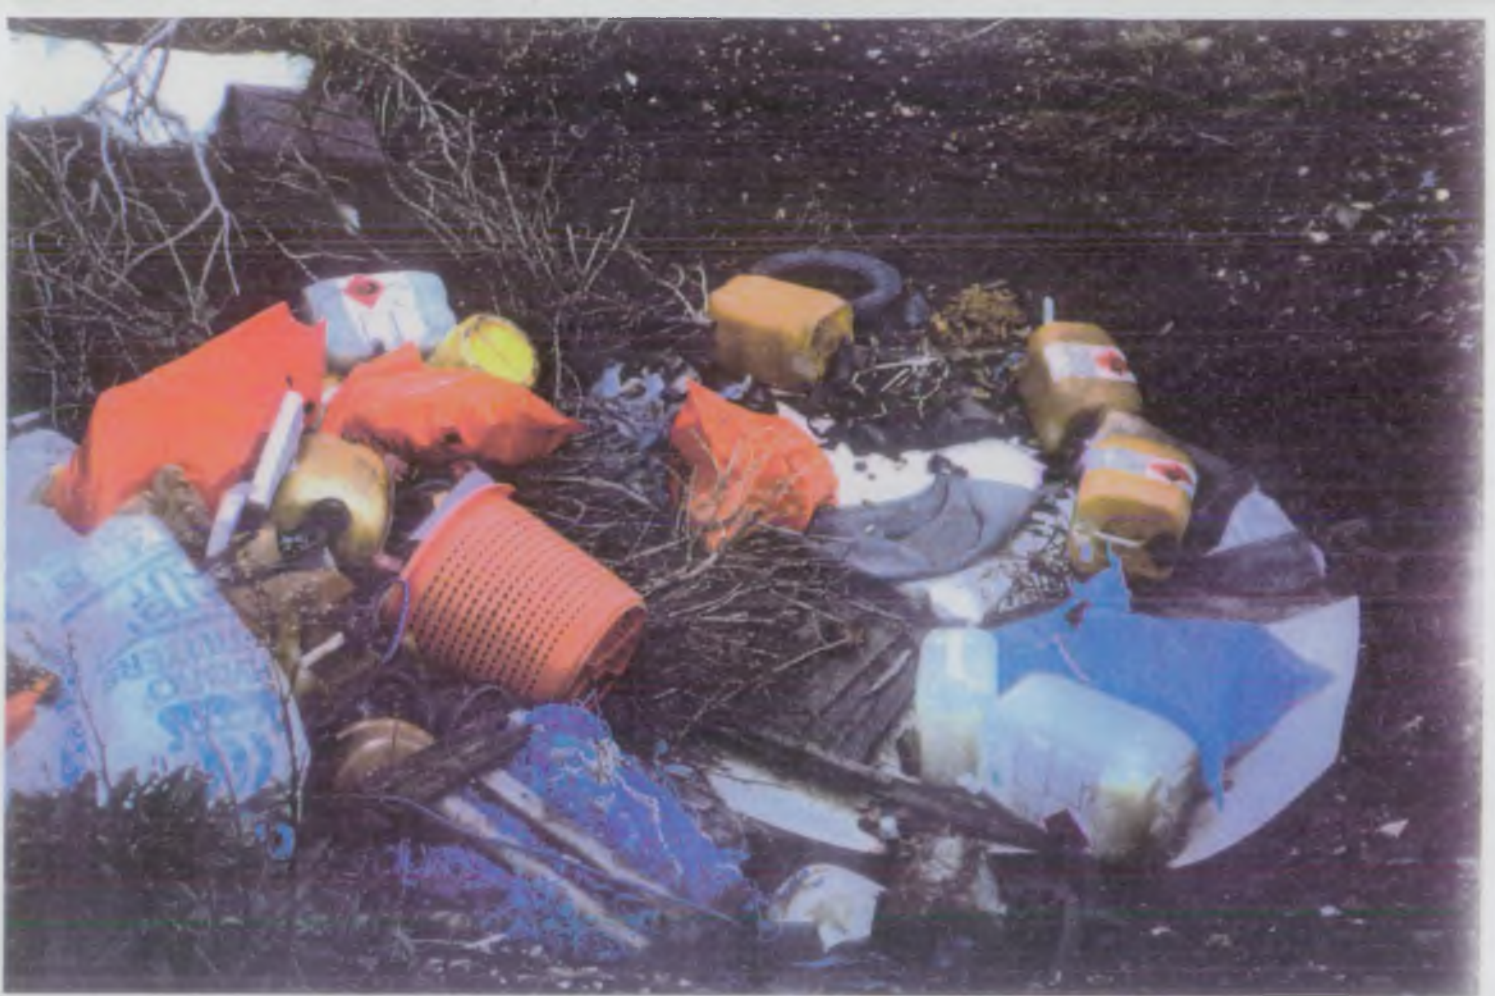
The origins of the trace amounts of this pesticide could be associated with the illegal tipping of materials in the mine shafts associated with the Lushington Mine draining through the Wheal Tye section to this adit, (see Appendix 2, photographs 32 to 35). These shafts are outside the boundary of the former CDE site.

P32 - P35: Show very recent and continuing dumping in open shafts of the Wheal Tye section of Lushington Mine. These shafts, at approximately SW 683 473, connect directly to adit D9, and indirectly to adit D12.

A site meeting has taken place between staff of the NRA and Cornwall Waste Regulation Authority with an objective to prevent such illegal tipping taking place in future.

The Cornwall Waste Regulation Authority will be asked to investigate the feasibility of removing this deposited material from the mine shafts without causing environmental damage. If it is possible to remove this material, then following removal, the shafts should be capped.

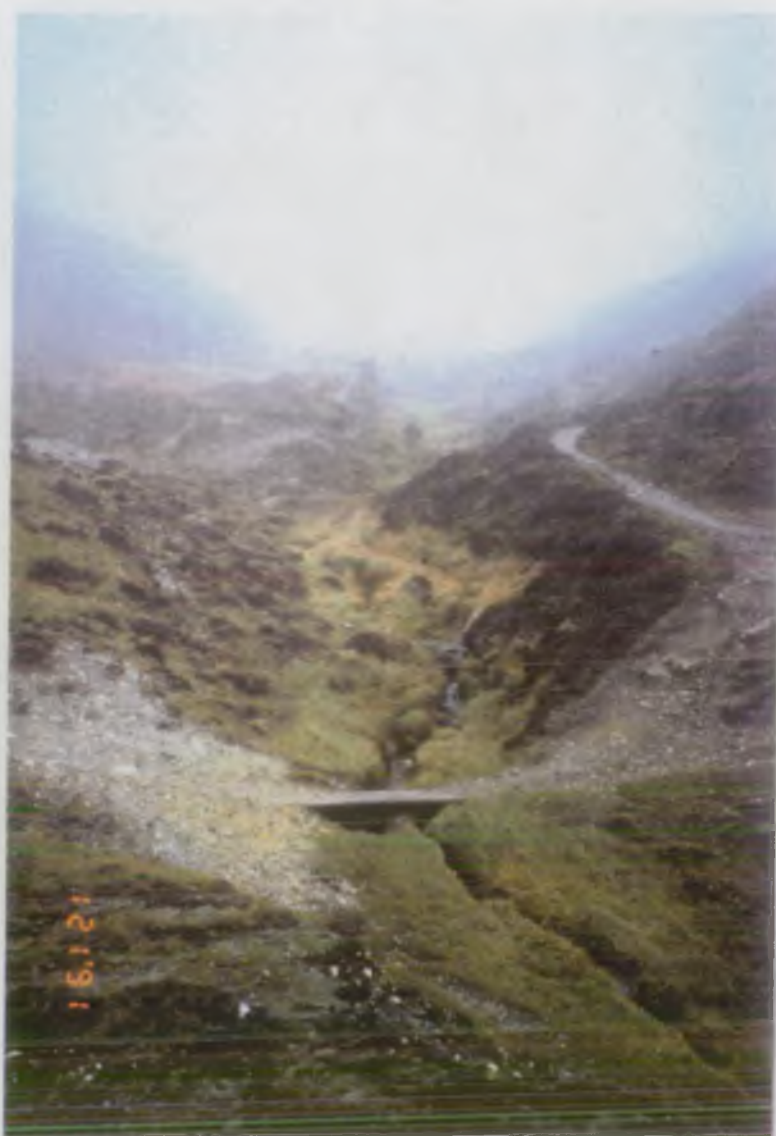
E3 Tributary of Sally's Bottom Stream flowing north at boundary fence,
Nancekuke. Sampling location at SW 6783 4690.

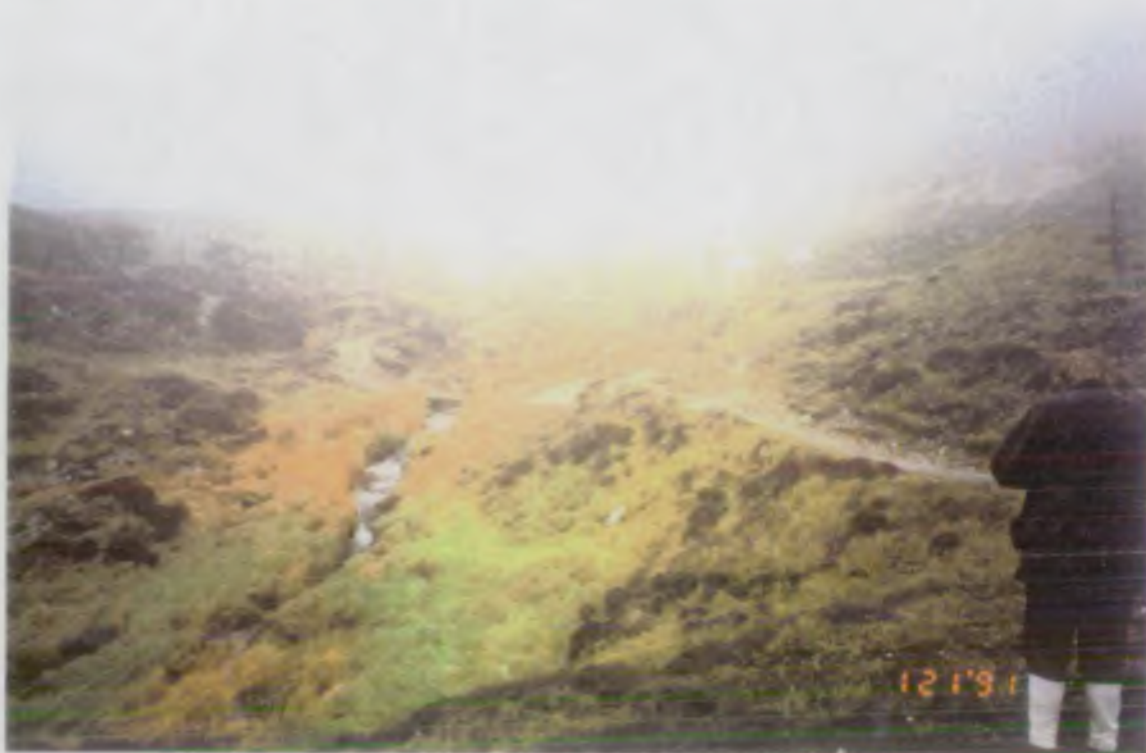
E4 Sally's Bottom Stream flowing west at boundary fence, Nancekuke.
Sampling location at SW 6786 4696.

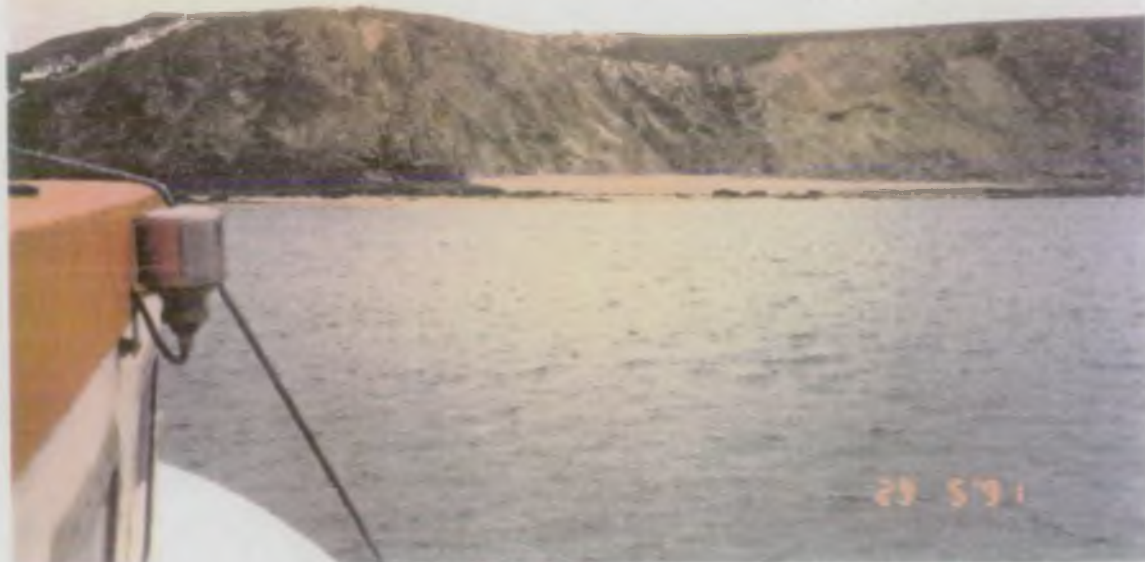
E5 Adit discharge at Porthtowan (SW 6888 4682).

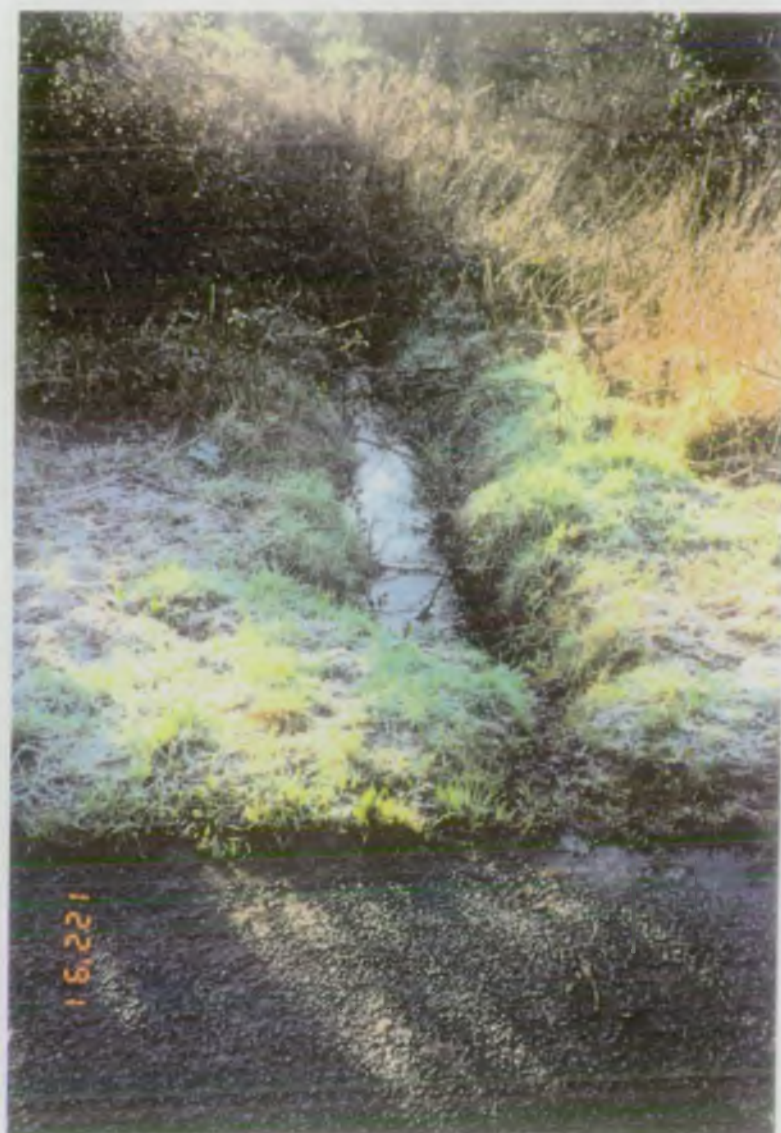
E6 Tributary of Redruth Stream flowing south from Nancekuke Common.
Sampled at road culvert (SW 6885 4619).
