WATER QUALITY INVESTIGATIONS AT NANCEKUKU, CORNWALL

WQP/92/002

TECHNICAL REPORT NO. WQP/92/002

APPENDIX 1. SAMPLING LOCATIONS AT NANCEKUKUKE

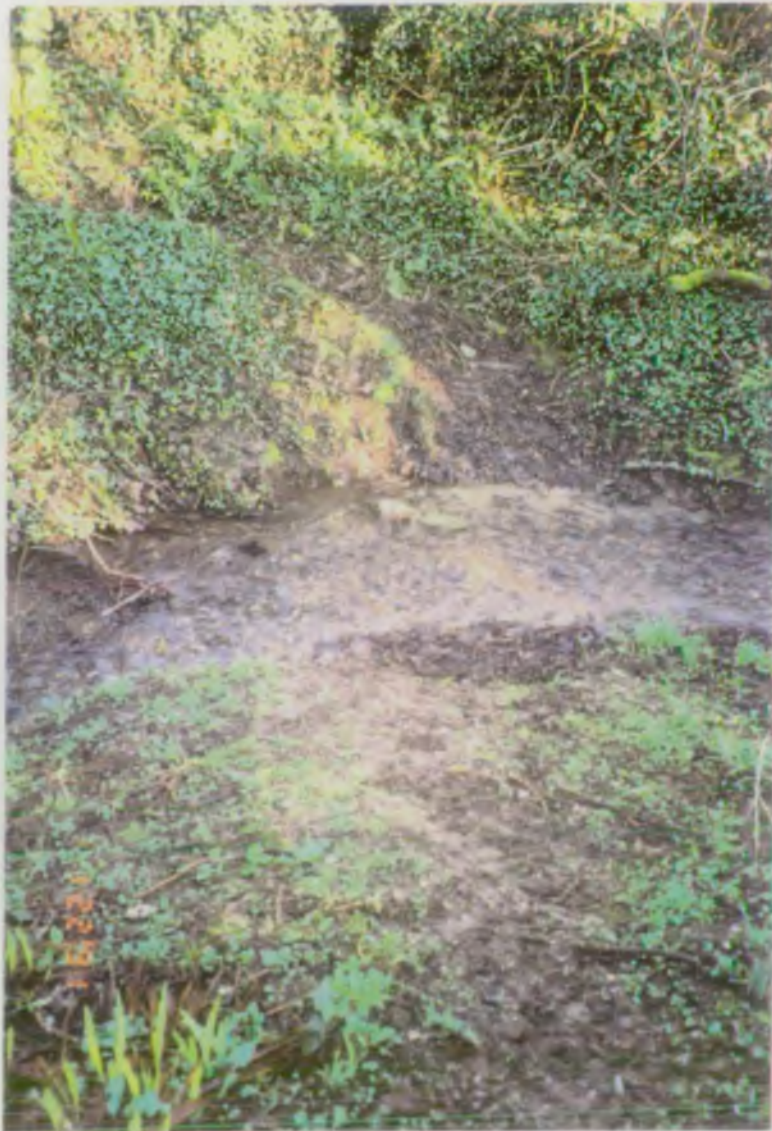
E7 Tributary of Portreath Stream sampled north of the Cambrose/Laity Moor road at SW 6904 4567.

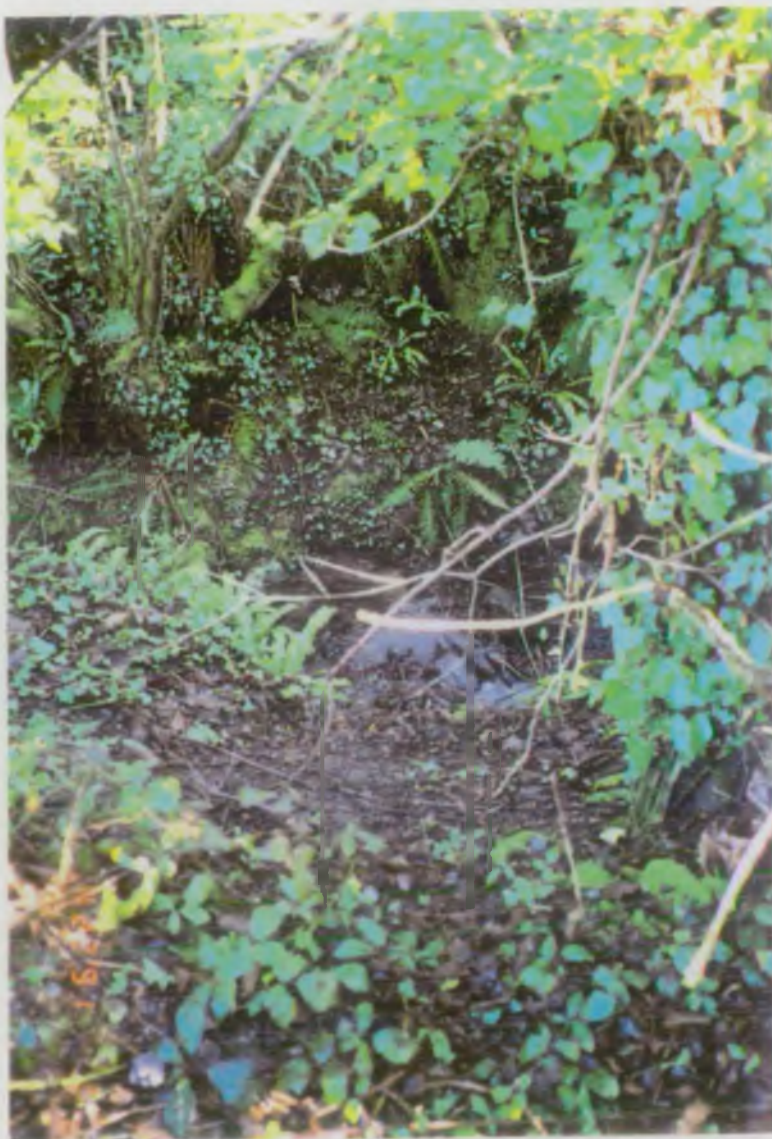
E8 Tributary of Portreath Stream sampled east of the Cambrose/Laity Moor road
at SW 6879 4529.
