*A Report on the River Chew
at Chewton Mendip
6th August 1992*

A REPORT ON THE RIVER CHEW AT CHEWTON MENDIP, BRINGING TOGETHER
INFORMATION FOR THE PURPOSES OF DETERMINING AN ACCEPTABLE
APPROACH FOR DEALING WITH POLLUTION RELATING TO UNSEWERED VILLAGES.

Samantha Dawe Water Quality Officer 6th August 1992

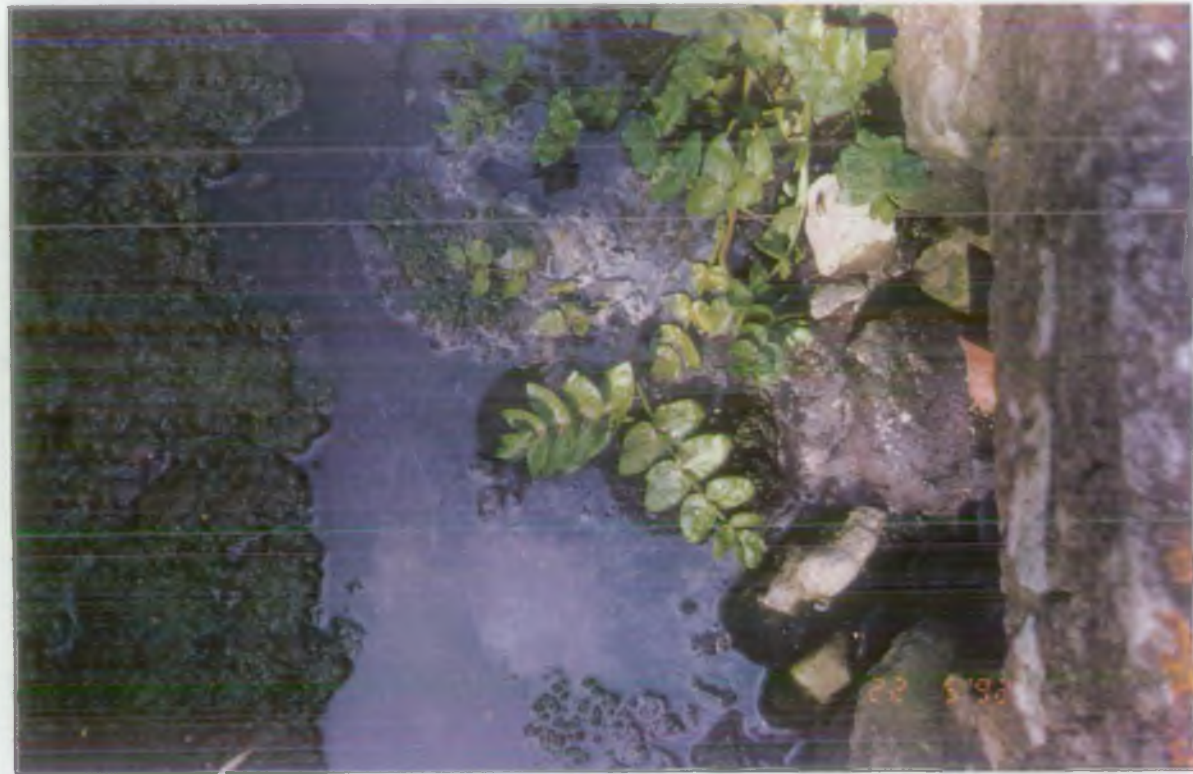
Two sewage discharges to the river, just upstream of the ford ('Pachorse bridge').
Note algal problem, and discoloration of stream bed.

There is evidence of two discharges occurring to the river just upstream of the ford, as marked on the map. It is also known that discharges occur from the school and numerous private dwellings.

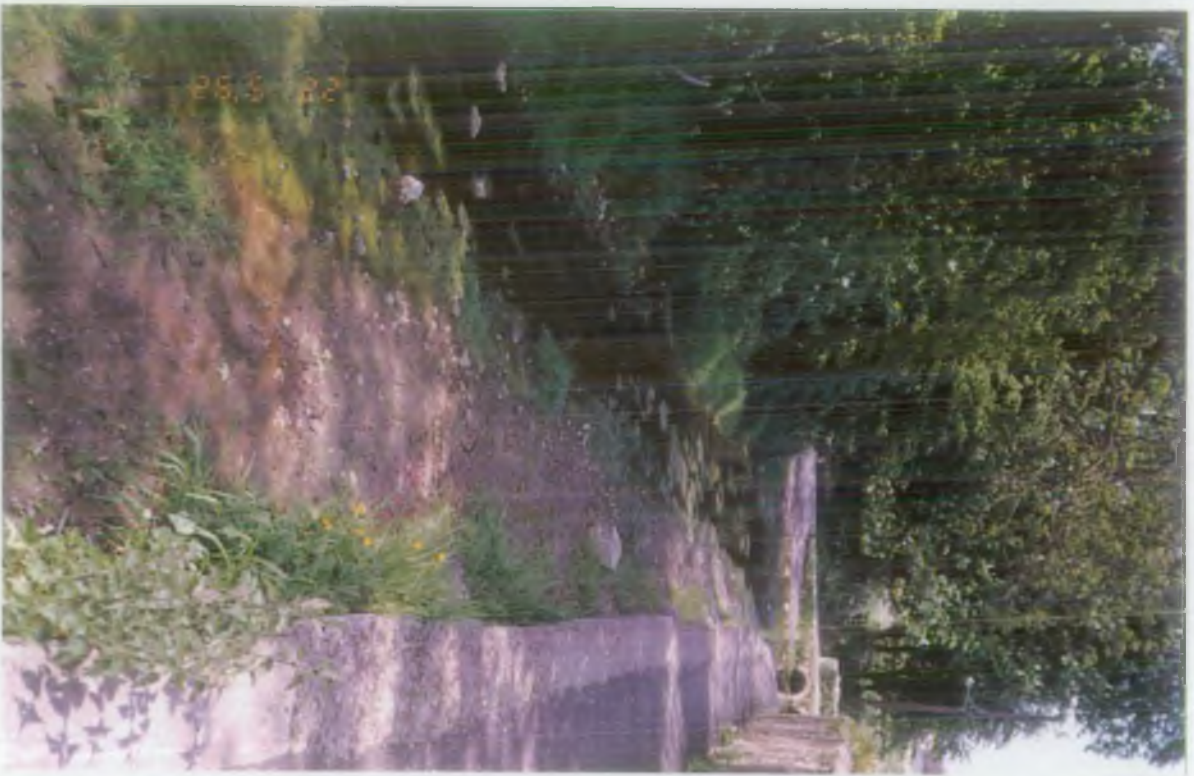
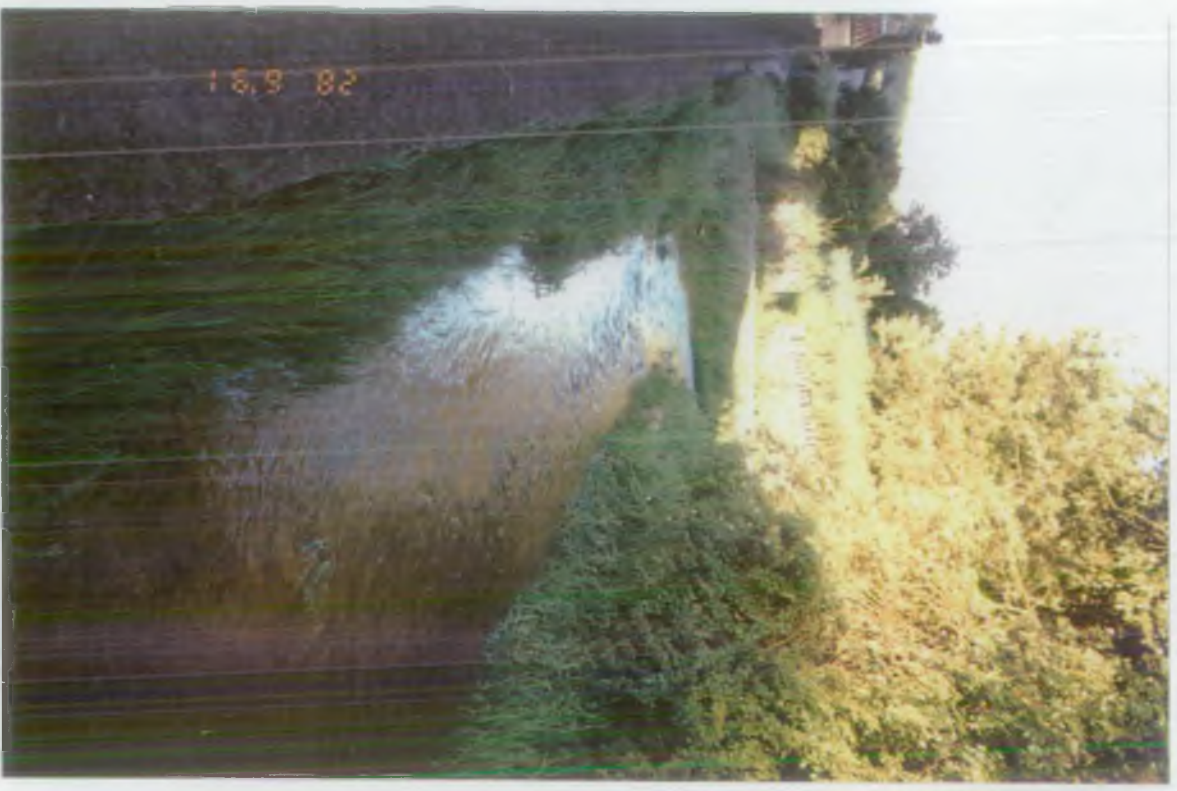
River flows just downstream of the headsprings. Note low flow and algal problem on 22.5.91.

In May 1992, a report that the river was green and slimey was received. This was found to be due to algal growth which was excessive at this time probably due to low flows.

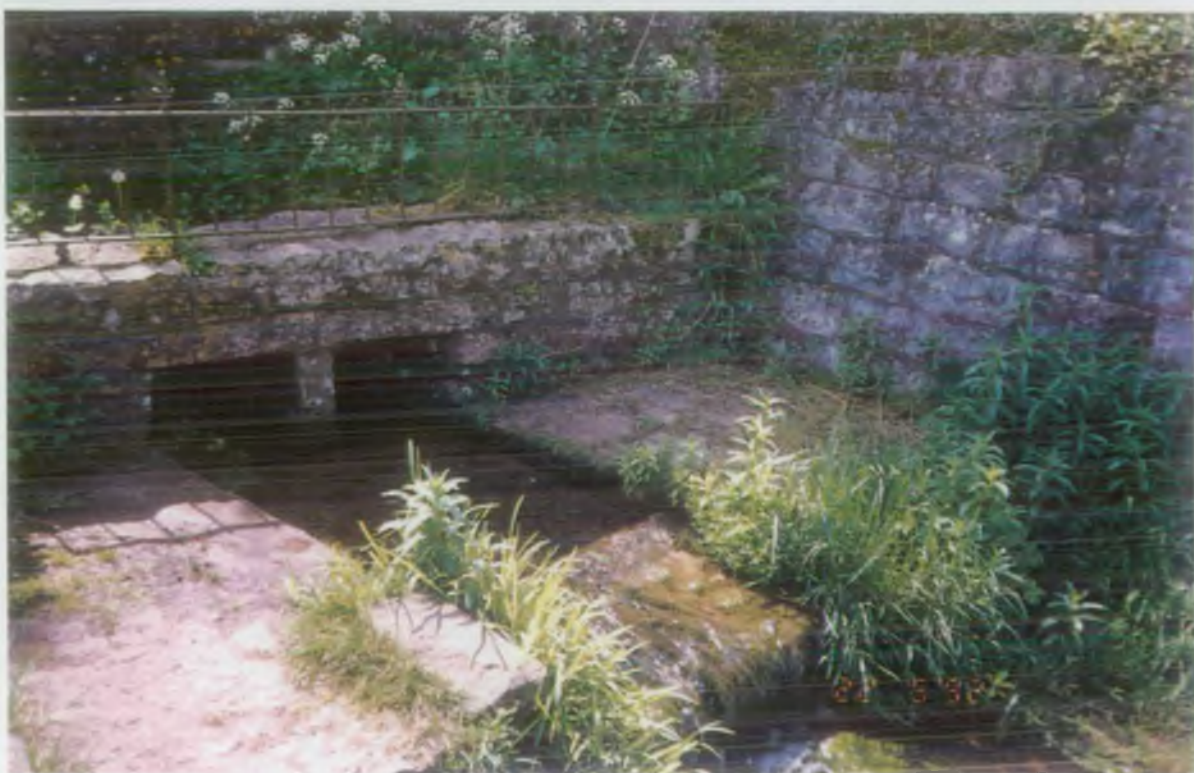
Head springs of River Chew, upstream monitoring point.
 This is the flow released by Bristol Water Co.
 Photo taken on 22.5.92. Note fairly low flow.

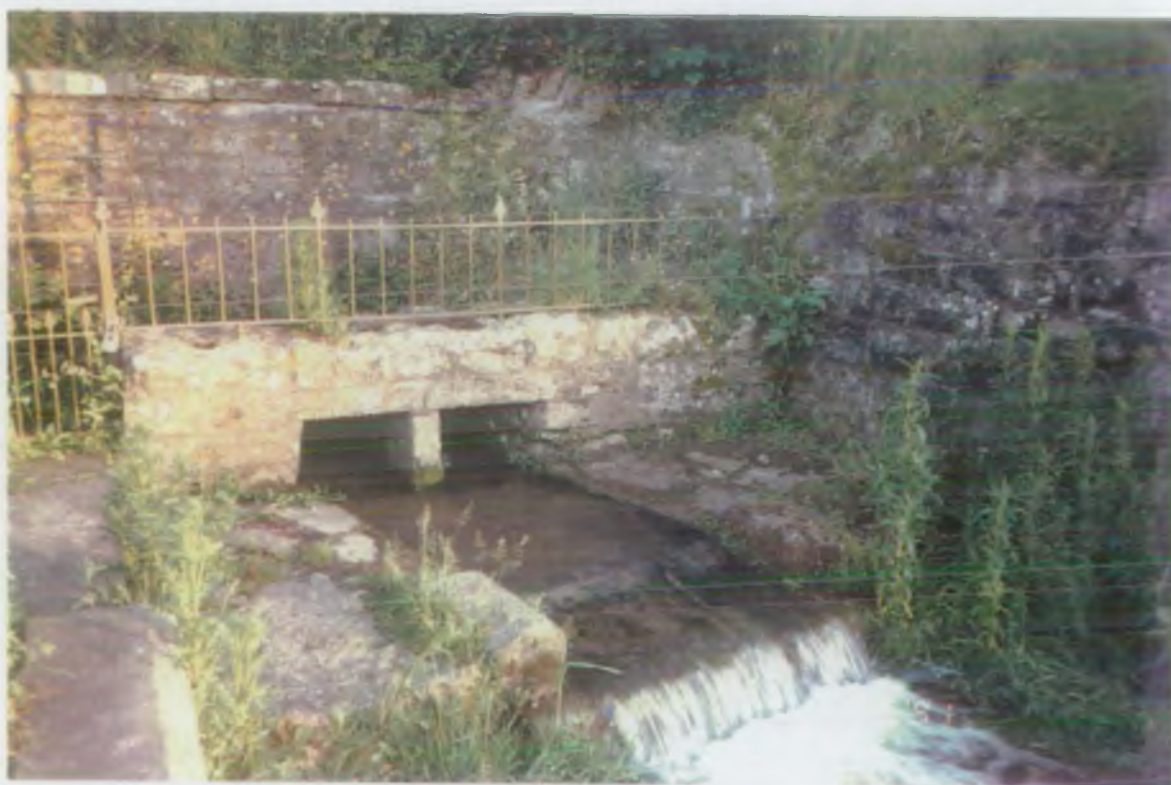
Discharge at head spring is much greater. Photo taken
 on 28.6.91.

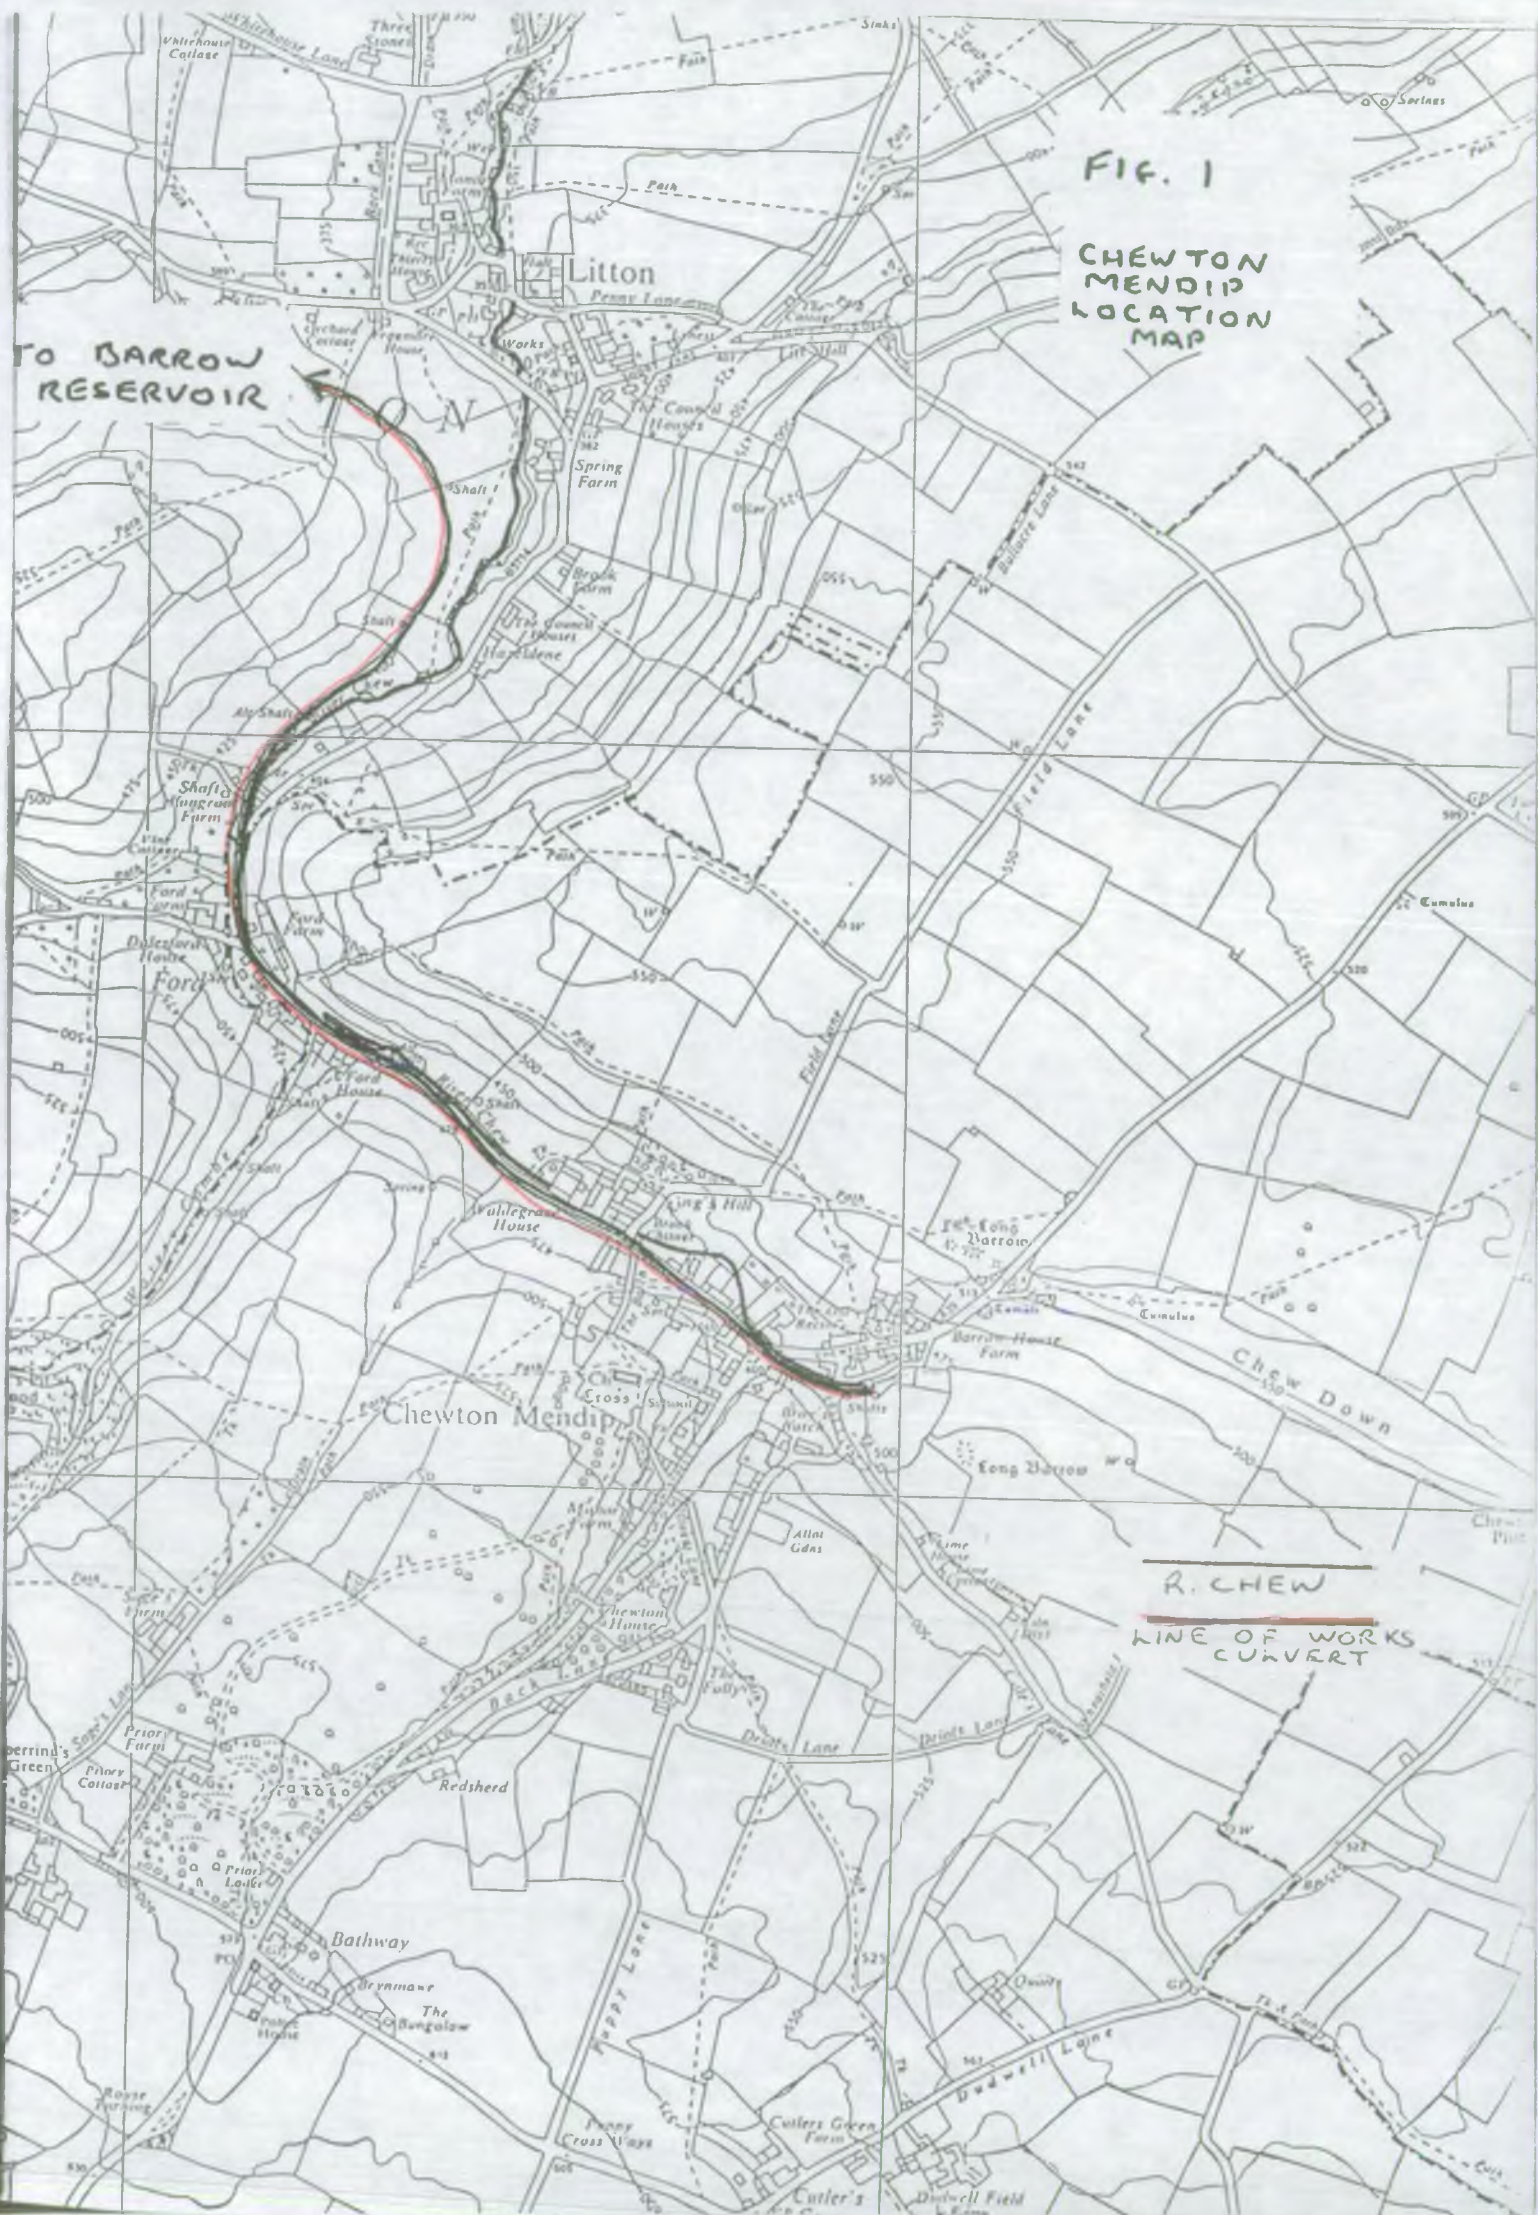
The safe disposal of sewage in Chewton Mendip is made difficult by the importance of the catchment for supply purposes. Wessex Water operates a policy of embargo on septic tank soakaways in much of the area. This is due to the close proximity of the line of works culvert and the many springs which feed into it.

The line of works culvert dates from 1846 and is still used as the water source for Barrow Reservoirs, situated south of Bristol. Water in the culvert has long suffered from pollution; both from the springs which feed it and from the ingress of polluted water through joints and cracks in the masonry of the culvert. In places, pollution from this latter cause has been so severe that pipes have had to be installed in the culvert to prevent inflow. Septic tanks are, therefore, not an acceptable option for sewage treatment in most of the area.

Two applications for consents to discharge from small sewage treatment works are currently pending. These treatment plants will outfall at points A and B on Fig 2. In both cases, the proposed discharges replace existing septic tank and, in one case, farm discharges which were known to cause environmental problems. The standard of effluent achieved by these plants should be a considerable improvement on the previous discharges. However, since the number of properties served by each outfall is increased, the actual load on the river will probably remain constant.

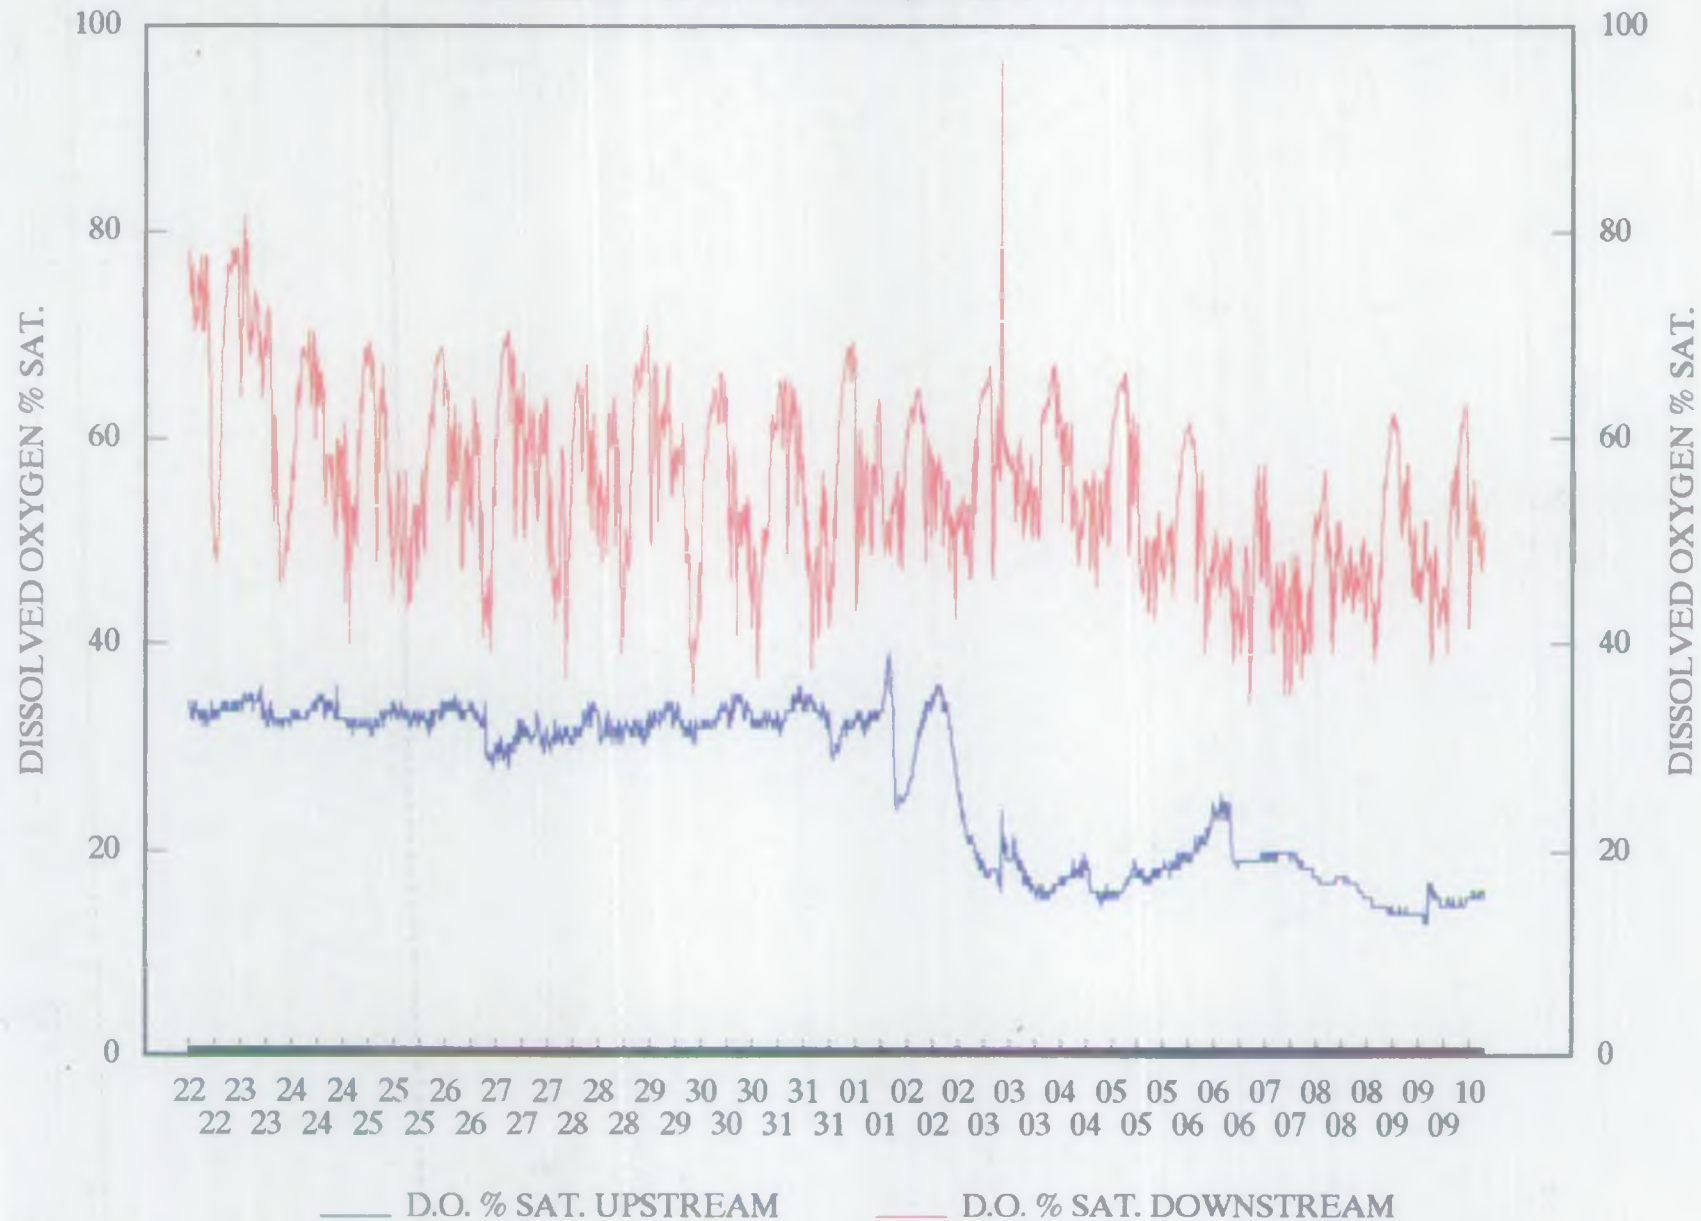
RIVER CHEW AT CHEWTON MENDIP

COMPARISON OF D.O. LEVELS, 22 MAY TO 10 JUNE 1992

When the exercise was repeated during the early summer of 1992 the conclusions based on the results obtained are not dissimilar to those during the previous December. The Ammonia levels upstream of Chewton Mendip remained constant at just greater than 0mg/l, whilst the downstream levels fluctuated according to the time of day and were generally higher than those recorded upstream. The graphs show levels in excess of 2mg/l occurring frequently. Dissolved Oxygen levels in the upstream site at first appear to be surprisingly low and are lower than those downstream, although this could be due to the physical nature of the river having just emerged from its spring source. Downstream of the village, fluctuation in Oxygen levels is much more pronounced and again, when results for a few days are graphed on a larger scale, the correlation between Ammonia peaks and Oxygen sags during the period from morning through to the early hours of the following morning becomes more readily visible. The recovery appears to commence at approximately 0200 hours each morning.

Gradual overall decline recorded in Dissolved oxygen is probably due to probes becoming covered with silt or algae.

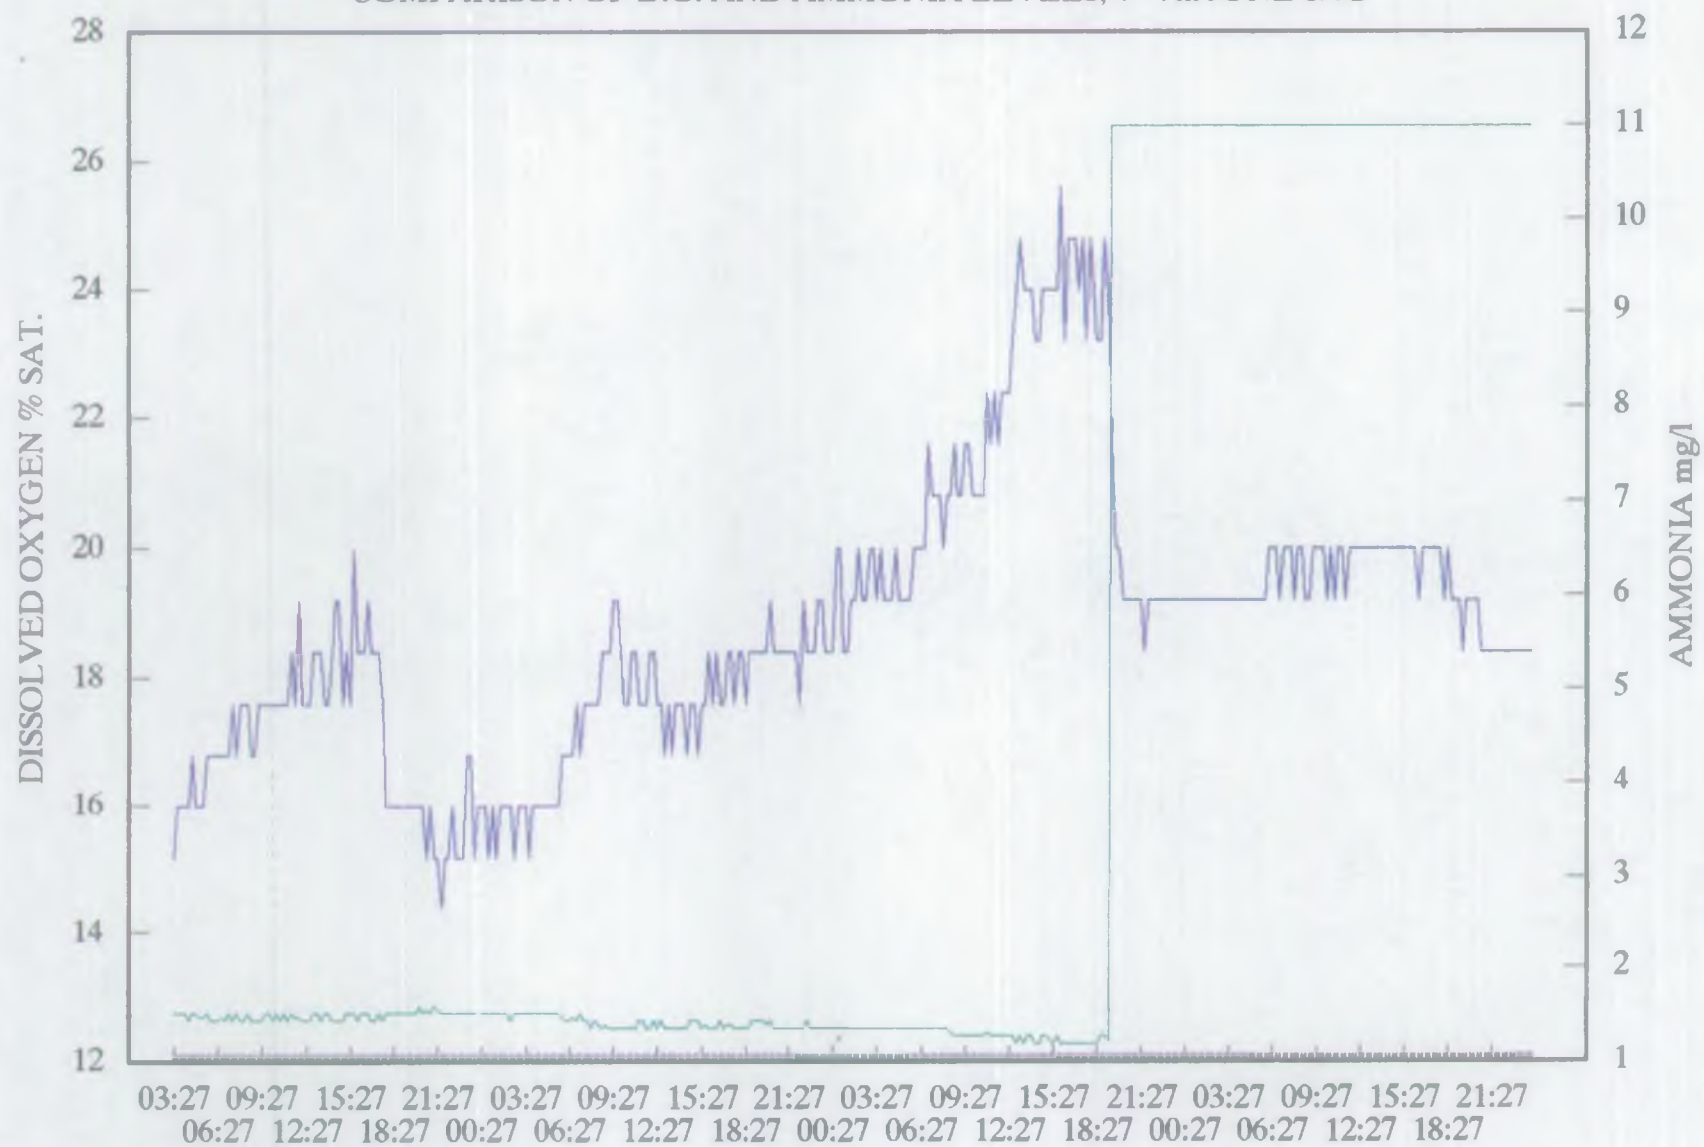
RIVER CHEW AT CHEWTON MENDIP

COMPARISON OF D.O. AND AMMONIA LEVELS, 4-7th JUNE 1992

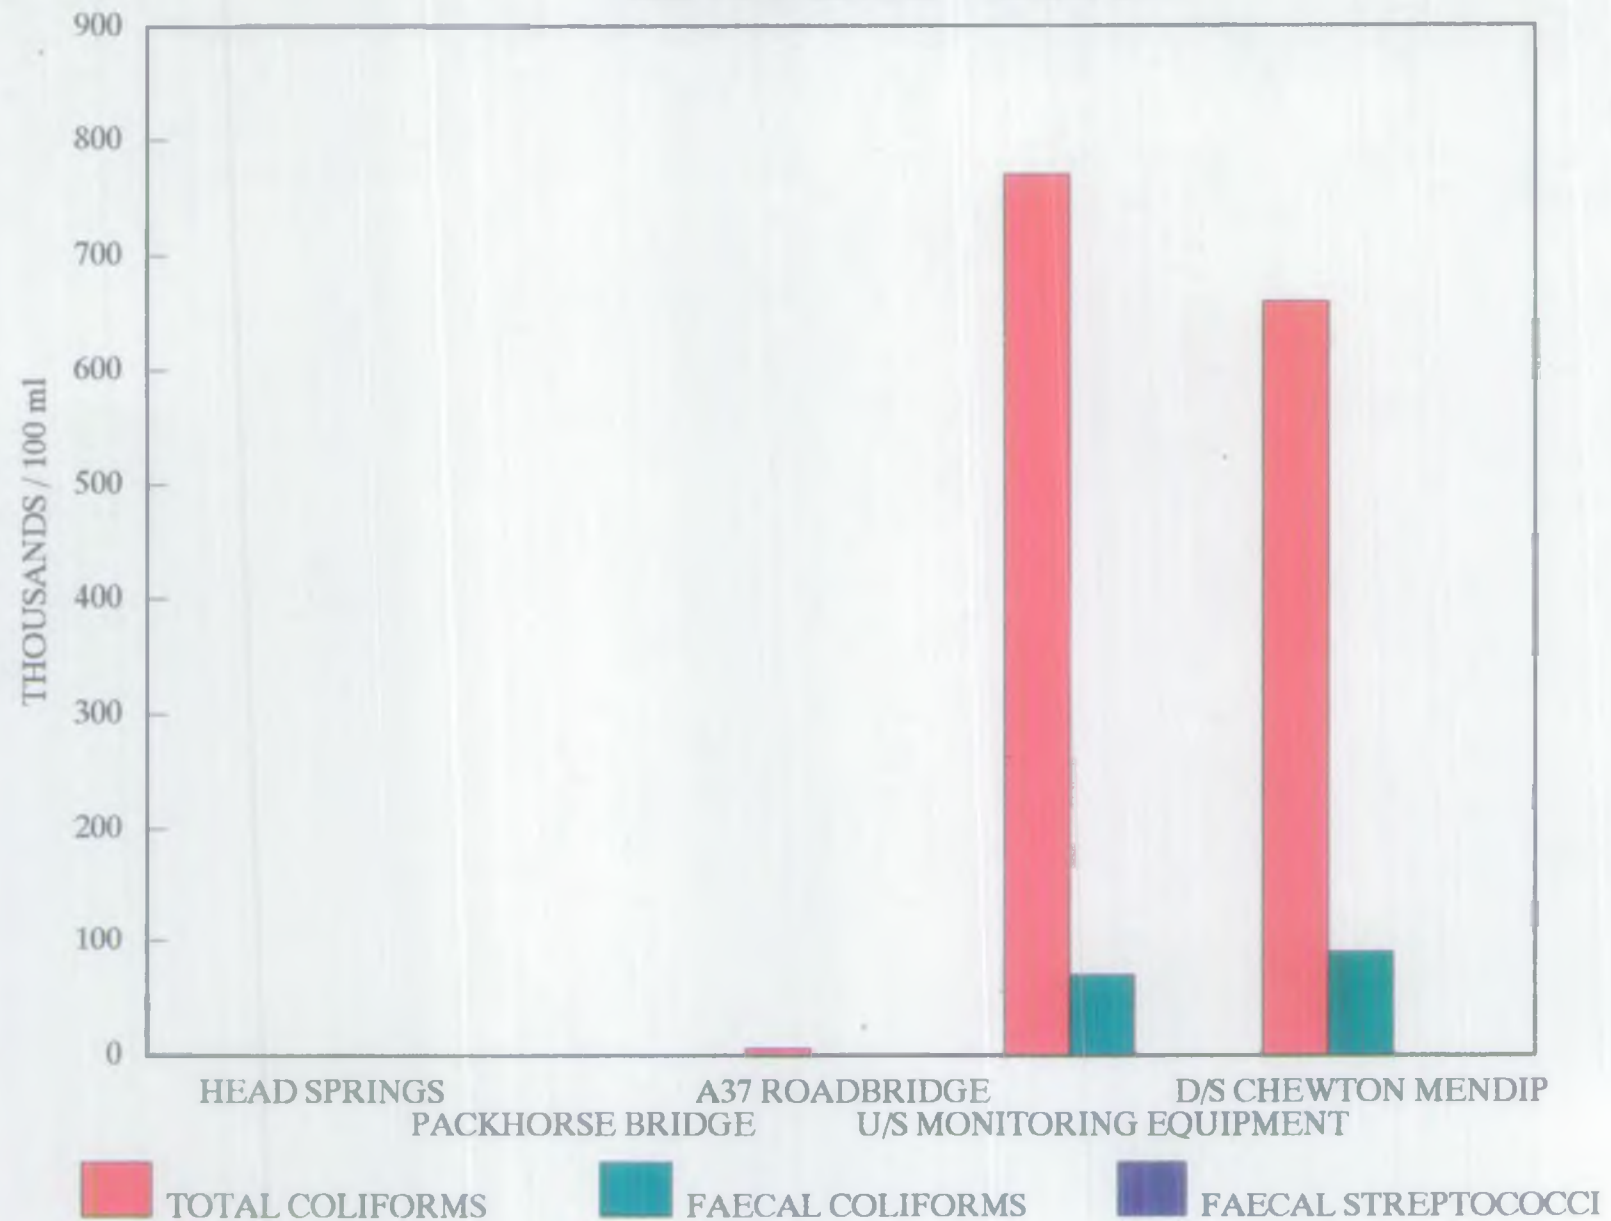
RIVER CHEW

CHEWTON MENDIP – 22 MAY 1992

The results of sampling are illustrated graphically in Appendix V of this report. They show that a significant increase in bacterial levels occurs downstream of Chewton Mendip compared with the Headsprings. The most striking difference arises between the sample sites at the A39 bridge and 'upstream of monitoring equipment'. The latter is positioned downstream of the majority of houses, public house, school and village hall, below which bacterial levels are elevated. Upstream of the A39 bridge there are at least two crude discharges to the river and two consented package treatment plant discharges. The 'Packhorse Bridge' sample point should indicate whether a bacterial problem arises from the crude effluent.

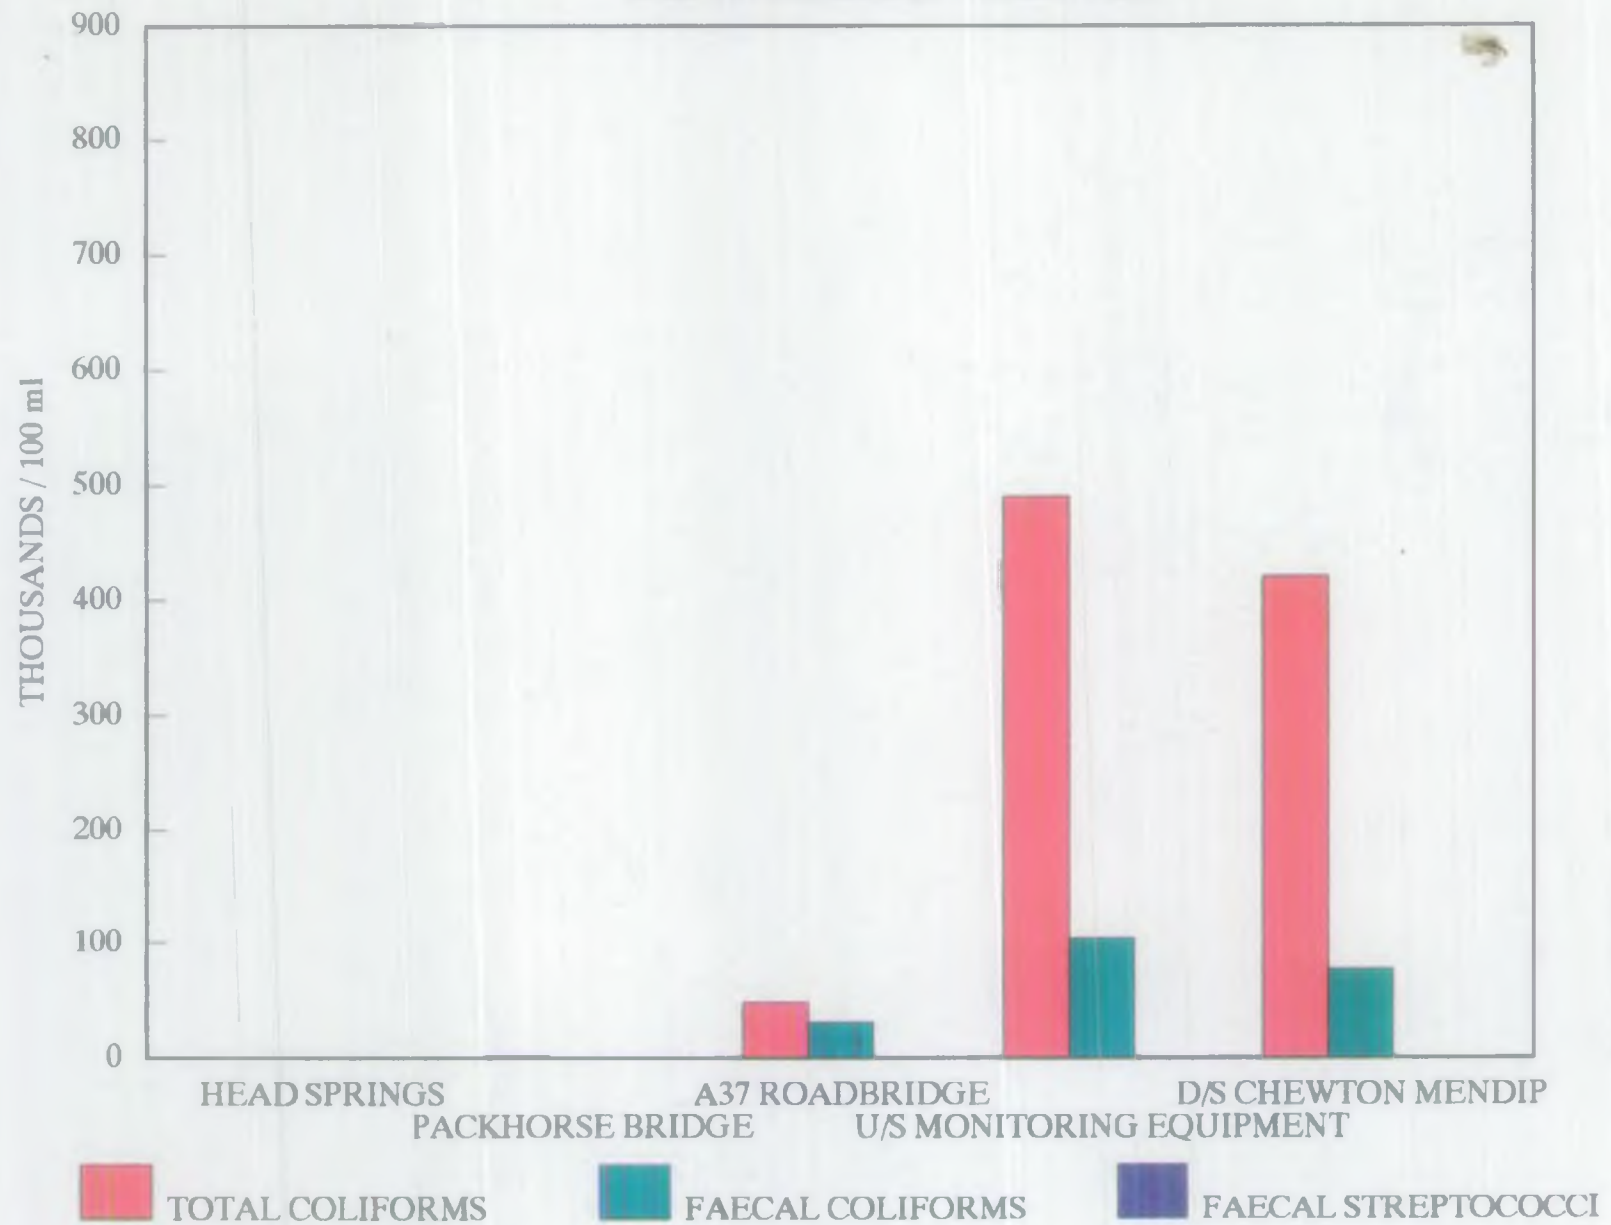
RIVER CHEW

CHEWTON MENDIP – 28 MAY 1992

There could be little other bacterial input to the watercourse except for field or road run-off under wet conditions. The only significant rainfall occurred prior to sampling on 28th May.

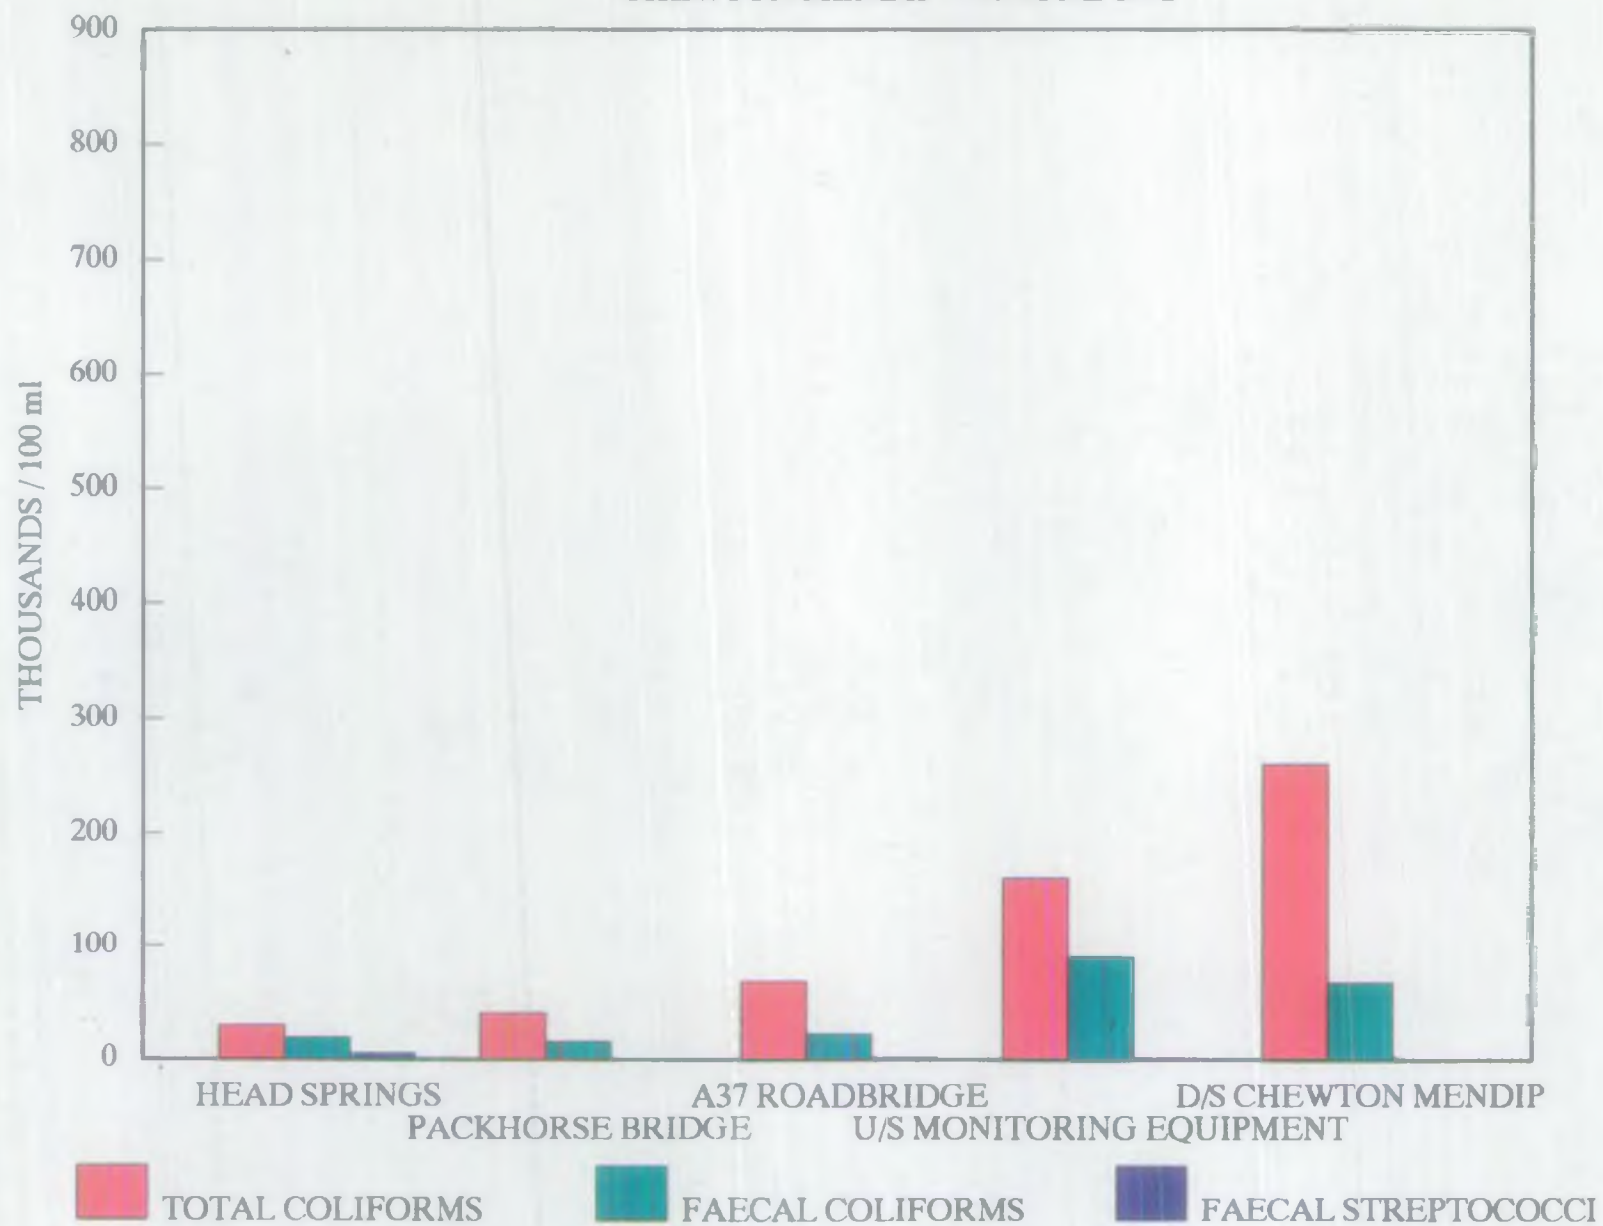
RIVER CHEW

CHEWTON MENDIP – 03 JUNE 1992

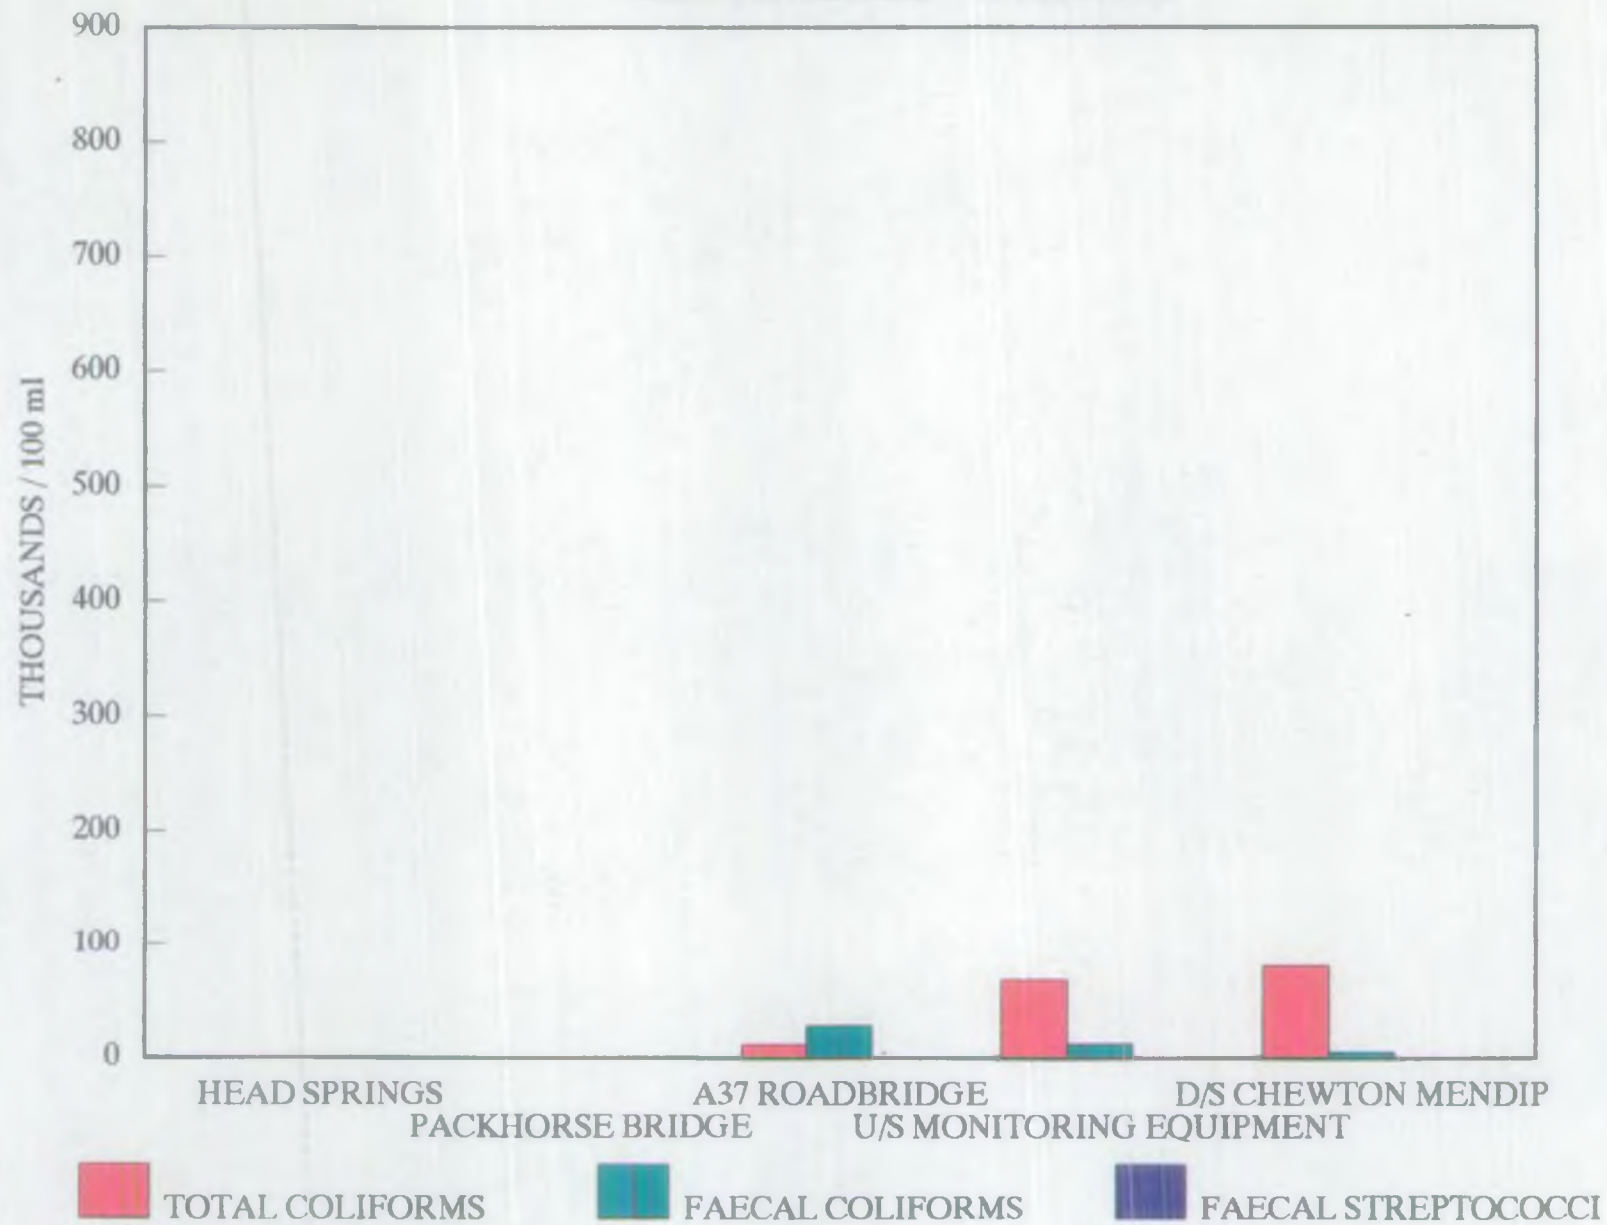
RIVER CHEW

CHEWTON MENDIP – 10 JUNE 1992
