MEASURES FOR PROTECTING UPLAND WATER QUALITY (FORESTRY)

Progress report for 1991/92

SR 3052

Authors: D W Swift and R L Norton

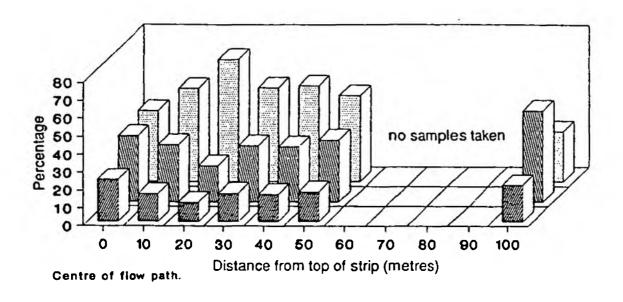
Figure 7.2 Particle size analysis of sediment deposited on the buffer strip

Samples of sediment were taken during late August 1991. All of the samples taken from the 'east' site were found to be 100% organic (peat) so no particle size analysis could be carried out. The results for the 'west' samples are presented in Table 7.1 and in a simplified form as clay, silt and sand in Figure 7.2.

There is one exceptional sample: that from the centre of the channel at 20 m has an unusually high proportion of sand. Apart from this, all of the samples from the centre of the channel are substantially similar to corresponding ones at the side. Also, the data are consistent with a gradual decline in the amount of sand content - which could be accounted for by depletion of the suspended material - and a corresponding increase in the proportion of finer particles. Finally, the quality of sediment from the side stream is comparable with that from the 50 m sample.
