DEE CATCHMENT MANAGEMENT PLAN

BIOLOGICAL ASSESSMENT OF
AGRICULTURAL CATCHMENTS

REPORT EAN/93/05

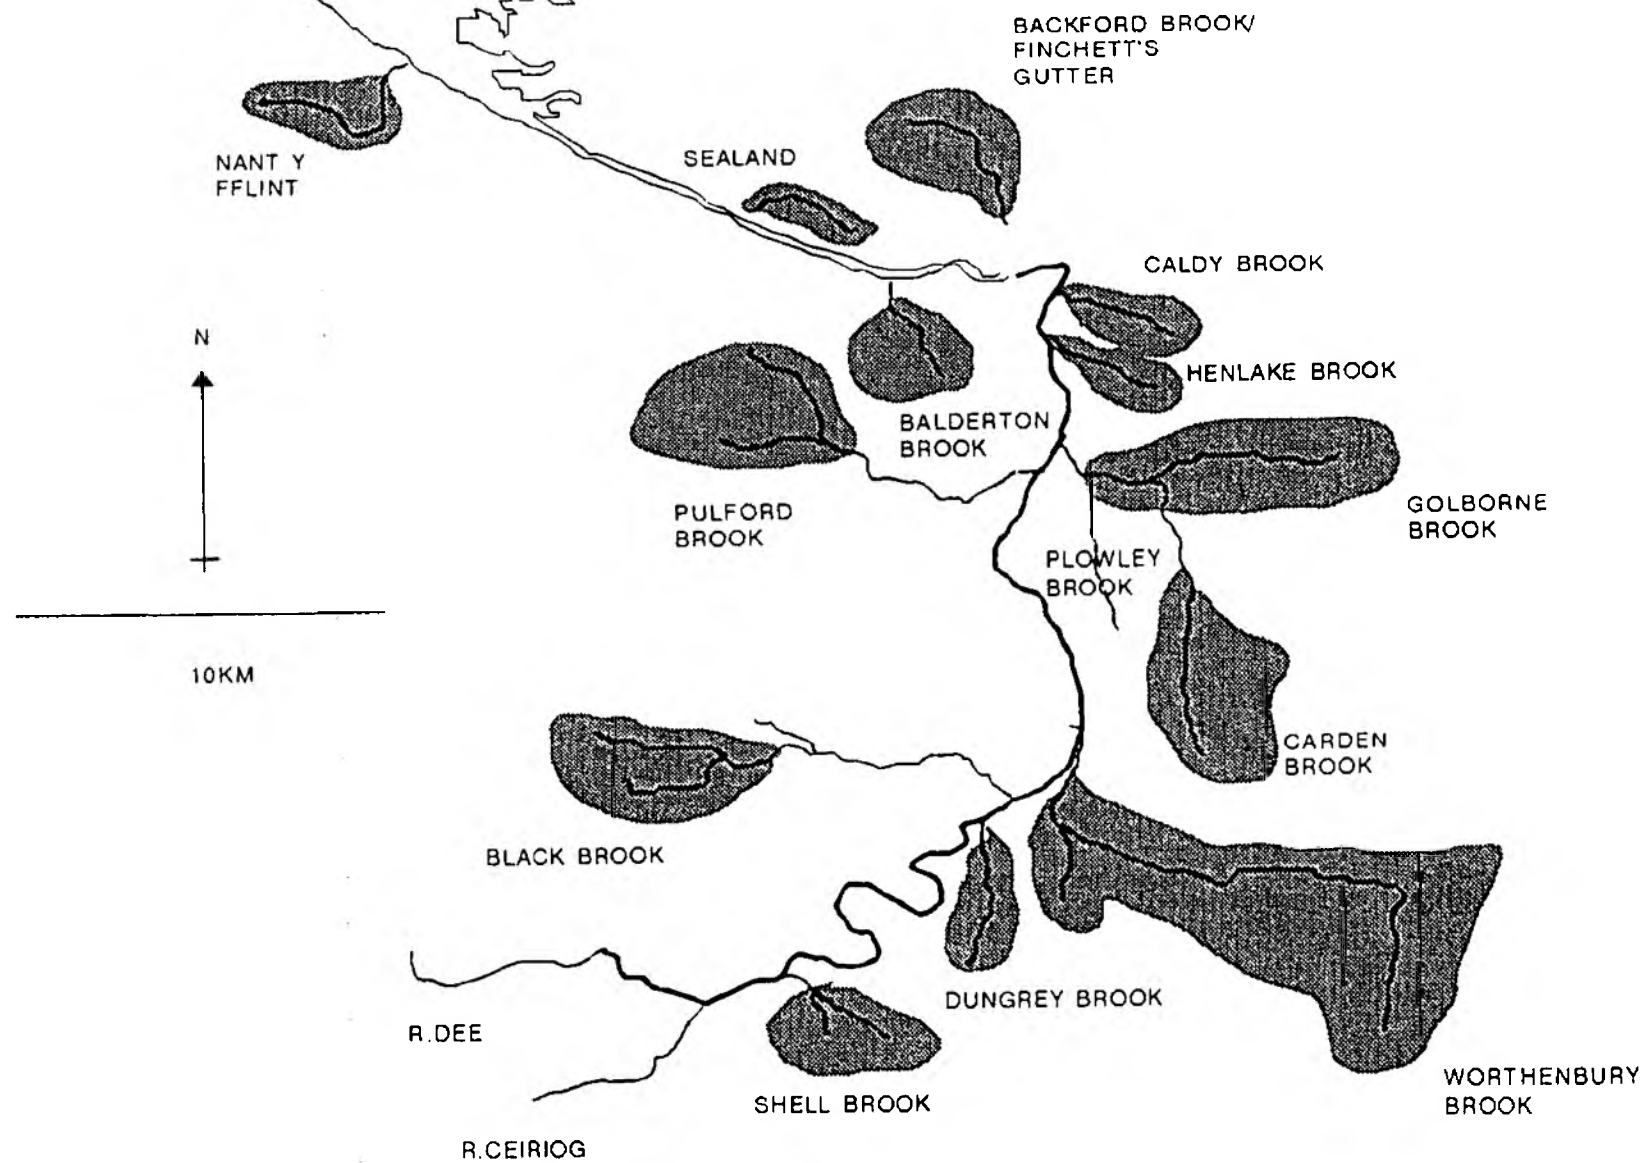
FIG 1. MAP SHOWING CATCHMENT AREAS
SAMPLED. AUGUST, 1993

Sub-catchments to be sampled were selected in consultation with Area Pollution Control Officers and were confined to the middle and lower Dee tributaries downstream of its confluence with the River Ceiriog (Fig.1). The sub catchments comprised the following:

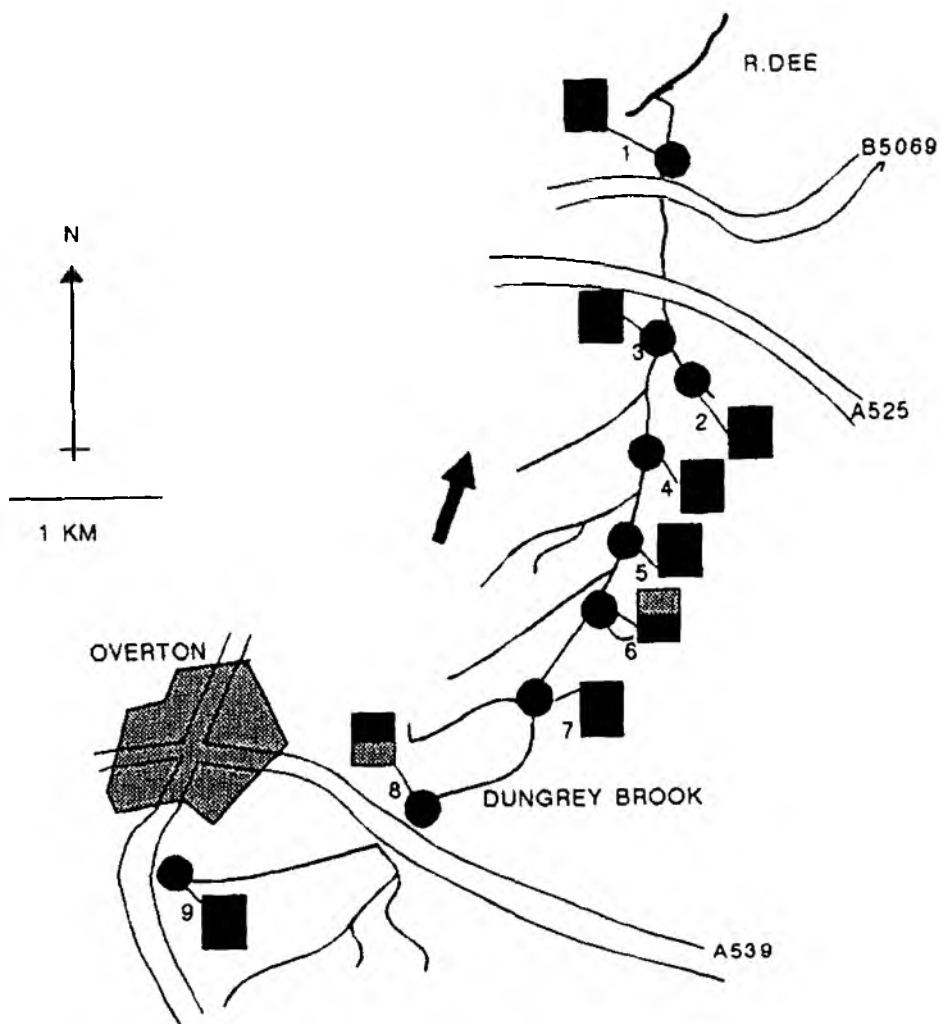
FIG.3 DUNGREY BROOK
SHOWING SITES SAMPLED

SITE NO.	NAME/LOCATION	NGR (SJ)	BMWP SCORE	AGP	COMMENTS
1	B5069 Road Bridge	399458	19	4	
2	Trib. DS Orchards farm	402445	16	4	Silty substratum
3	DS Cloy Bank farm	398447	15	4	Silty substratum
4	US Cloy Hall ditch	397438	2	4	
5	Cloy	396433	3	4	Black anoxic mud on stream bed
6	Near Nant	395427	25	4	Silty substratum
7	US Cae Dyah	391419	20	4	Silty substratum
8	Near Hill farm	385411	21	3	
9	DS Overton	371408	14	4

1. The Cloy area of Dungrey Brook has been the subject of a previous biological impact assessment study which highlighted a problem in the area (EAN\93\TM08)
2. All sites sampled in this catchment were severely polluted and this exercise was unable to distinguish the impact of any specific discharge. It appears that the poor quality may be due to the combined effects of many polluting influences from several farms in the area. This should be the subject of further investigation.

RECOMMENDATION 3

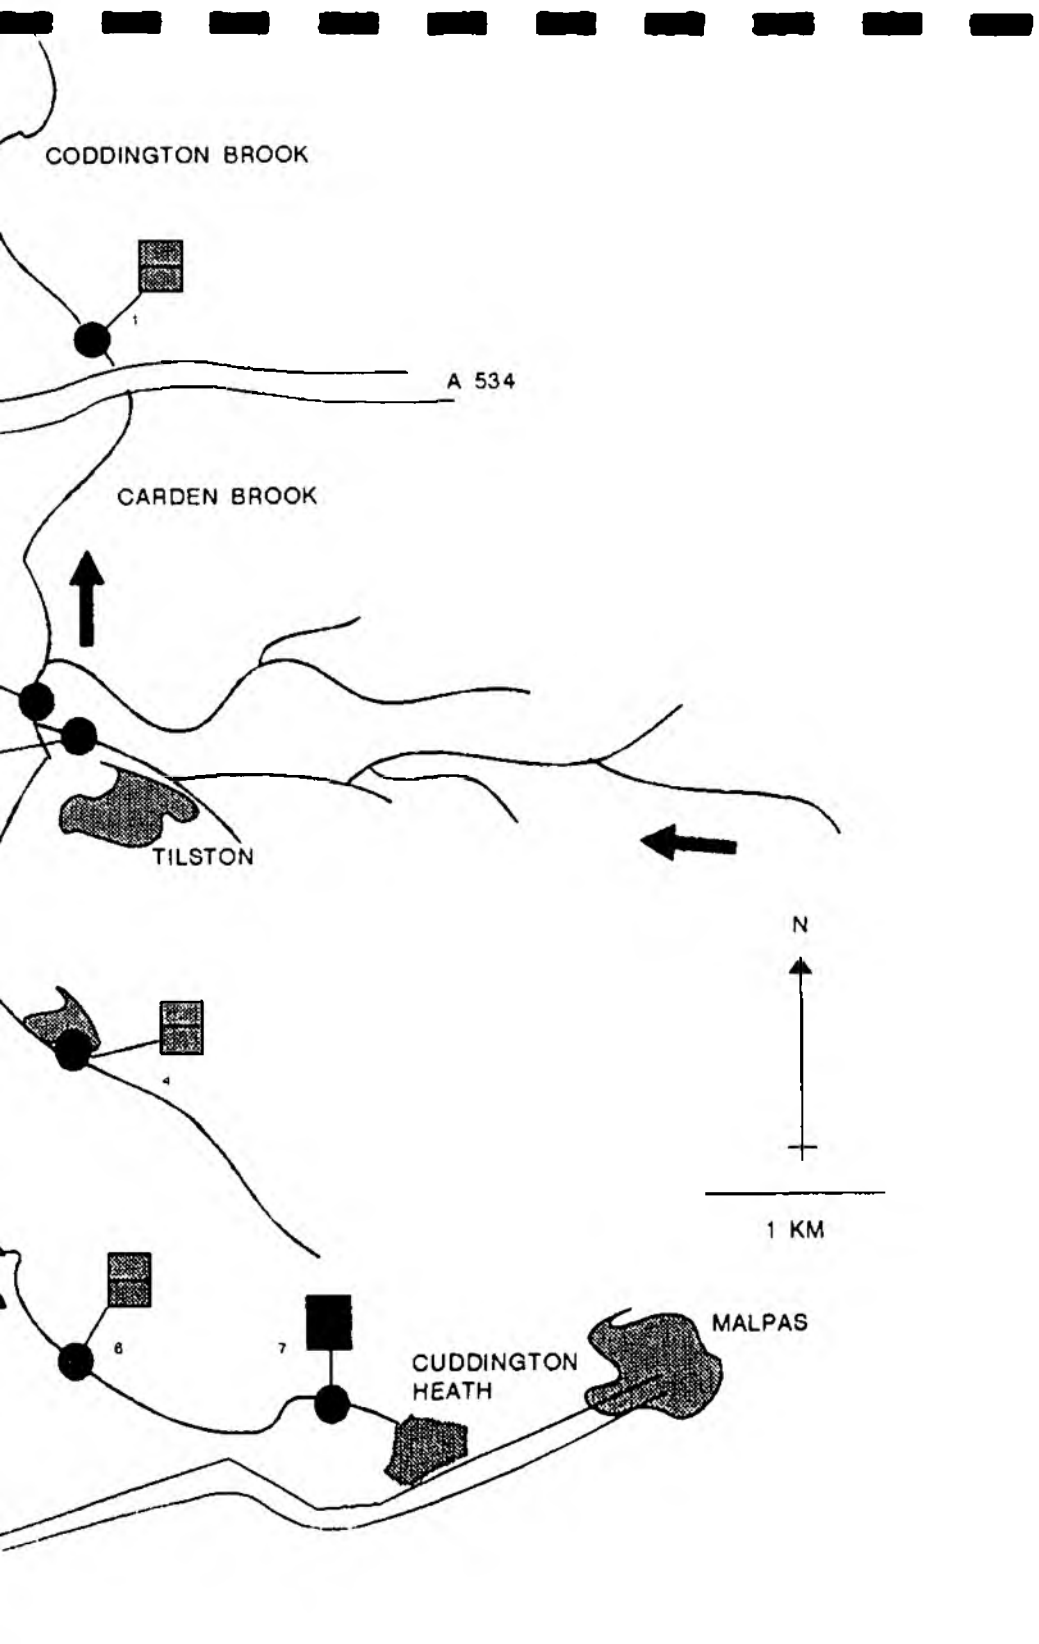
FIG.6 CARDEN BROOK
SHOWING SITES SAMPLED

SITE NO.	NAME/LOCATION	NGR (SJ)	BMWP SCORE	AGP	COMMENTS
1	A534 Road bridge	457543	42	3	
2	Tilston Road bridge	454519	40	3	
3	Trib @ Little Tilston	455517	40	3	
4	Trib. DS Horton Green	454494	42	3	
5	Parr Green Hall	448496	40	3	Silty substratum
6	DS Cherry Hill farm	455474	29	3	Trace of sewage fungus present
7	Chorlton Lodge	468470	8	4

- 1 Carden Brook at Tilston has been the subject of a previous biological impact assessment of the effects of farm effluent (EAN\93\TM11).
- 2 Influences from septic tanks at Cuddington Heath upstream of site 7 require investigation.

RECOMMENDATION 9

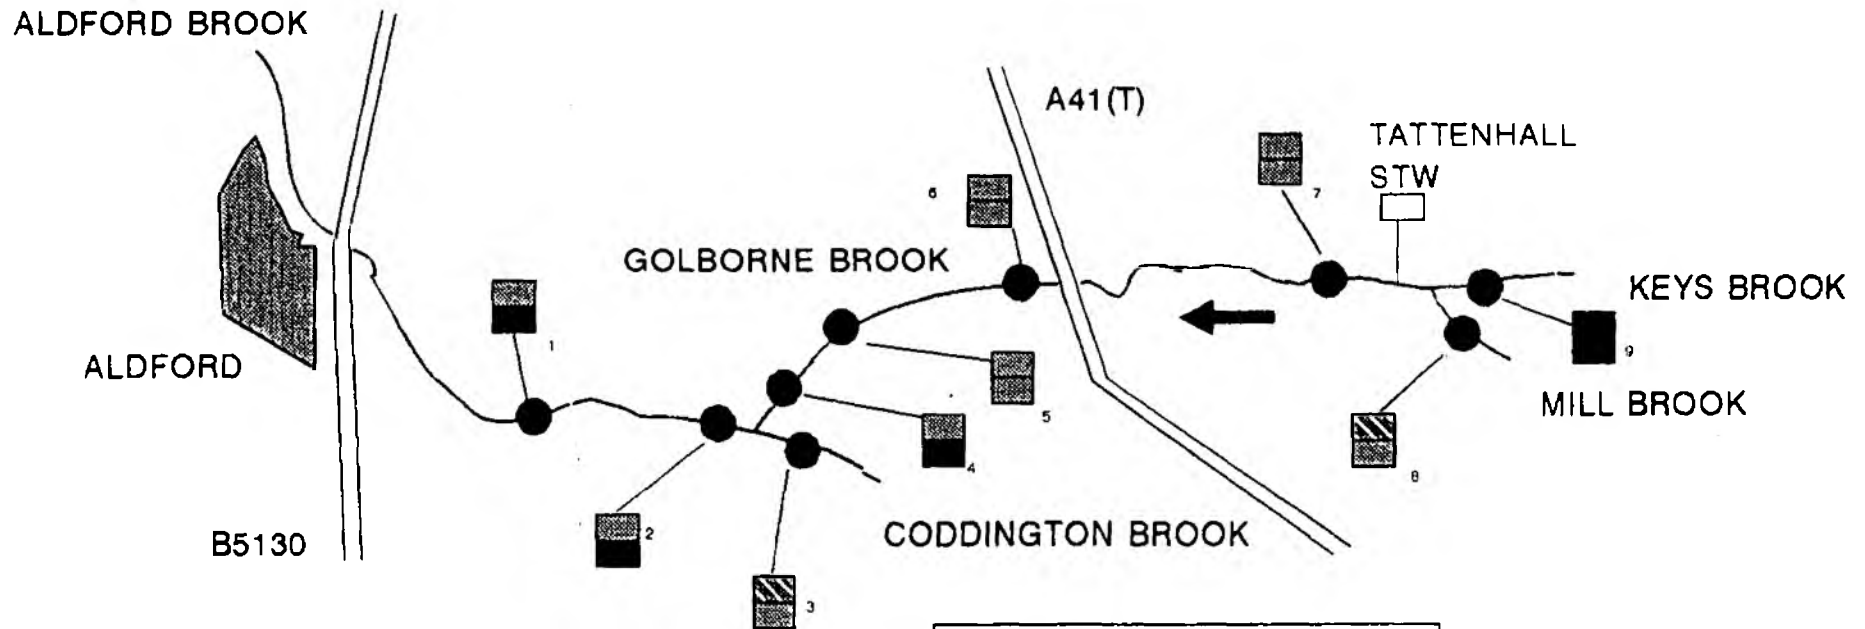
FIG.7 ALDFORD/GOLBORNE BROOK
SHOWING SITES SAMPLED

SITE NO.	NAME/LOCATION	NGR (SJ)	BMWP SCORE	AGP	COMMENTS
	<u>Aldford Brook</u>				
1	Lea Hall	435584	43	4	Sweep sample taken
2	DS Coddington Brook	443482	49	4	Sweep sample taken
	<u>Coddington Brook</u>				
3	US Aldford/Golborne Bk.	444583	54	3	Silty substratum
	<u>Golborne Brook</u>				
4	US Coddington Brook	444584	43	4	Silty substratum
5	DS Lea Newbold farm	447589	42	3	Silty substratum
6	Milton Green	461591	30	3	
7	DS Russia Hall and Tattenhall STW	474592	26	3	Trace of sewage litter present
8	Keys Bk US Mills Bk	480591	6	4	
9	Mills BK US Keys Bk	481599	50	3

1. Sites in Aldford Brook, Coddington Brook and the lower reaches of Golborne Brook were of a slow-flowing silty nature suitable for sweep or kick/sweep sampling only. The poor results obtained at these sites could be a reflection of the poor habitat rather than indicators of organic pollution.
2. Golborne Brook upstream of site 5 was organically polluted due, possibly to contamination from Tattenhall STW, though the effects from this source may be masked by a severe organic contamination of Keys Brook upstream of site 8 which requires further investigation.

RECOMMENDATION 10

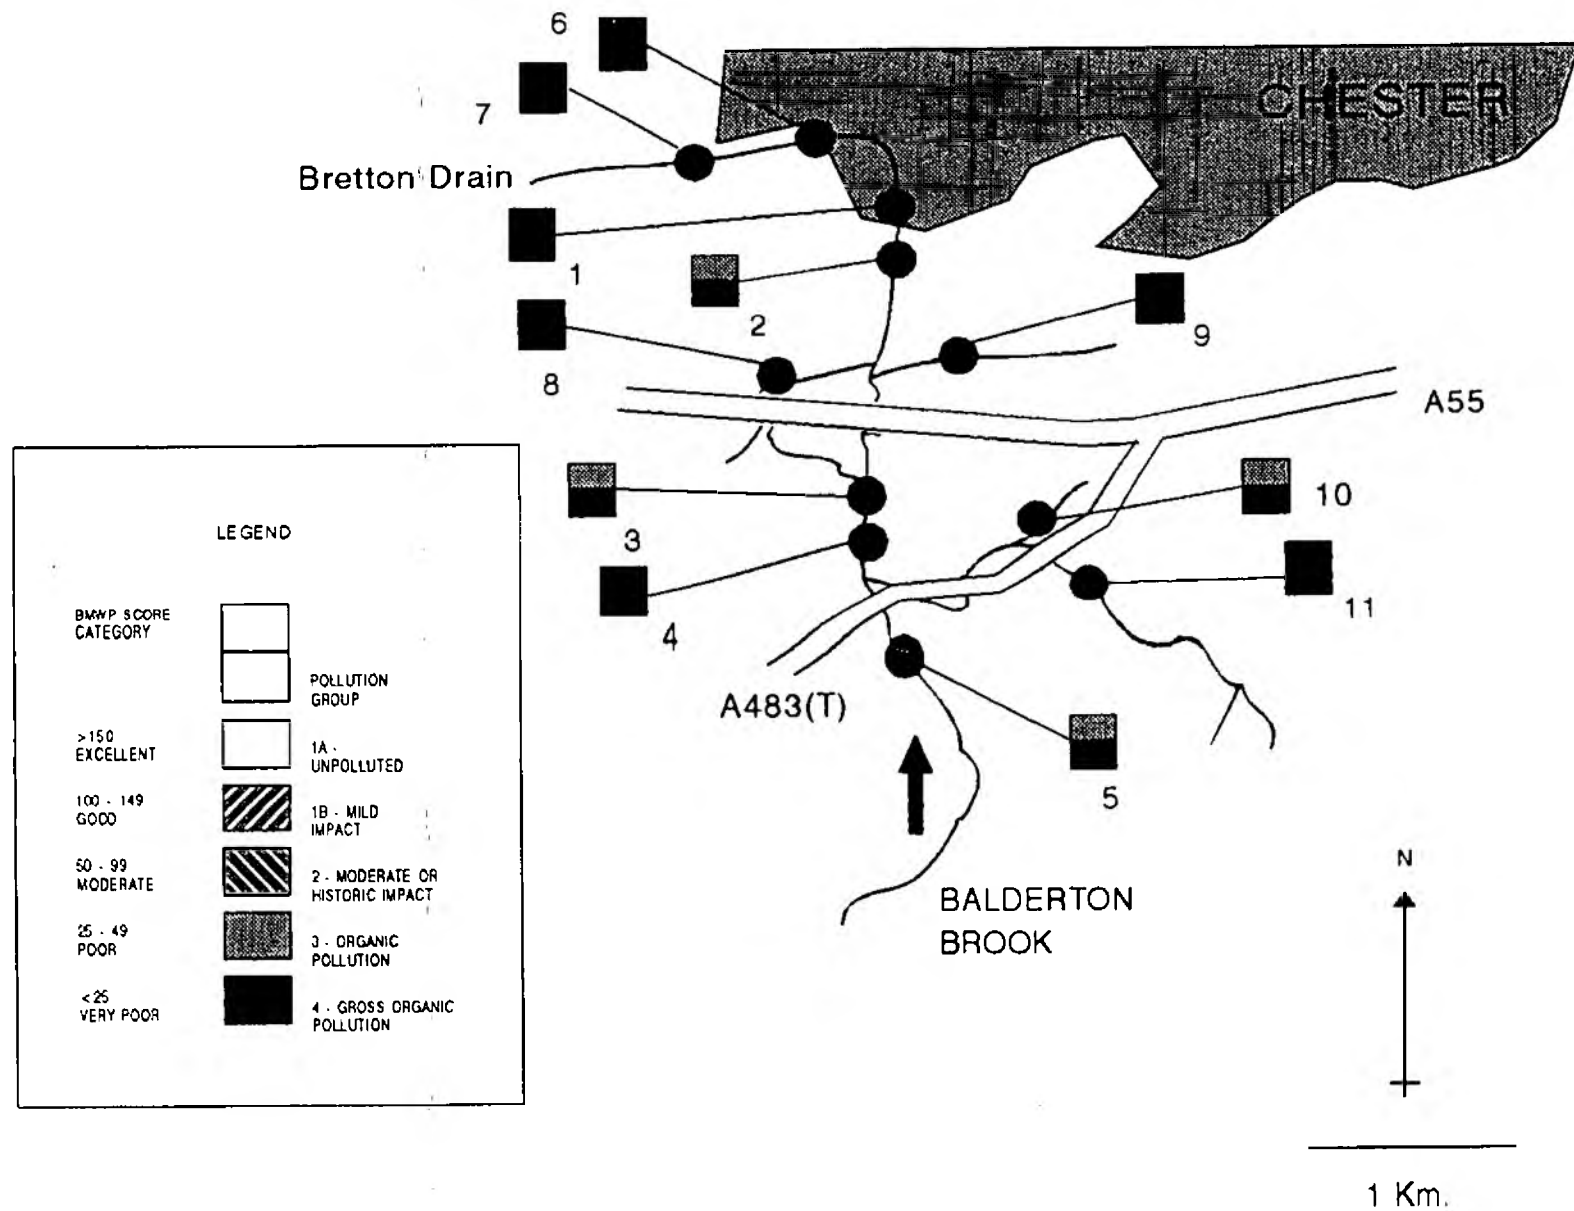
FIG.10 BALDERTON BROOK CATCHMENT
SHOWING SITES SAMPLED.

SITE NO.	NAME/LOCATION	NGR (SJ)	BMWP SCORE	AGP	COMMENTS
1	Sandy Lane	377641	15	4	Silty substratum
2	US Sandy Lane	378641	31	4	Silty substratum
3	DS Rough-hill	378632	42	4	Silty substratum
4	US Rough-hill	378622	19	4	Silty substratum
5	DS Oldfields farm	379614	26	4	Silty substratum
	<u>Bretton Drain</u>				
6	Sandy Lane	375648	23	4	Sweep sample taken
7	US Meadow House	369647	13	4	Sweep sample taken
	<u>Tributaries</u>				
8	DS Common farm	373629	11	4	Sweep sample taken
9	DS Moat farm	384632	16	4	
10	DS Two Mile House	388621	36	4	Silty substratum
11	DS Belgrave Bridge	388618	23	4

1. Despite the poor habitats found at all sites it is evident that this whole sub catchment is badly organically polluted.
2. Specific discharges were discovered between sites 1 & 2; 3 & 4 and upstream of site 5. These are the subjects of current further investigations
3. The upper reaches of the tributaries upstream of sites 7, 8, 9 & 10 are also being investigated further by pollution control staff.

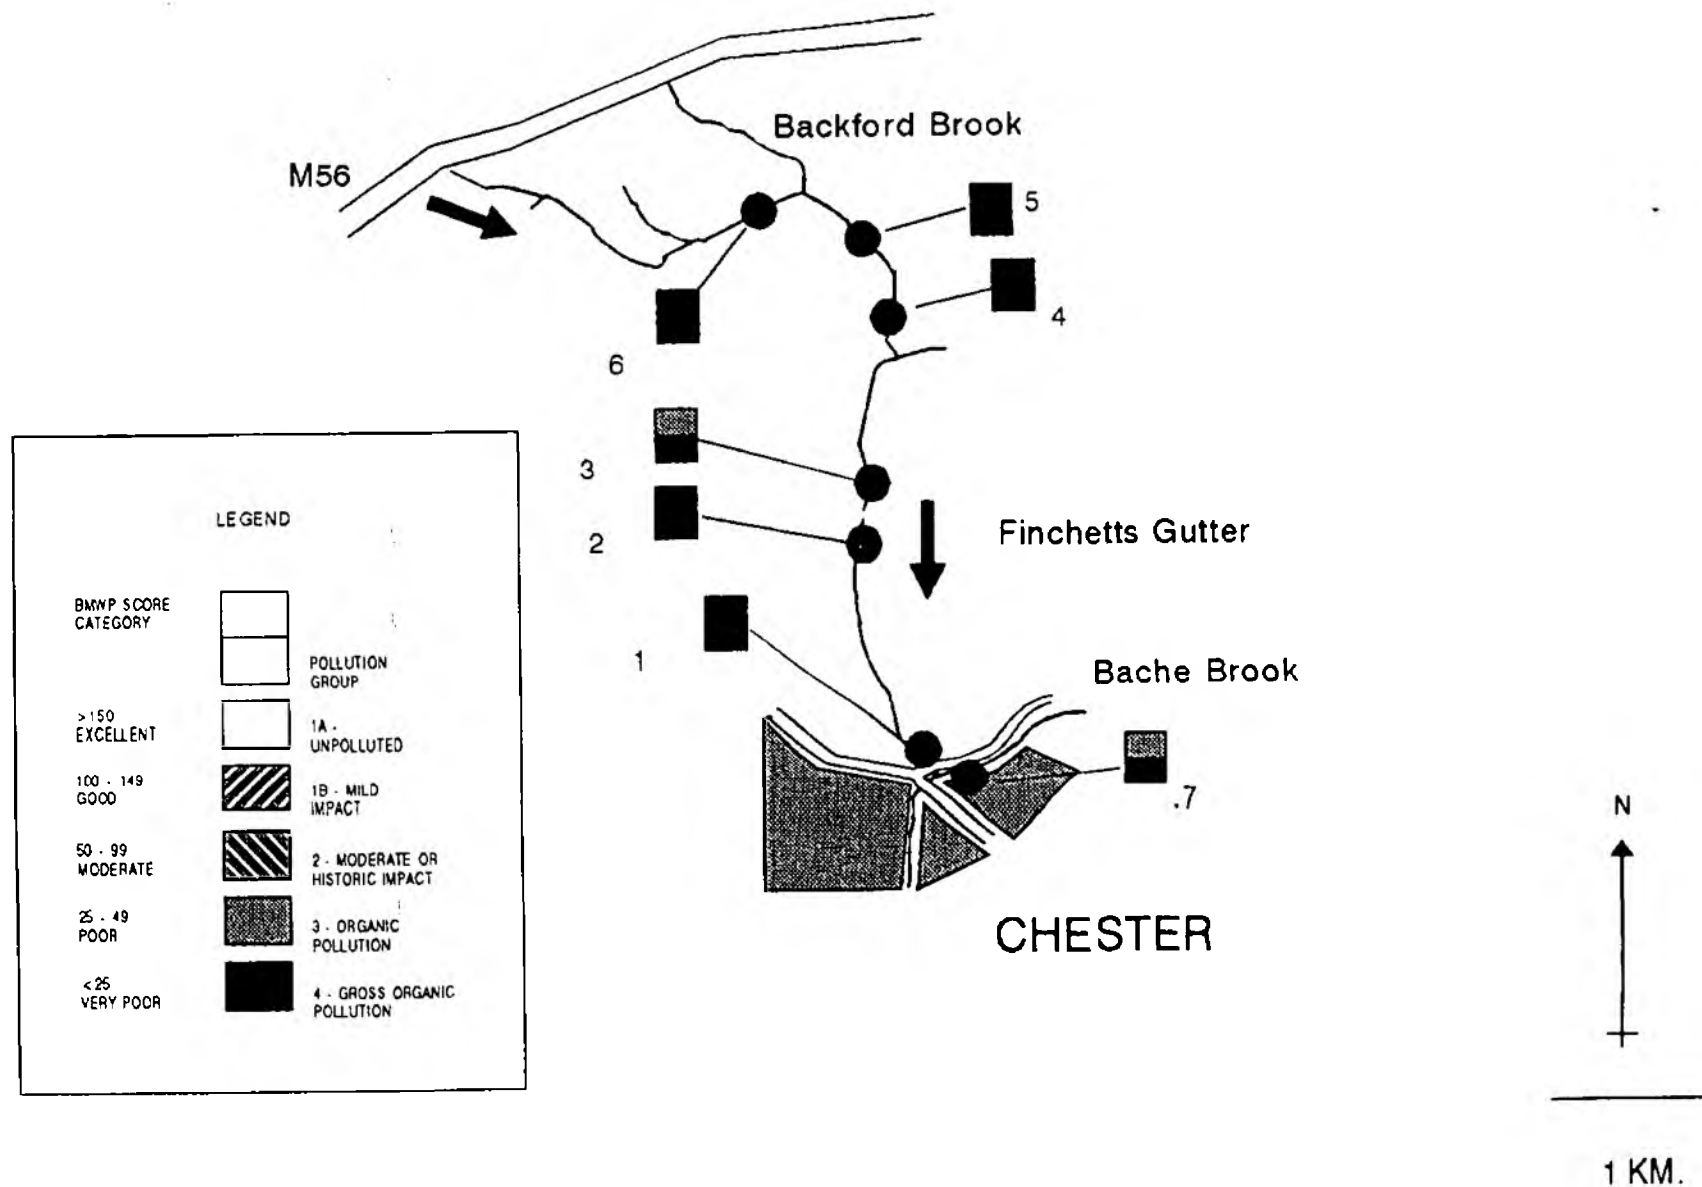
FIG.13 BACKFORD BROOK SHOWING SITES SAMPLED

SITE NO.	NAME/LOCATION	NGR (SJ)	BMWP SCORE	AGP	COMMENTS
	<u>Finchett's Gutter</u>				
1	US Bache Brook	399679	23	4	Silty substratum
2	At Knoll's Bridge	395693	21	4	
3	DS Chester Zoo	396696	25	4	Sandy substratum
	<u>Backford Brook</u>				
4	At Station Road	397713	24	4	10% sewage fungus cover. Sewage smell evident
5	US Lea Hall FB	396716	19	4	Foaming on water surface
6	DS Lea Manor Hall farm	390719	19	4	>10% sewage fungus cover
	<u>Bache Brook</u>				
7	At Countess Way	398679	36	4	Trace of sewage fungus together with gross sewage litter

1. Finchetts Gutter, was adversely affected by tip laechate from a disused landfill site and, possibly, by leachate from a settlement lagoon associated with a now defunct cheese processing plant, both located between sites 2 & 3. These were the subject of investigations by pollution control staff.
2. Sites in Finchetts Gutter upstream of site 2 and all sites in Backford Brook were also of very poor biological quality. This may be attributed to intermittent sewage discharges between sites 3 & 4 and to occasional discharges of waste from Lea Manor farm, upstream of site 6. These sources should be investigated further.

- 3 A series of Combined Sewer Overflows located upstream of site 7 cause severe sewage pollution of Bache Brook. This requires action.

RECOMMENDATION 18

RECOMMENDATION 19

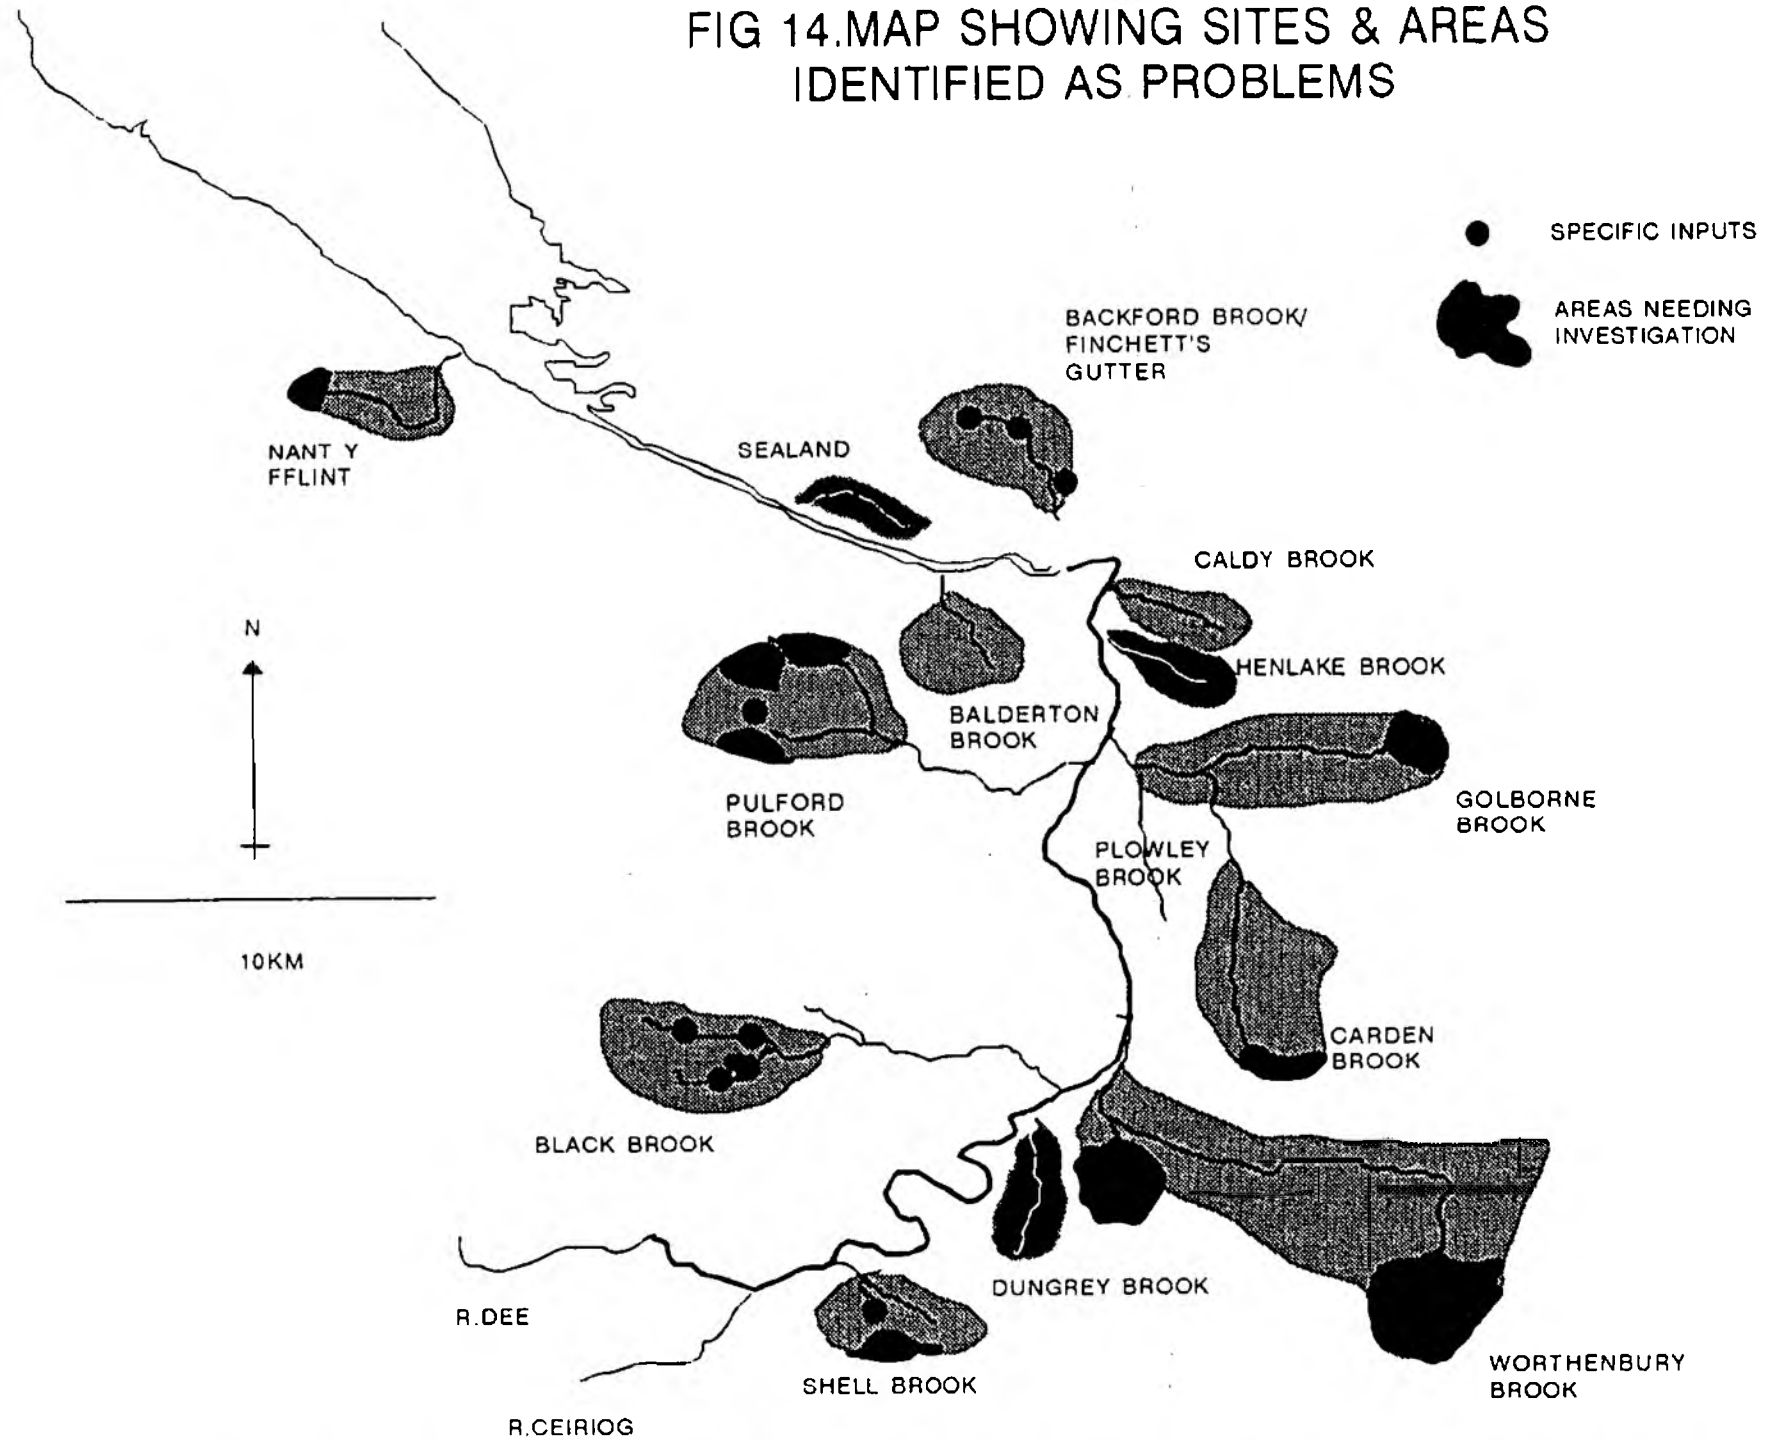
FIG 14. MAP SHOWING SITES & AREAS
IDENTIFIED AS PROBLEMS

1 The biological quality in all catchments surveyed was generally very poor. In total, fourteen subcatchments were sampled at ninety seven sites on five consecutive working days. The resource used consisted of 20 staff days, shared equally between pollution control and EAU staff, for sampling and about 10 EAU staff days in production of this report. In effect, however, pollution control staff were made aware of the specific problems in terms of inputs and areas requiring investigation at the time of the survey, since they were actively involved in the field assessment. This report formalises those assessments in the form of specific recommendations, many of which will have already been acted upon. These can be summarised as follows; (Fig.14)

Kilhendre Brook	Kilhendre farm Kilhendre Hall farm
Glan yr Afon Brook	Gardden Hall farm CSO at Rhostyllen Plas y Fron farm
Stringer's Brook	Town Drain farm
Backford Brook	Lea Manor farm Sewage discharge near Chester Zoo
Bache Brook	CSOs

Kilhendre Brook	Septic tank influences in the Dudleston heath area.
Dungrey Brook	The whole subcatchment
Glan yr Afon Brook	Gardden Industrial Estate
Worthenbury Brook	Upper reaches of Red Brook Middle reaches of Emral Brook
Carden Brook	Septic tank influences in the Cuddington Heath area.
Aldford Brook	Keys Brook upstream of Tattenhall STW
Pulford Brook	Septic tank influences in the Caer Estyn area. Trib. Warren Dingle in the Kinnerton area Trib. Warren Dingle in the Broughton area.
Henlake Brook	The whole subcatchment
Sealand Drain	The whole subcatchment
Nant y Fflint	The upper reaches.
