WHITLAND FLOOD ALLEVIATION SCHEME

National Rivers
Authority
Welsh Region

Whitland

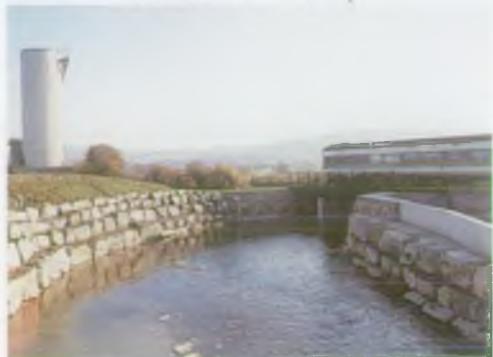
Channel realignment works - River Gronw.

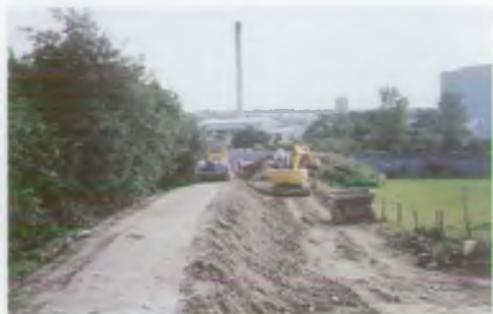
Work in progress - River Gronw floodbank on playing fields north of the A40.

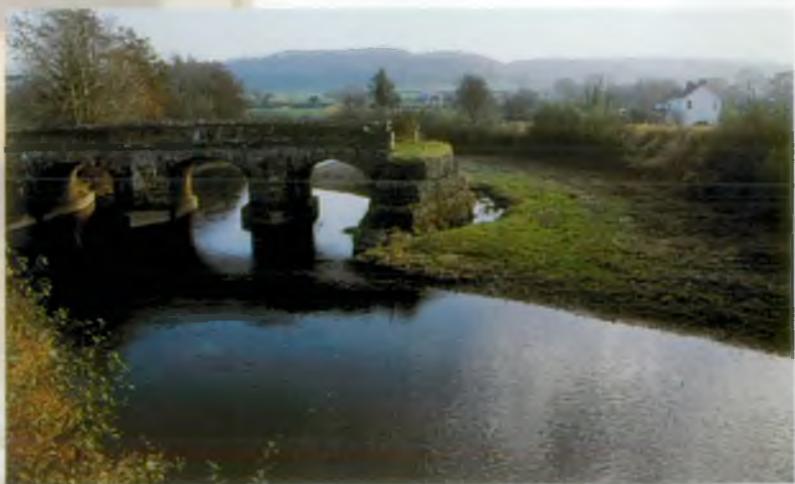
Flood relief channel - Old Trevaughan Bridge, River Taf.

- underpinning the existing bridge arches;
- lowering bed levels through the bridge;
- buttressing the western end of the bridge; and
- forming a flood relief channel to one side of the existing bridge.

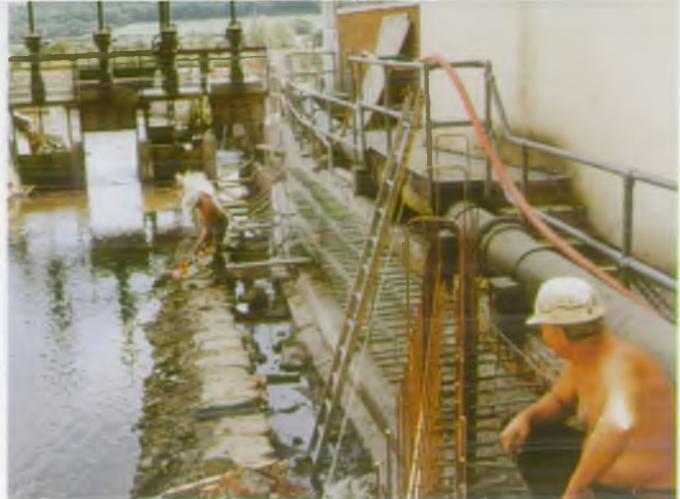
Work in progress showing difficult working conditions, restricted access and complex services arrangements within Creamery site.

Construction of the River Gronw scheme posed a variety of challenging engineering problems. Most of the river works were undertaken within the confines of a complex factory environment, bounded to the north by the Carmarthen-Haverfordwest trunk road and to the south by the London-Fishguard main railway line. Construction work was restricted to a narrow working strip alongside the watercourse and access was further restricted by the presence of a complex network of pipe and service crossings running under, over and alongside the river channel. Much of the work could only be carried out from within the river channel and operations were

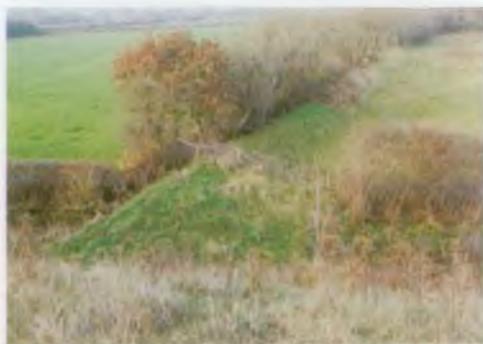
Barrier bank - Cwmfelin Boeth.

town. To prevent this migration across the flood plain a barrier bank was constructed. This work was carried out by the Welsh Water Authority direct labour workforce apart from a small section which fell within the highway boundary and was carried out by Dyfed County Council. The whole scheme was funded by the Welsh Office

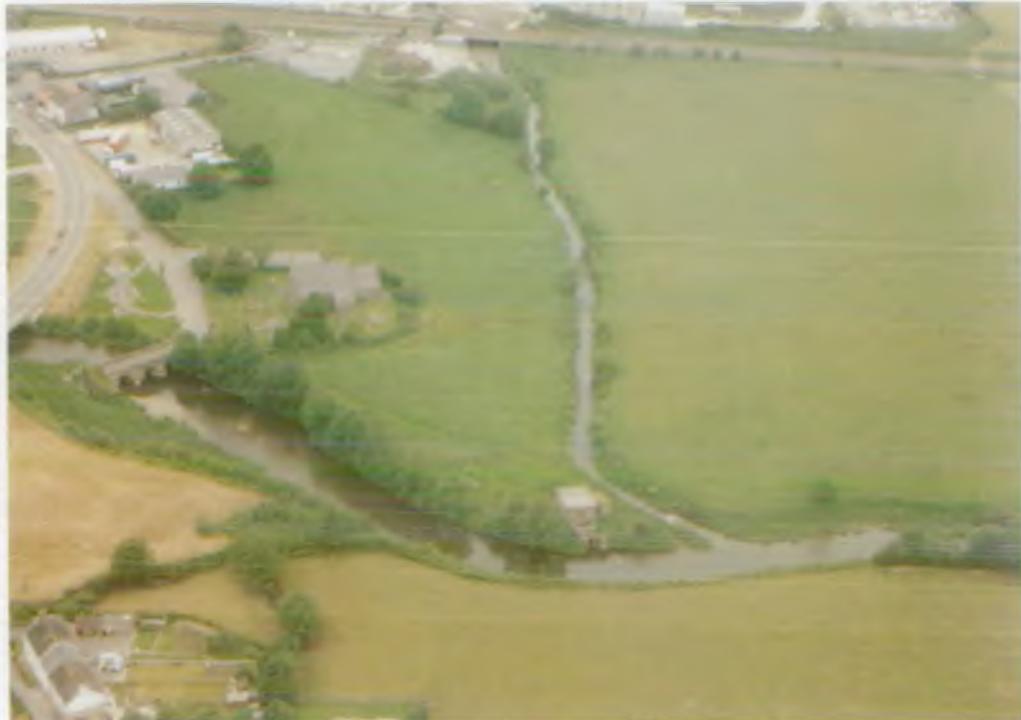
Confluence of Rivers Taf, Gronw and Cwm Gron showing Old Trevaughan Bridge flood relief channel.

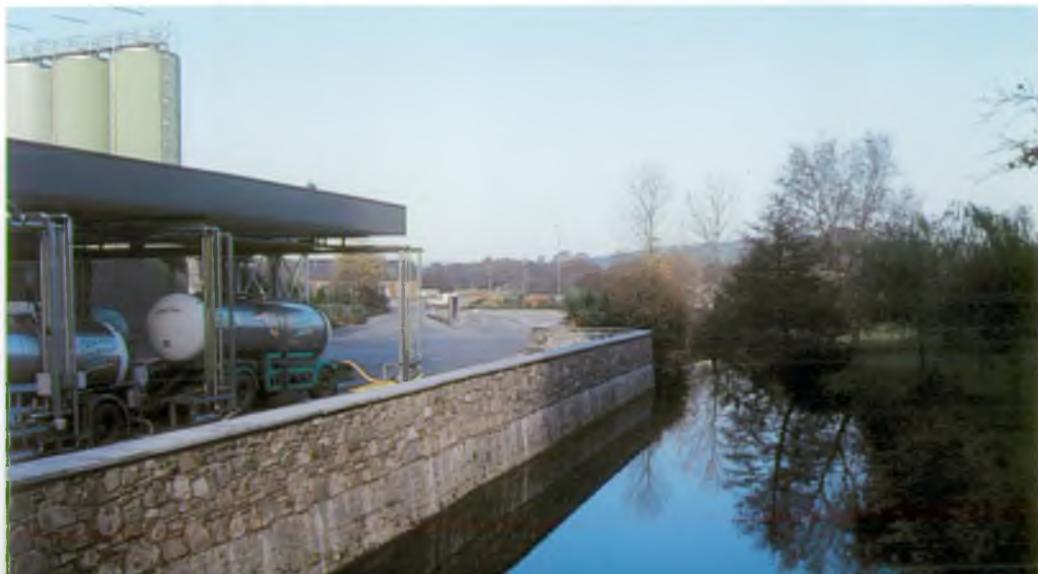
New flood defences alongside loading bay.

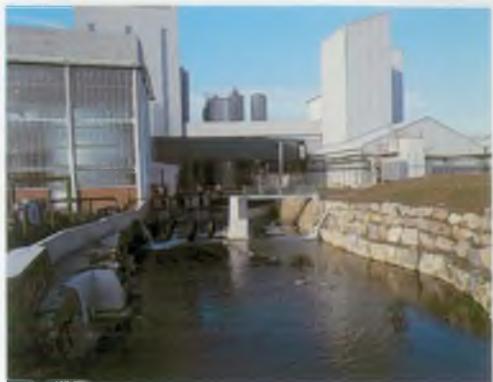
Realigned channel and flood defences upstream of railway bridge.

- constructing flood banks to the north of the A40;
- enlarging the A40 bridge by providing a second opening;
- raising flood walls along the west bank of the Gronw through the Creamery;
- bypassing the existing sluice structure using a side weir and overflow channel; and,
- realigning the existing channel to accommodate the overflow channel and improving the capacity and the entry and exit conditions at the railway bridge.

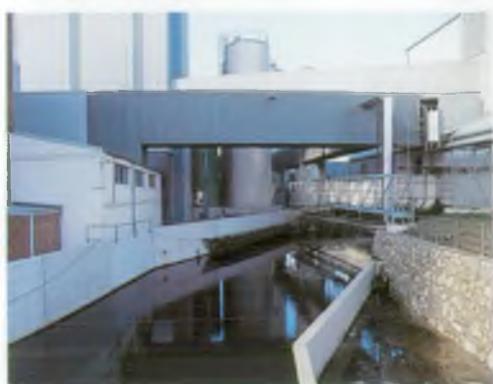
Side weir and sluice bypass channel.
