**THE INVESTIGATION OF THE  
TAFF LITTER PROBLEM**

**NOVEMBER 1989**

Report No - PL/EAE/89/2

By :- Gillian L. Davies  
Environmental Appraisal Officer  
SE.Environmental Appraisal Unit,  
St. Mellons Business Park,  
St. Mellons,  
Cardiff.

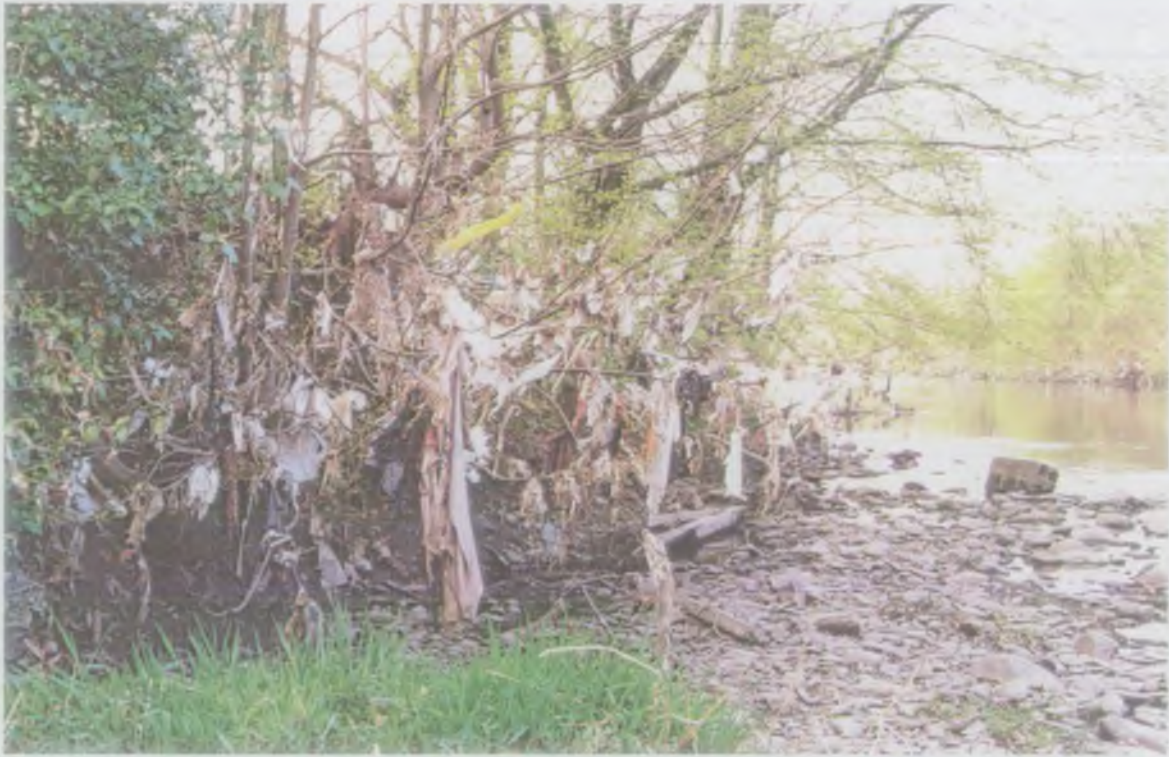
Photograph 1: An illustration of the Taff litter problem.

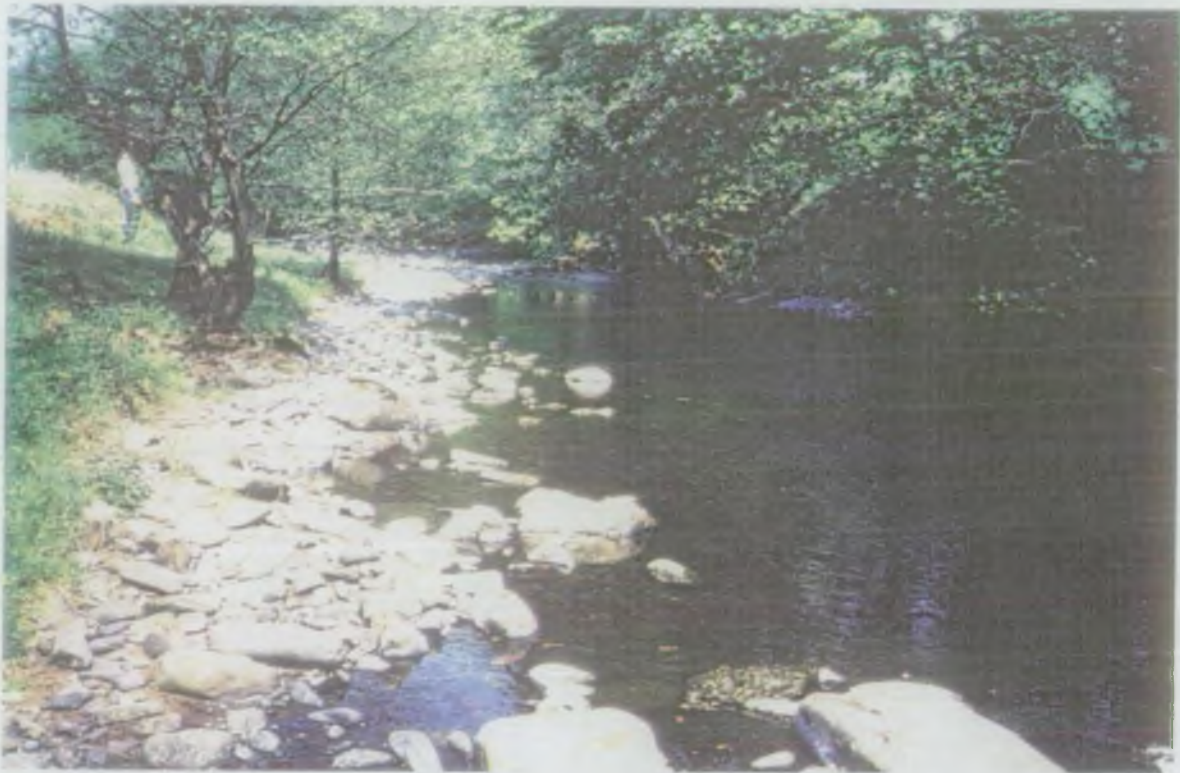
Site T2: A clean site high in the catchment.

Traces of picnic debris.

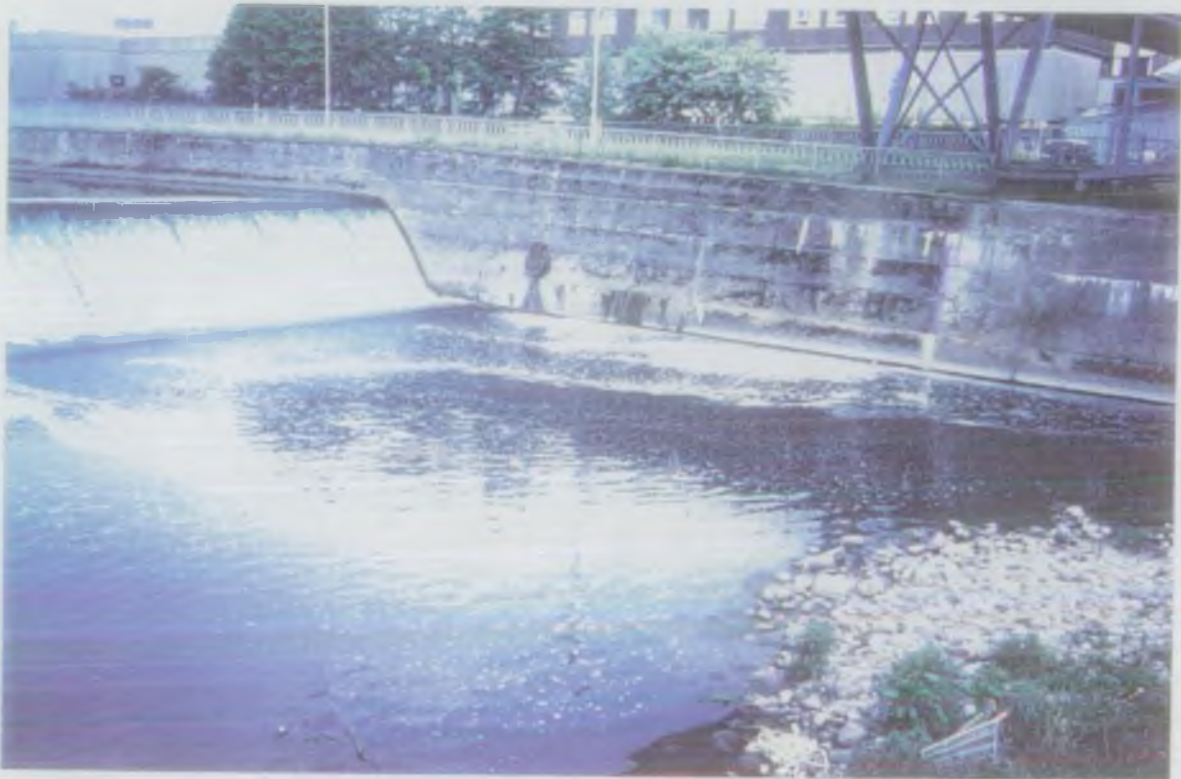
Site T4: At Merthyr Tydfil - affected by a Surface Water Outfall (S.W.O.) and debris such as supermarket trollies.

Only a slight sewage litter contamination despite the presence of a SS0 within the reach (see photograph). Heavily contaminated with litter from the footbridge which is the main pedestrian exit from the car park into Merthyr shopping centre and largely comprised of wrappers, take-away cartons, cardboard boxes and a whole bin-bag full of rubbish. 7 supermarket trollies visible in the river channel.

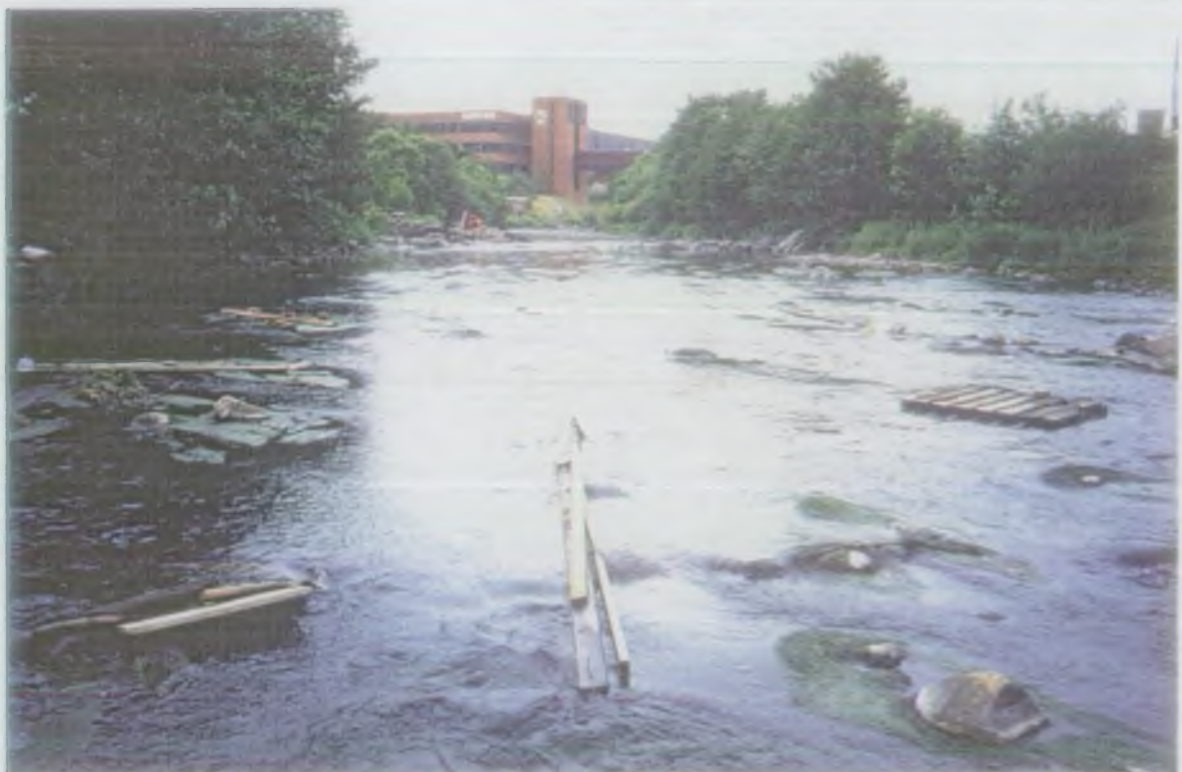
Site T5: Downstream of the Hoover Factory, Pentrebach. Heavier objects in the river channel and an amount of builders rubble dumped on the bankside.

Some sewage litter contamination and paper litter, glass, polythene bags/strips, but large amount of builder's rubble, furniture and carpeting material. Council workmen use the upper right bank to store road materials plus building repair work and easy access from conurbation opposite to dump rubbish.

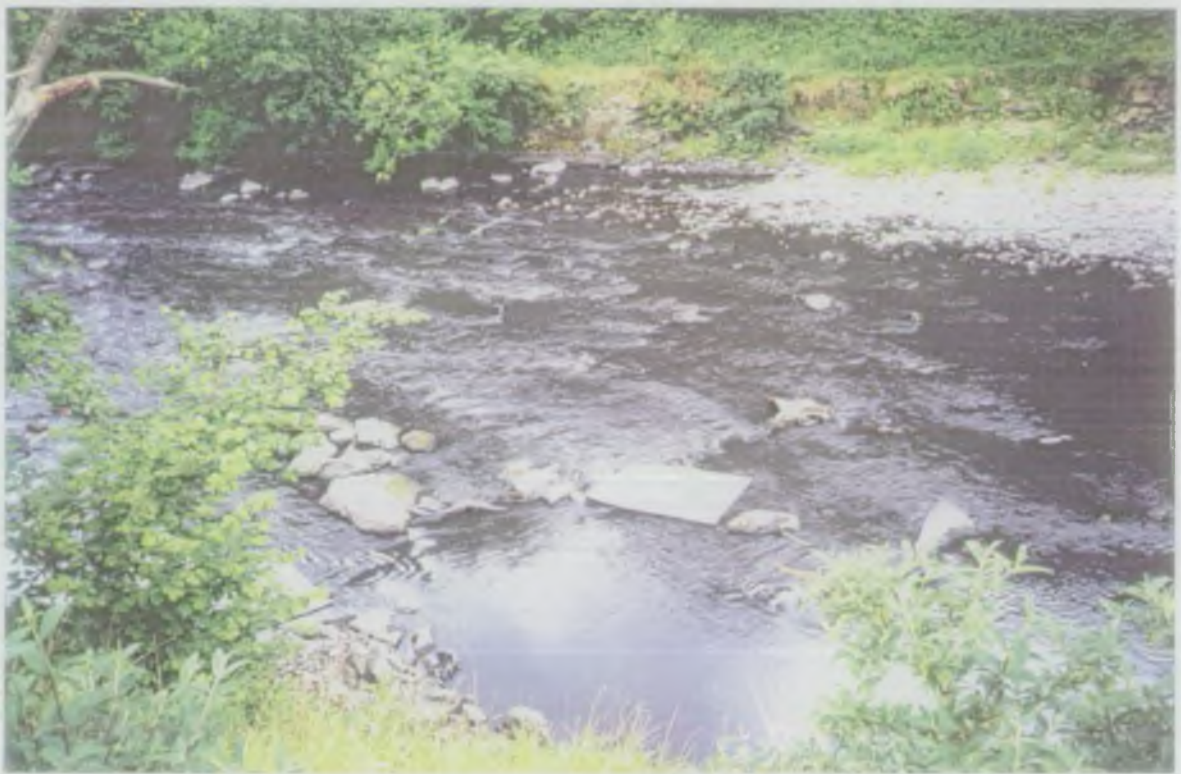
Site T10: Downstream of the Taff Bargoed tributary demonstrating the effect of coal solids on water quality.

Very obvious water quality deterioration caused by coal solids input from Taff Bargoed with the river bed no longer visible and water black. Some sewage litter contamination and refuse e.g. floor covering, clothing with no obvious point source.

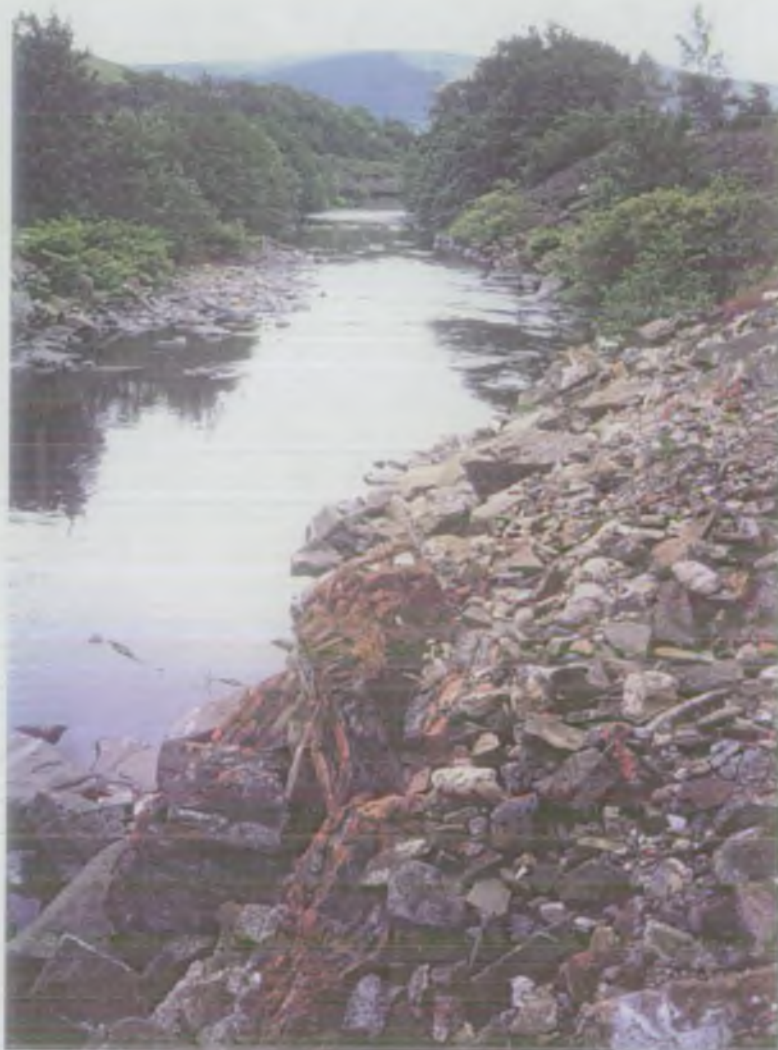
Site T11: Tons of builders rubble and general refuse form much of the right hand bank.

Heavily contaminated with refuse, builders rubble etc. and evidence of fly-tipping in lay-by on opposite side of road. Physical characteristics of reach made it unsuitable for the accumulation of sewage litter (very little overhanging vegetation). River bed not visible due to coal solids.

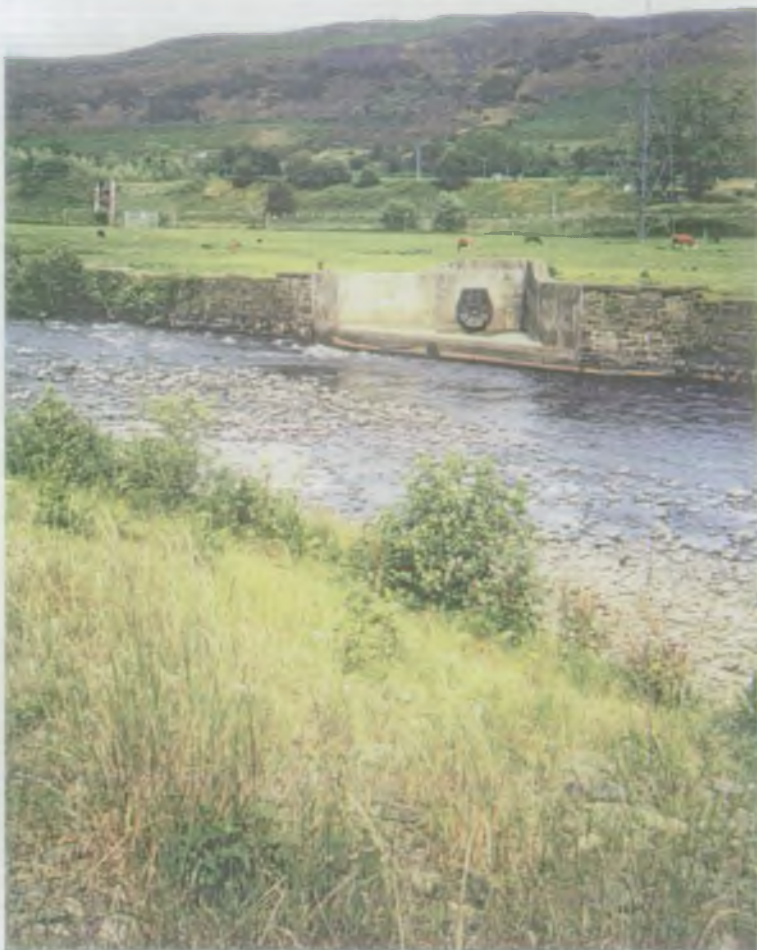
Site T12: Cilfynydd STW Storm Sewage Outfall, a potential source of sewage derived litter.

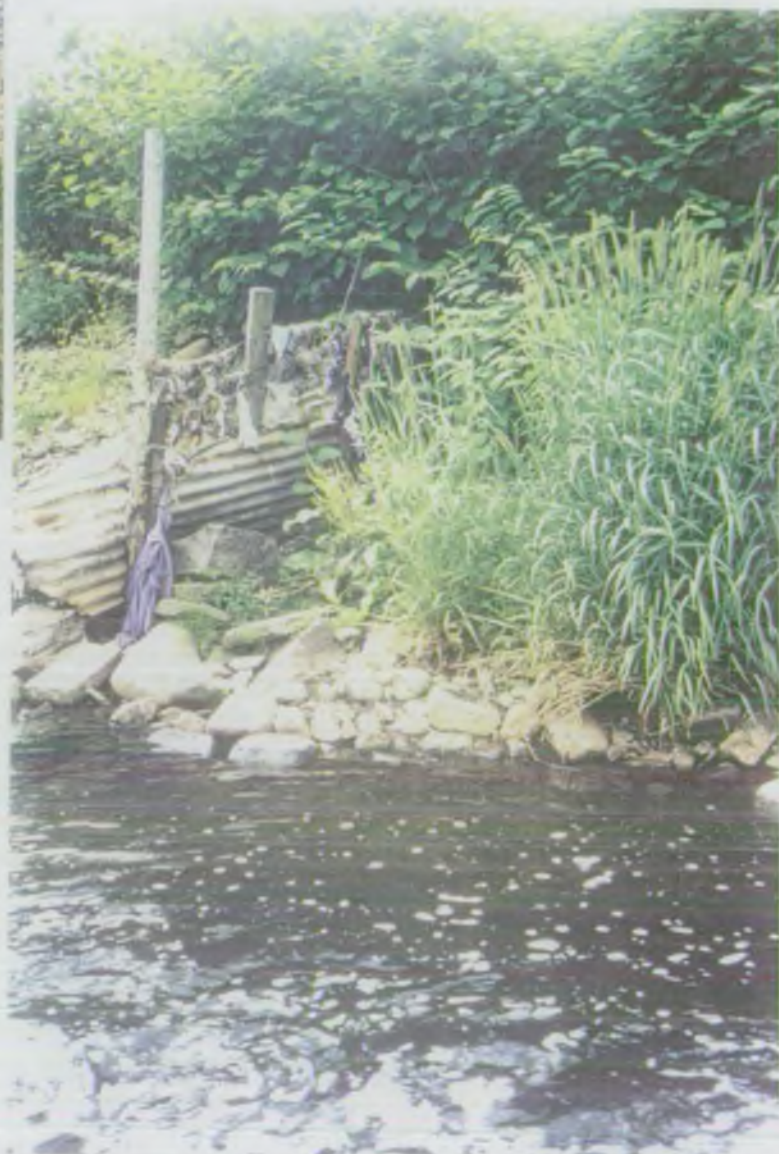
Site T12: The fence on the river bank d/s Cynon STW Final Effluent is draped in rags, plastic strips and sewage derived litter.

D/S Cilfynydd STW storm water overflow and Cynon STW final effluent discharges into the reach. Mainly sewage litter - the fence on bank adjacent to Cynon STW outfall is draped in clothing/plastic strips (see slide).

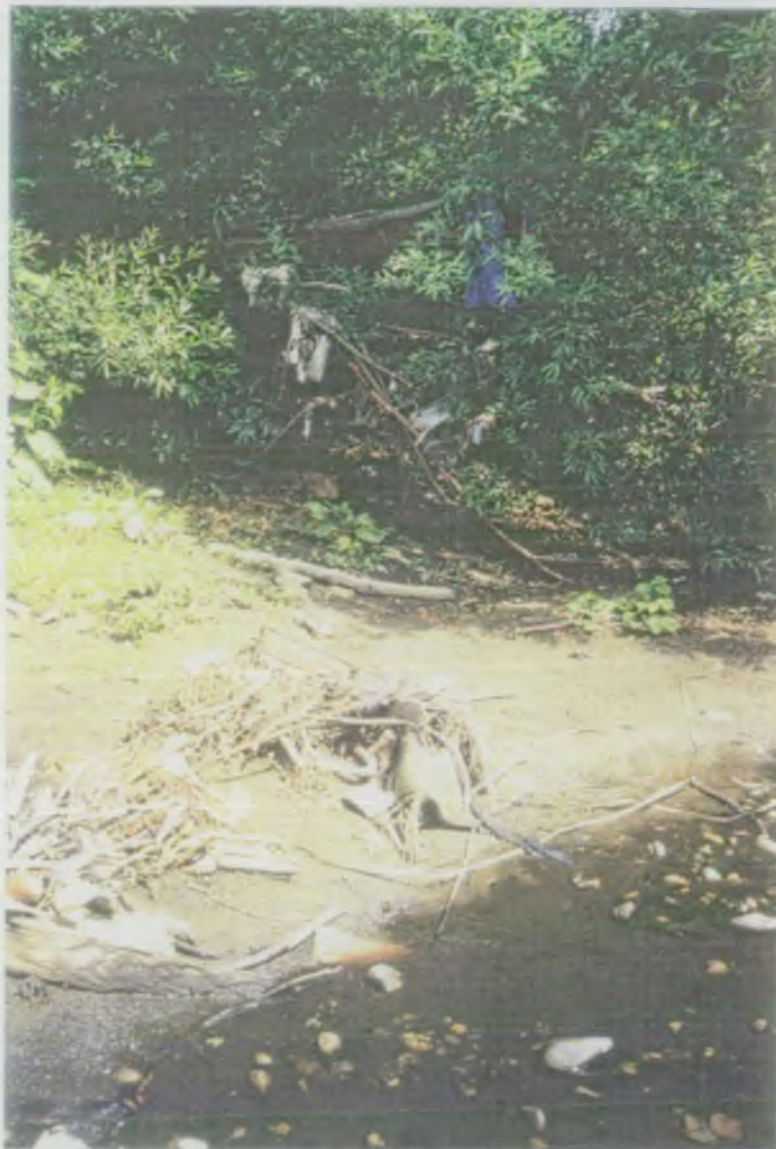
Site T19: Typical of the rubbish found strewn around the banks of the Lower Taff.

D/S Radyr Weir. Close to railway line and consequently railway sleepers and a huge cable drum had been dumped there. Large amounts of refuse and sewage litter deposited on the right bank in particular.

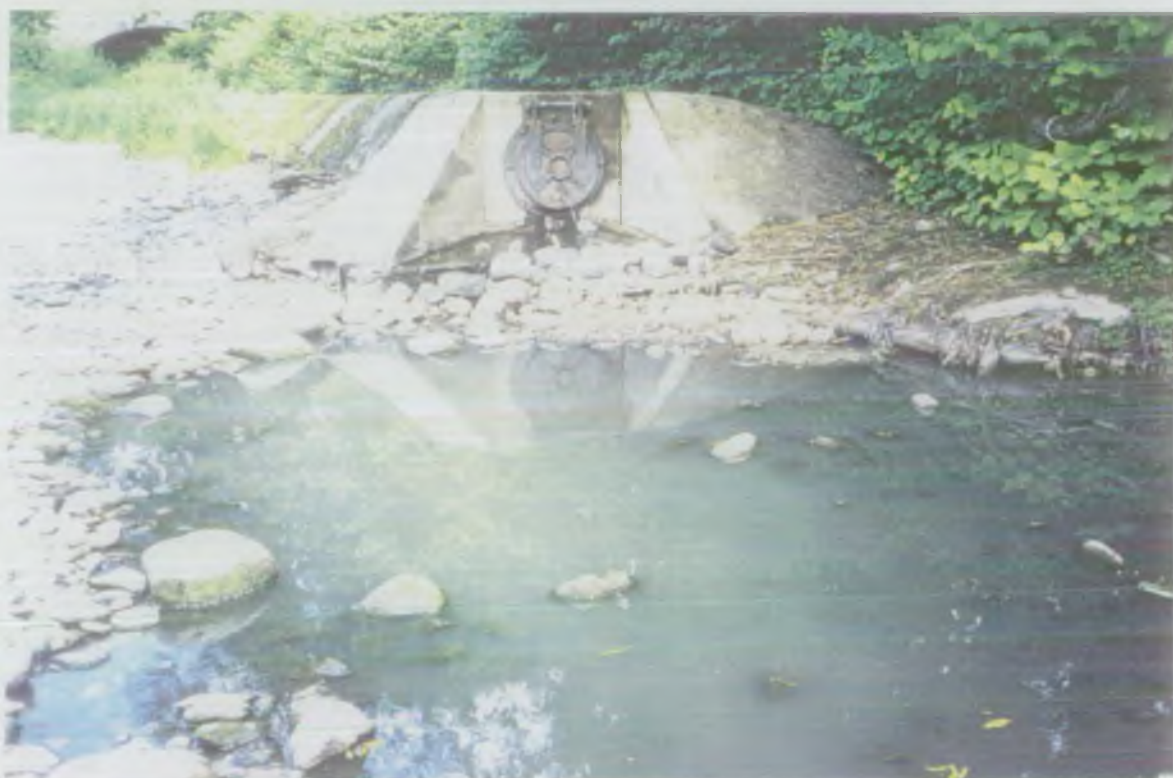
Site T20: At Fforest Farm railway bridge, Whitchurch, Cardiff. A storm sewer overflow discharging in dry weather with a pool of sewage at the outfall.

Sewage derived litter was mainly caught up on bankside vegetation and the only site downstream of Merthyr Tydfil at which it was absent from the transect (T11) had no overhanging vegetation. At site T20 (Fforest Farm, Whitchurch) sewage remained ponded around a Storm Sewage Overflow but at this and other sites with a potential point source (T9, T12), sewage litter was also found in similar abundance upstream of the outfall within the reach.

SSO with sewage ponded around the outfall but upstream contamination by sewage litter also. Less refuse here and more water-bourne debris.

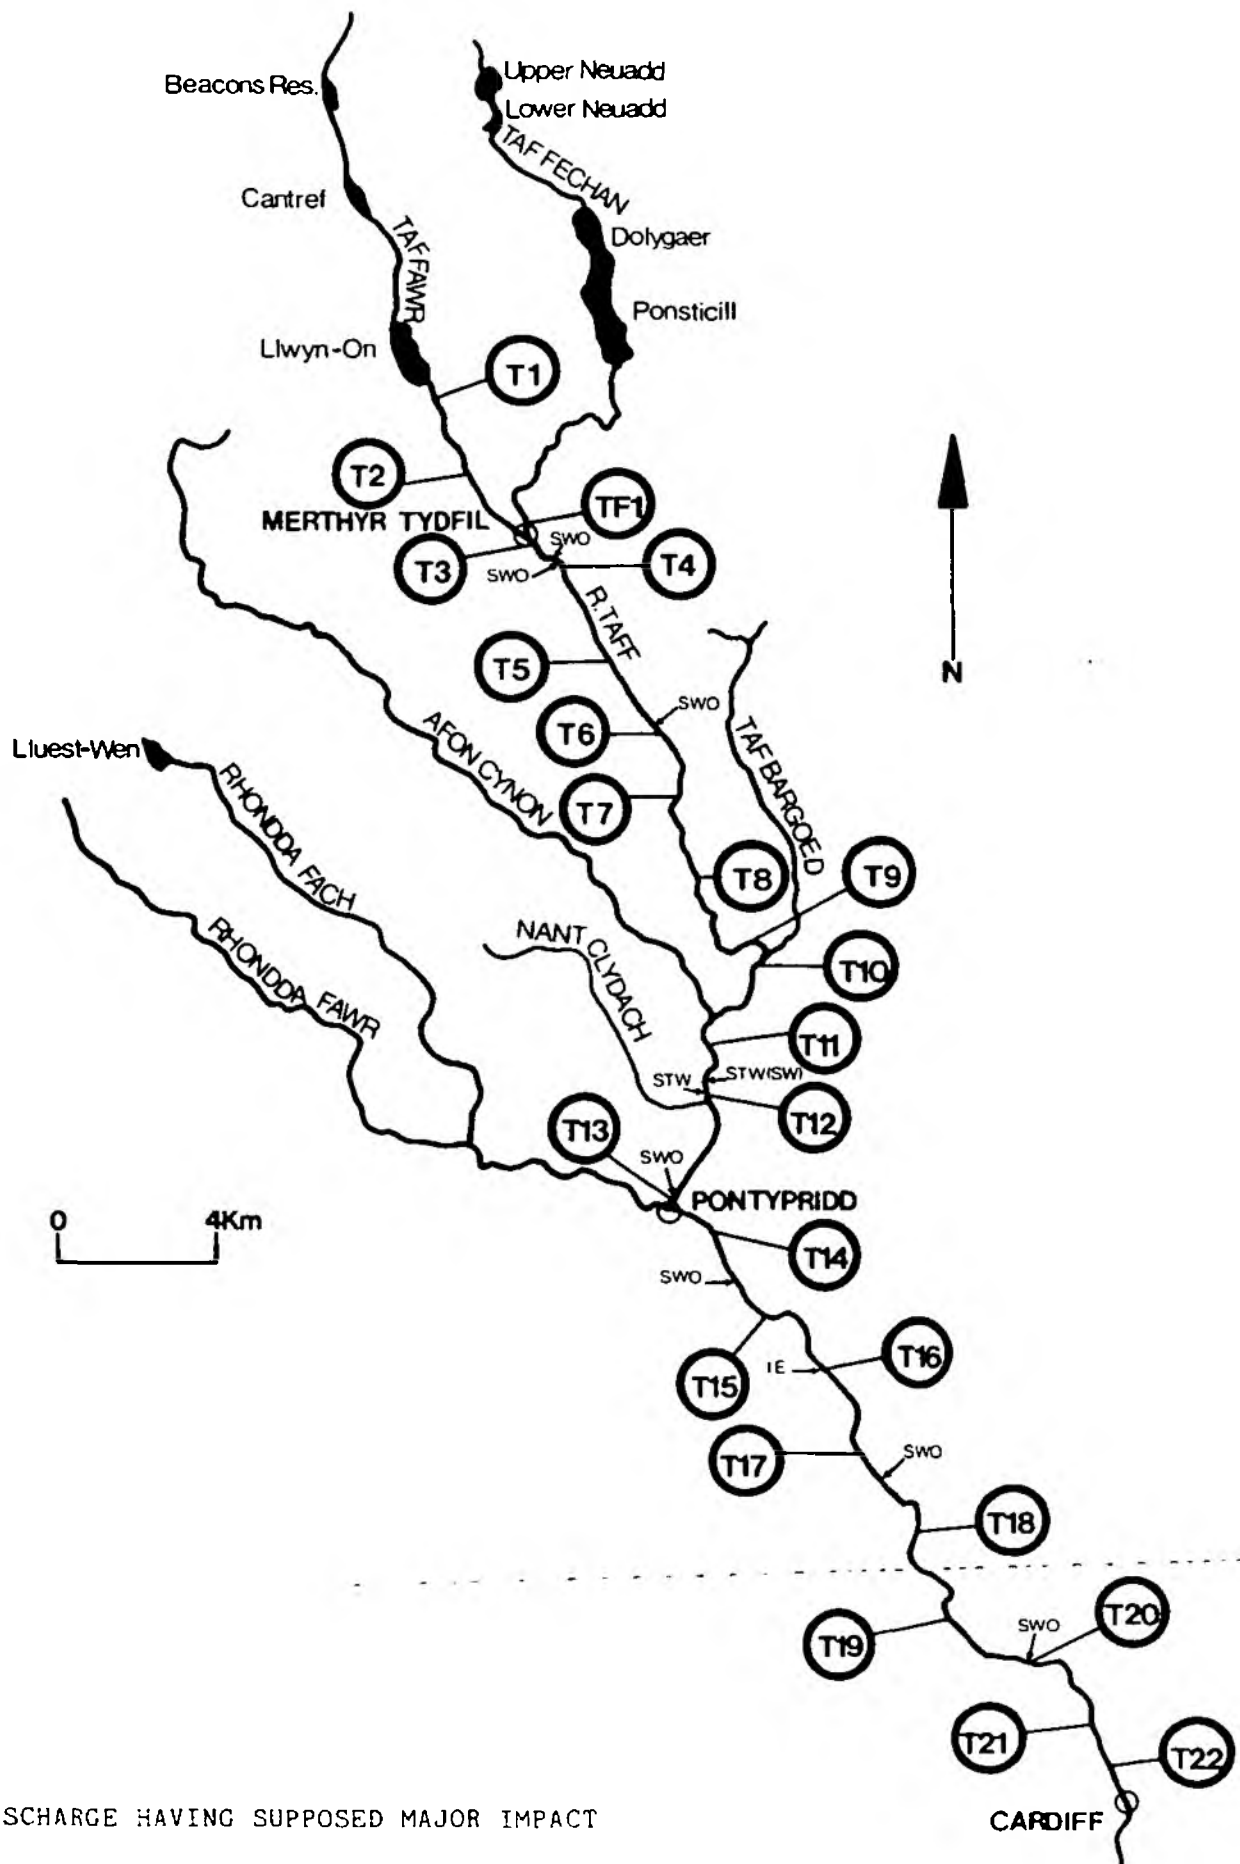
Data were collected for 22 sites on the Taff Fawr and 1 on the Taff Fechan at its confluence with the Taff Fawr (Fig 1). A photographic record of a) the reach and b) the bankside was obtained for each site, the whole survey being carried out between 22nd May - 6th June 1989.

Fig.1 : Survey sites and discharges which are the supposed major sources of litter in the Taff catchment.

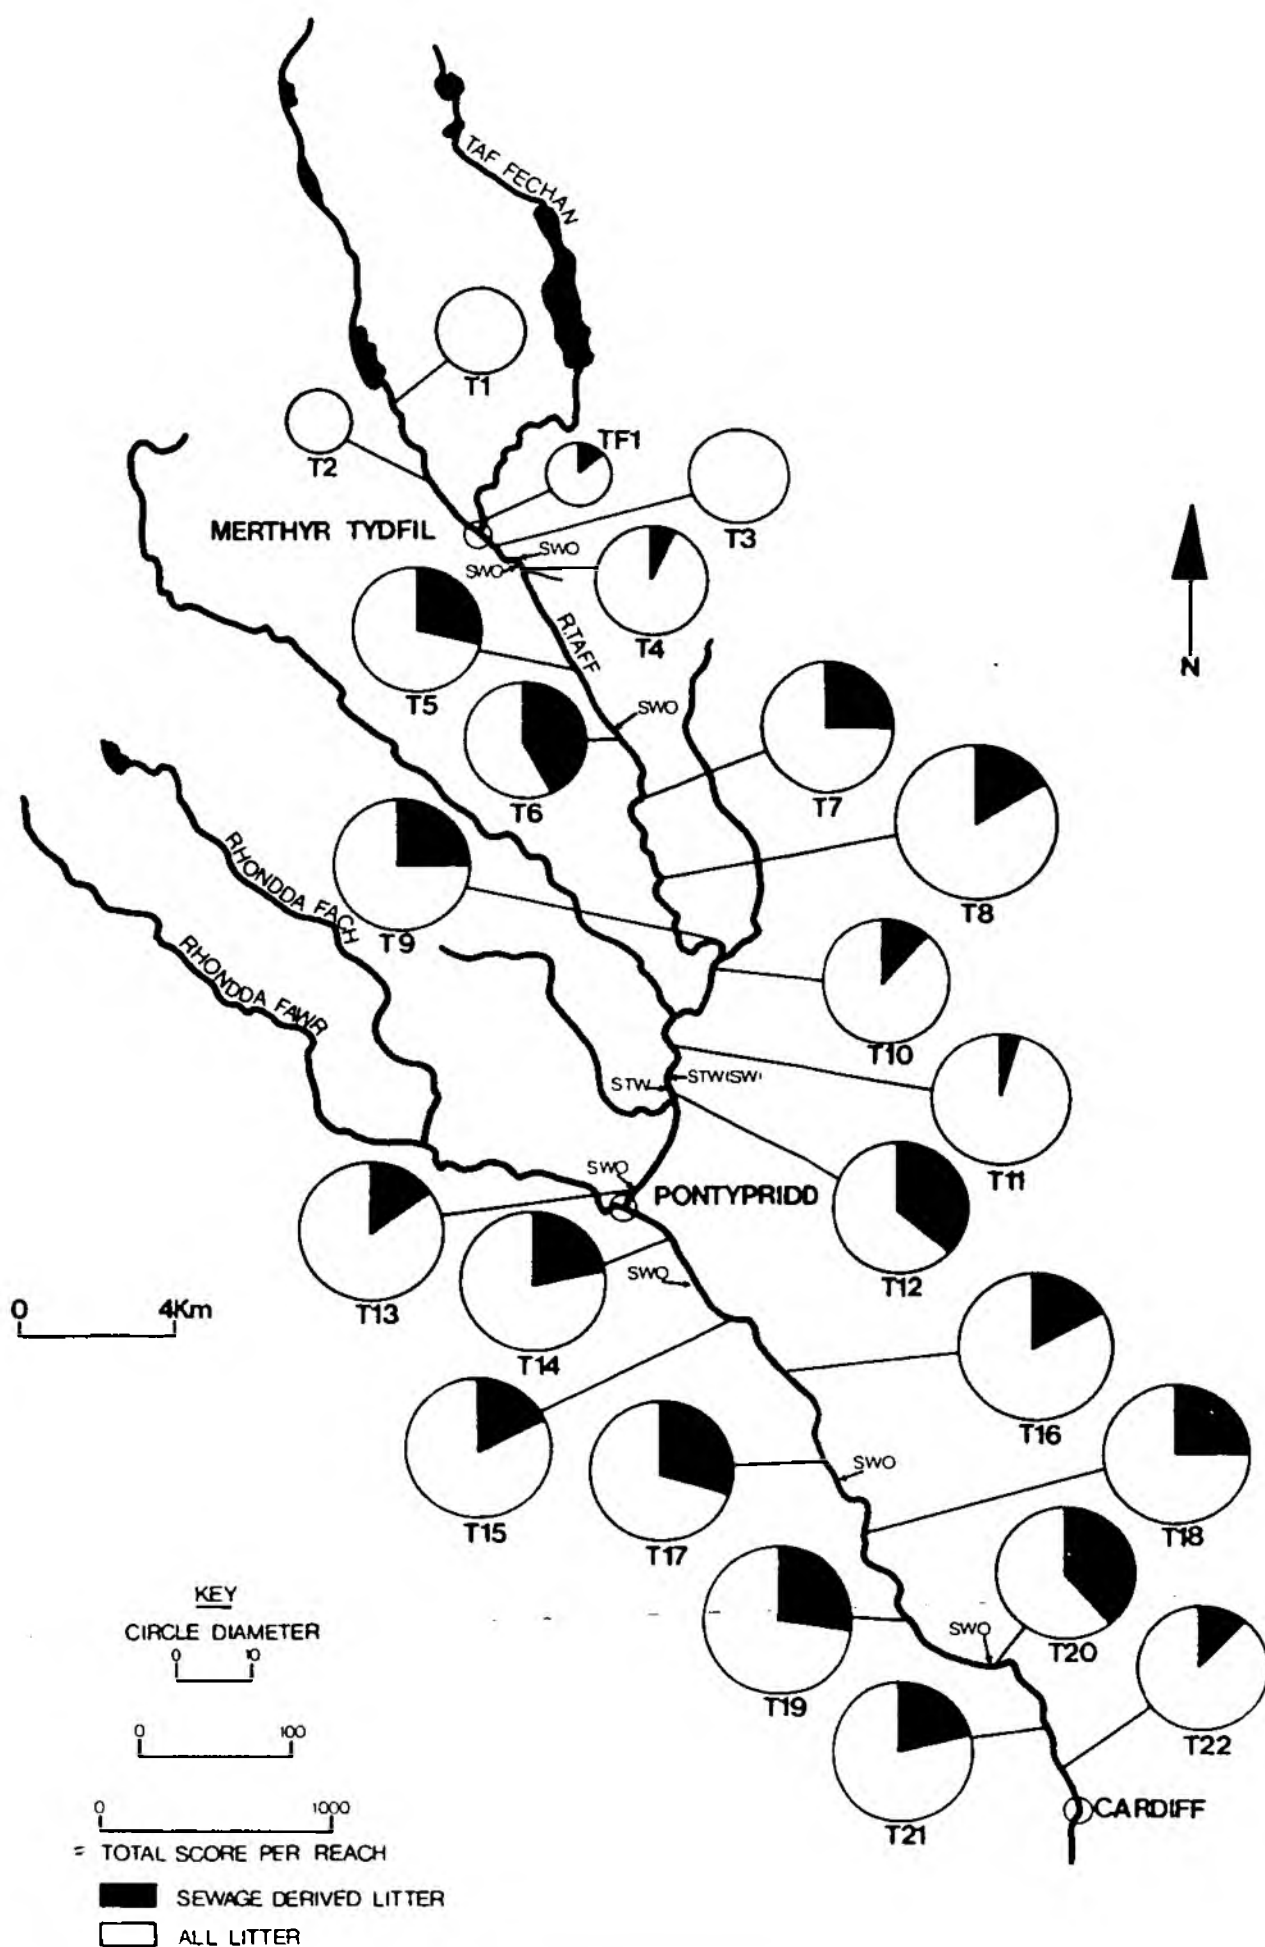
The proportion of sewage derived litter and refuse are illustrated in Fig. 2 as pie diagrams with the diameter of the circle representing the log total score. Sewage derived litter was virtually absent on the Taff Fechan but was present at all sites on the Taff Fawr from Merthyr Tydfil downstream. Upstream of Pontypridd, because background levels are low, the proportion of sewage derived litter can be attributed to a number of point sources previously identified by the Pollution Control Section as potential major inputs (Figs 1 and 2). However, downstream of Pontypridd and the major tributary rivers (Taff Bargoed, Afon Cynon, Nant Clydach and the Rhondda) (Fig. 1), sewage derived litter is ubiquitously distributed upstream and downstream of any point sources with only slight localised increase. Sewage derived litter forms greater than 25% of all litter at sites T5, T6, T12, T17, T19 and T20, with the highest percentages at sites T6 (42%), T12 (36%) and T20 (38%).

FIG.2 : Abundance of litter and the proportion which is sewage derived at each survey site on the Taff.

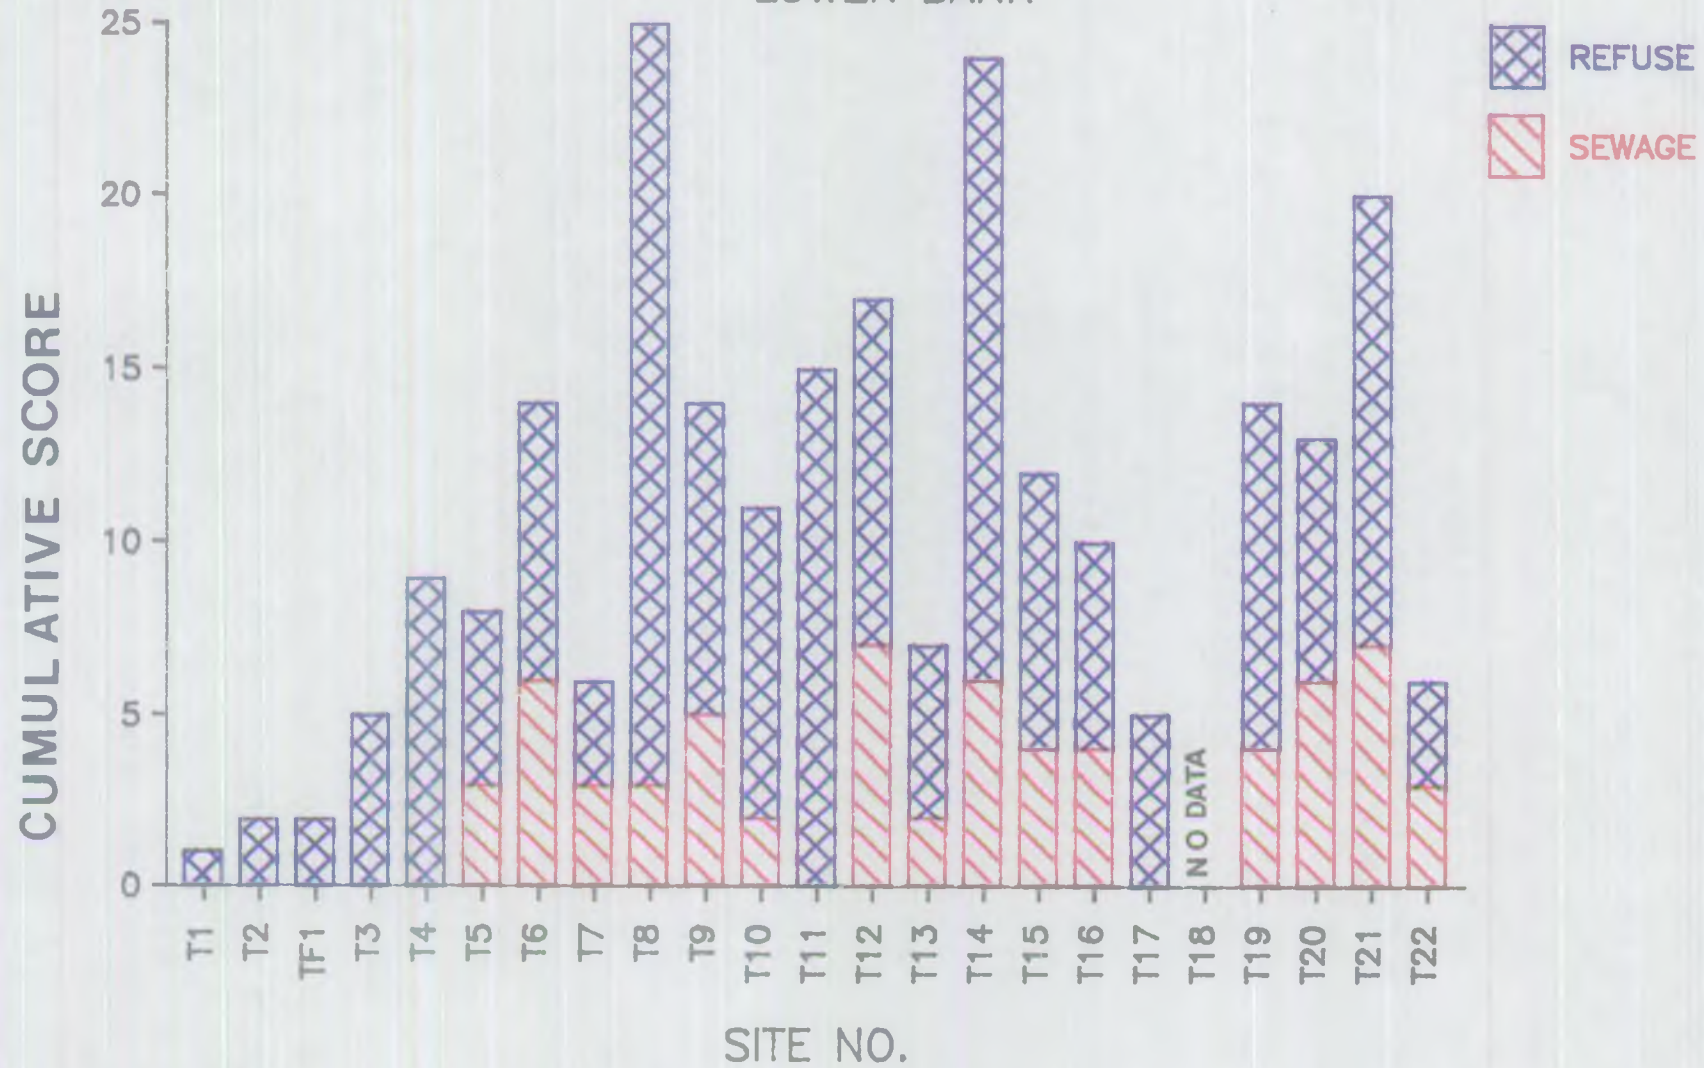
Fig 4:

Generally, the main component of litter on the lower bank was sewage mixed with the type of refuse associated with sewage e.g. plastic strips and clothing, and similarly on the middle bank. As the maximum height of the flood channel was reached sewage litter became less evident. The upper bank tended to be generally less littered but the main component was refuse. Site T2, between Llwyn On Reservoir and Cefn Coed was the cleanest site and the heaviest contamination with both sewage and refuse recorded at site T20 (Fforest Farm, Whitchurch).

# TAFF LITTER: SEMI-QUANTITATIVE ASSESSMENT

LOWER BANK

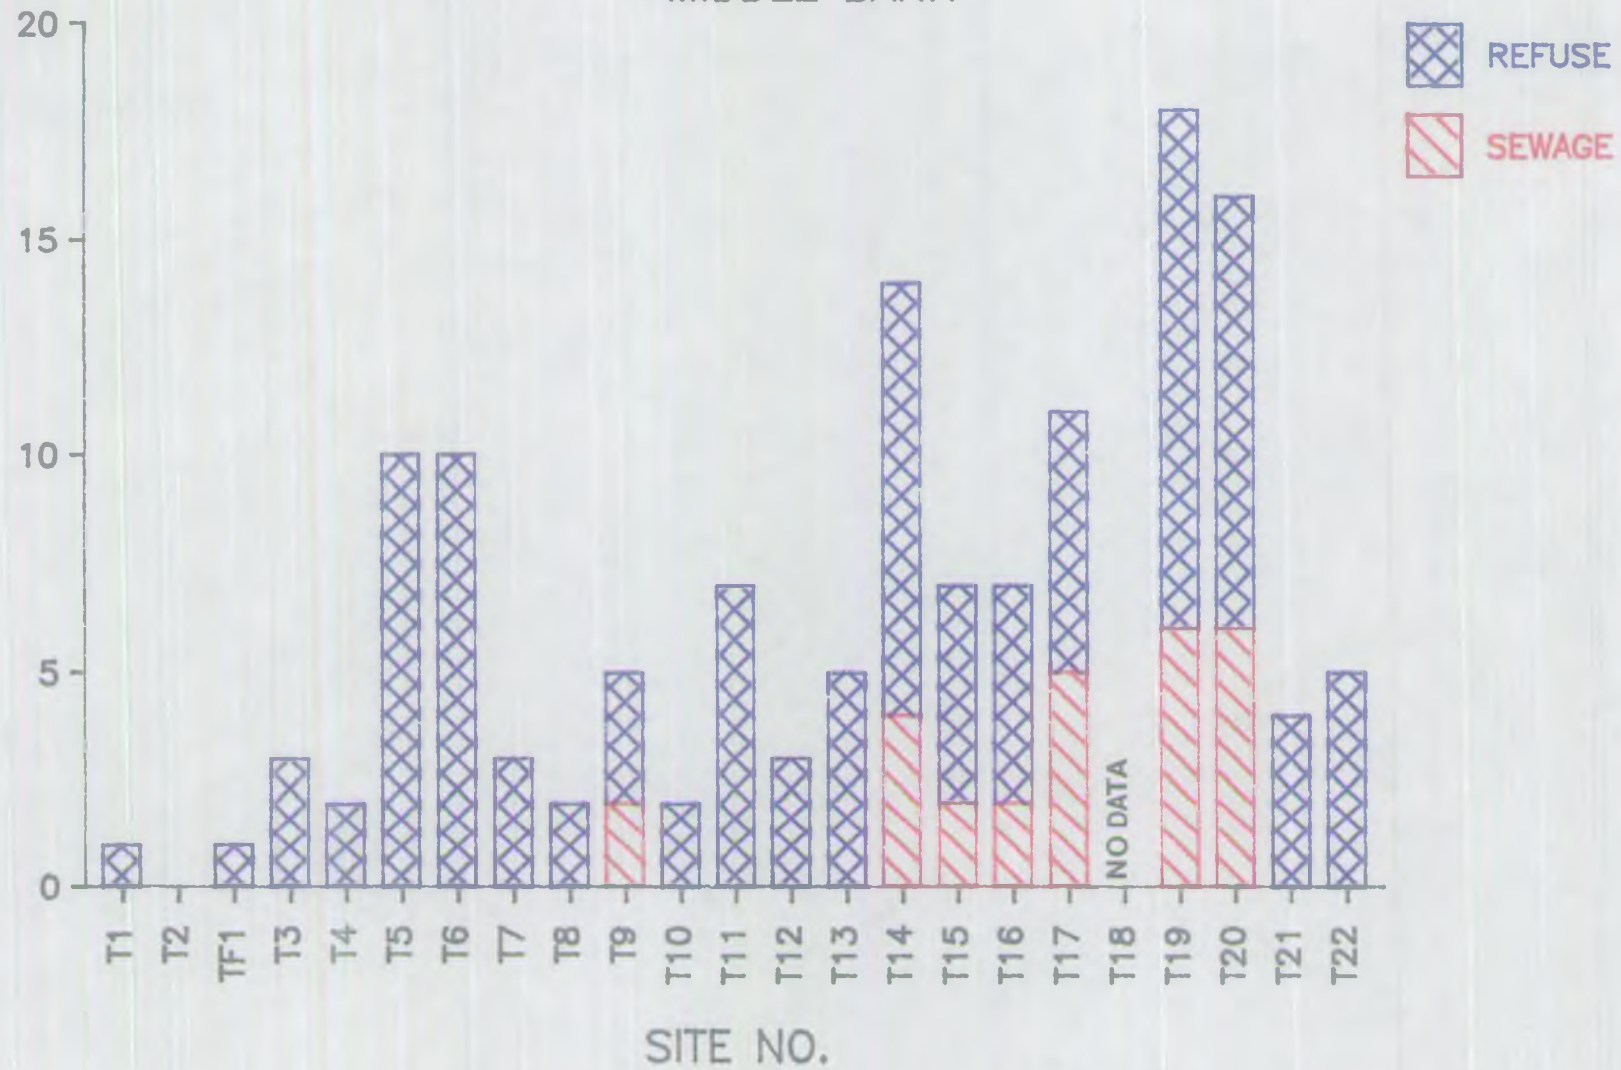
**Fig 5:**

# TAFF LITTER: SEMI-QUANTITATIVE ASSESSMENT MIDDLE BANK

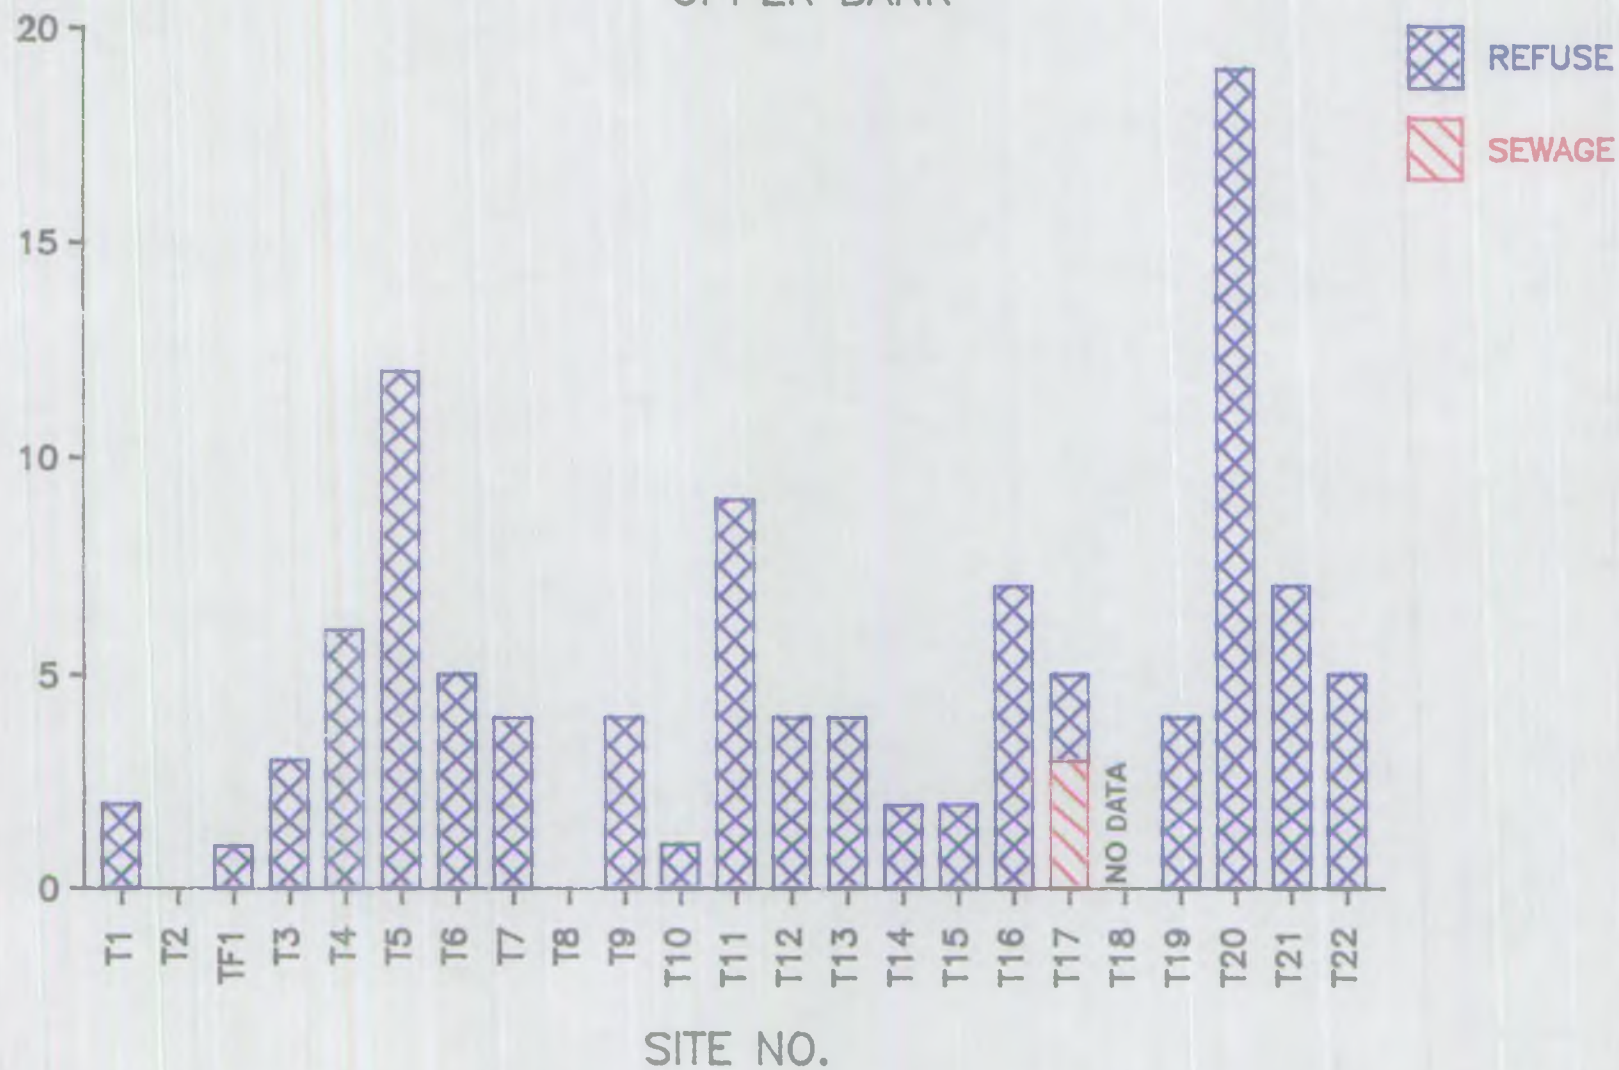
Fig 6:

# TAFF LITTER: SEMI-QUANTITATIVE ASSESSMENT UPPER BANK

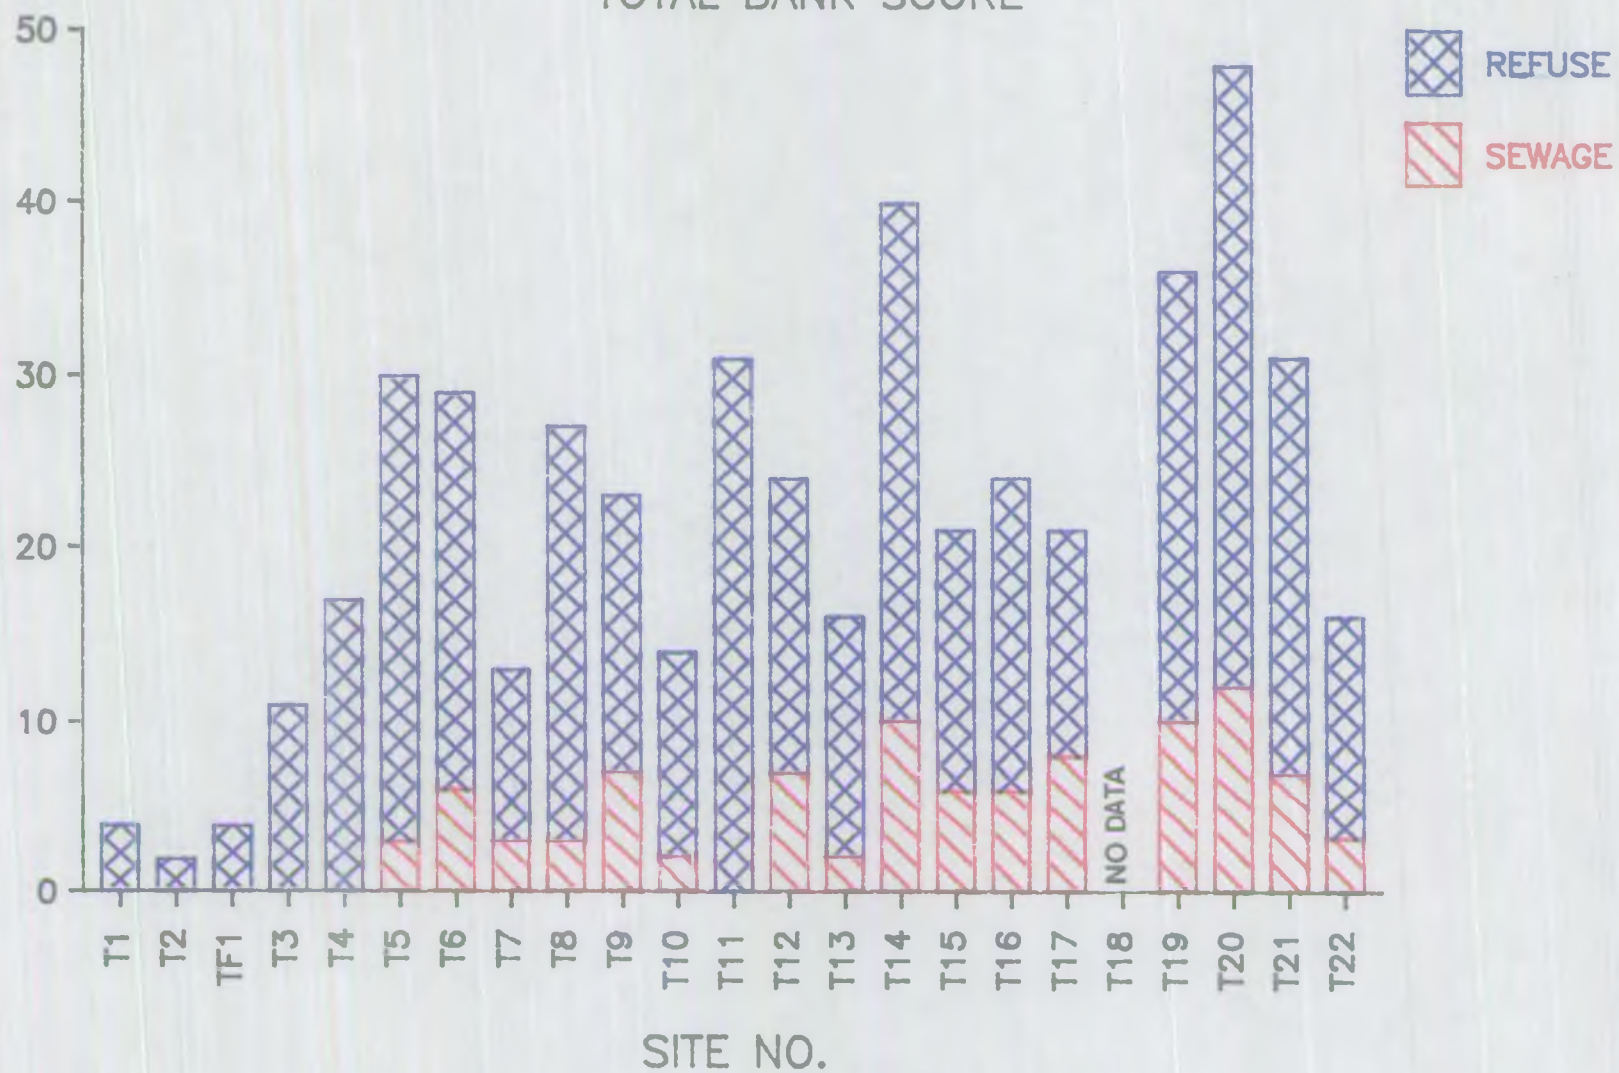
Fig 7:

# TAFF LITTER: SEMI-QUANTITATIVE ASSESSMENT

TOTAL BANK SCORE
